Seismic Evaluation Summary

1717 4th Street
Santa Monica, California

February 7, 2020

Job No. 19-L173

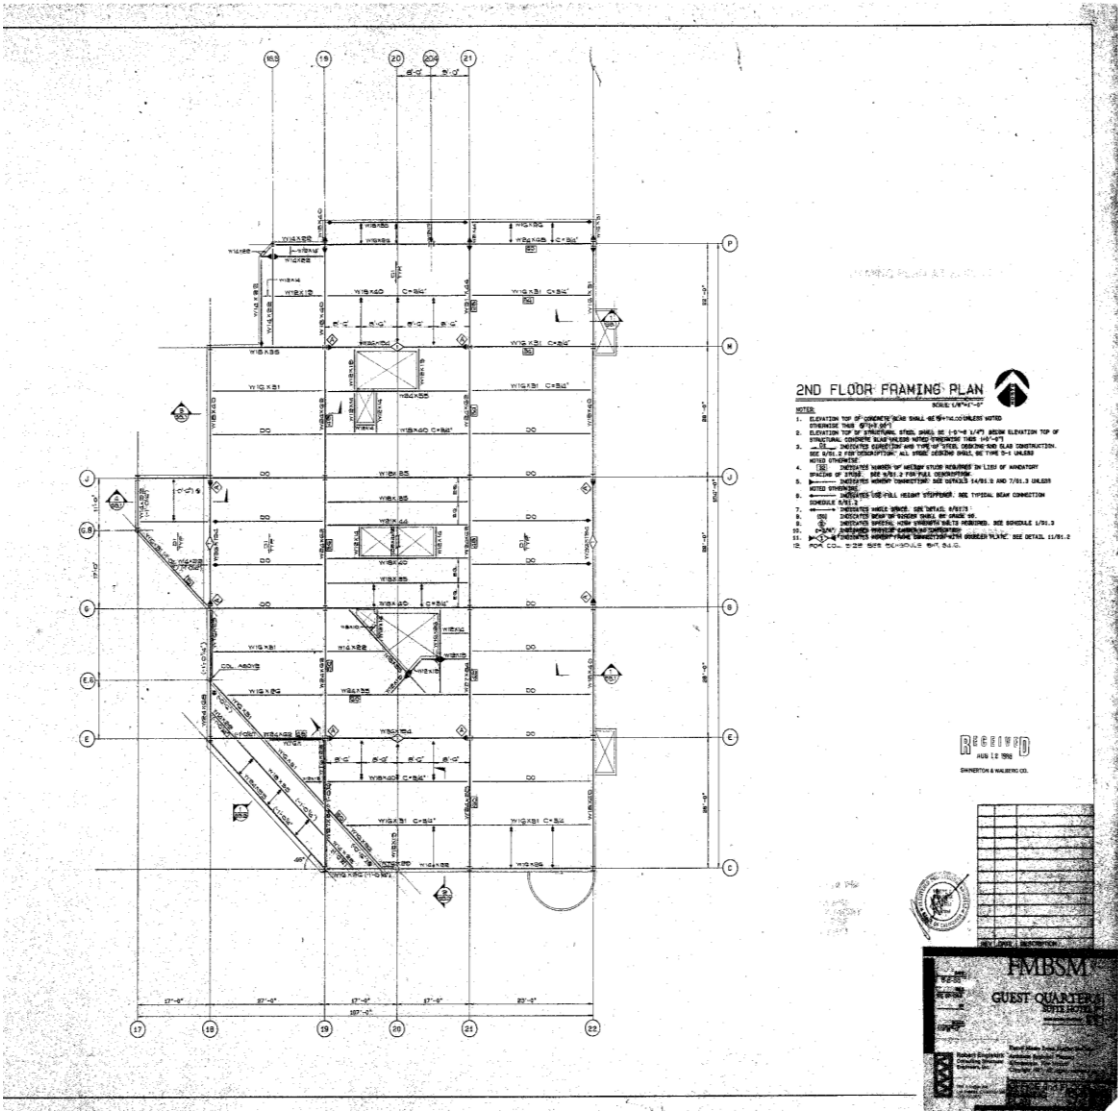
Figure 2.1 Typical Floor Framing Plan

The lateral force resisting system consists of pre-Northridge steel moment resisting frames. Two are located along the North-South direction along grids 18 and 22. The remaining steel moment resisting frames are located along the East-West direction along grids E and M.

The arrangement of the steel moment frames is shown in Figure 2.1. The building is classified as Building Type S1: Steel Moment Frames with Stiff Diaphragms. It is our understanding that the building was constructed in 1989, therefore, is not considered as a benchmark building per ASCE 41-13.

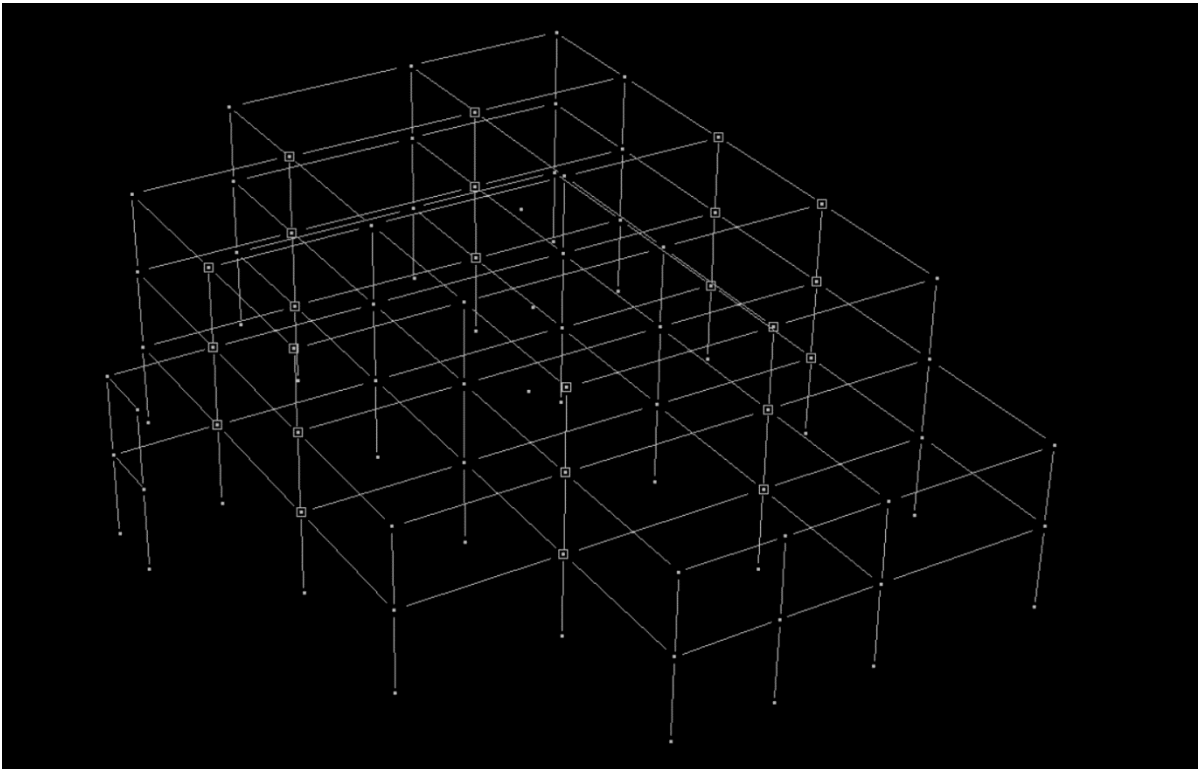
Figure 3.1 3D Structural Model of the building in Perform3D

ASCE 41-13 Seismic Evaluation and Retrofit of Existing Buildings Tier 3 Systematic Evaluation was employed as the evaluation method. The Tier 3 procedure for non-linear static evaluation was implemented to evaluate potential seismic deficiencies of the building. Given the building’s lateral-force-resisting system described in Section 2.0, the building is classified as a Type S1 structure in accordance with ASCE 41 Table 3-1. To perform the evaluation, a three-dimensional finite element model was created using structural analysis and design software PERFORM 3D, as shown in Figure 3.1.

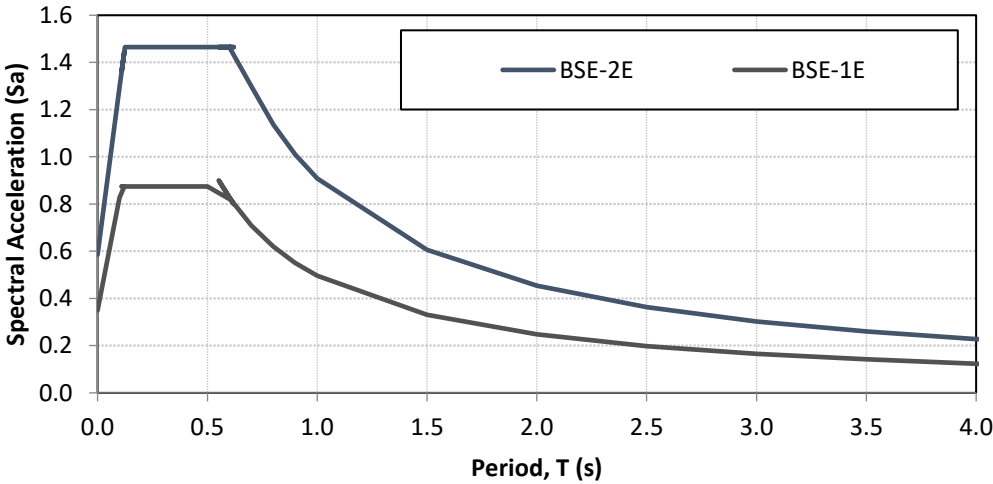
Figure 4.1 BSE-2E & 1E Spectral Ordinates per ASCE 41-13

Spectral accelerations were obtained from the USGS for the Basic Safety Earthquake-1 (BSE-1E) hazard levels and Basic Safety Earthquake-2 (BSE-2E) hazard levels. The ordinates required for the Basic Performance Objectives for Existing Buildings (BPOE) are illustrated in Figure 4.1. The BSE-2E hazard level corresponds to an earthquake with an average return period of 975 years or 5% probability of exceedance in 50 years. BSE-2E spectral accelerations are used to verify that the building satisfies Collapse Prevention performance objectives. The BSE-1E hazard level corresponds to an earthquake with an average return period of 225 years or 20% probability of exceedance in 50 years. BSE-1E spectral accelerations are used to verify that the building satisfies Life Safety performance objectives.
