**Santa Monica-Malibu  
Unified School District**  
John Muir - SMASH Elementary School

**Findings Report**  
**Building Envelope Investigation**

Report Date: June 30, 2022

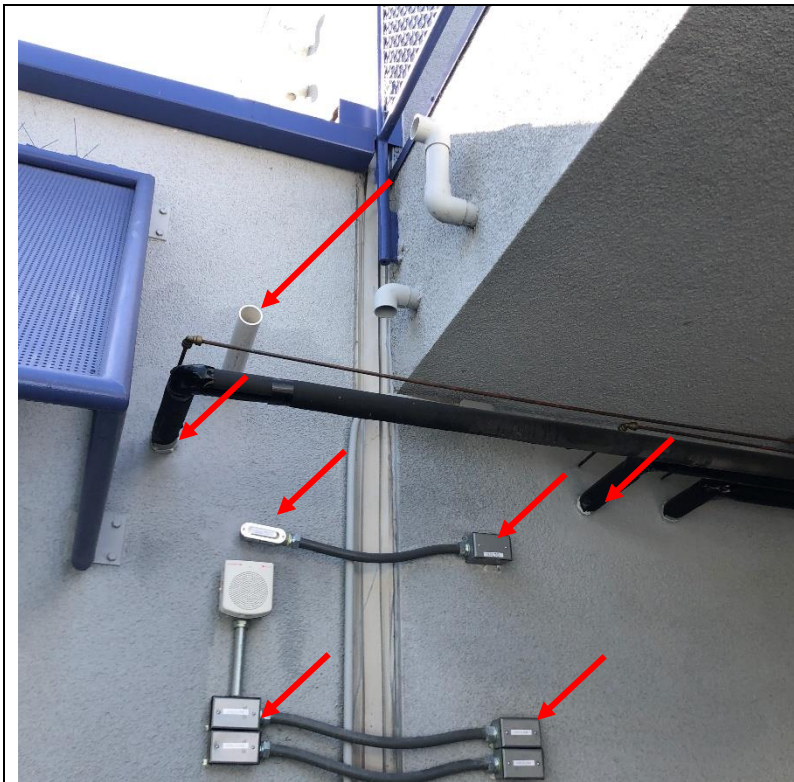
**Photo 06:**  
Penetrations in the cement plaster assembly.

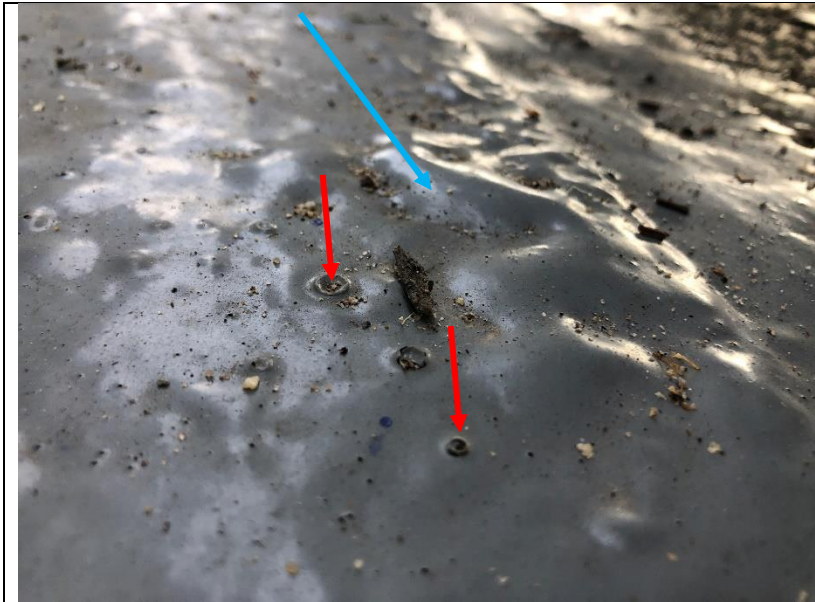
In general, the traffic coating is well adhered to the substrate and in good condition. Several patches were observed around the campus. Blistering and pinholes were observed at several of the traffic coating patches (**Photos 50 – 52**).

**Photo 51:**  
Blisters (blue arrow) and pinholes (red arrows) in a traffic coating patch indicating trapped water and/or coating failure.

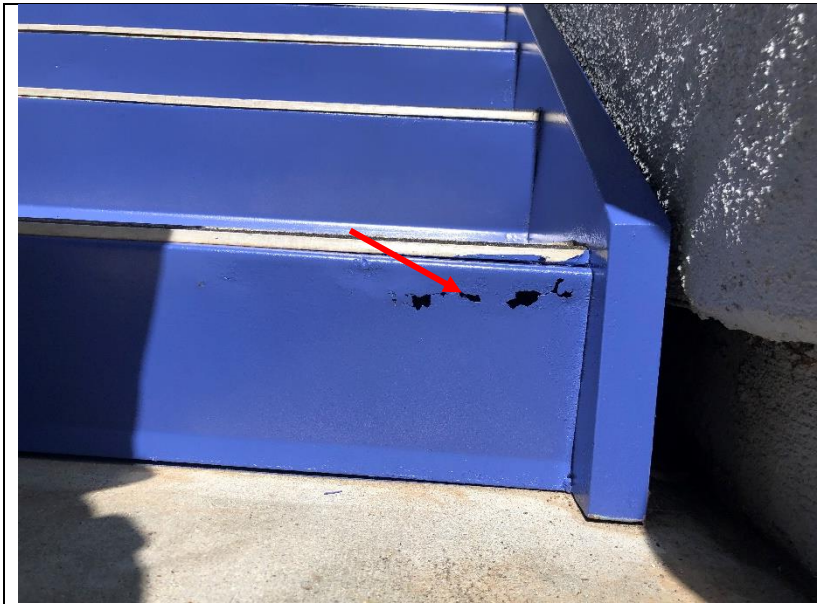
Steel-framed stairs were located at various locations around the campus. At several locations, corrosion was observed at the metal stair treads and risers. A crew was painting various stairs and trim during the investigation. DTR did not observe any surface preparation taking place before the areas were painted. Corrosion damage was still visible in some locations after the new paint had been applied (**Photos 65 – 68**).

**Photo 68:**  
Corrosion was observed on the stairs after repainting.

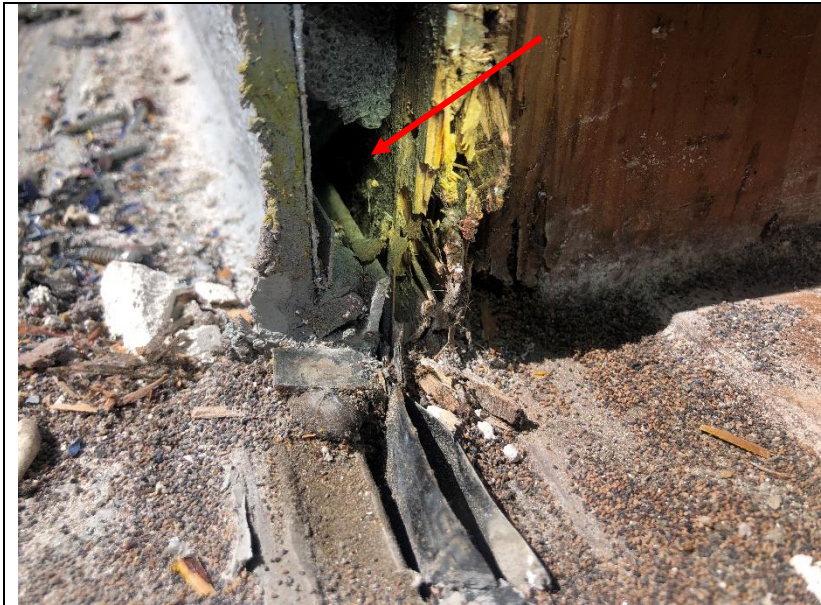
**Photo 72:**

Dry rot and damp wood within the wall assembly.

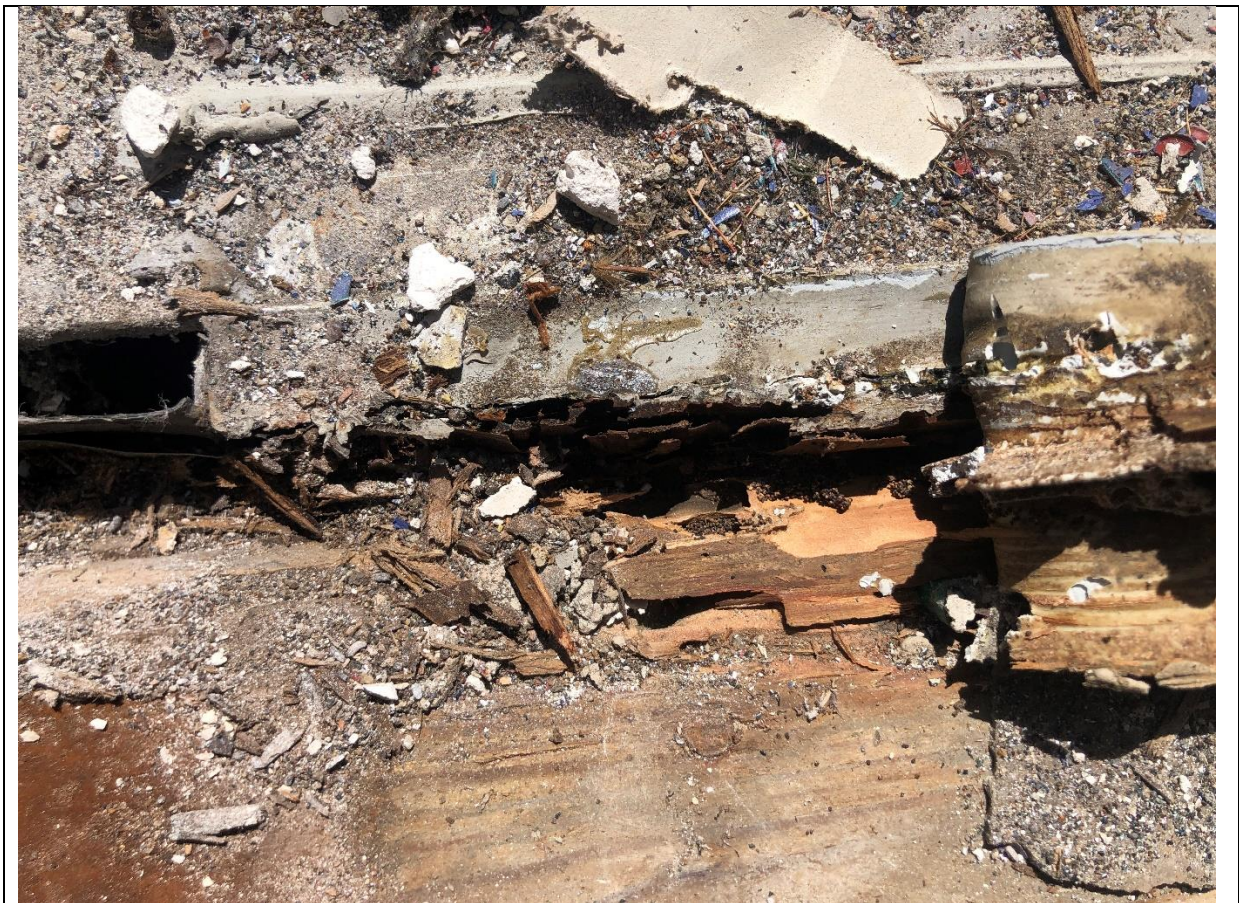
As each hollow metal frame was removed, DTR was able to observe the wall assemblies as well as the threshold transition to the traffic coating. At the threshold of classroom 480, an expansion joint ran parallel to the door. The expansion joint was meant to allow the elevated walkway to move separately from the building. A sufficient slope to drain was not achieved and standing water was observed in the neoprene water stop at the expansion joint. The neoprene water stop was installed at the same plane as the cement plaster which does not conform to the 2001 drawing set for the construction of the elevated walkways (**Photos 69 – 72 and Fig 02**). The exposed edge of the exterior plywood wall sheathing was damp to the touch. Moisture readings along the wood door sill framing ranged from 20.1 to 30.6 % moisture. These readings are high enough to result in wood damage. Dry rot and what appeared to be insect damage were also observed along the sill. Water damage was also observed at the upturn of the jambs (**Photos 73 - 79**).

**Photo 73:**  
Dry rot, water damage, and suspected insect damage at the threshold of classroom 480

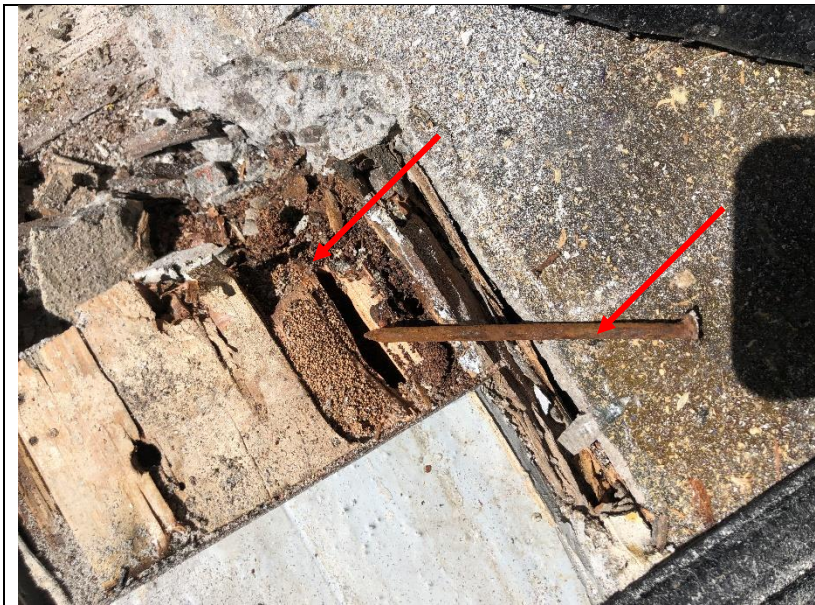
At the other three locations where hollow metal frames were removed, the transition of the deck to the walls did not incorporate an expansion joint. Similar water damage was observed at each threshold. In some locations, such as Classroom 455 and Workroom 252, damage at the transition from the sill to jamb was significant, suggesting that water was moving down between the rough opening and the jambs of the hollow metal frames and collecting on the sill at those corner locations. The exposed edge of the exterior plywood wall sheathing was damp to the touch. Dry rot and what appeared to be insect damage were also observed along the sill. Corrosion was visible at fasteners at the sills and jambs of each door (**Photos 80 – 88**).

**Photo 88:**  
Dry rot, water damage, corroded fasteners, and suspected insect damage at the threshold

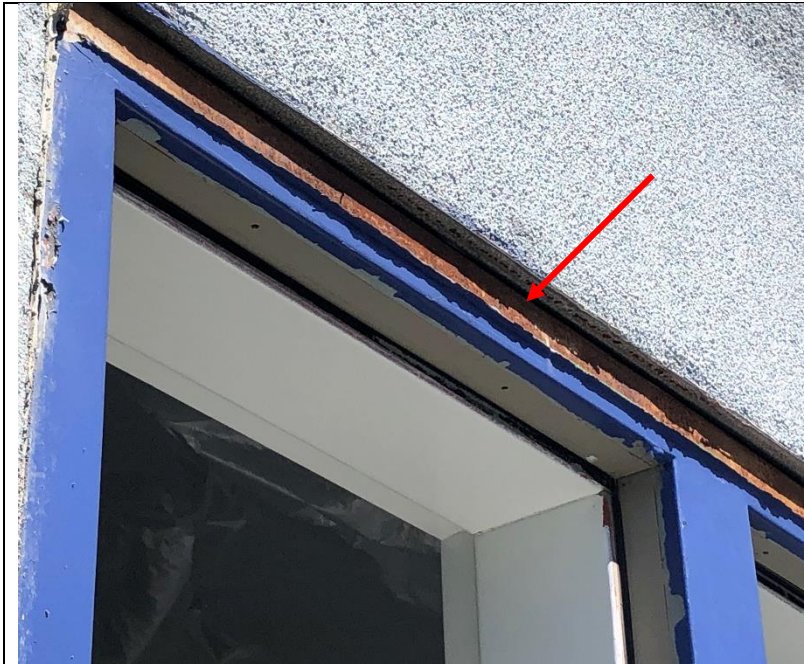
DTR observed that some of the hollow metal-framed doors had head flashing such as Technical Room 570, while others did not such as Classroom 480. When the head flashing above the door was removed at Technical Room 570, corrosion was observed along the head of the hollow metal frame. No weep screed was observed in the plaster stop at that location (**Photos 95 – 96**).

**Photo 95:**  
Corrosion was observed behind a head flashing at one of the hollow-metal framed doors indicating moisture behind the flashing.

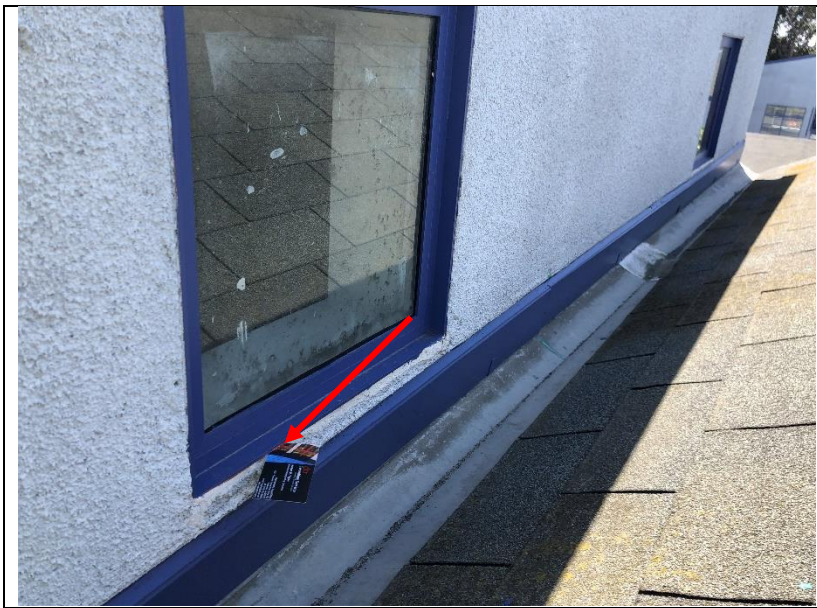
**Photo 109:**  
A sealant failure at the perimeter of an aluminum-framed window at roof level.

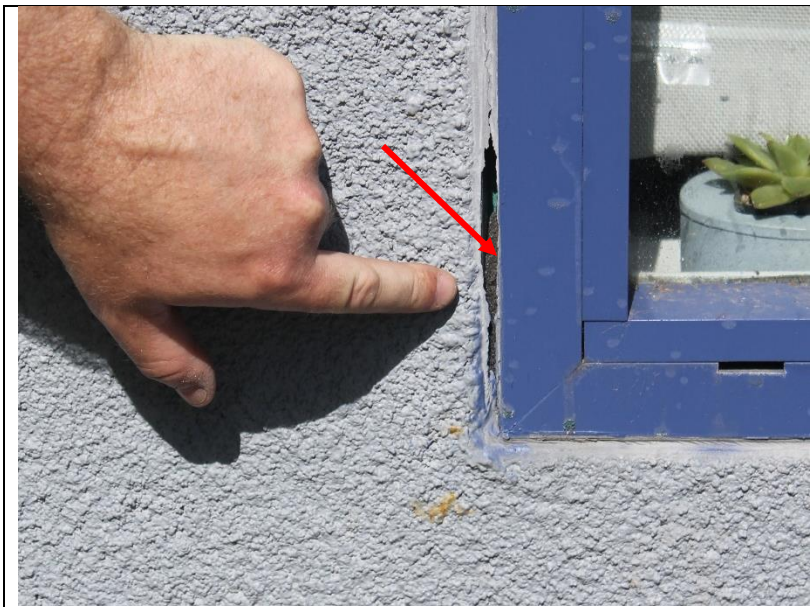
**Photo 110:**  
A sealant failure at the perimeter of an aluminum-framed window.

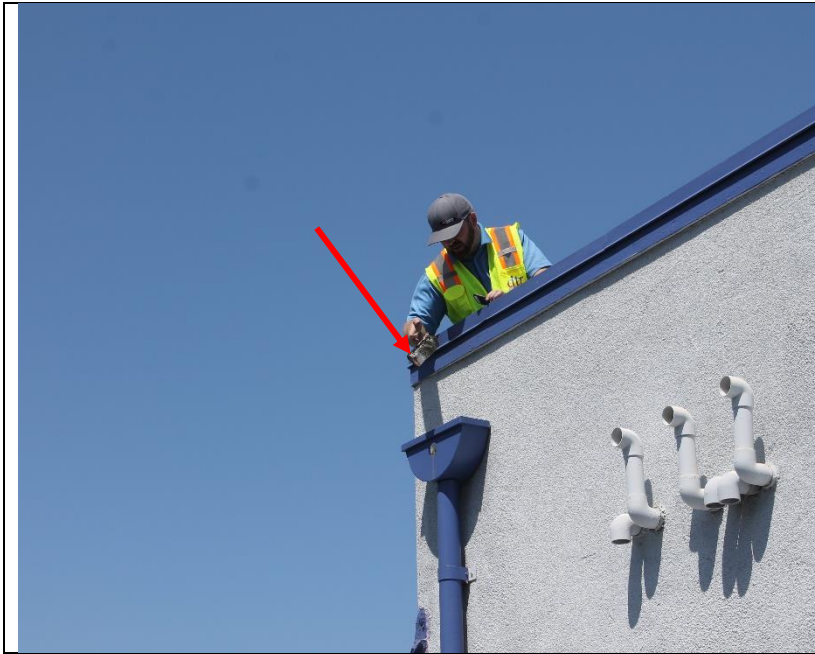
**Photo 152:**

Significant granule loss from the asphalt shingle roofs was also apparent from the amount of washed-off debris that has built up in various areas. A downspout on building A was blocked and filled with debris. Several of the gutters were partially filled with granules. Corrosion and holes in the gutter system were also visible at several locations (**Photos 152 – 158**).

DTR clearing a blocked downspout.

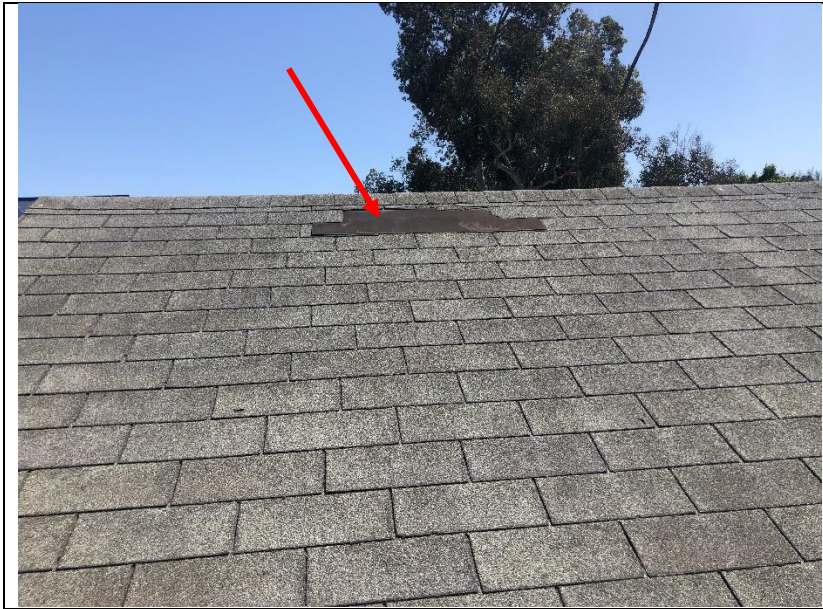
**Photo 160:**

In several locations, shingle tabs were observed on the roof deck or were missing altogether. Vent pipe penetrations on the shingle roofs were corroded. At one location at building C, a leak was reported under one of these vents. The vent is adjacent to other deficiencies on the roof and the location of water ingress could have more than one contributing factor. Similar corroded vents at other buildings had a self-adhered membrane flashing it to the roof in a nonstandard installation (**Photos 159 – 162**).

Shingle tabs were observed on the roof deck, damages on the roof, or were missing altogether.

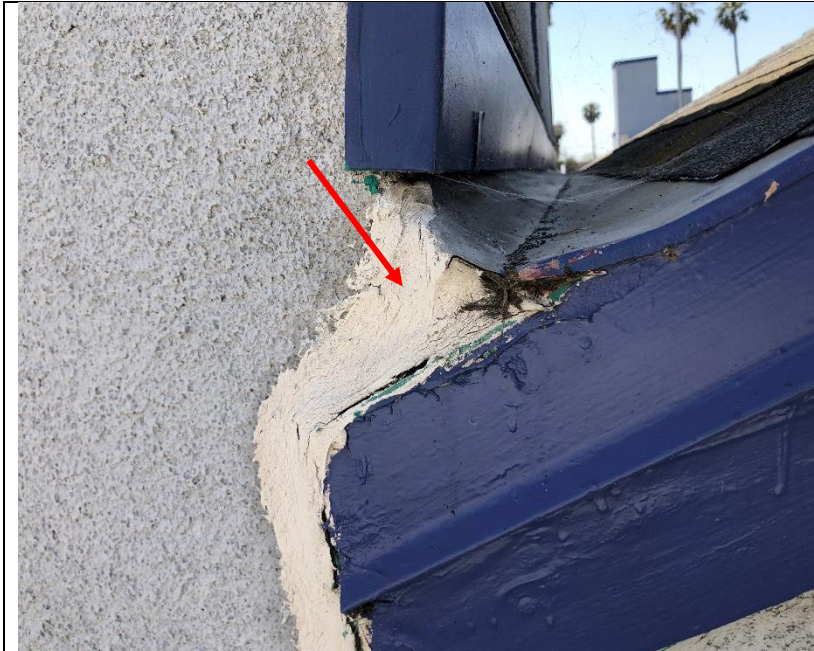
Sealant was observed at the ends of the sheet metal valley, at the downturn onto the wall. The sealant was cracked and openings were visible. This condition was systemic in many of the sawtooth valleys (**Photos 168 – 169**).

**Photo 168:**  
Sealant was observed at the ends of the sheet metal valley

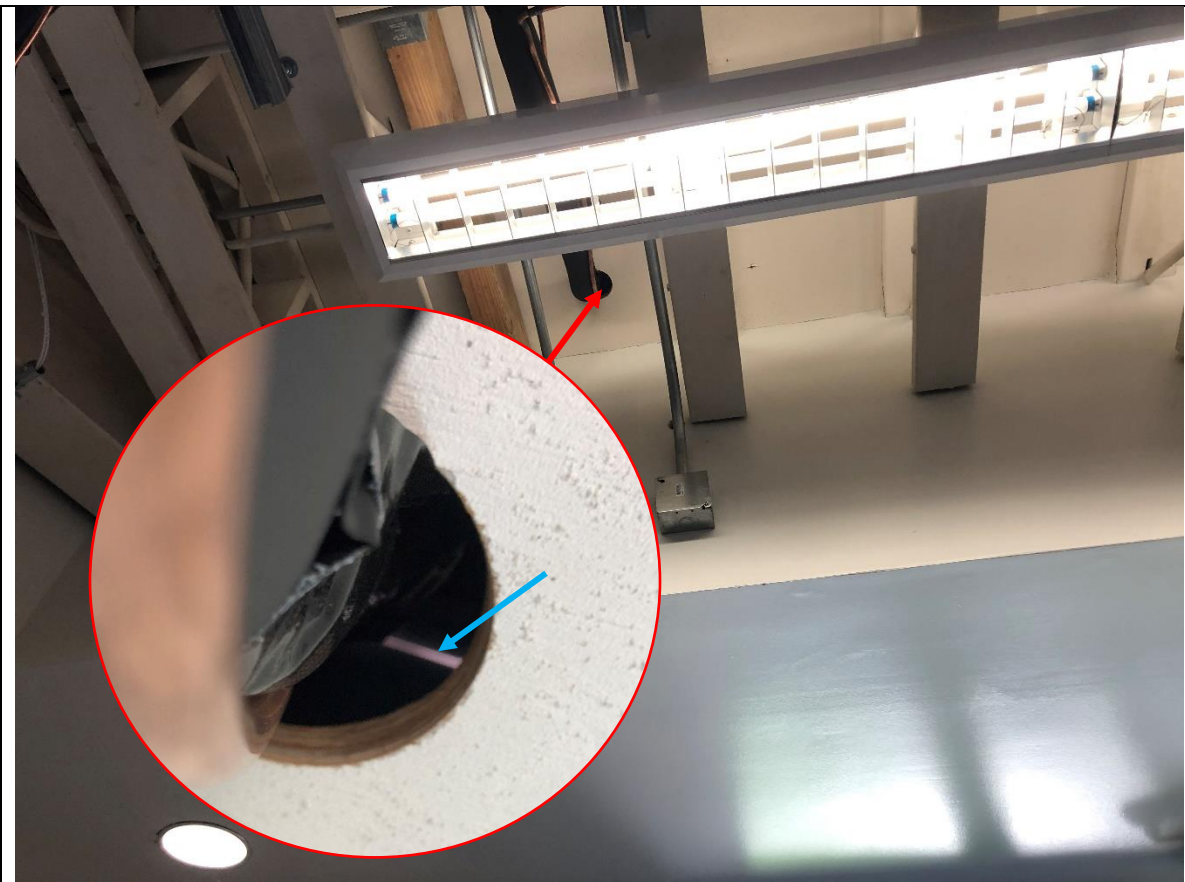
**Photo 182:**  
Exterior light was visible through the wall system over the east entrance to the library. The location is a reported leak site.

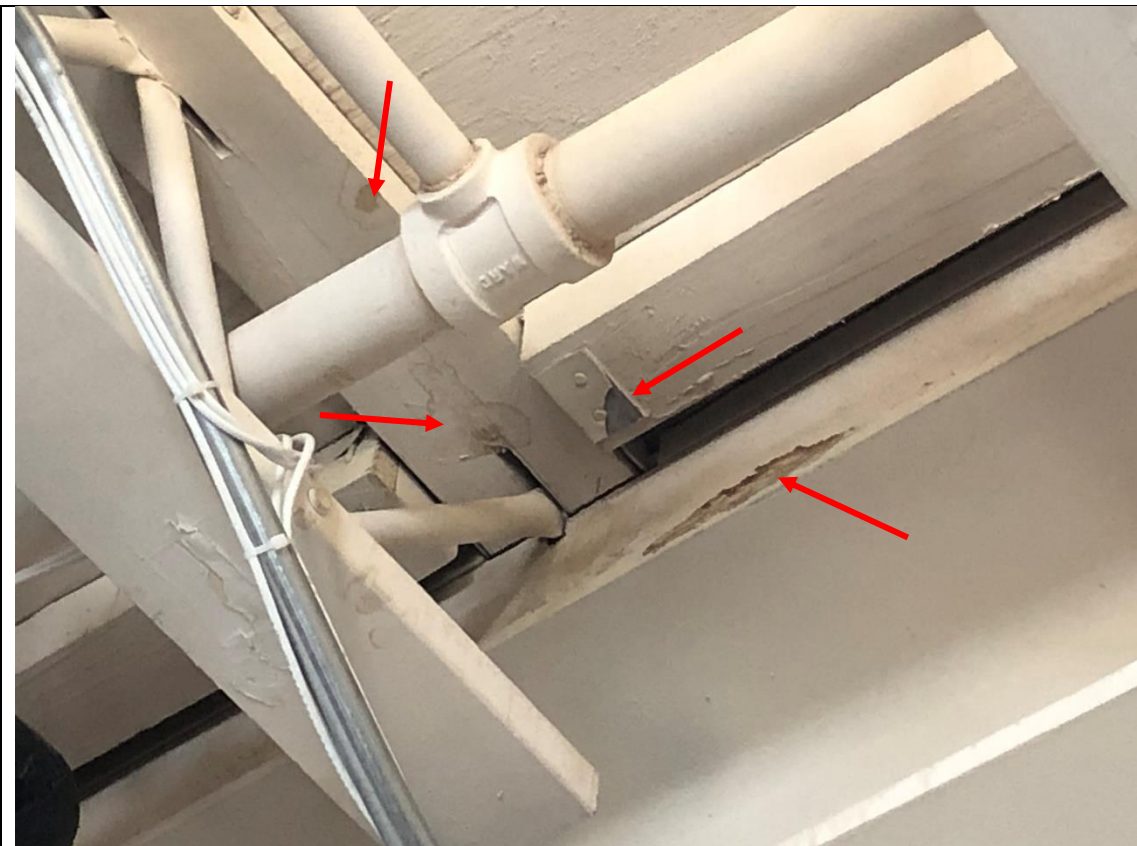
**Photo 195:**  
Water stains and failing paint on the ceiling in the multipurpose room.

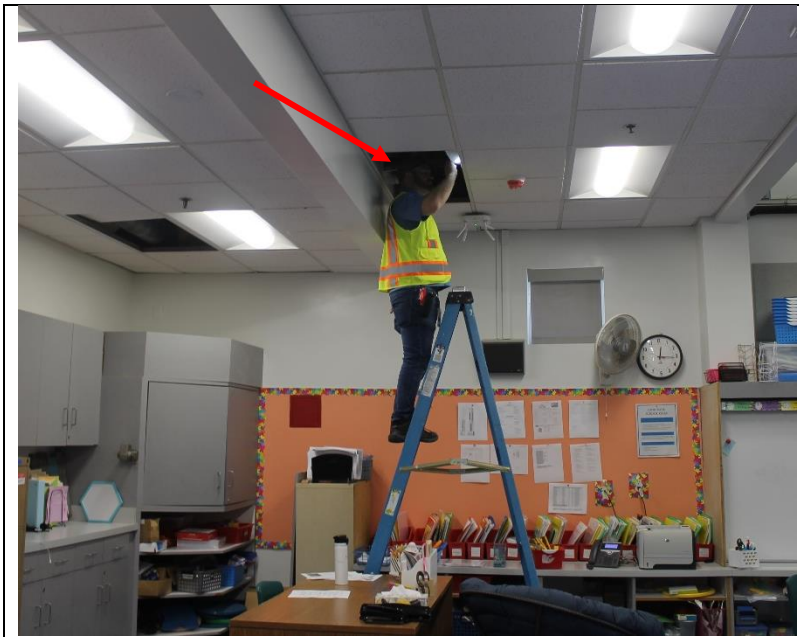
**Photo 198:**  
DTR making observations above the ceiling panels in a classroom in building C

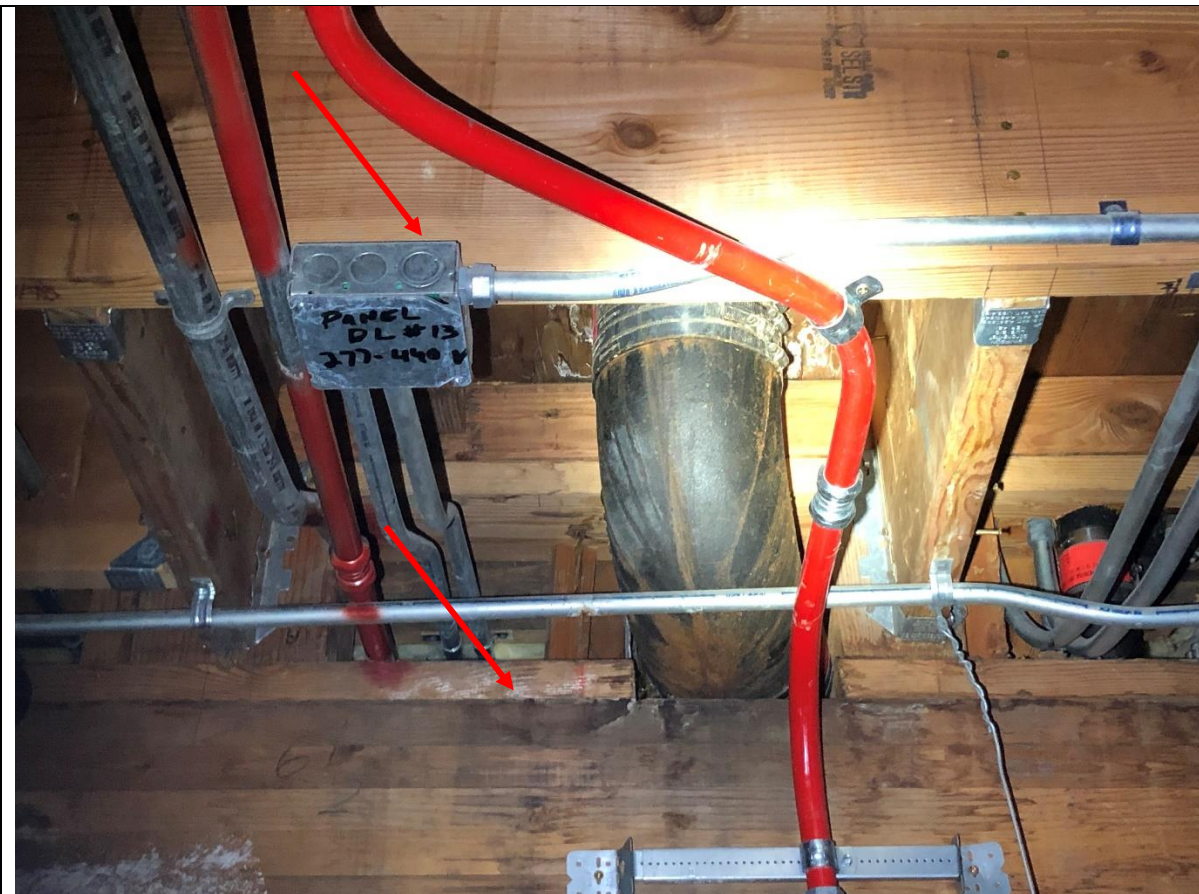
**Photo 204:**

Water damage and possible biological growth above the ceiling tiles in room 205 Teacher's Prep.

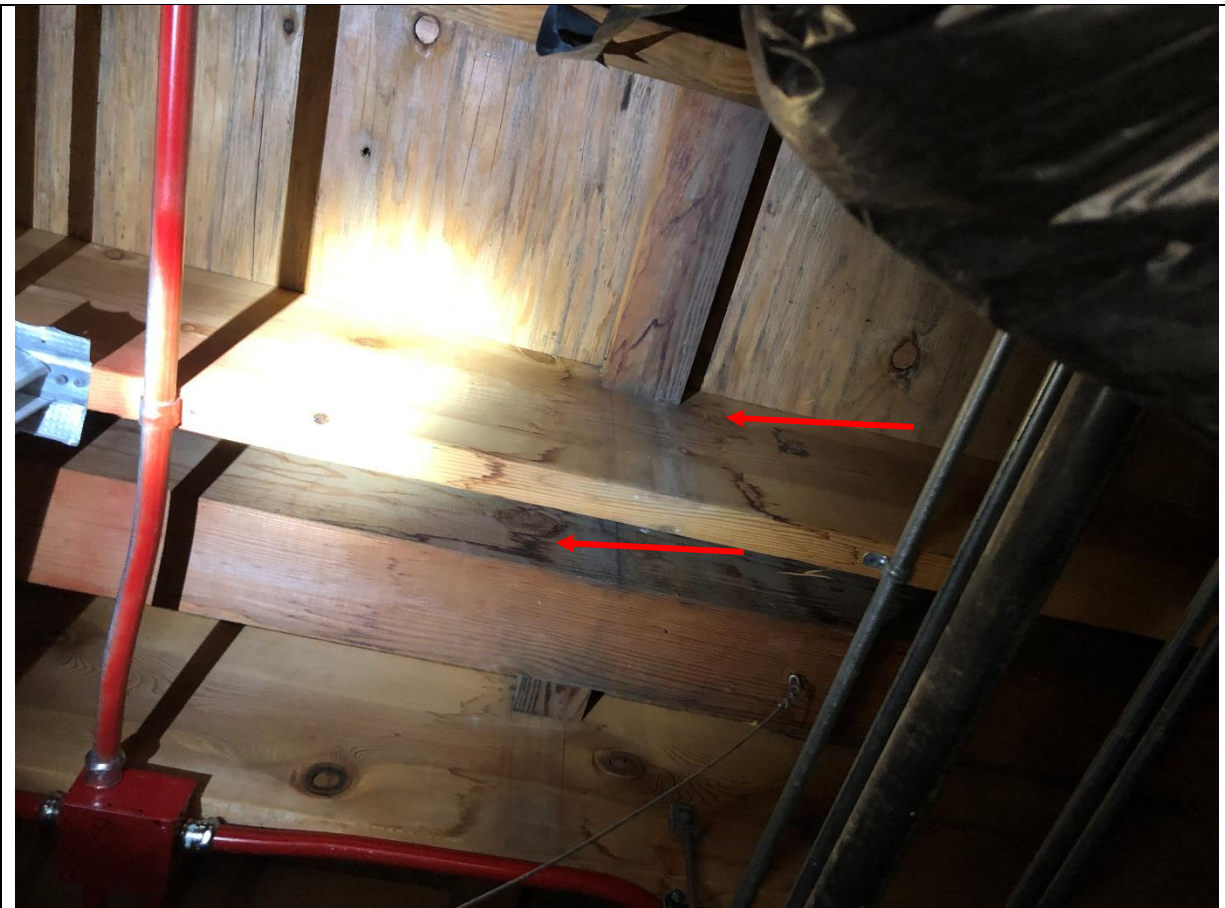
**Photo 205:**  
Water damage and staining above the ceiling tiles in room 205 Teacher's Prep.

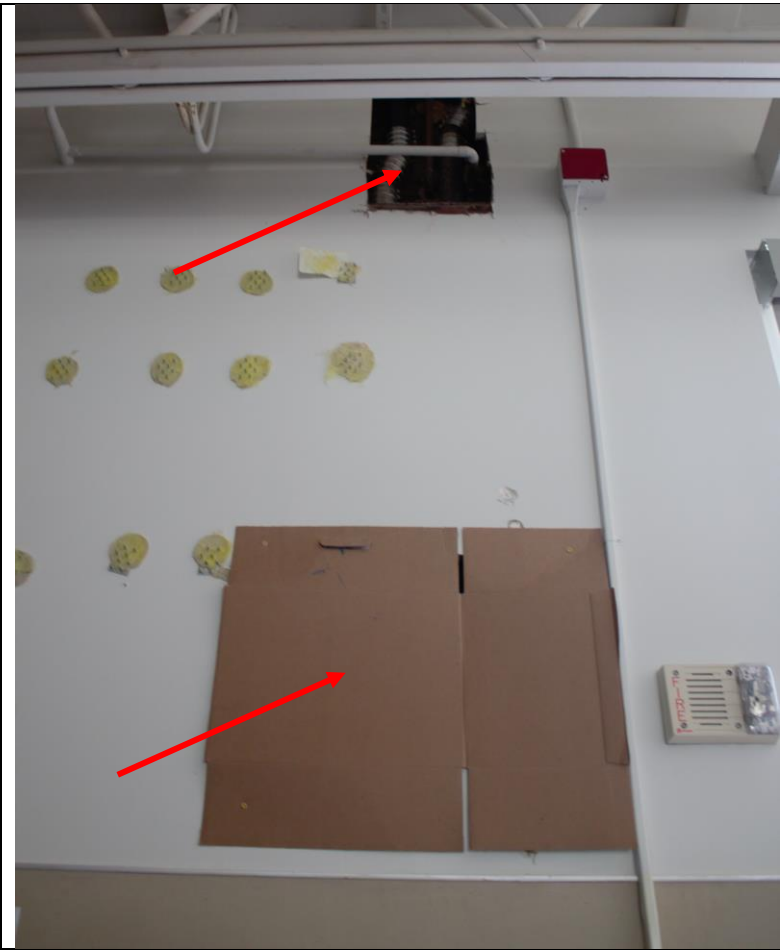
**Photo 212:**

Interior finishes had been removed at two classrooms in building D prior to the DTR site assessment, in an effort to address a leak at this location.

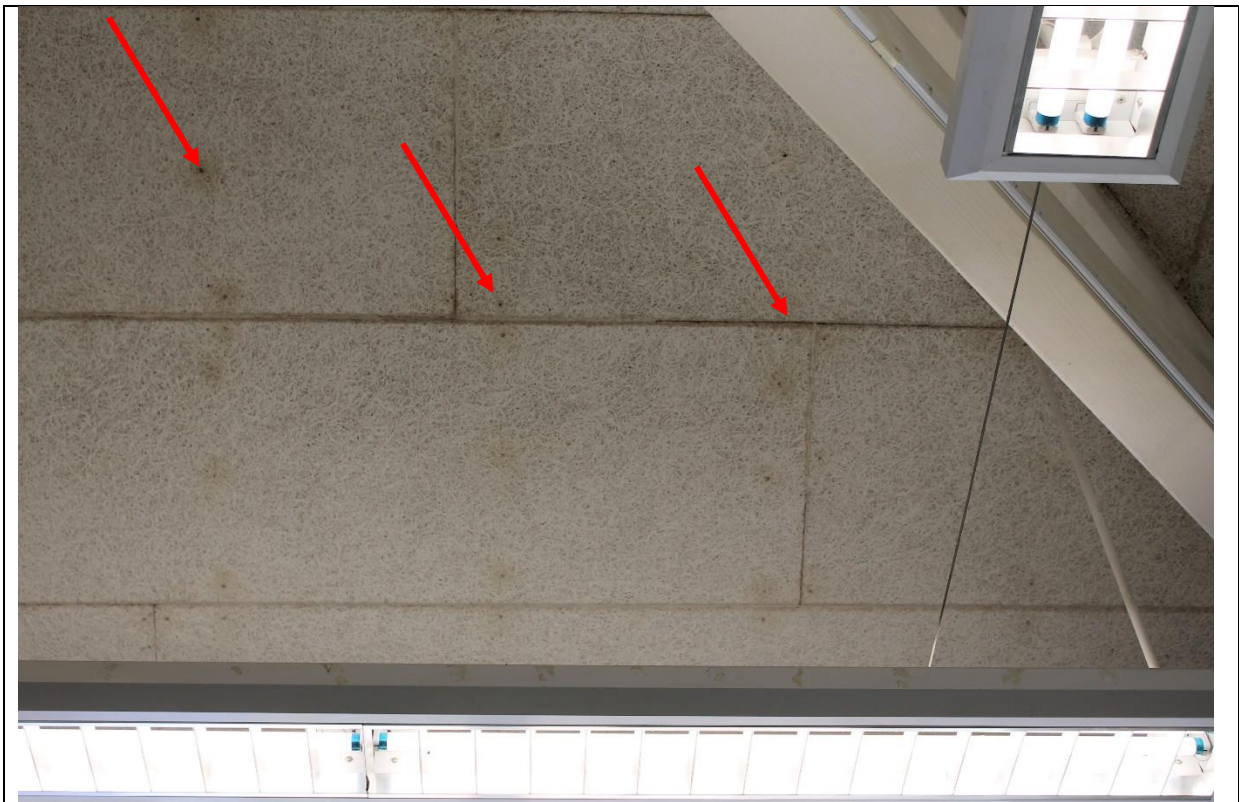
**Photo 219:**  
Water staining at the acoustical panels on the ceiling of the classrooms in building D.

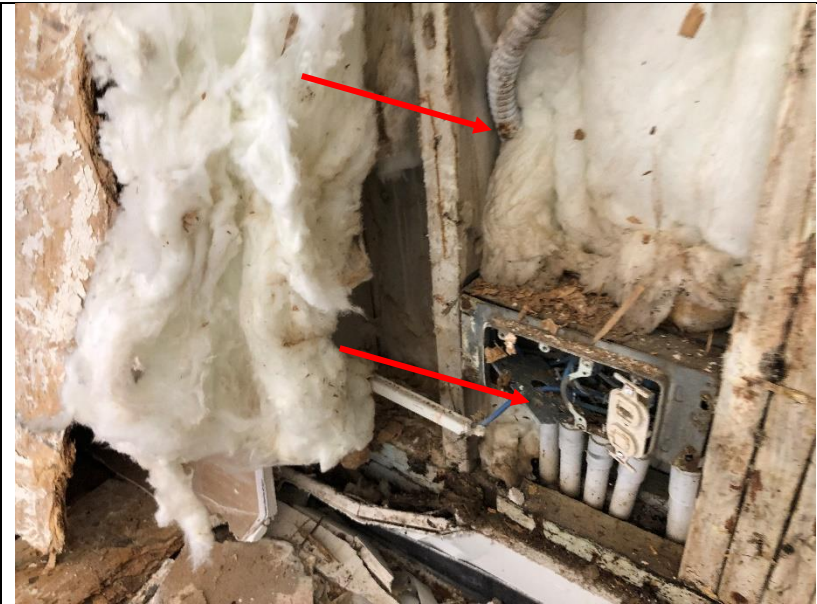
**Photo 251:**

Corrosion and water damage were observed at several electrical junction boxes and electrical conduits in the south (exterior) wall of room 415.

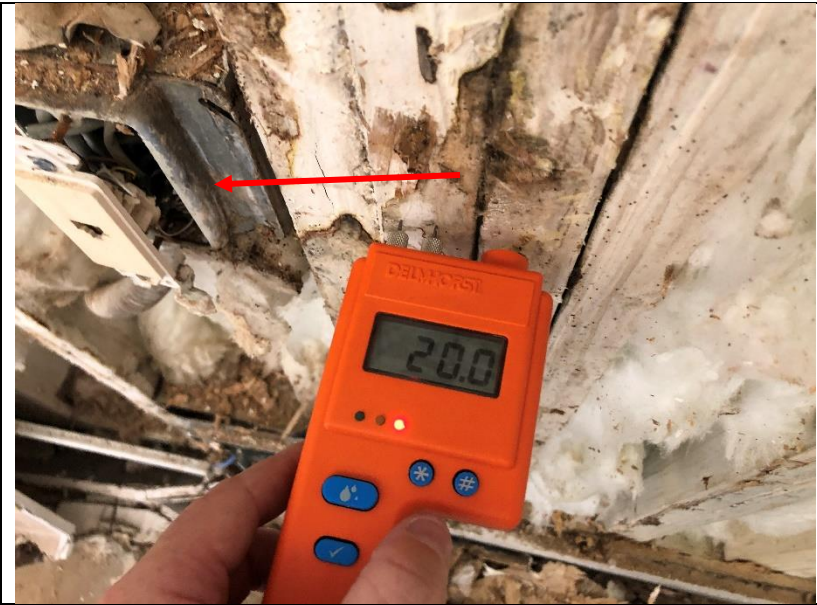
**Photo 252:**

Corrosion and water damage were observed at several electrical junction boxes and along electrical conduits.

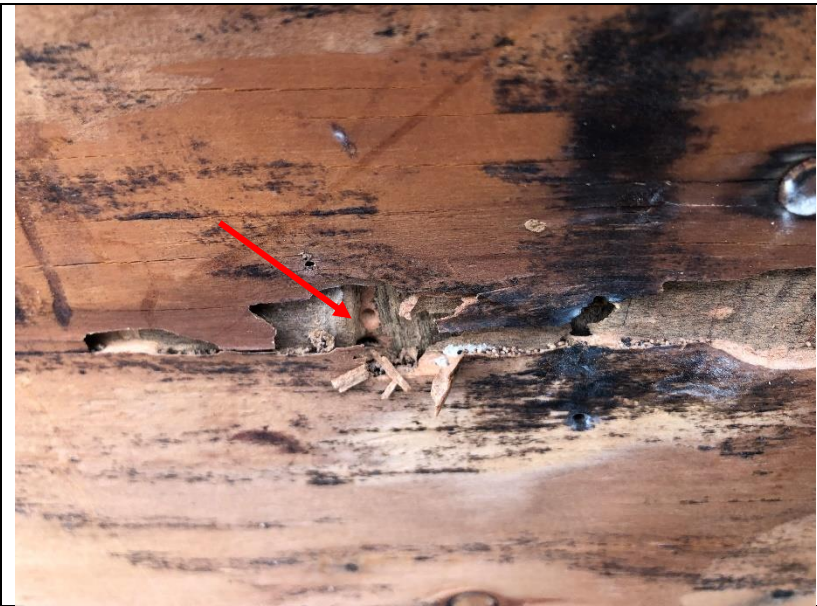
**Photo 266:**  
Insect damage was observed on the exterior side of the exterior plywood sheathing after the building paper had been removed.

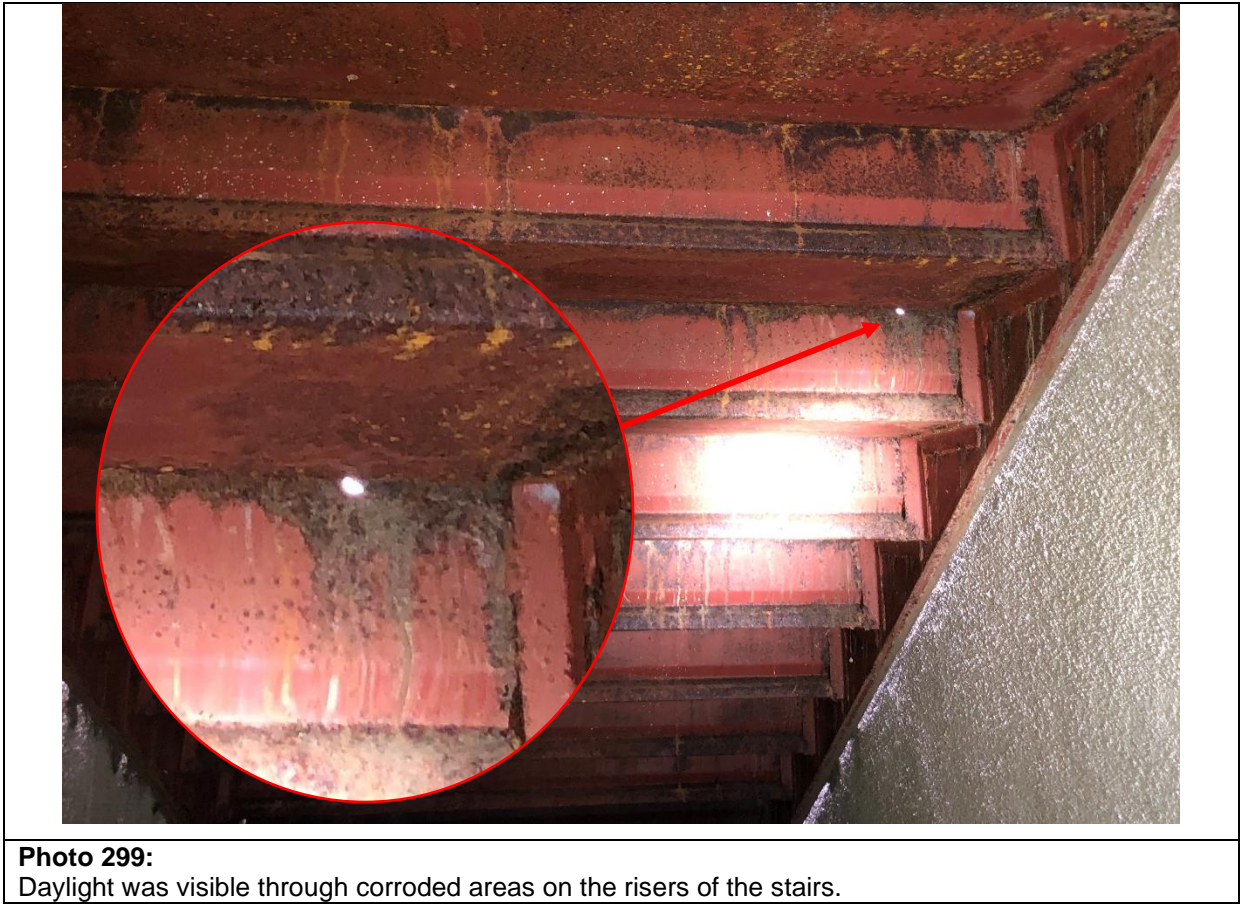
**Photo 299:**  
Daylight was visible through corroded areas on the risers of the stairs.

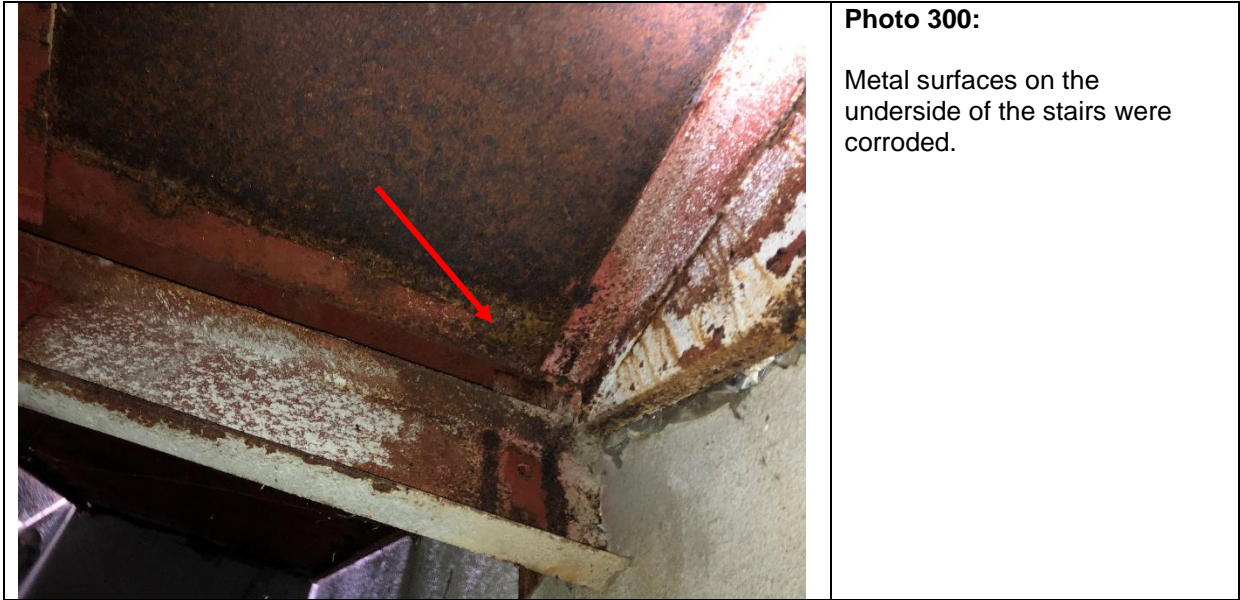
**Photo 300:**  
Metal surfaces on the underside of the stairs were corroded.

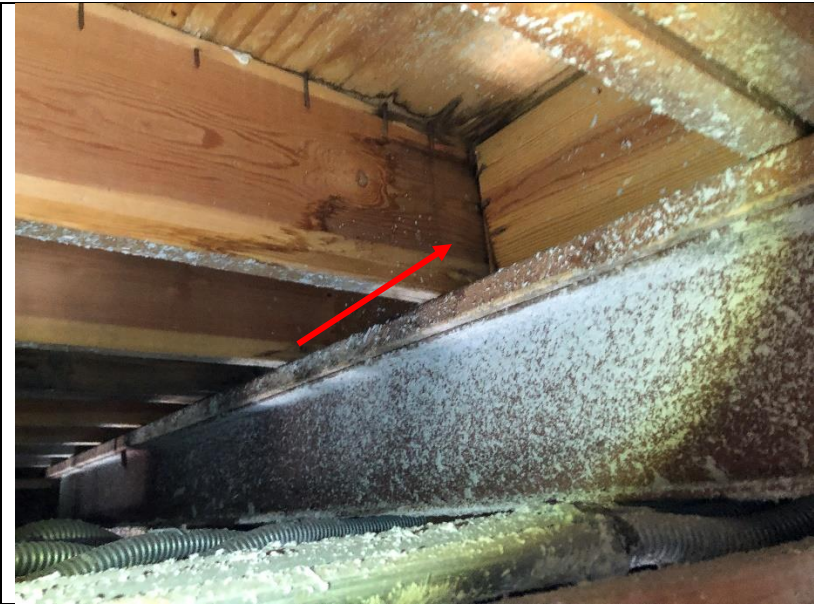
**Photo 336:**

Staining was observed at the joists under the walkway outside room 415.

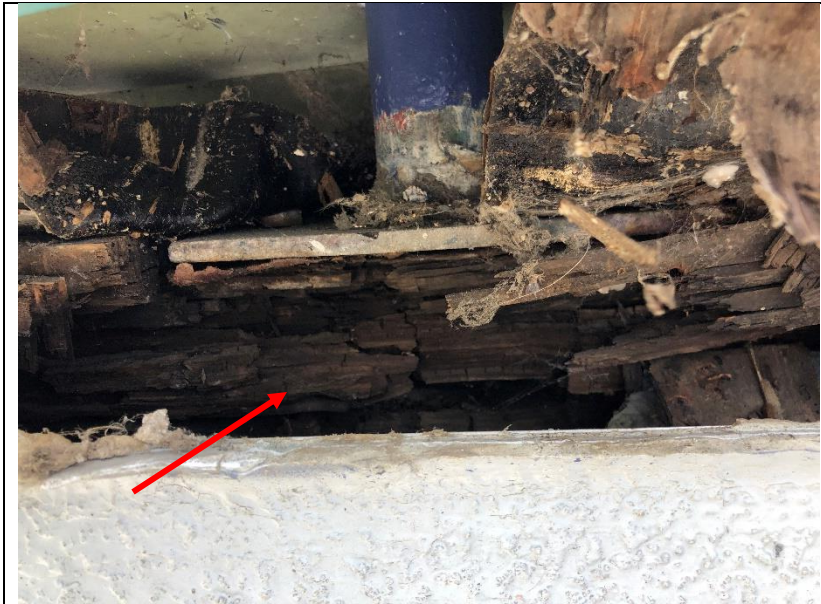
**Photo 340:**  
A void was observed under the coping cap outside room 400 at one of the handrail anchor plates where the wood structure had deteriorated.

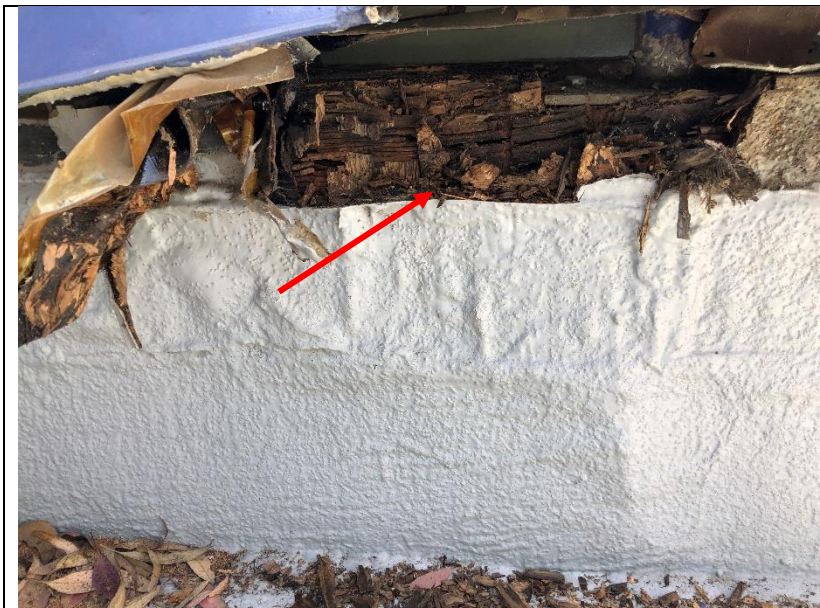
**Photo 346:**  
Wood rot and deteriorated wood materials at the handrail curb under the coping cap outside room 400.

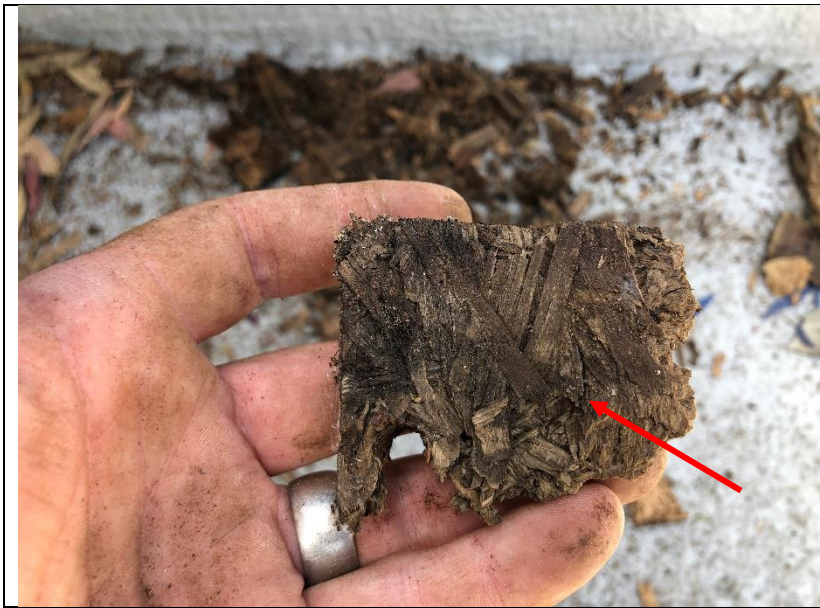
**Photo 347:**  
Deteriorated OSB material that fell from under the coping cap at the handrail curbs during observations.

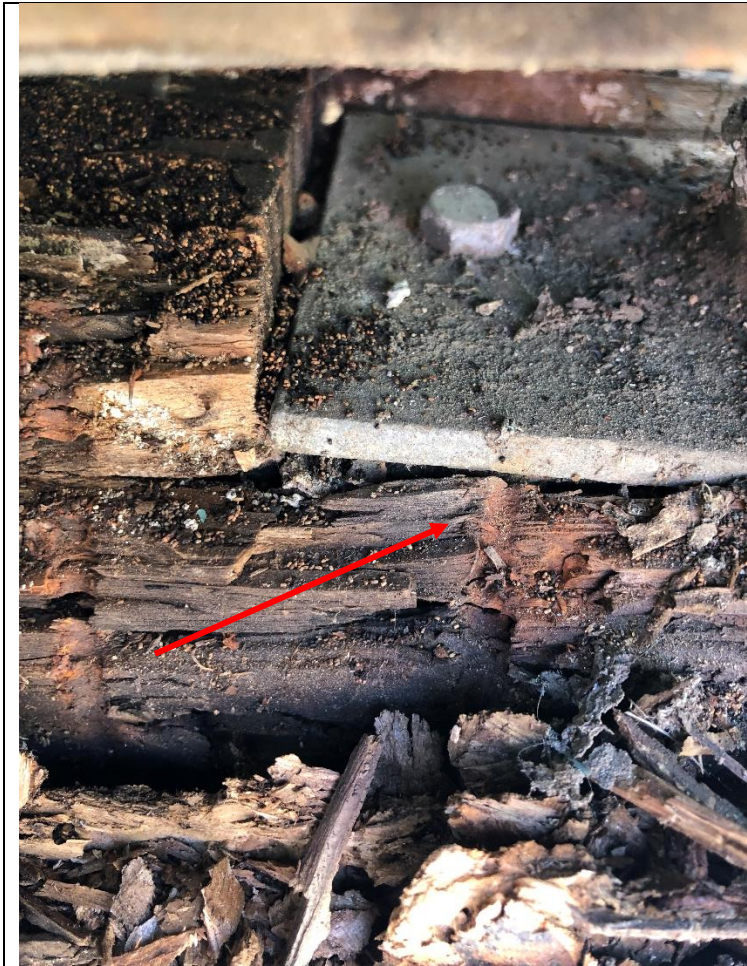
**Photo 349:**  
Wood rot and deteriorated wood materials were observed under the coping cap at the handrail anchor plates on the curbs.
