SITE ASSESSMENT

MALIBU MIDDLE HIGH SCHOOL
SANTA MONICA-MALIBU UNIFIED SCHOOL DISTRICT

MALIBU MIDDLE & HIGH SCHOOL
Campus Master Plan

Nov 2019

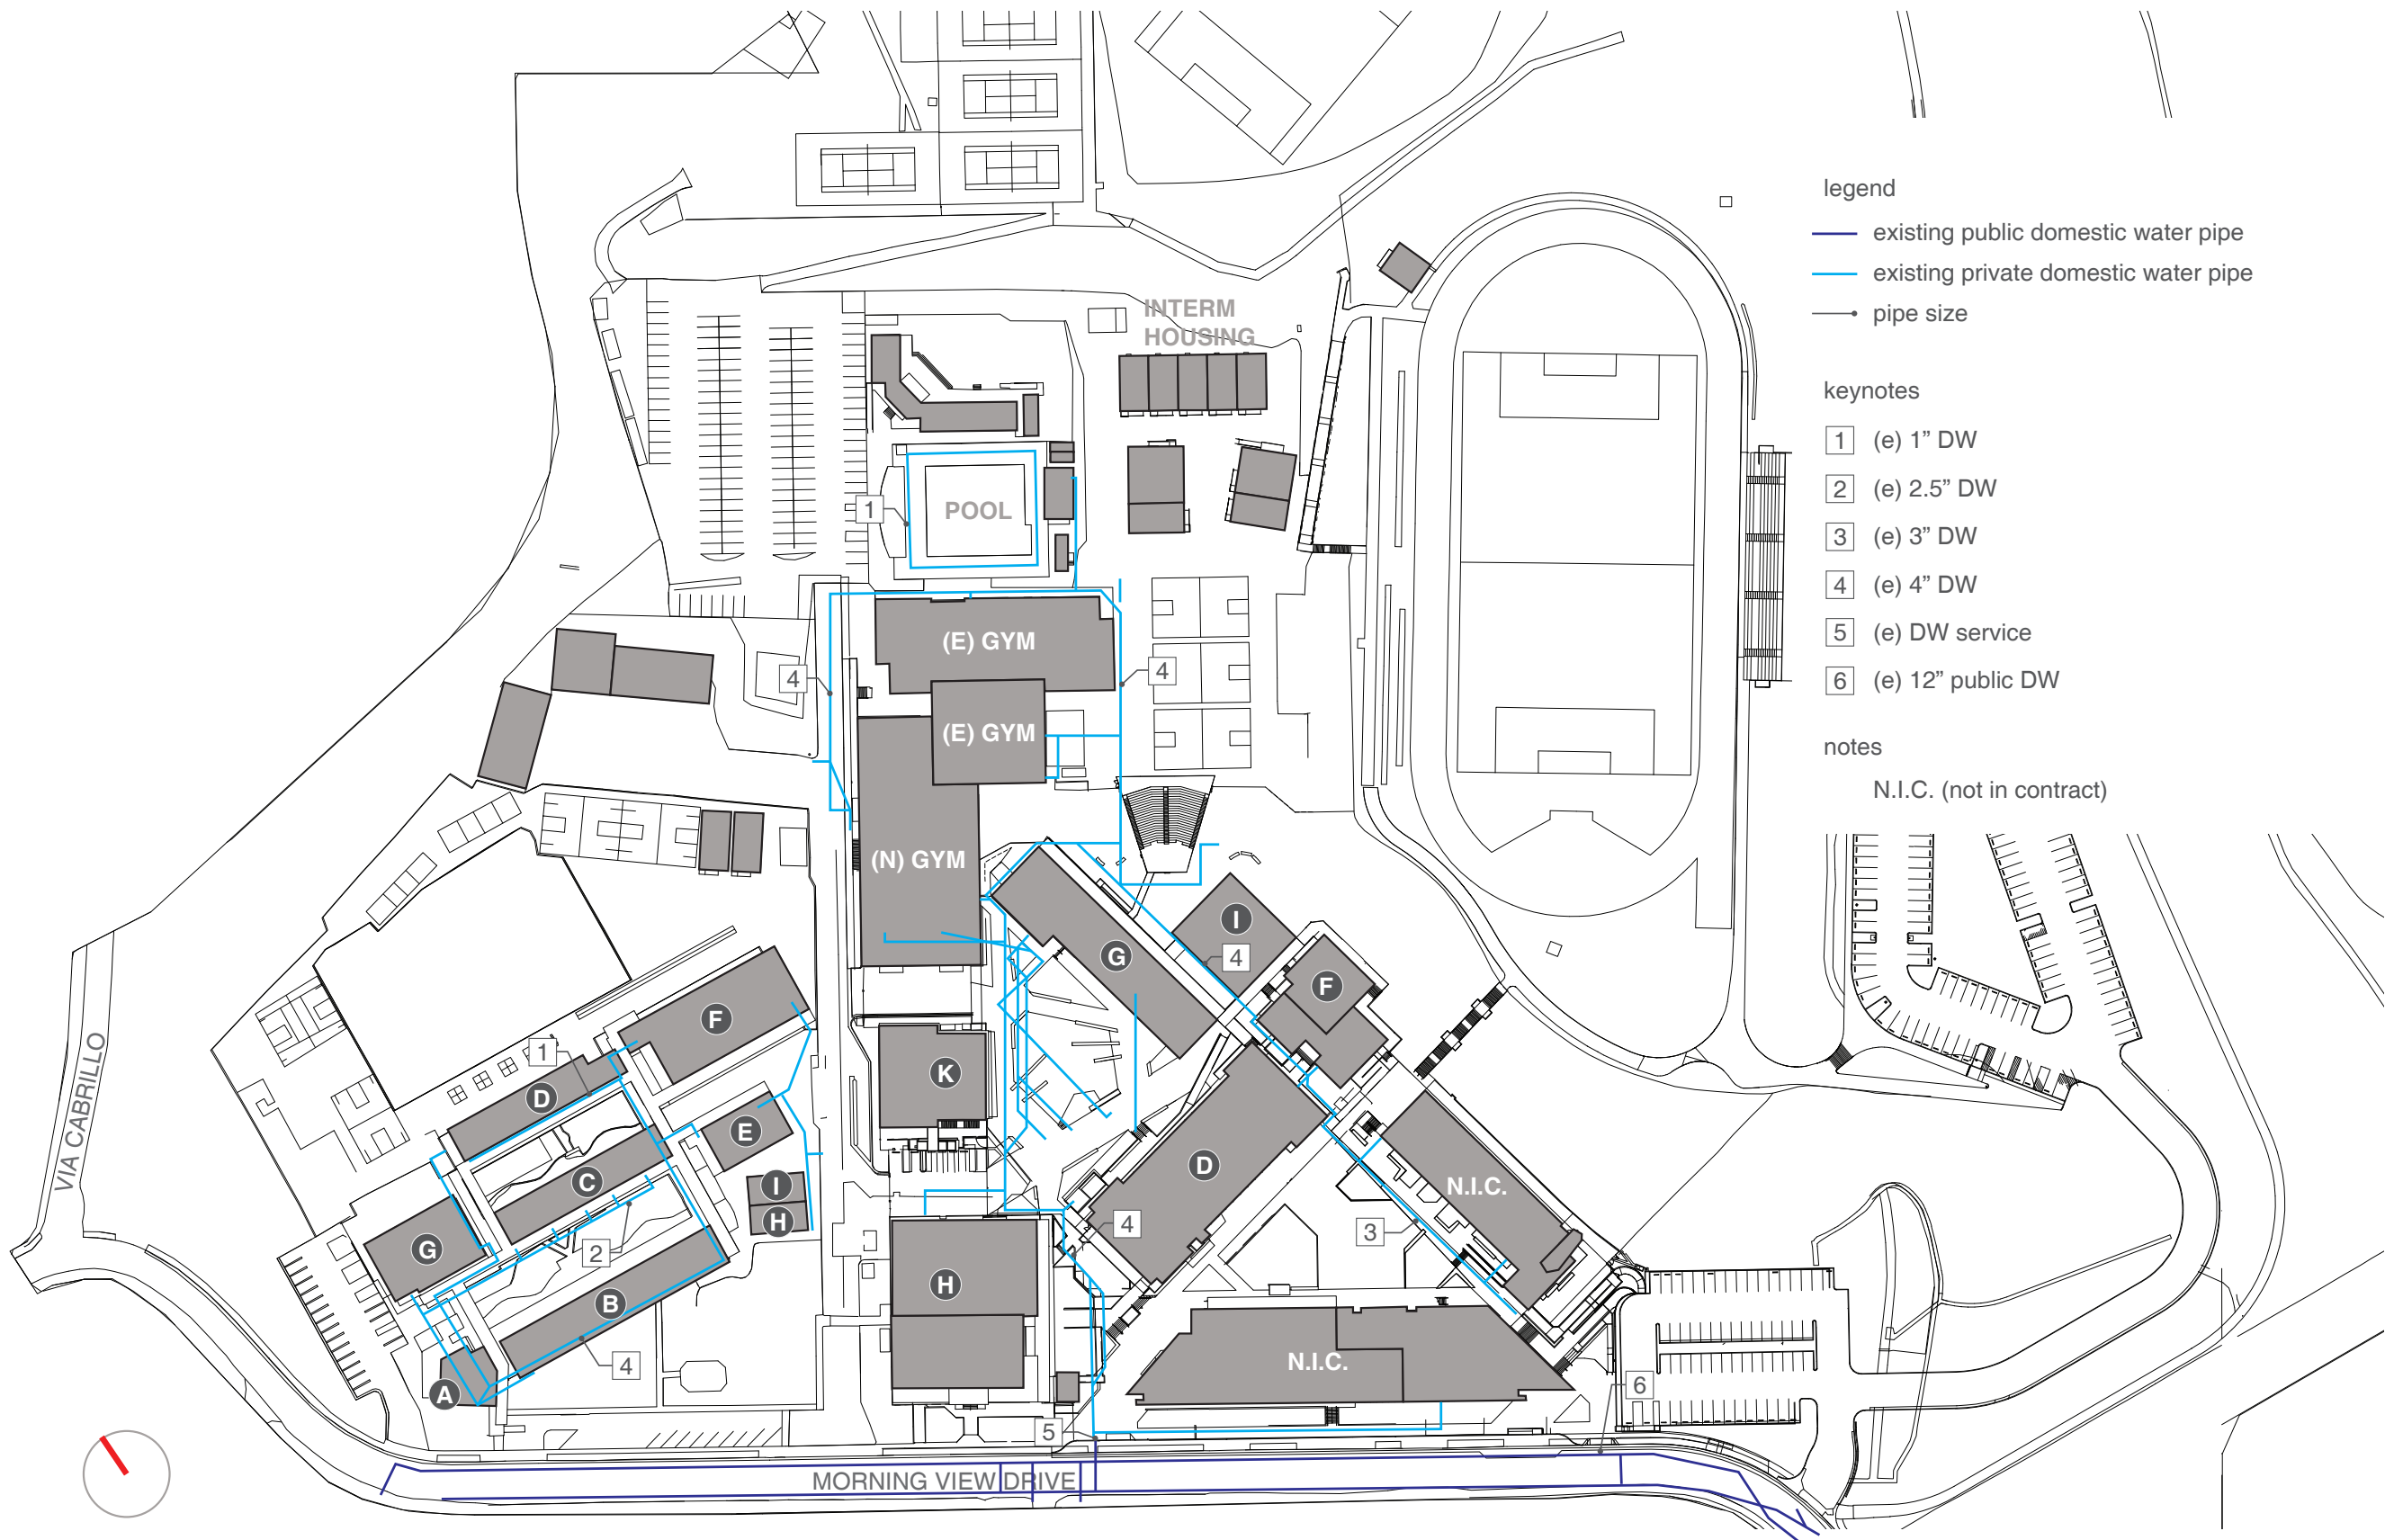
Figure 3.1-1 Campus-Wide Civil Domestic Water

The majority of the domestic water mains and laterals are original to building construction dates and should be regarded as having reached their service life.

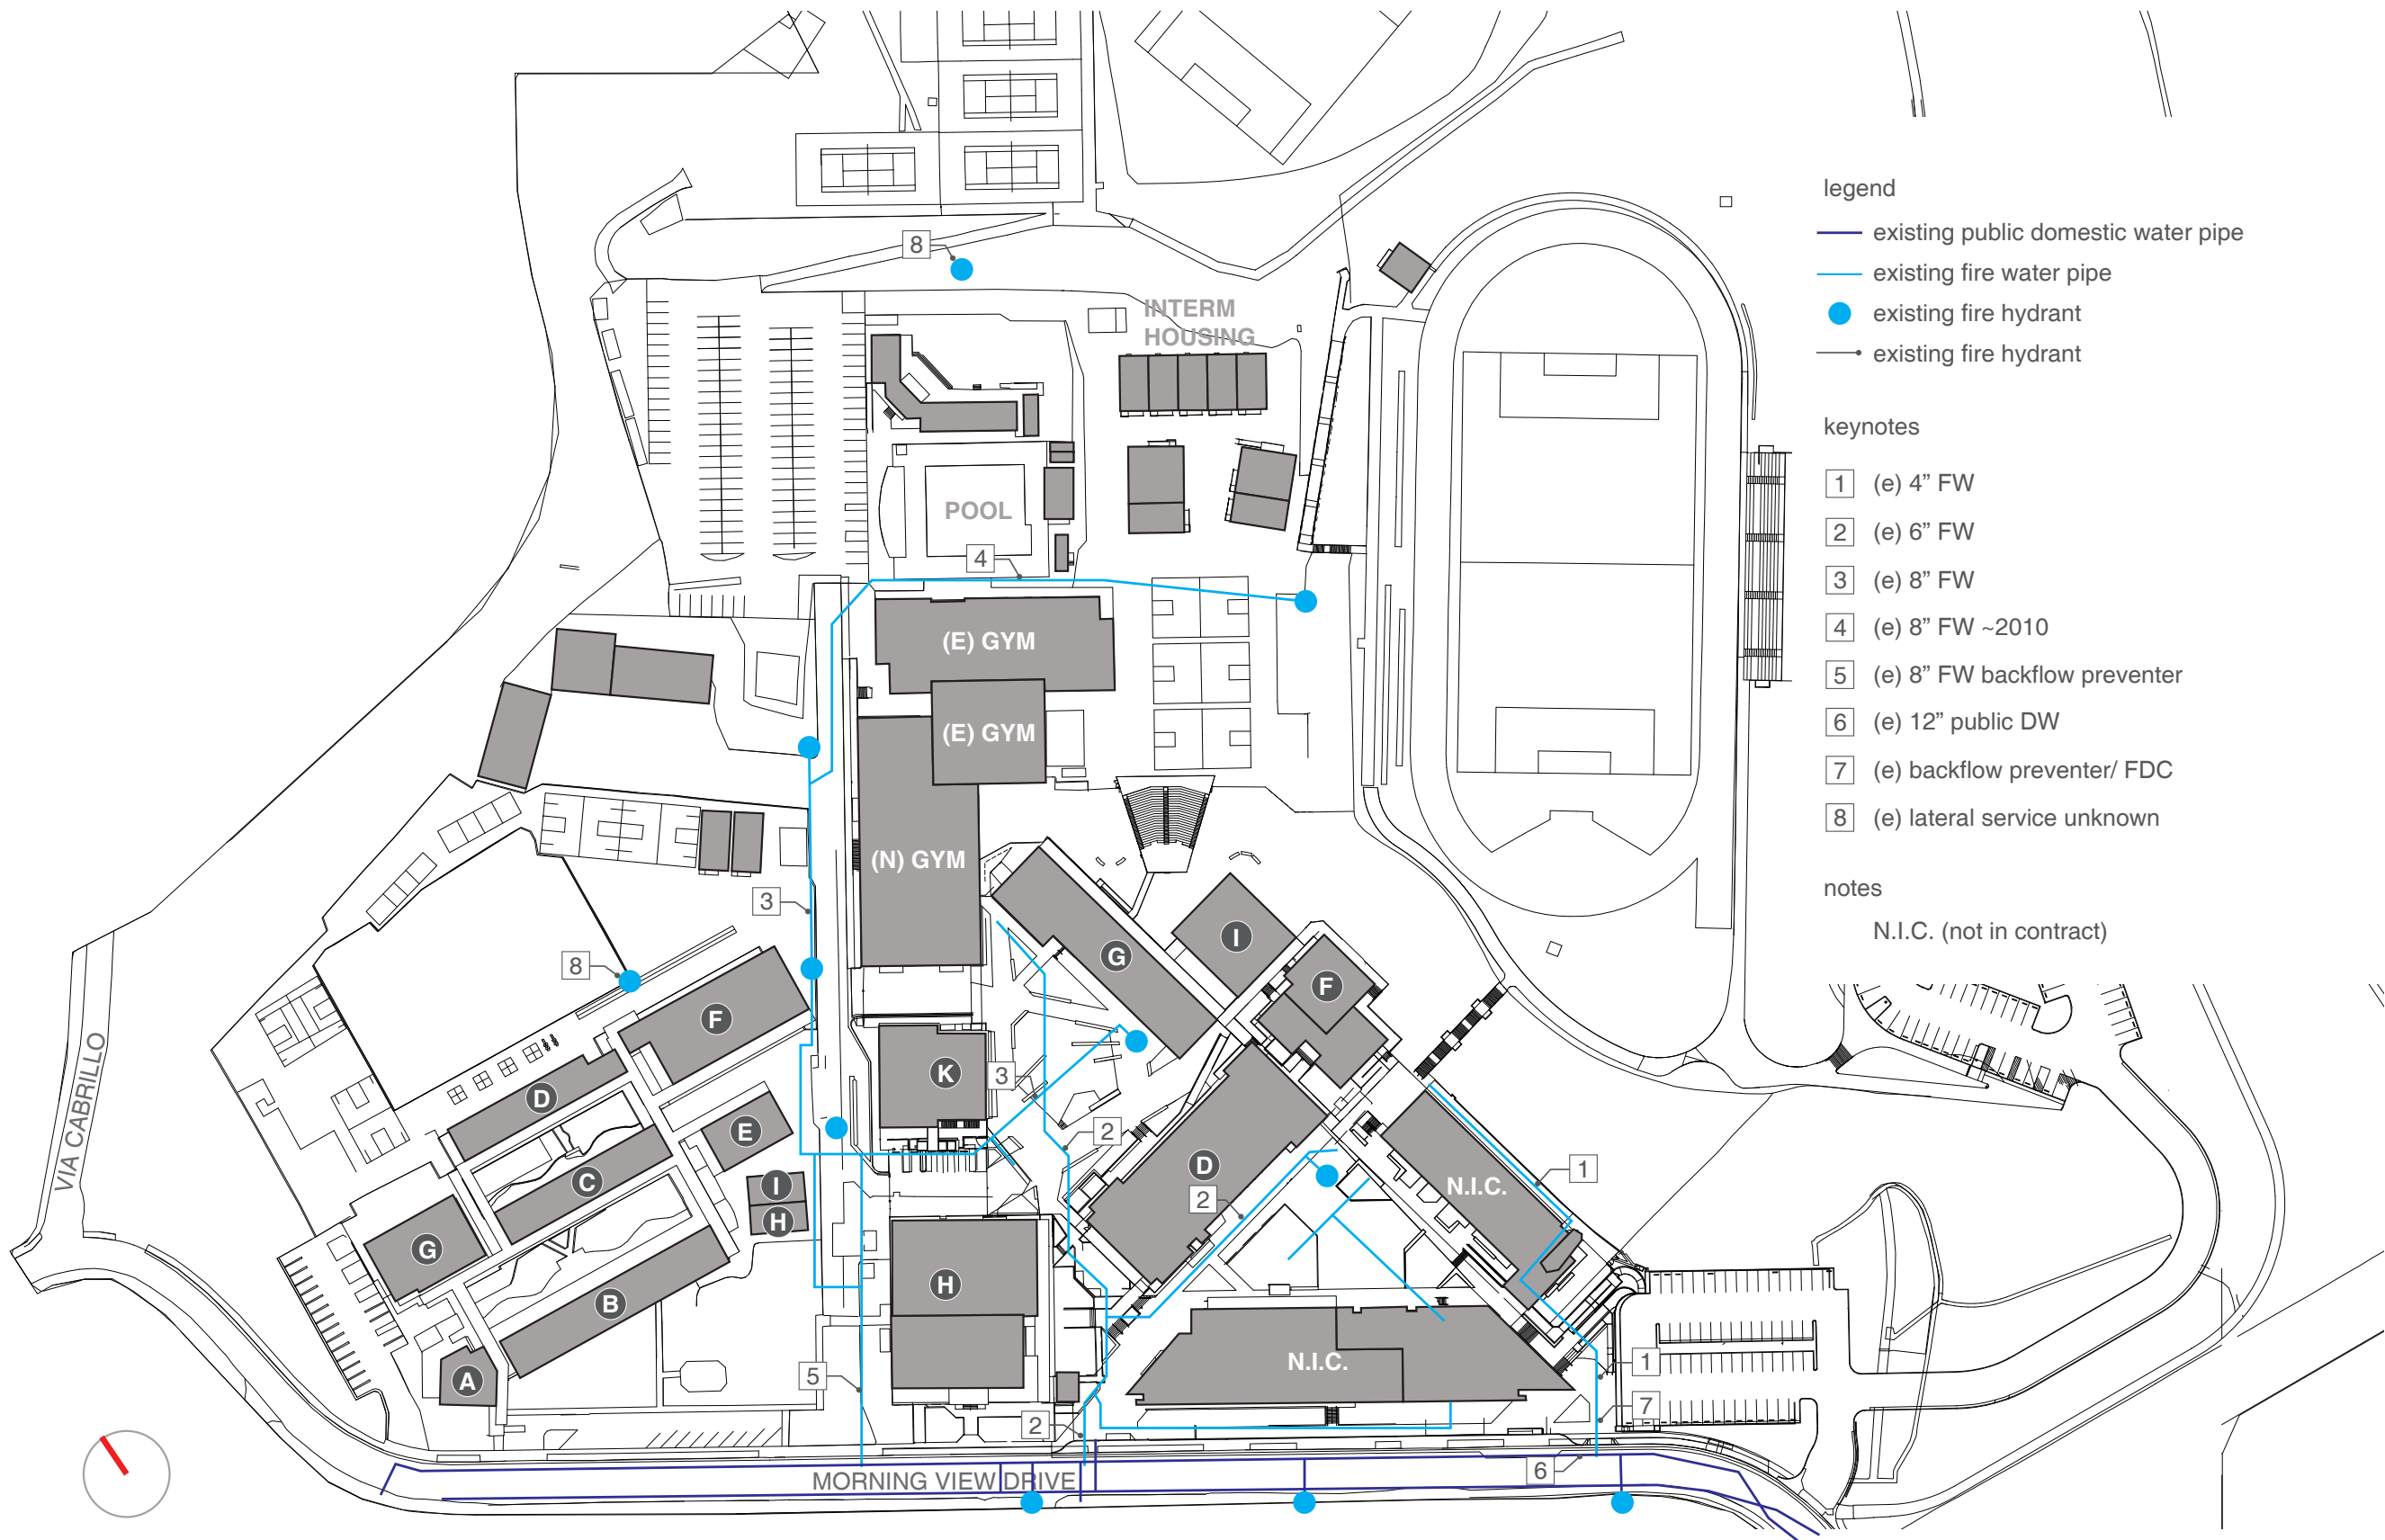
Figure 3.1-2 Campus-Wide Civil Fire Water

The campus is served by a dedicated fire water system of unknown age servicing onsite fire hydrants and building fire water connections. Useful service life of underground fire water lines should be regarded as 50 years.

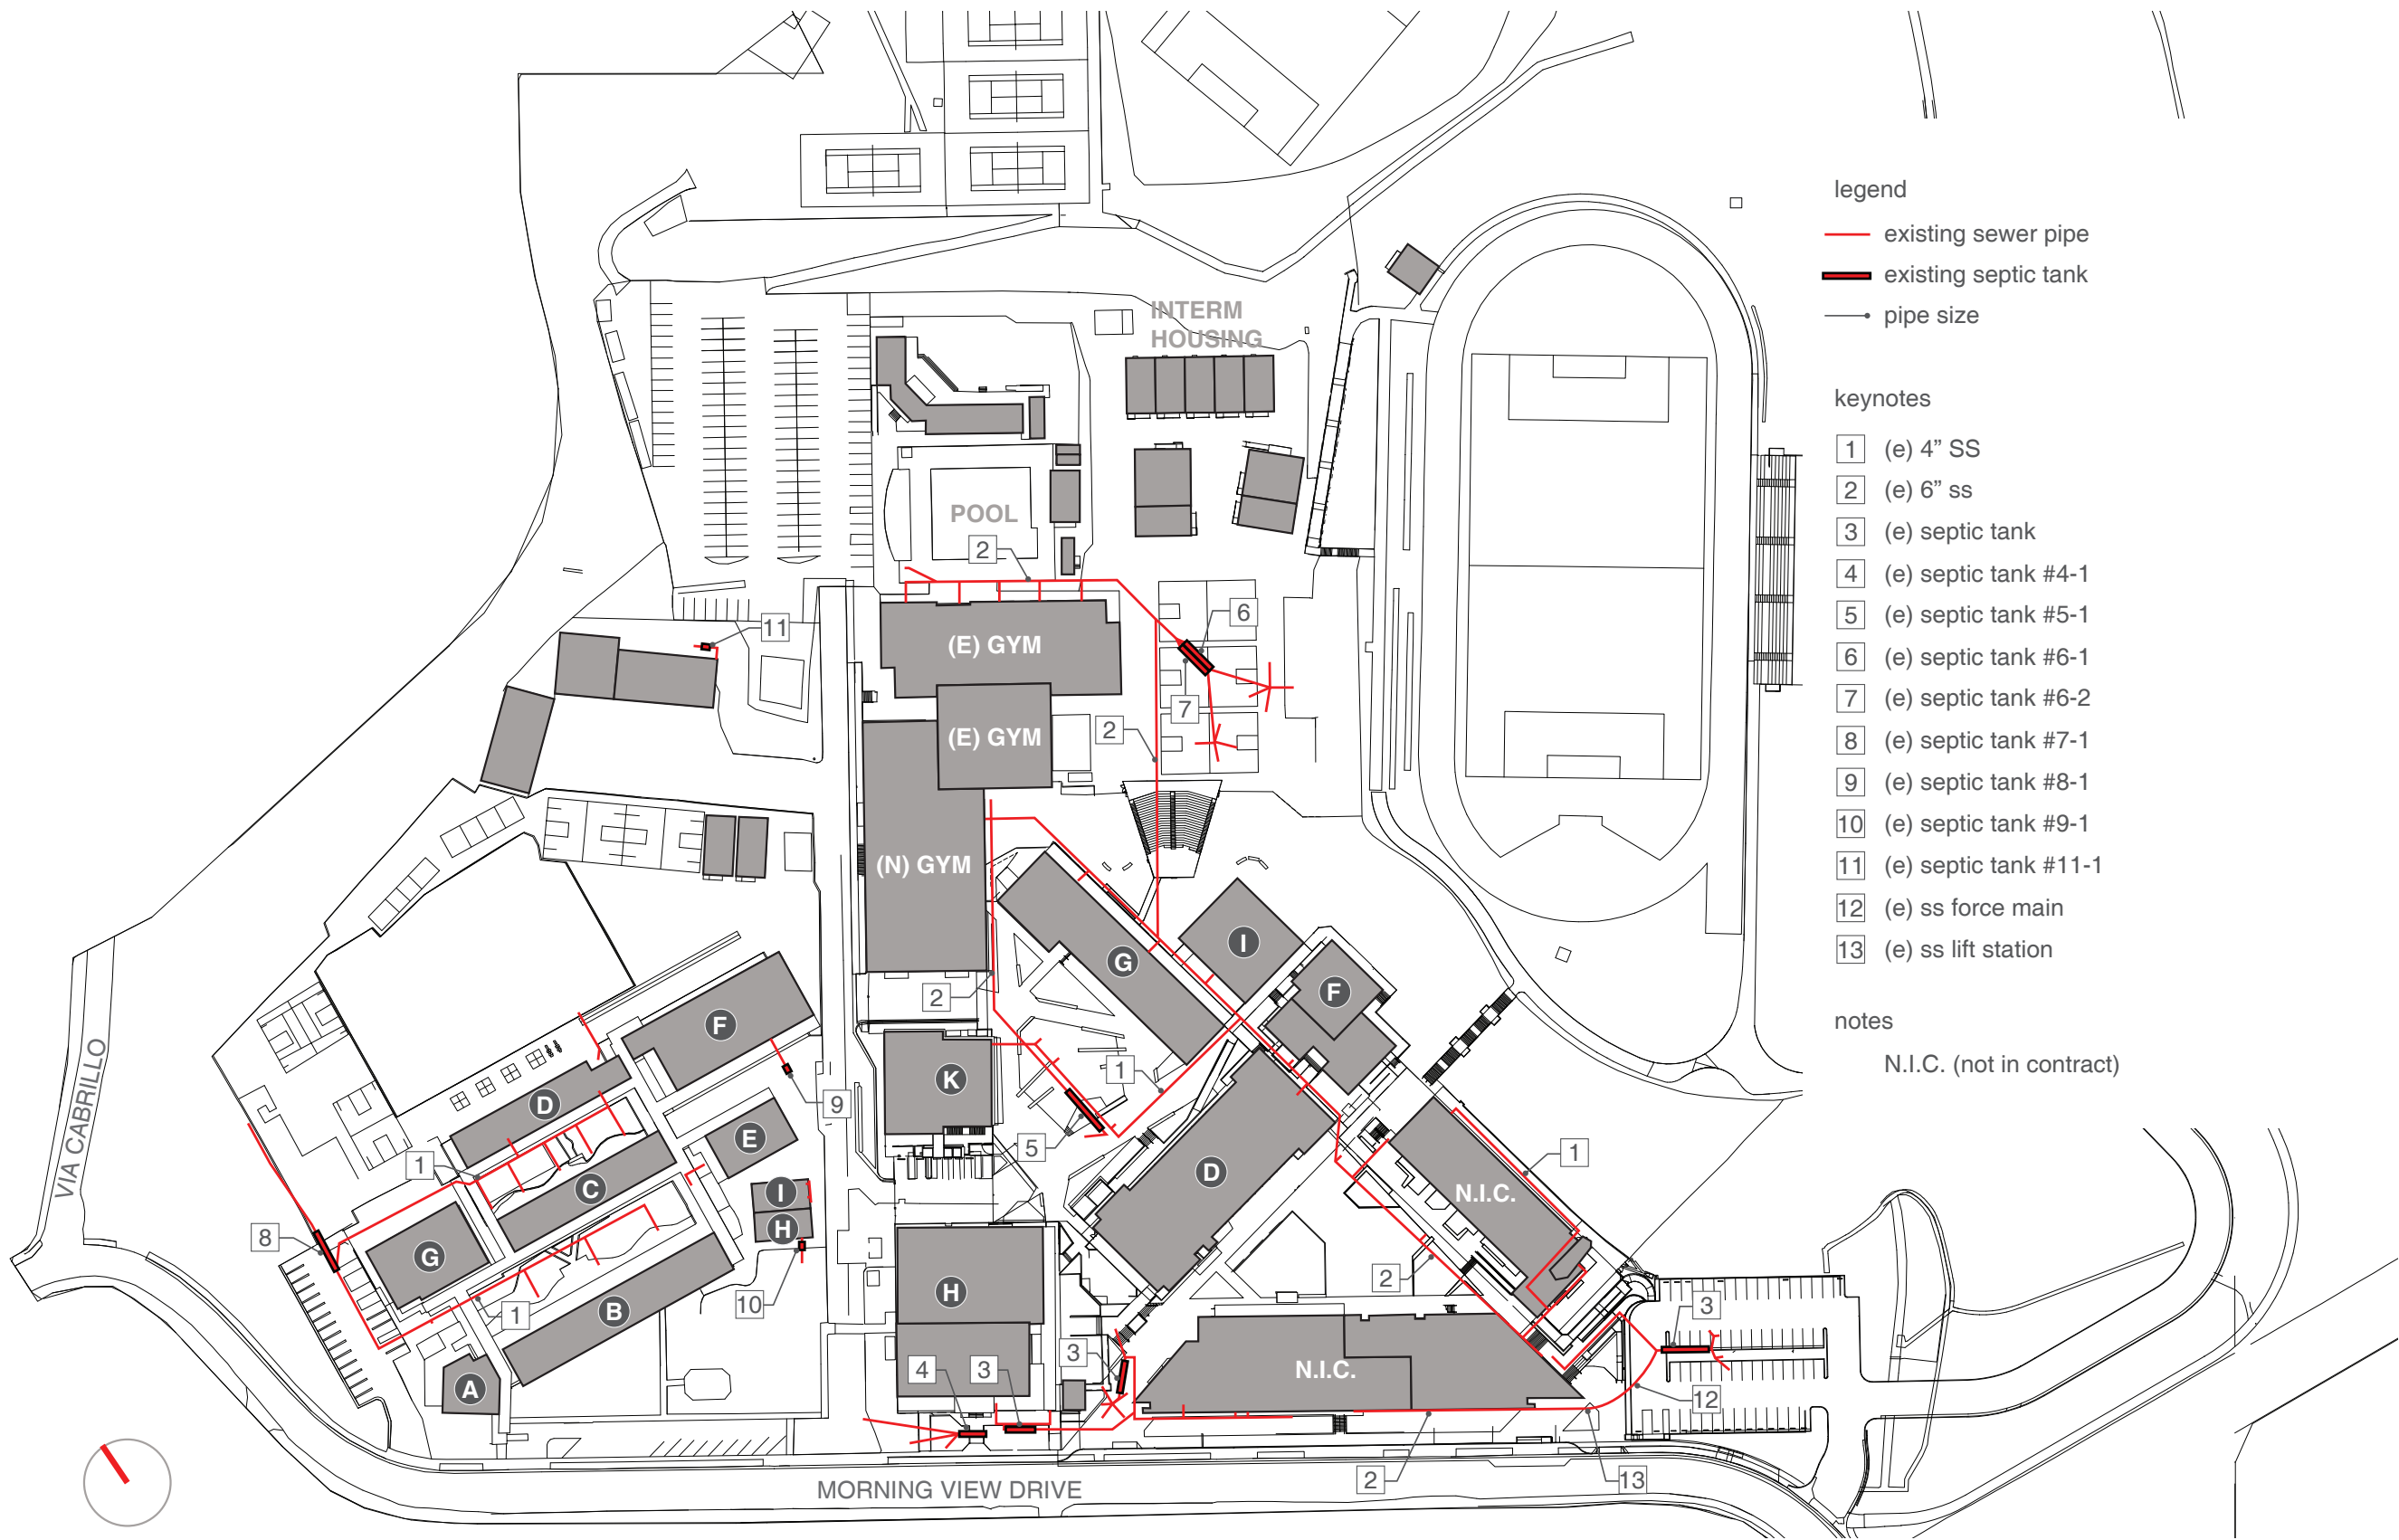
Figure 3.1-3 Campus-Wide Civil Septic Sewer

The campus is served by multiple on-site wastewater treatment systems consisting of septic tanks and seepage pits. Record drawings indicate recent replacement of the septic tank in the high school rec court and new systems to be installed as part of the phase 3 construction work. Existing sewer lines outside of the phase 3 work appear to be original to building construction dates and should be regarded as having reached their service life.

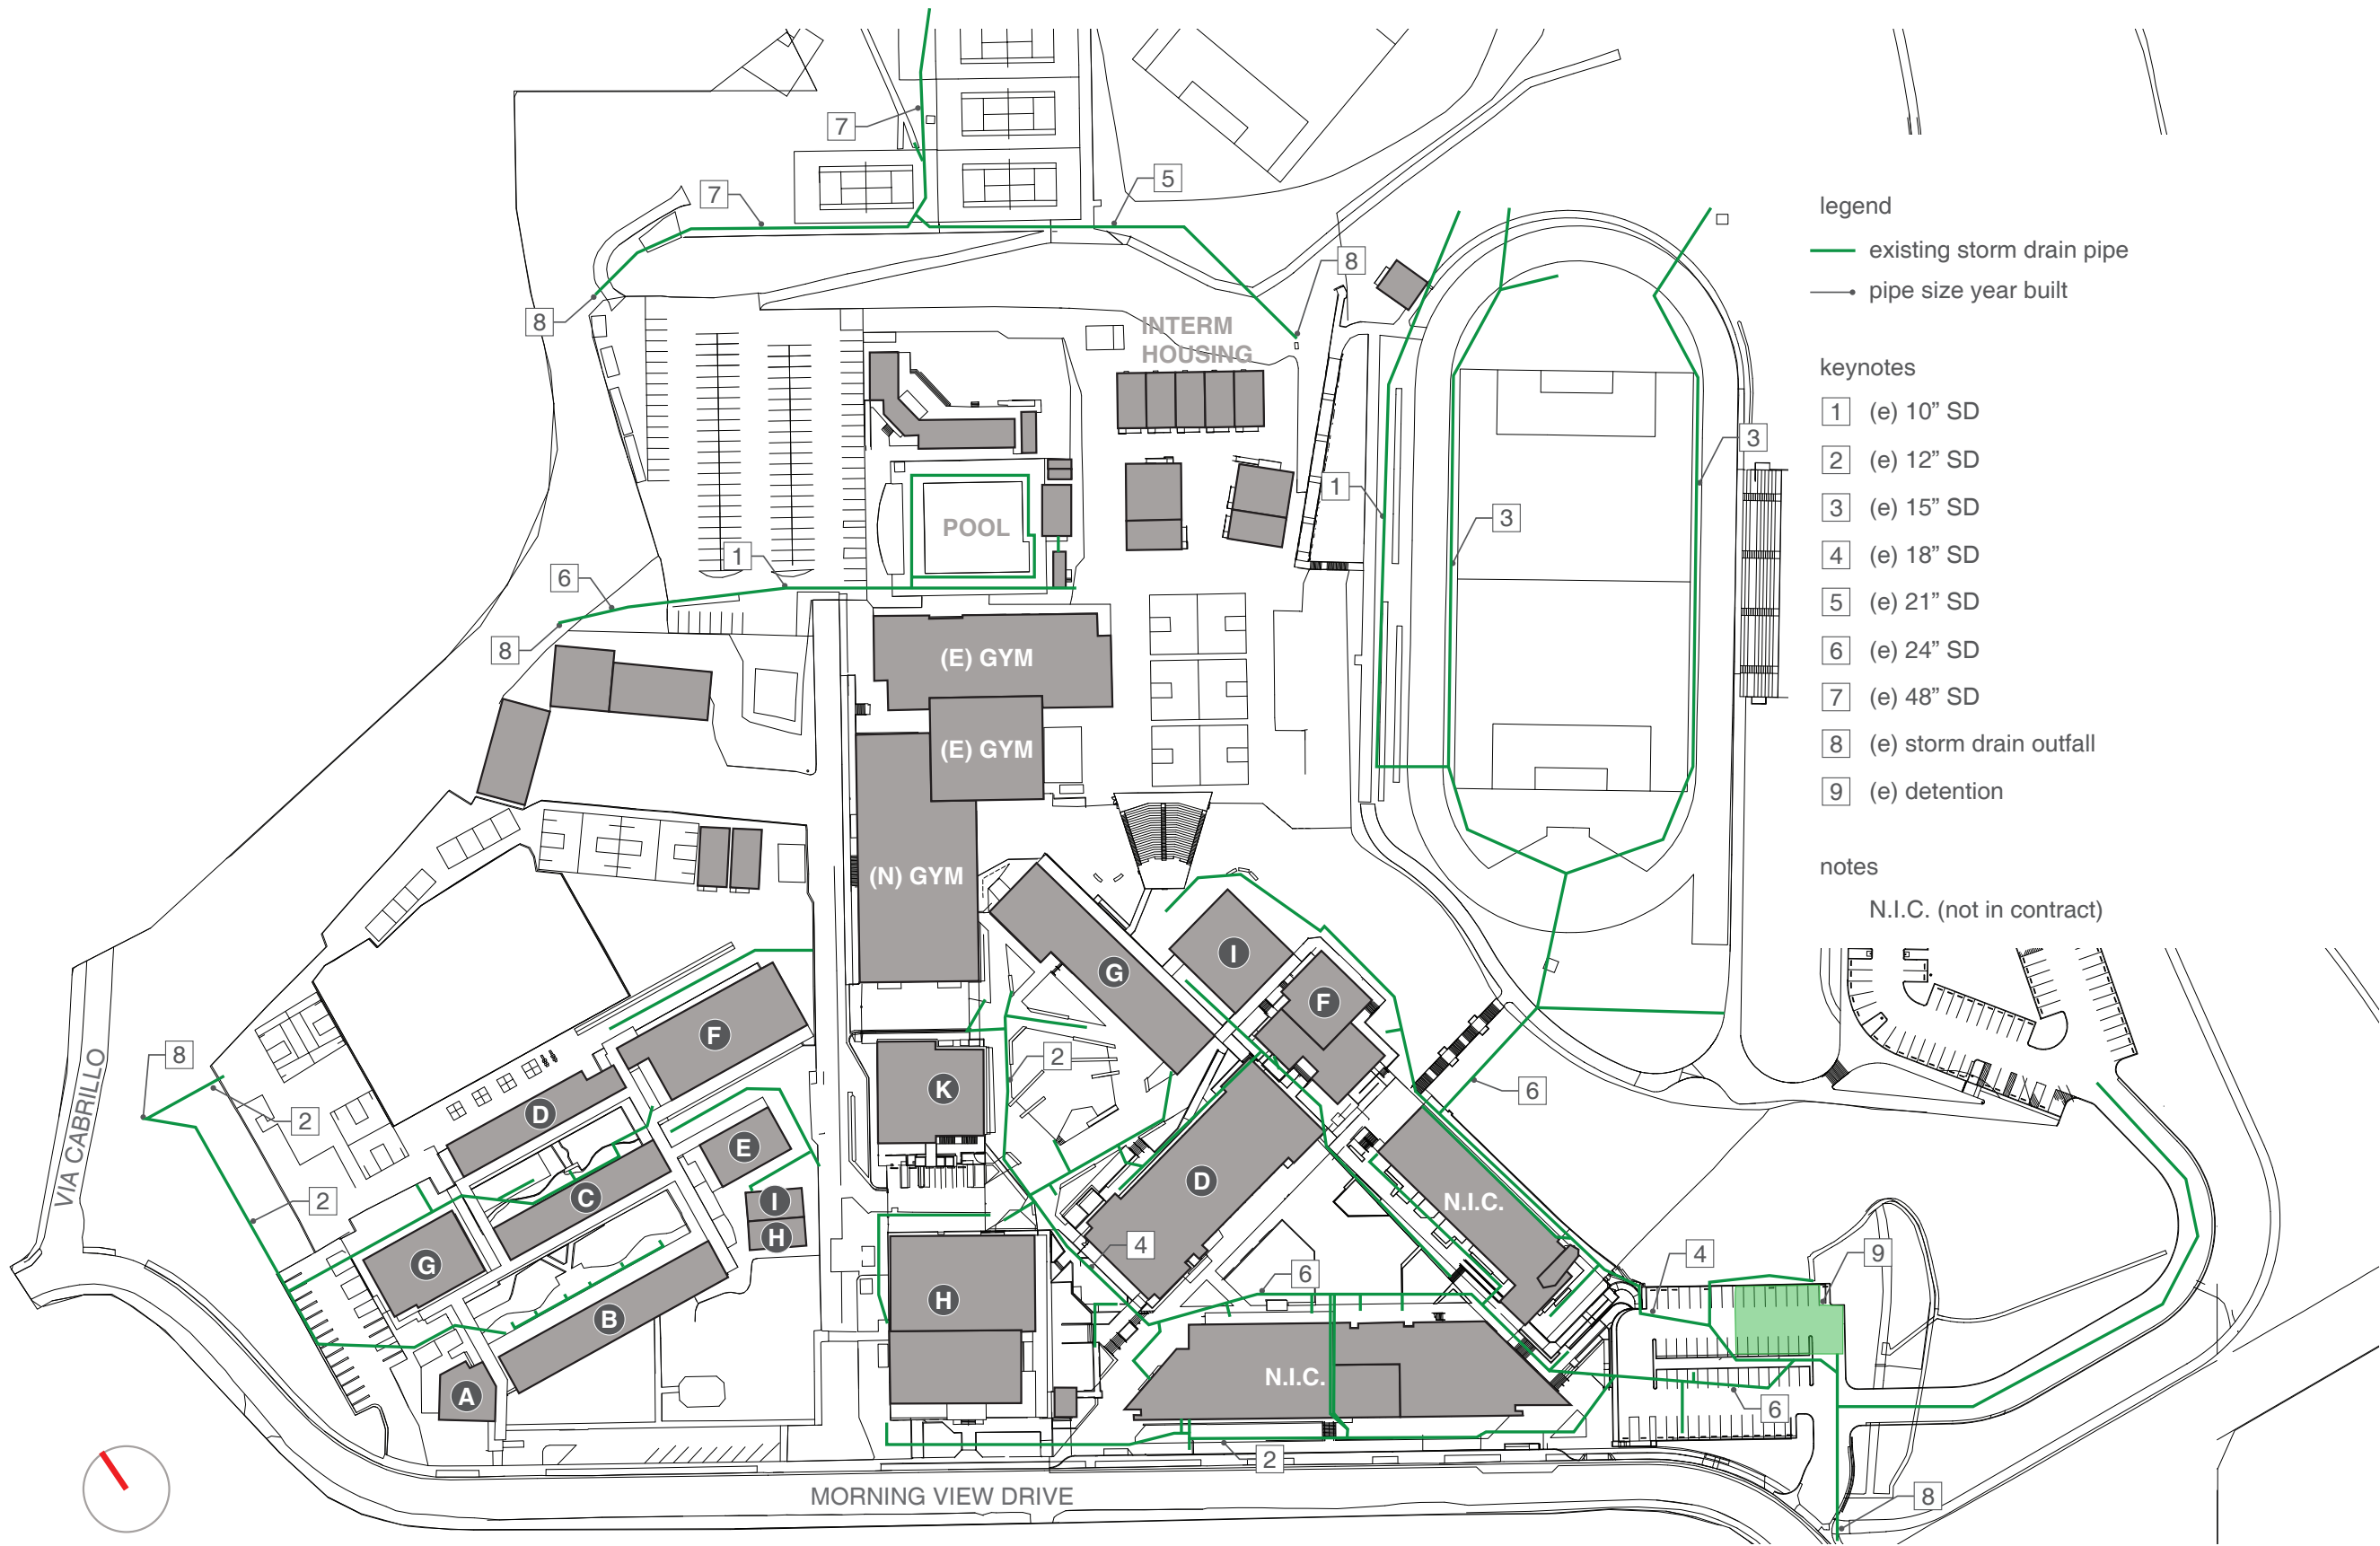
Figure 3.1-4 Campus-Wide Civil Storm Water

Drain inlets were observed with standing water and captured trash. Discussions with site personnel reveal areas of flooding at the bottom of the tennis courts, basketball courts, and outside building 1.

Underground storm drain piping is of unknown age and should be regarded as having a useful life of 50 years.

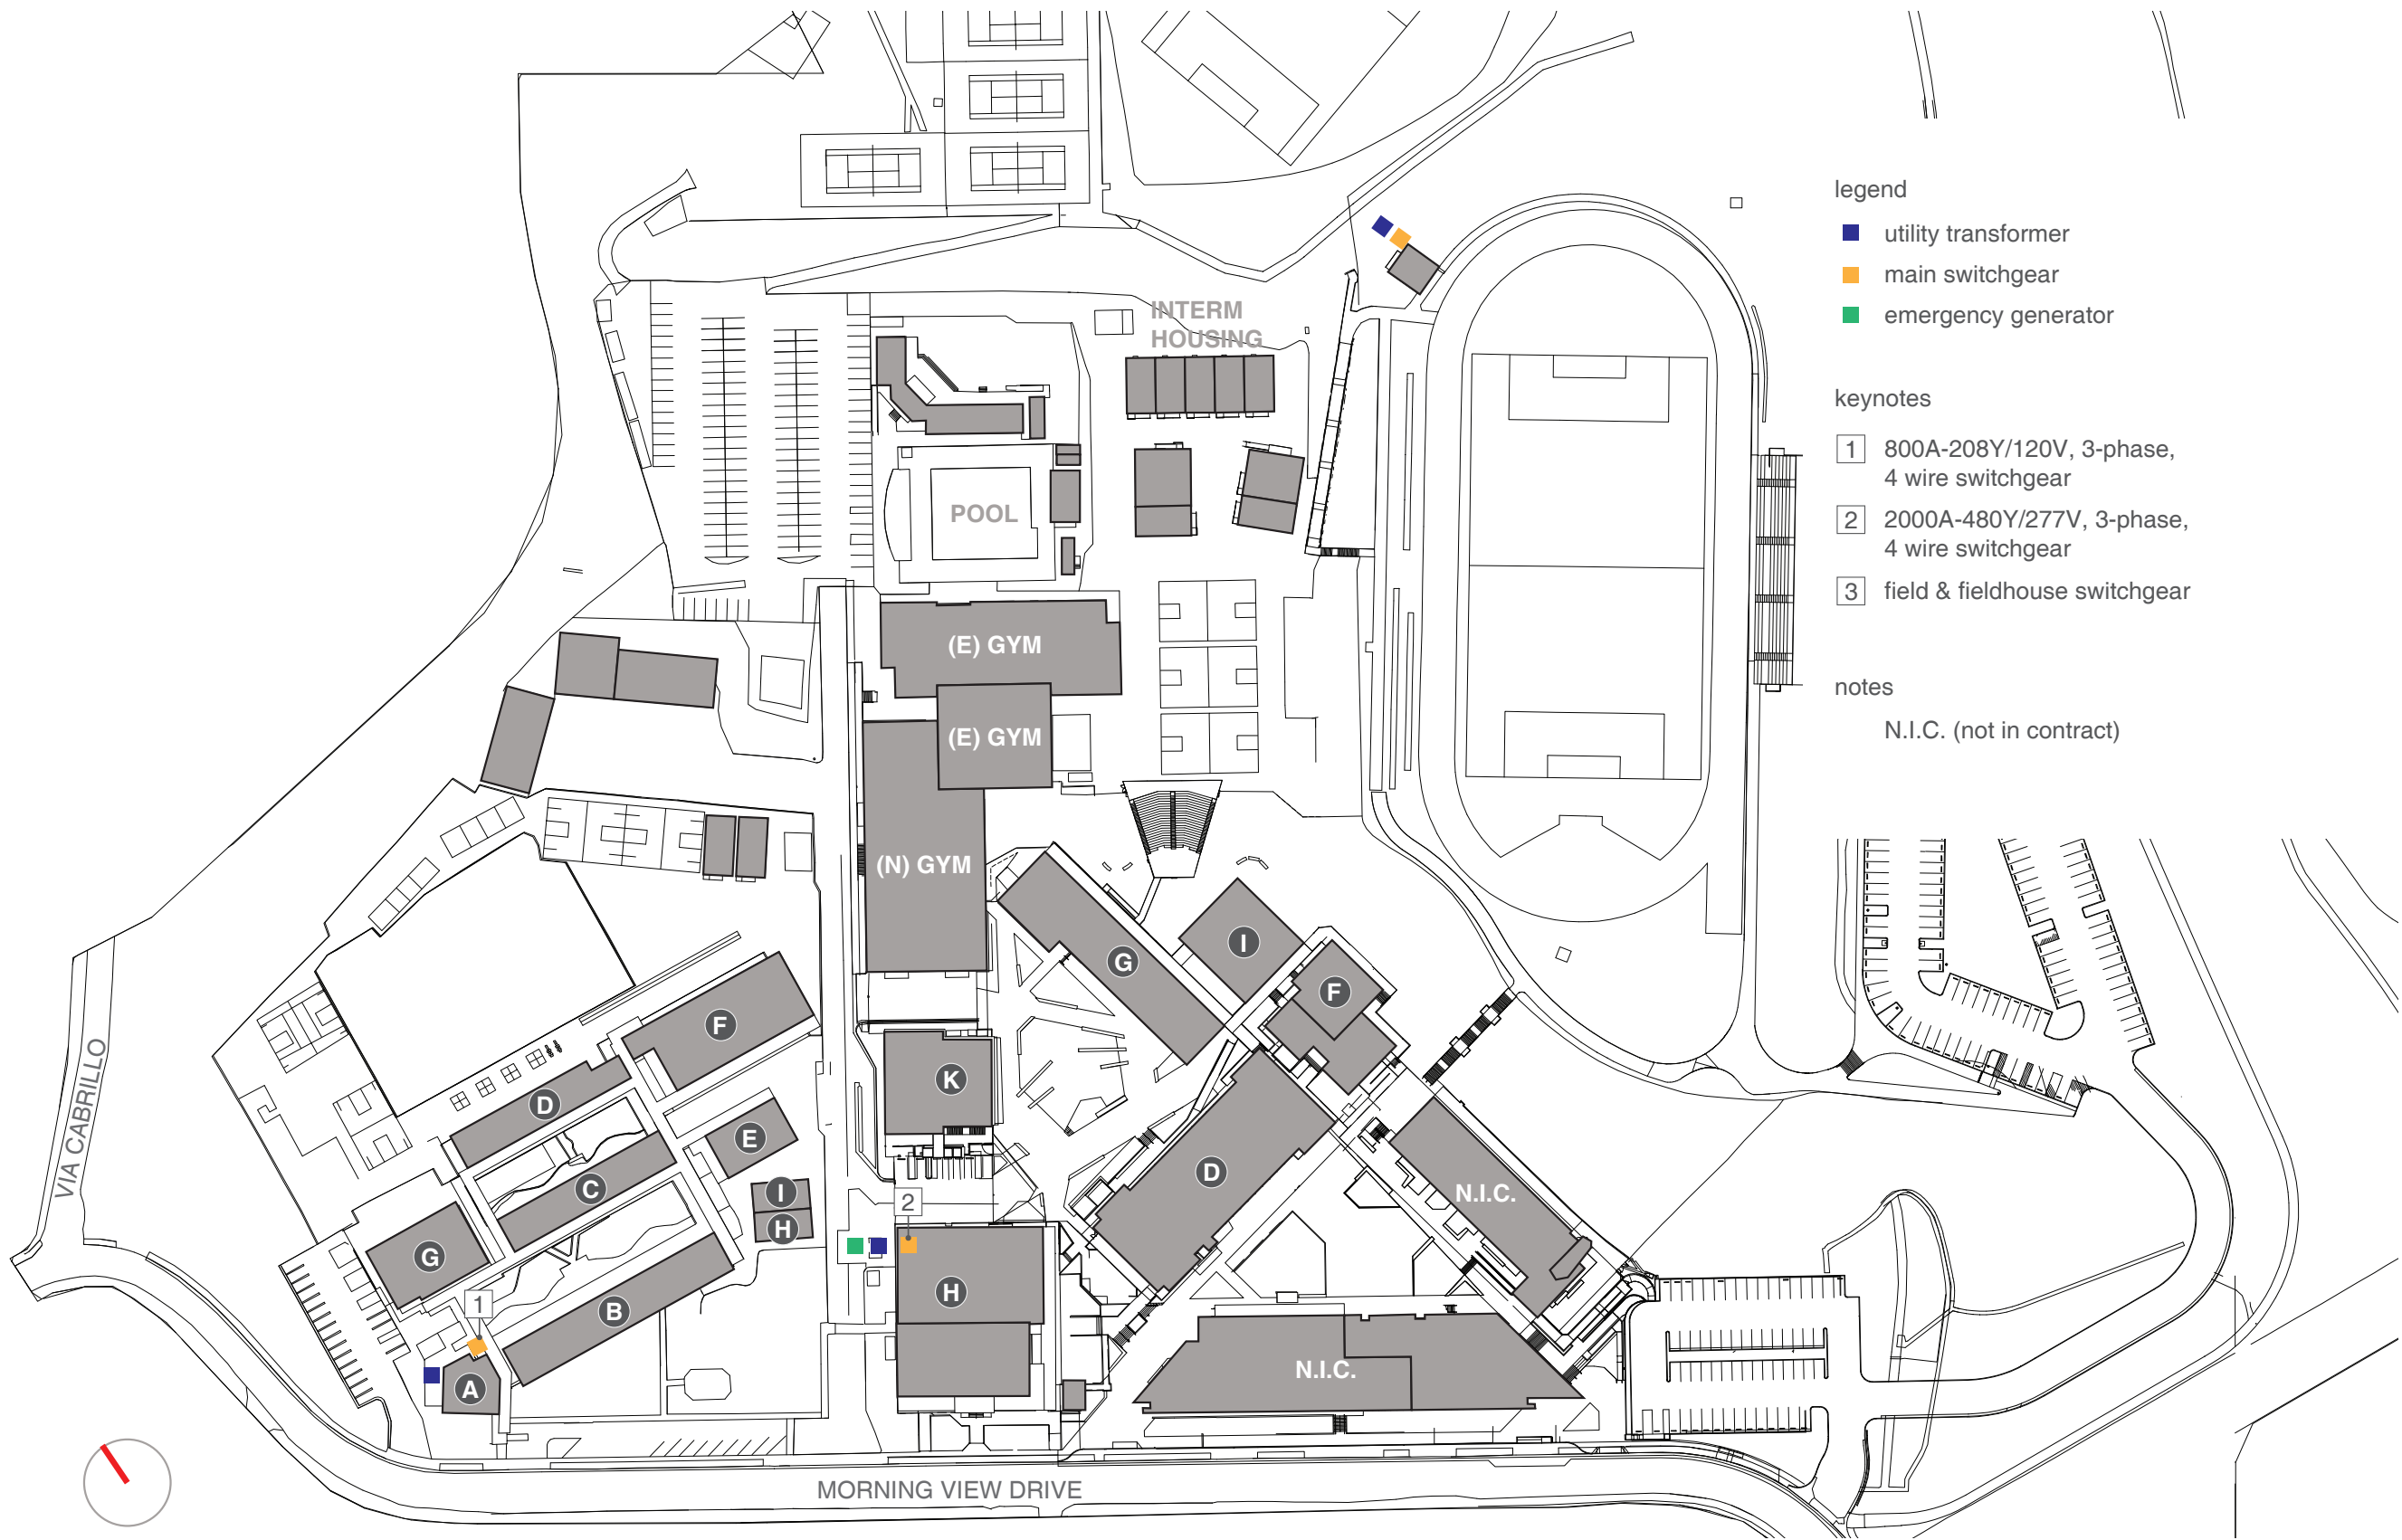
Figure 3.1-5 Campus-Wide Electrical Systems

School is currently being fed from 750 KVA utility transformer. The main switchgear is indoor, and it is a 2000A, 480Y/277V, 3-phase, 4 wire unit. The utility transformer was roughly installed around year 2015 and some distribution equipment seem to be in good condition. Older 1200A switchgear, which feeds most of campus, is also being fed from the 2000A switchgear. The electrical distribution system consists of original (very old) and newer equipment from different manufacturers. The campus electrical distribution system is currently partially backed up by a 60 KW emergency generator. Current switch gear is adequate for campus expansion, but old switchgear and other distribution panels are old and need to be replaced. Staff members mentioned that power goes out at least once per month during summer, and at least 2-3 times per month during winter. A larger backup emergency generator or inverter is highly recommended.
