SITE ASSESSMENT

MALIBU MIDDLE HIGH SCHOOL
SANTA MONICA-MALIBU UNIFIED SCHOOL DISTRICT

MALIBU MIDDLE & HIGH SCHOOL
Campus Master Plan

Nov 2019

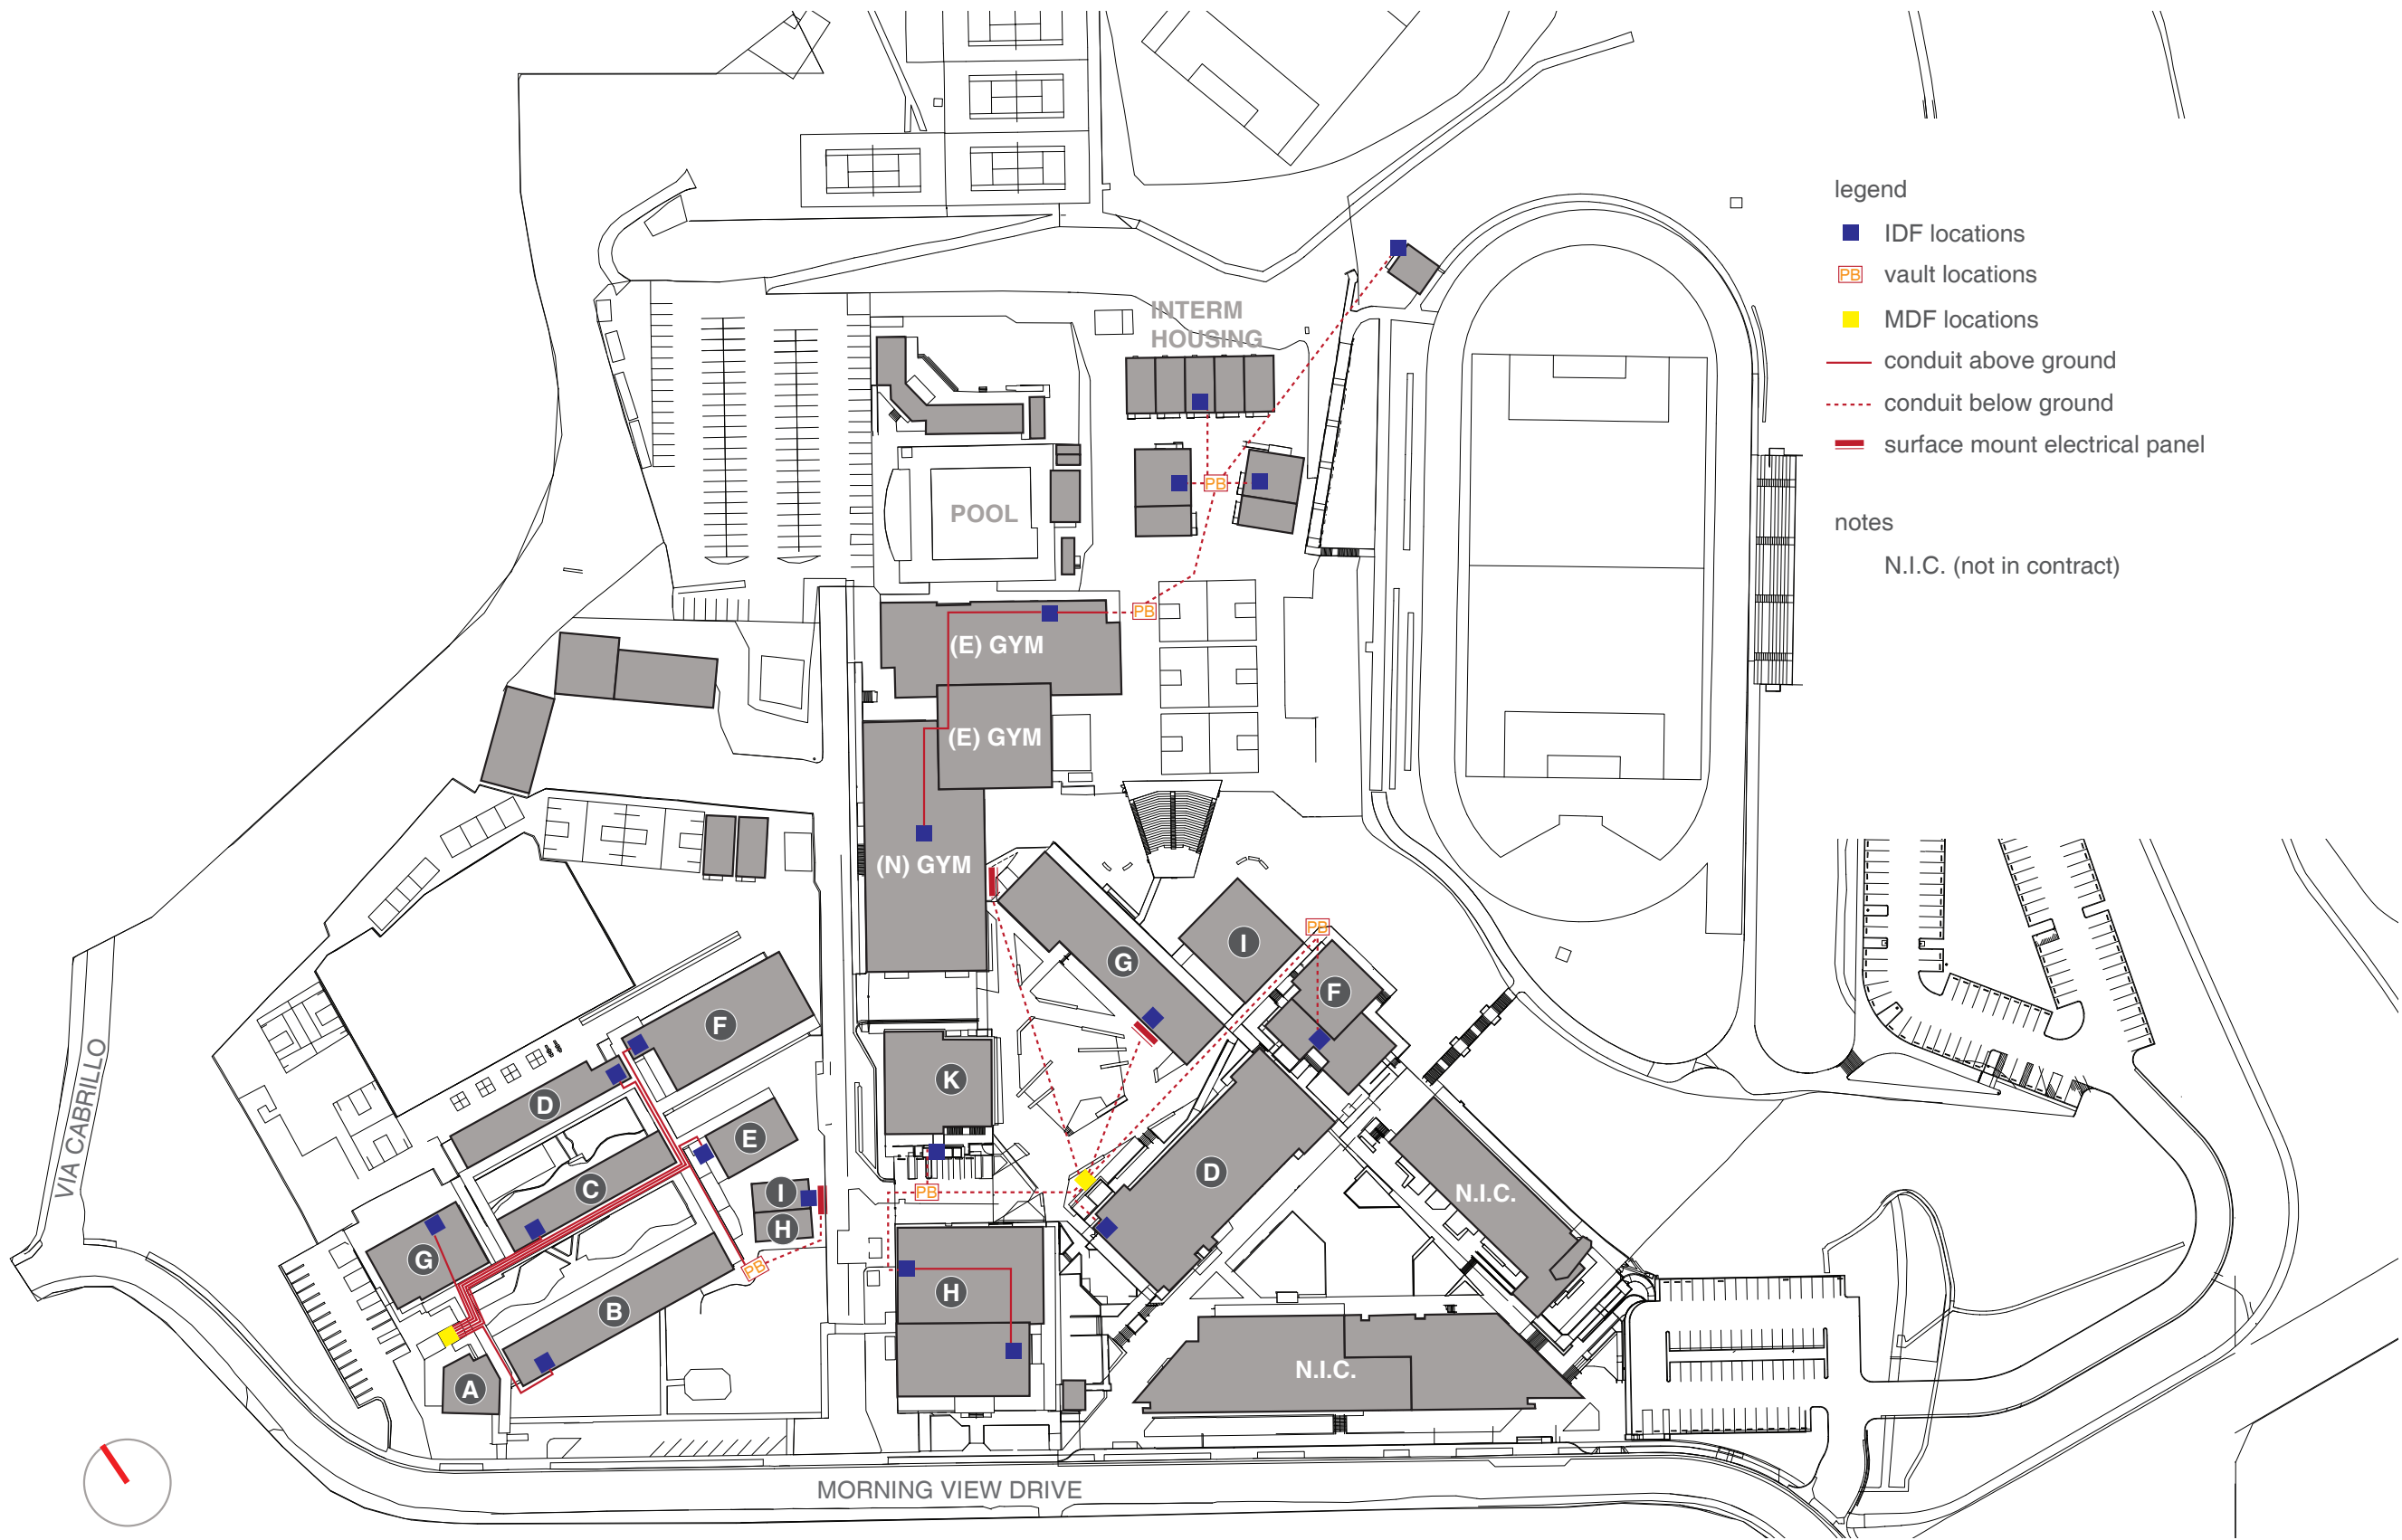
Figure 3.1-6 Campus-Wide Technology Systems

Observation: During our site visit we found a total of four (4) vaults located through-out the campus. Out of the four (4), we had the opportunity to open two (2). It is suggested to perform a campus cable audit of all used and unused cabling to determine what cable is abandoned and able to remove from underground pathways.

We also noticed there is 50% of non-OSP cabling in the underground conduit pathway system that does not meet NFPA 70, NFPA 70E, National Electrical Code 2017 code requirements and/or TIA industry standards. These cables must be removed and replaced with OSP cable and update code requirements and minimize damage to equipment and cabling with protection from water, rodents and lightning surges. Surges will almost always surpass the voltage rating of these devices causing them to fail. Proper grounding and bonding is necessary at all times.

Vault system can be reused and phased for new construction if required (additional vaults required per phasing to be determined).

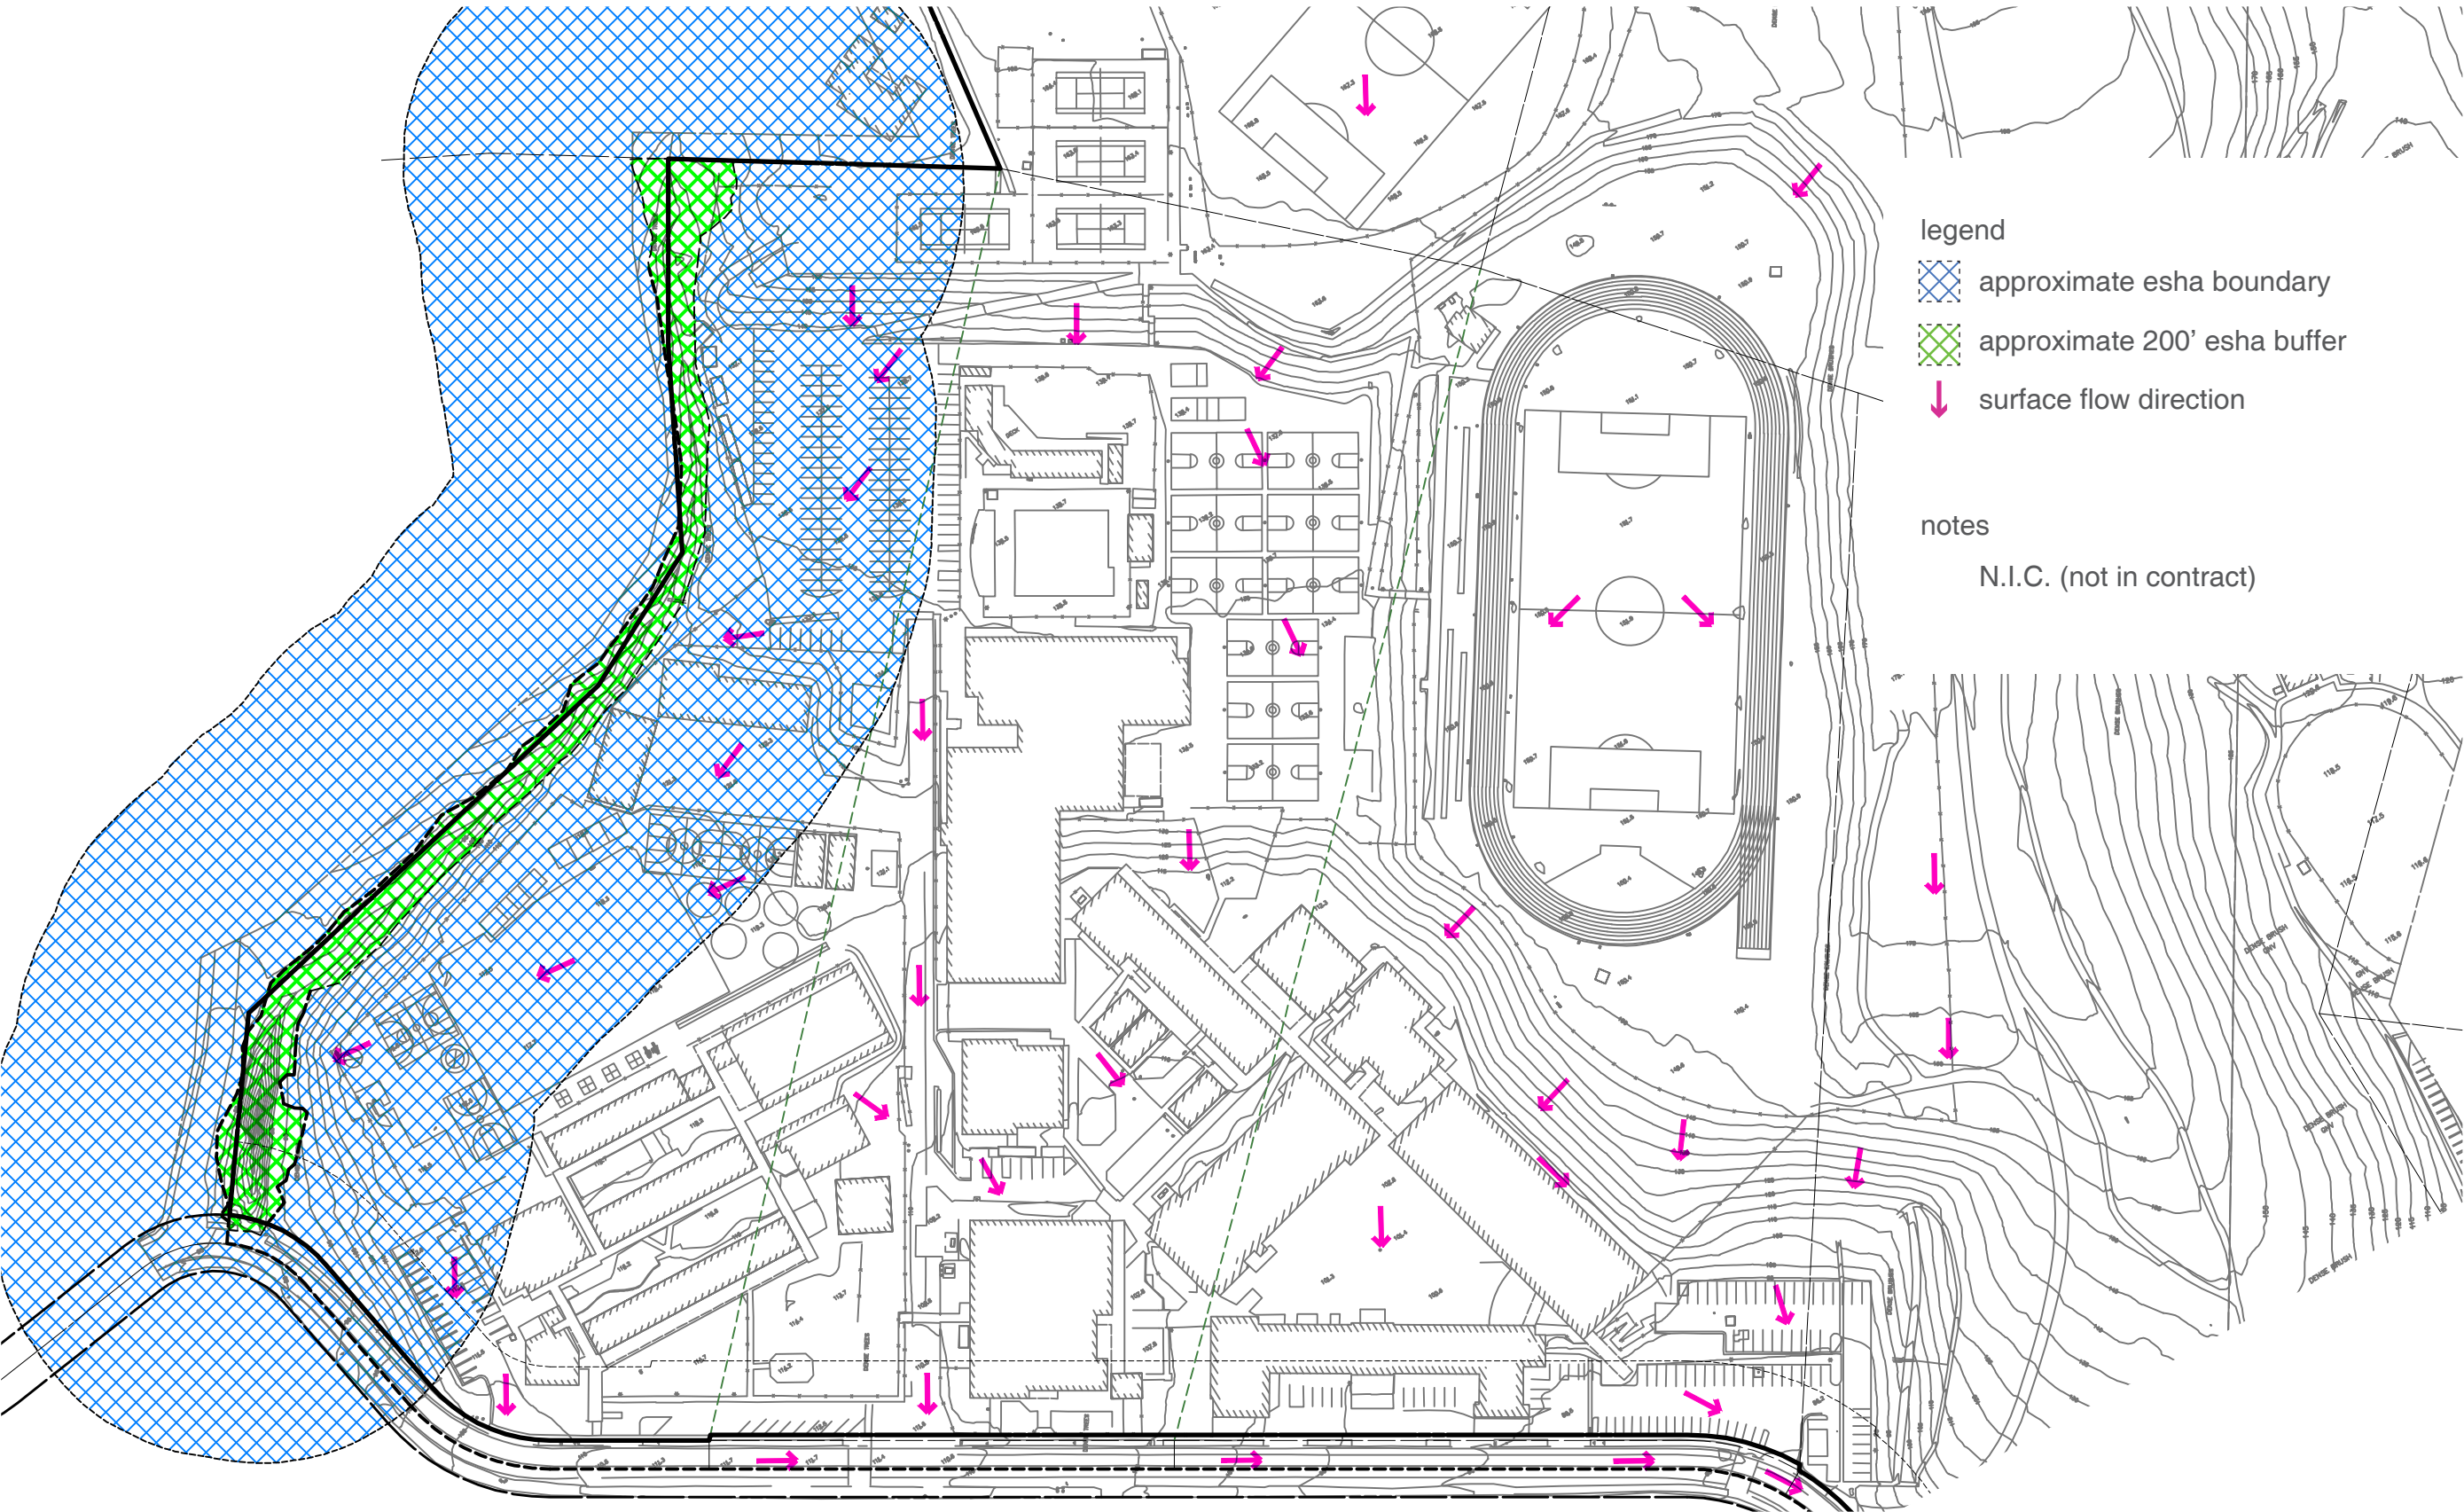
Figure 3.1-7 Grading Plan and ESHA Overlay

The City of Malibu's Local Coastal Program ESHA Overlay Map 2 and United States Geological Survey (USGS) Point Dume California 7.5 minute topographic quadrangle map shows an unnamed stream along the western edge of the middle school. Riparian areas within developed areas are designated as ESHA. The city of Malibu maintains policies to protect environmentally sensitive habitat areas within city limits and new developments must be sited and designed to minimize impacts to the ESHA. A development buffer between the limits of the ESHA will be required and is typically 100' minimum.

The unnamed stream potentially fits the definition of a water of the United States and is subject to the Clean Water Act Section 404.

Proposed septic systems should be designed and sited to avoid impacts to the ESHA. Adequate setbacks are required to protect the ESHA from increases in water and lateral see page of wastewater.

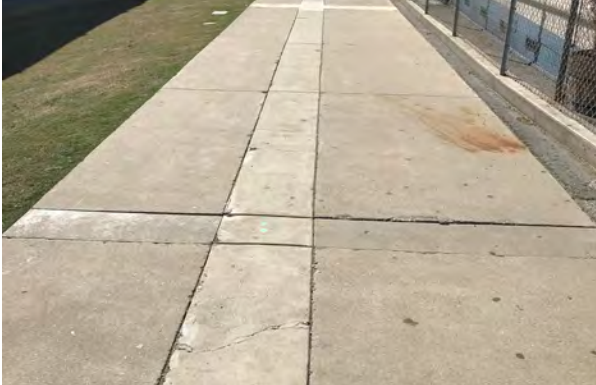
slope and low spots are apparent throughout the campus. The cafeteria and lunch area have several chips, crack, lifting panels and cross slope issues. Various areas around campus have panels lifting and are ground down for ADA compliance. The concrete at the amphitheater is in poor shape, cracks, deteriorated/non-existent joint sealants, and cracks are prevalent. Stairs at the amphitheater are worn and lights are non-functional. Pool deck is deteriorated and worn and should be replaced. Concrete along the north side of Bldg J.(Old Gym) has cross slope issues, saw cut trench patches, and cracks. Concrete paving at the track level is fair to good shape. A few panels with cracks/lifting, but most concrete panels are in good shape.

Concrete Paving

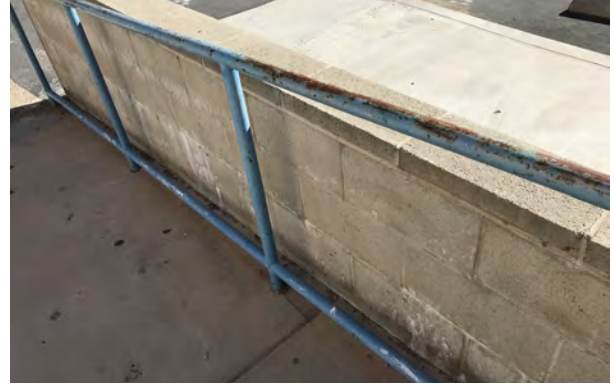
Concrete stairs are generally in poor shape. Most are missing the grooves and color differentiation at the step nosing. Several have chips, gouges and exposed handrail posts. Handrails seem compliant, but have lost a majority of the protective paint coating. Rust and deterioration are prevalent on the majority of the handrails.

Handrails

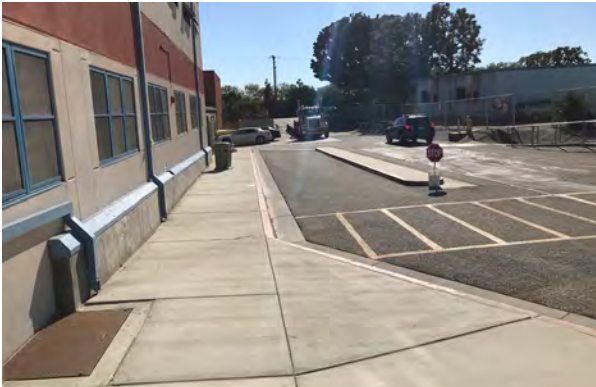
Missing Truncated Domes

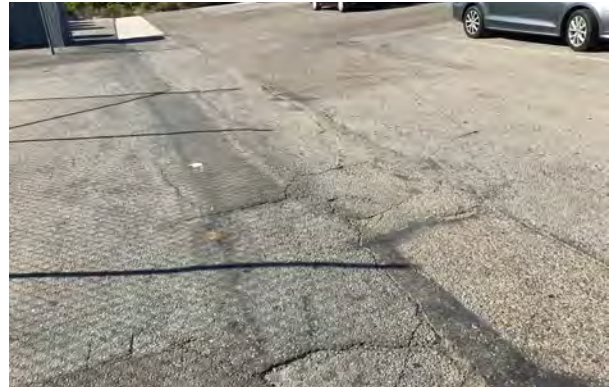
AC Paving is worn throughout campus and calls for replacement. The Hardcourt paving area can be rated as fair, but has several depressed areas due to constant trenching for new/upgraded infrastructure. Main entrance spine from Morning View Drive is cracking in several locations and worn down. The bus yard is in fair condition with a few areas of worn AC paving which can be filled. The upper parking lot northwest of the pool has several worn and cracked areas and should have the paving replaced. A newer upper parking lot and access road southeast of the track is in good condition. The vehicular access ramp to the tennis courts and the paving south of the courts is in poor shape with cracks, depressions, and erosion issues. It should be replaced. Parking areas south of the gym and Bldg K are in fair shape.

AC Degraded

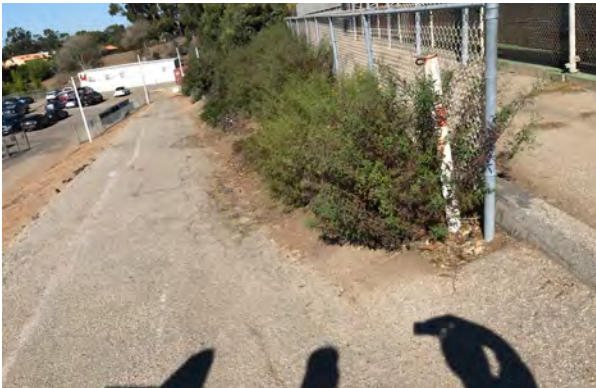
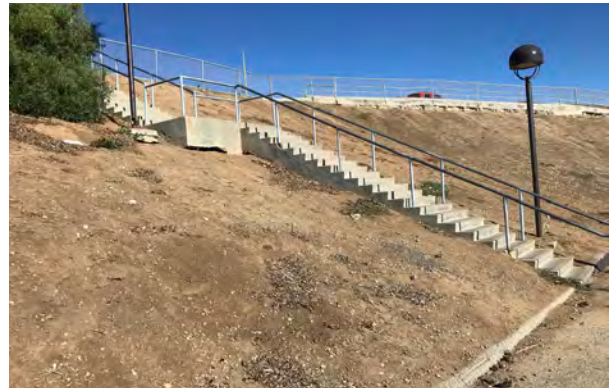
in no longer prevalent in any of the planters. Many large slopes have no planting and have erosion issues.(South of tennis courts, west of track, and west of amphitheater)

Erosion

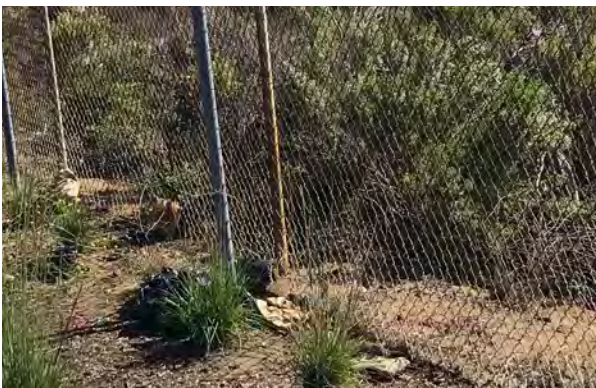
Currently there is chain link fencing along the eastern perimeter of the high school. It is in fair shape, could use some fabric mesh replacement. The southern boundary is also chain link and is currently in fair condition, could use some fabric mesh replacement. The western boundary is chain link fencing along the bus yard and the existing upper parking lot. A few areas have eroded and fencing should be adjusted/fixed. The western boundary chain link continues to the northern boundary and is in fair shape. The northern boundary by Clover Heights Avenue cul-de-sac is chain link fencing. It is in fair shape.

Chainlink Fencing

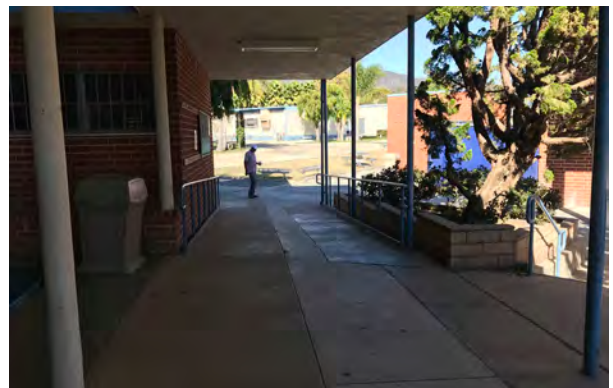
Cross Slope

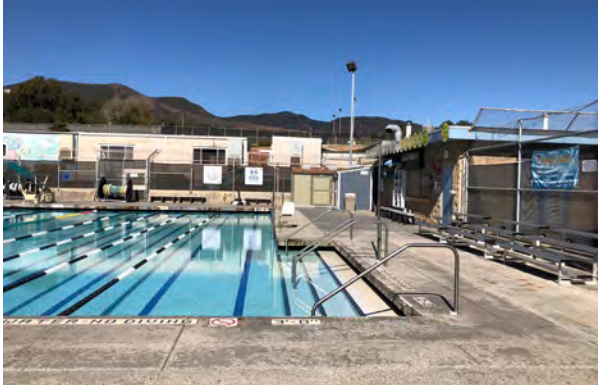
Pool facility is for District and community use. It currently is in poor shape. The pool decking is old (1990's), pitted and cracked. Staff reports issues with pumps, backwashing and equipment corrosion. The bleachers within the pool area are not ADA compliant. Perimeter chainlink fencing with windscreen is in fair shape.

Pool

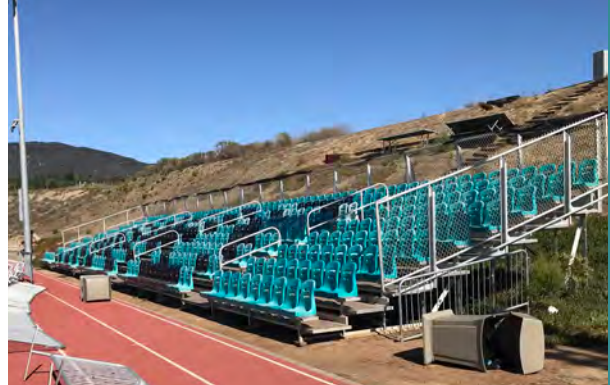
The Track is a synthetic system seems to be about 400 meters. It has eight (8) lanes and the Home bleachers are directly adjacent to the last lane leaving no room for pedestrian access separate from the track. The track is in fair shape with some worn areas and low spots.

Track Area - Bleachers

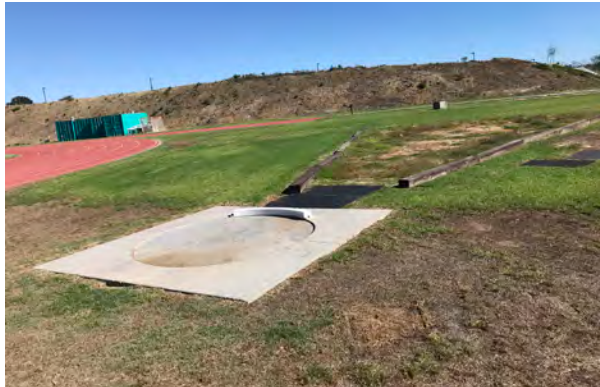
The Shot Put area is south of the track in a turf area. There is no accessible path to the shot put ring or pit. The pit is in poor shape and is inundated with many weeds, very little sand, and a rudimentary

Track Area - Shotput

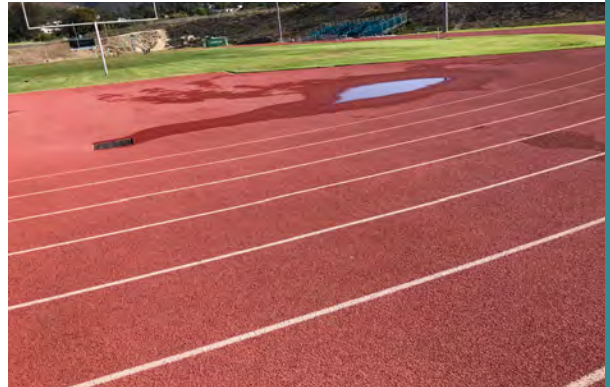
High Jump is located just north of the shot put area. It is located in an area fully enclosed in synthetic track surfacing. Track surfacing is worn but in fair shape. A low spot is prevalent with the high jump area.

Track Area - Low Spot

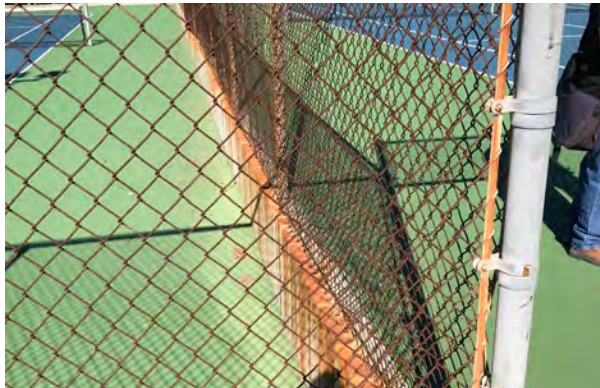
The Tennis Courts are located northwest of the track. The three (3) southern courts are in fair/poor shape. The fencing is rusting, a few cracks in the courts, the southern boundary fence posts required reinforcement, and a 6 inch plus difference between the east and west courts. The north tennis court is in fair shape with the exception of drainage/debris from the adjacent walk accessing the court area. No bleachers are present, only portable benches which are in fair condition.

Tennis - Rusty Fence

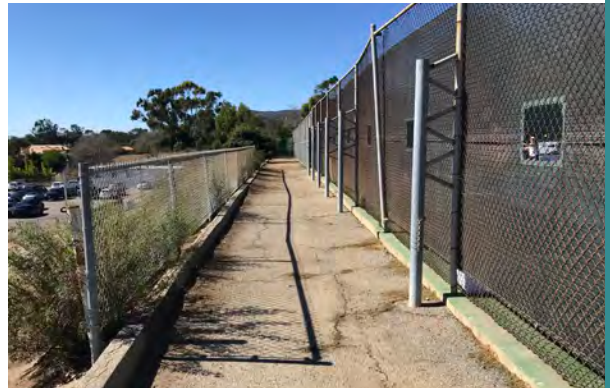
Tennis - Unsteady Post

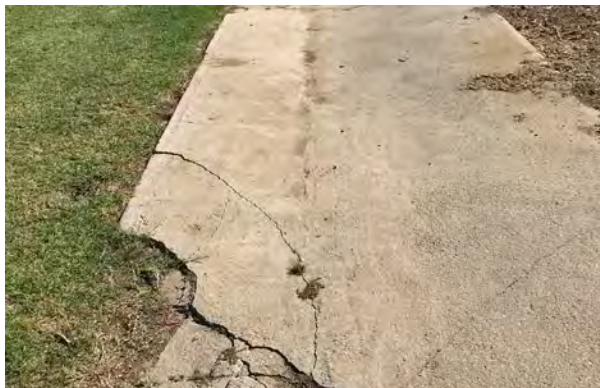
Broken Drainage - Concrete Ditch

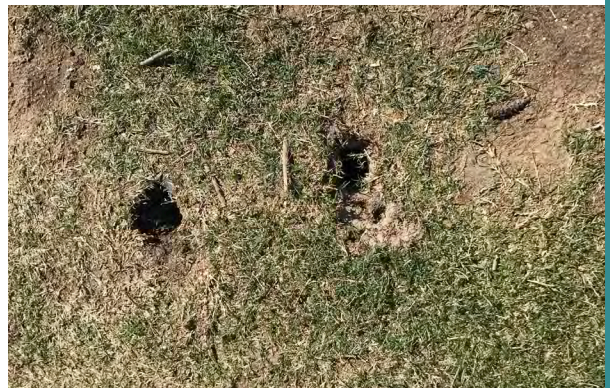
Broken Drainage - Gopher

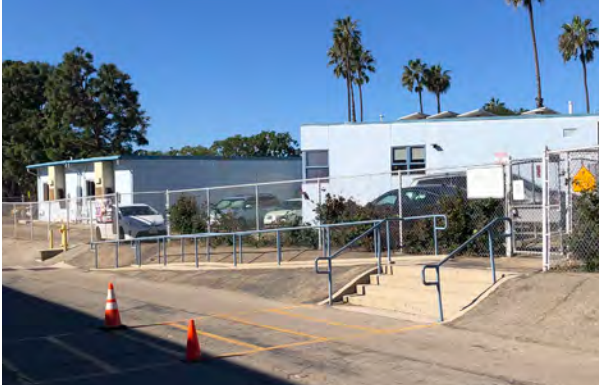
Truncated Domes

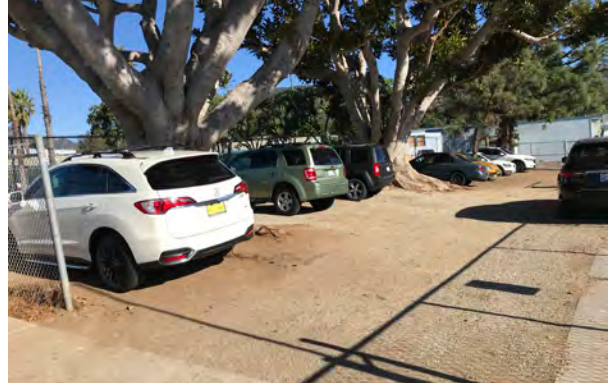
A small staff parking lot is located west of Bldg. G. ADA parking stalls in this lot meet all requirements of current code. Additional makeshift parking was provided east of Bldg. E, and west of the fire lane south of Bldg. H. Throughout the campus several cars are parked in non-designated areas which implies parking scarce for this site.

Limited Parking

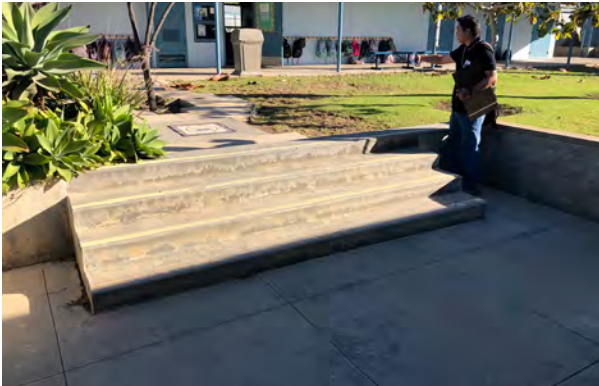
No Handrails

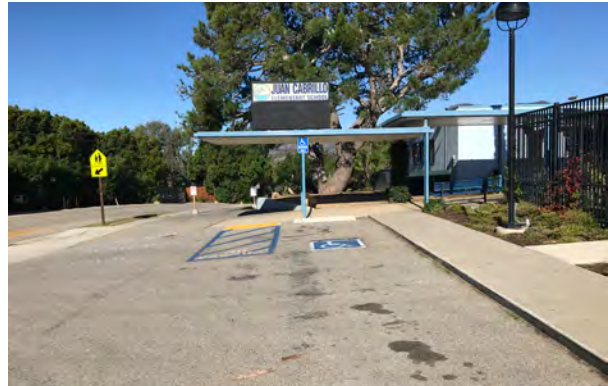
Child drop-off seems to occur at the parking lot along Morning View Drive. The parking lot drive aisle is inadequate for drop-off and vehicular circulation for parking purposes. The ADA stall has an access aisle which has a cross slope in excess of 2 percent which is not compliant with current codes.

Cross Slope > 2%

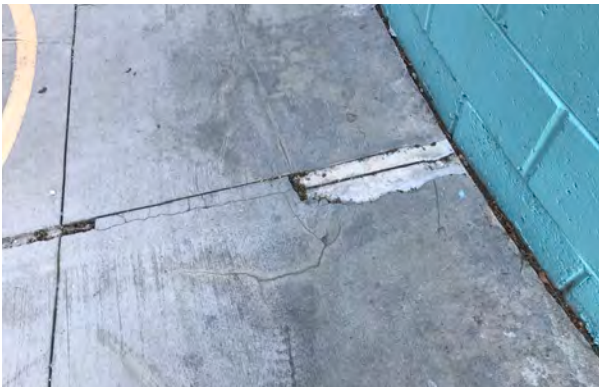
Concrete paving is of the original construction and has cracking, lifting, and is worn. North of Bldg. B there has been a thin layer of concrete over laid on the existing paving. This thin layer is cracking and several pieces have been removed by wear leaving several shallow divots in the paving. Concrete paving south of Bldg. C has several large cracks

Concrete Cracking

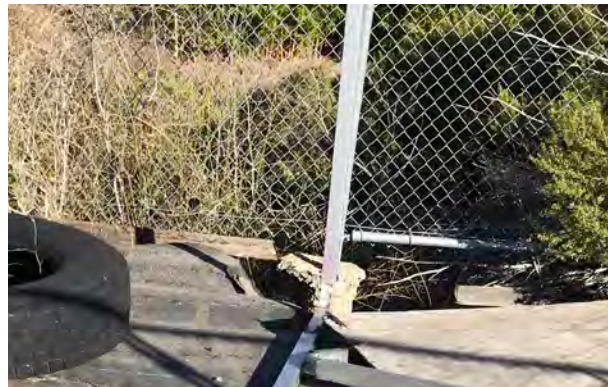
North perimeter fencing is chain link and is poor shape. Fence posts along the Environmentally Sensitive Habitat Area(ESHA) is eroding down the slope.

Erosion

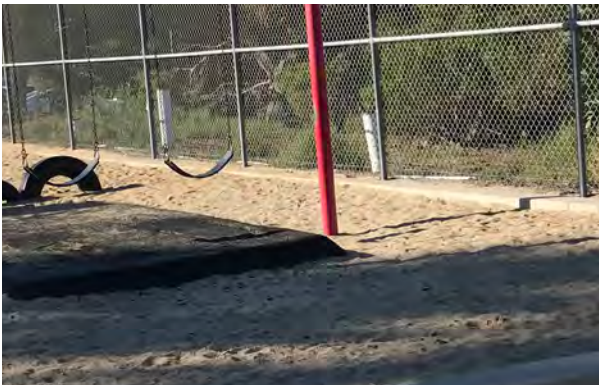
Sand box area is in poor shape. Curbing enclosing sand is chipped no elements in the sand area. Play structure is old and faded. Play surfacing seems recent and is in fair shape. Portable buildings have been placed over existing basketball courts south of the bus yard. Four (4) Basketball goals remain, one over laid by tetherball area and other three (3) by the sand area. Ball Walls are painted plywood and in fair/poor condition. AC paving within Playground/Hardcourt area is in generally poor condition. (See AC paving) Backstops have chain link which is in poor condition.

Play Equipment

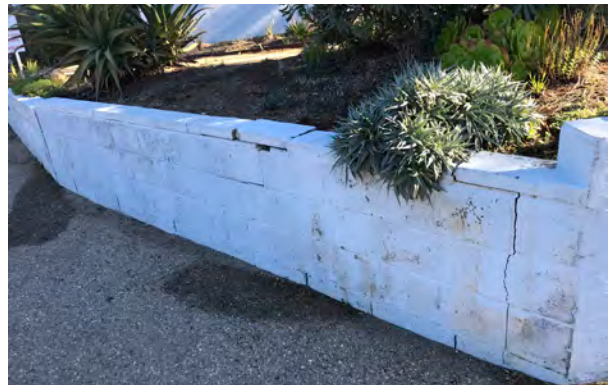
Walls
