# **BUILDING ASSESSMENTS**

MALIBU MIDDLE HIGH SCHOOL  
SANTA MONICA-MALIBU UNIFIED SCHOOL DISTRICT

4.0 Malibu Middle & High School Building Assessment

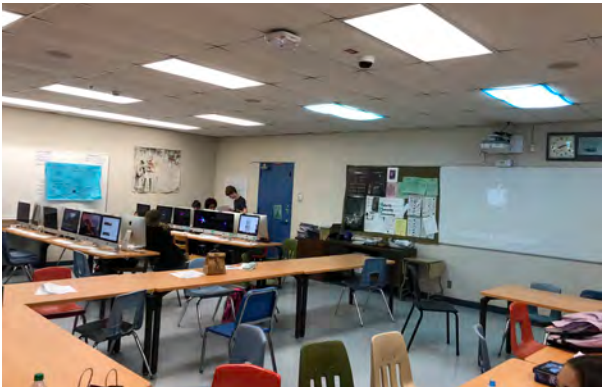
Typical science lab.

Typical lab classroom.

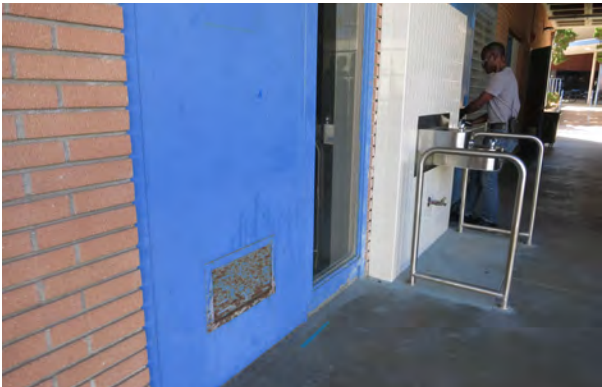
Typical restroom, boys.

Utility room door and drinking fountain.

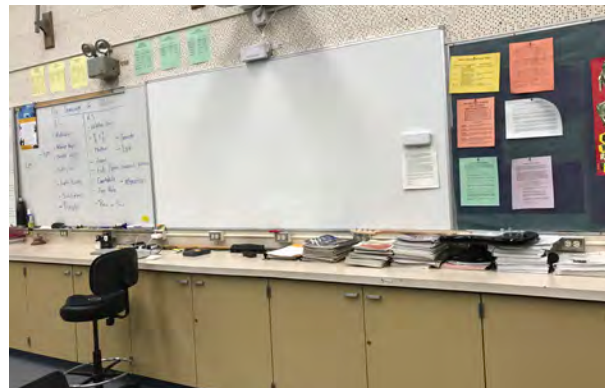
Band Classroom.

Typical casework.

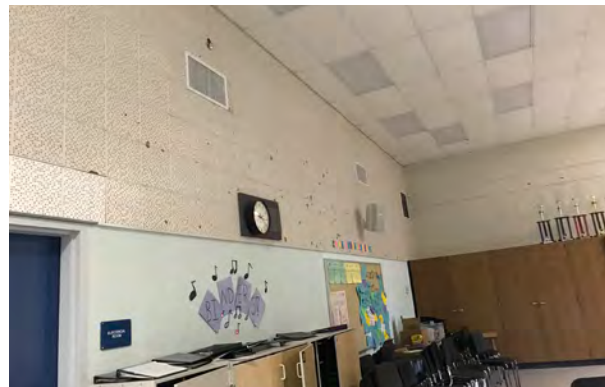
Music Classroom.

Typical glued-down acoustical wall panels.

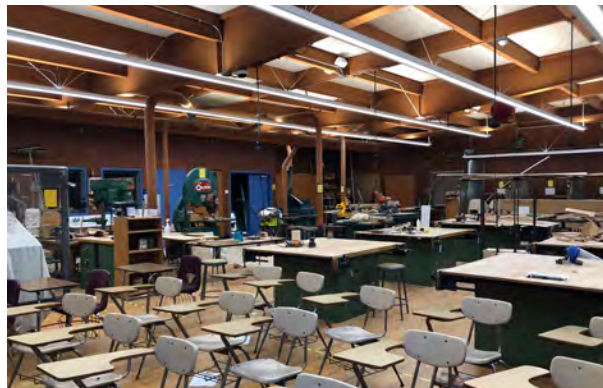
- Interior wood parquet flooring in the Makerspace appears original and is in poor condition. Floor is uneven, areas are sanded down but not refinished.
- Sealed concrete floor at Ceramics is in fair condition; needs to be resealed.
- Sheet resilient flooring at Special Ed is in good condition.
- Interior gypsum board painted walls and plywood paneling in Makerspace and Ceramics are in poor condition; good condition at Special Ed.
- Rubber wall base is in poor condition in Makerspace and Ceramics; good condition at Special Ed.
- Exposed ceiling with acoustical panels between painted steel beams appear in acceptable condition.
- Acoustical ceiling panels at Special Ed are in poor condition with stains and warping.
- Casework at Makerspace and Ceramic appear original and in poor condition; casework at Special Ed in good condition.

Typical original parquet flooring.

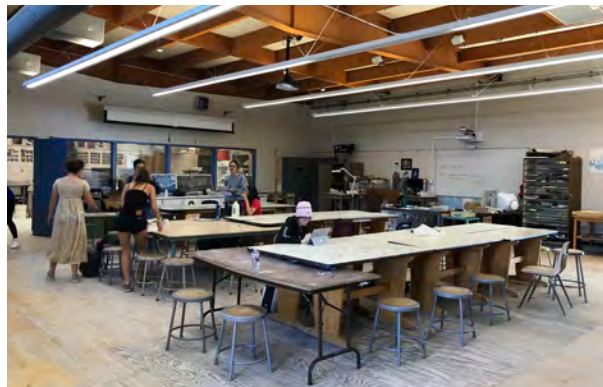
3D Art - Ceramics.

3D Art Classroom.

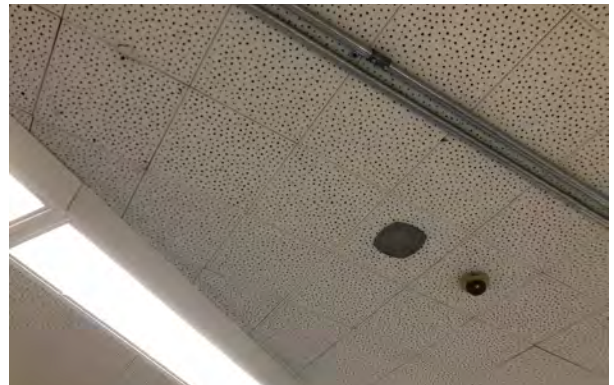
Typical refurbished casework.

Typical gluedown ceiling tile.
