March 20, 2017

Mold and Moisture Investigation Report: Findings of Initial Assessment

**John Muir Elementary School
Classrooms 600, 615, 205 and the
Media Center
2526 Sixth Street
Santa Monica, CA 90405**

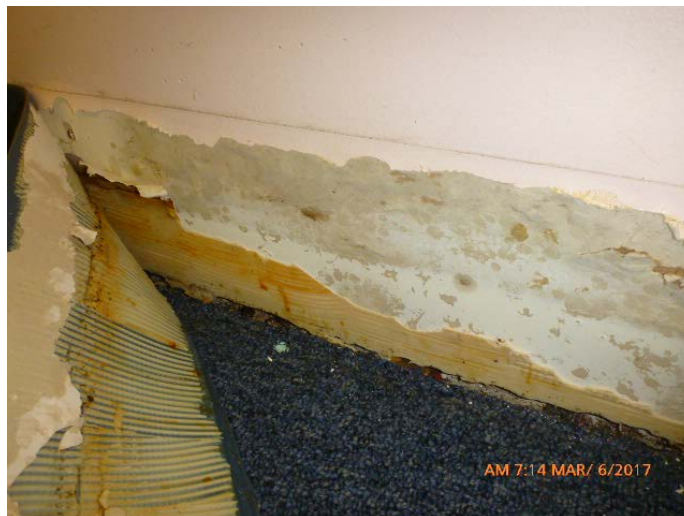
Photo #6: Close-up of base of north wall and moisture impact

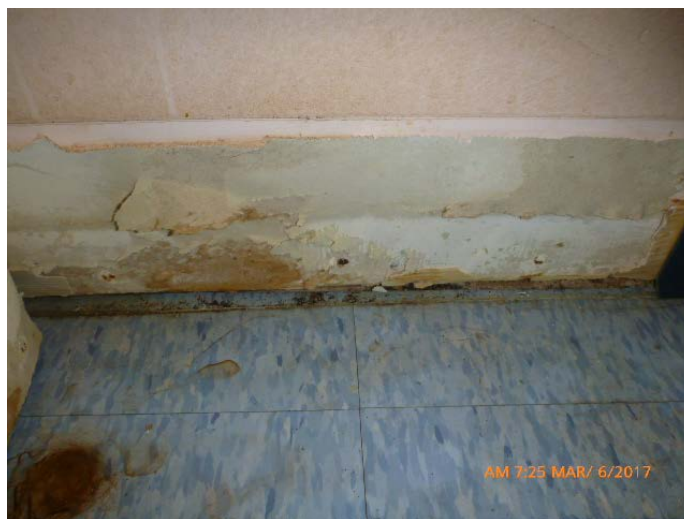
Ref #	Functional Area/Location	Observations/History	Area of Mold ^a	Area of Moisture ^b	Moisture Readings ^c	Photo # ^d	Sample # ^d
A	Classroom 615 – General Exterior	Classroom 615 Placard at entrance.	\	\	\	1	OA1
		Overview of exterior (1 st floor) of classroom 615.	\	\	\	2	
		First outdoor control air sample collected.	\	\	\	\	
B	Classroom 615 – General Interior	Overviews of classroom 615 interior – south and northeast.	\	\	\	3, 4	IA1
		Overview of north wall adjacent side entry.	\	\	\	5	
		Close-up of base of north wall. No visible mold growth observed; however, strong musty odors and significantly elevated moisture levels were present.	\	~5 ln. ft.	5.0% (gypsum)	6	
		Overview of backside of north wall in hallway.	\	\	\	7	
		Close-up of base of wall and staining on vinyl floor tile. No visible mold growth observed; however, strong musty odors and significantly elevated moisture levels were present.	\	~6 ln. ft.	>6.2% (gypsum)	8

Photo #8: Close-up of base of wall and moisture impact. Staining observed on vinyl floor tile

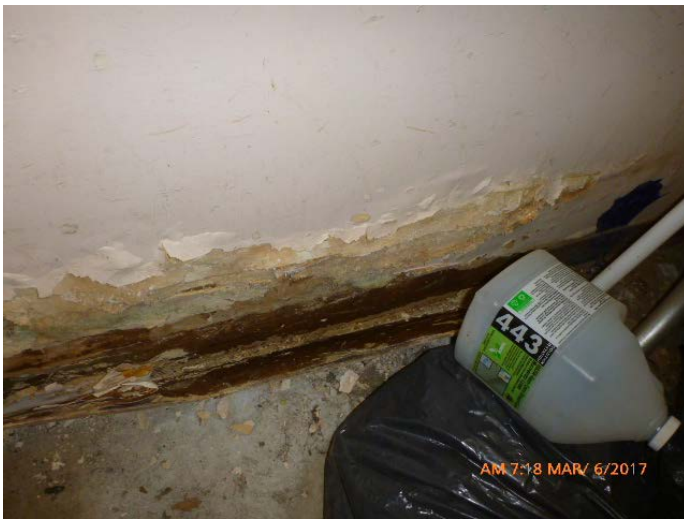
C	Custodial Closet Adjacent CR 615	Overview of Custodial closet in hallway adjacent to classroom 615.	\	\	\	9	\
		Overviews of the east wall in closet. Heavy moisture damage, visible mold growth and significantly elevated moisture present along base of the east wall.	>4 ln. ft.	>6 ln. ft.	>6.2% (gypsum)	10, 11	
		Additional moisture impact along north wall adjacent to the mop sink.	\	>2 ln. ft.		12	
		Additional moisture impact observed along base of south wall. Moisture measurements of wall materials significantly elevated.	\	>6 ln. ft.		13

Photo #11: Heavy moisture damage, visible mold growth and elevated moisture along base of east wall

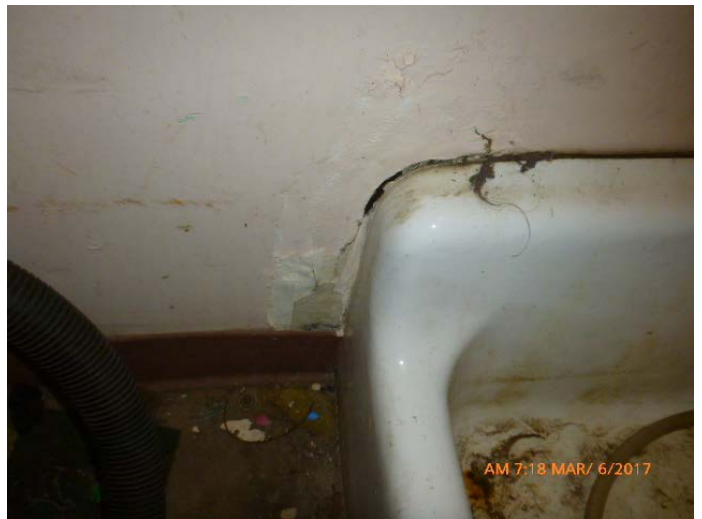
Photo #12: Additional moisture impact along north wall adjacent mop sink

12. Inspect and repair any plumbing leaks at mop sink in custodial closet adjacent to classroom 615.

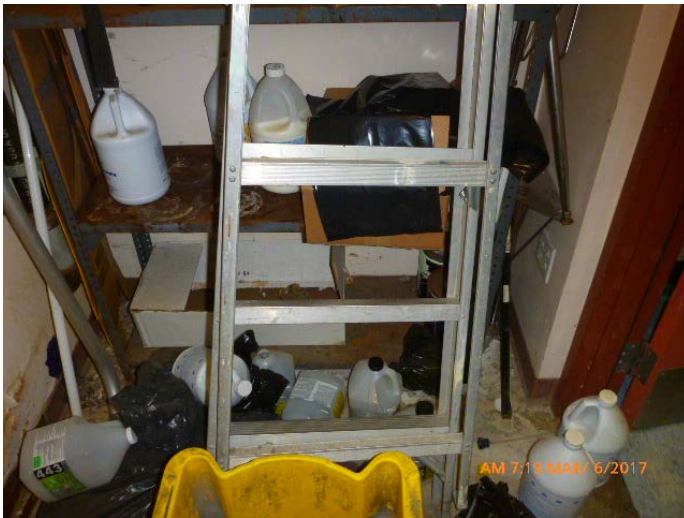
Photo #13: Additional moisture impact observed along base of south wall

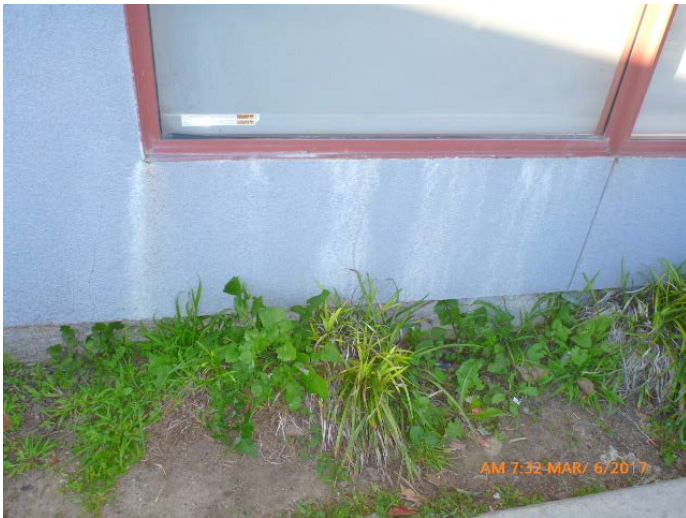
Photo #17: Staining observed below window along north perimeter

8. In consultation with an appropriately qualified construction professional, inspect classroom 600's north window. The window is suspected to leak based on visual findings.

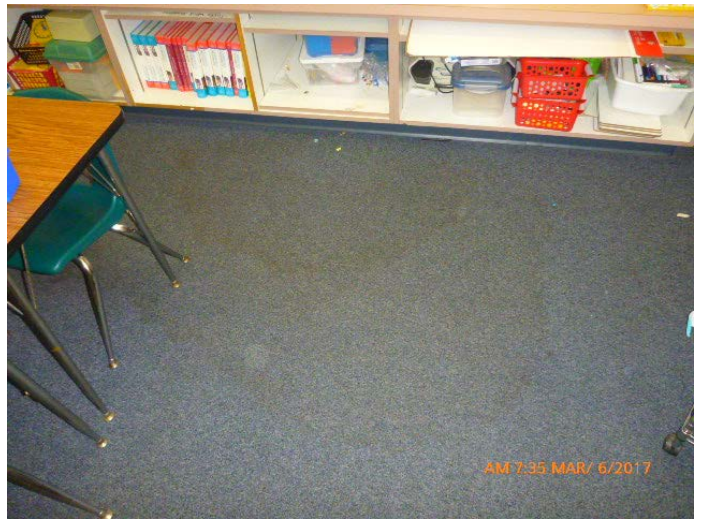
Photo #20: Stained carpeting along north perimeter

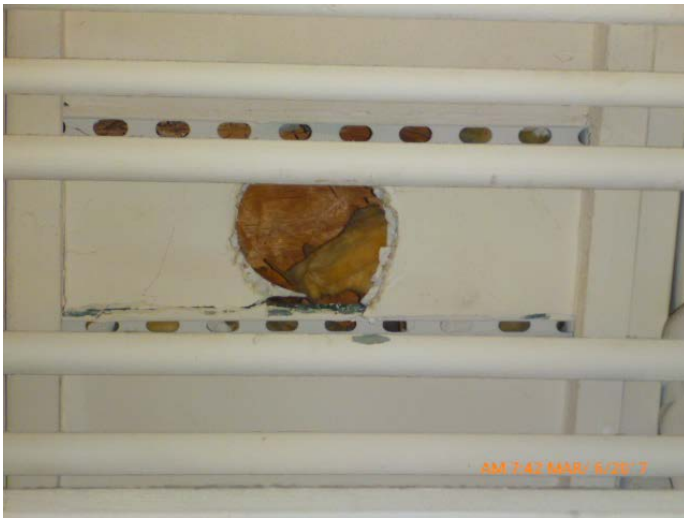
Photo #21: Hole observed in ceiling above stained carpet

9. Replace all moisture-impacted ceiling tiles and monitor during next period of heavy rains. If staining re-occurs, reassess and repair roof leaks.
10. Inspect and repair hole in ceiling of classroom 600. During this process, inspect the ceiling cavity for additional moisture issues including mold growth.

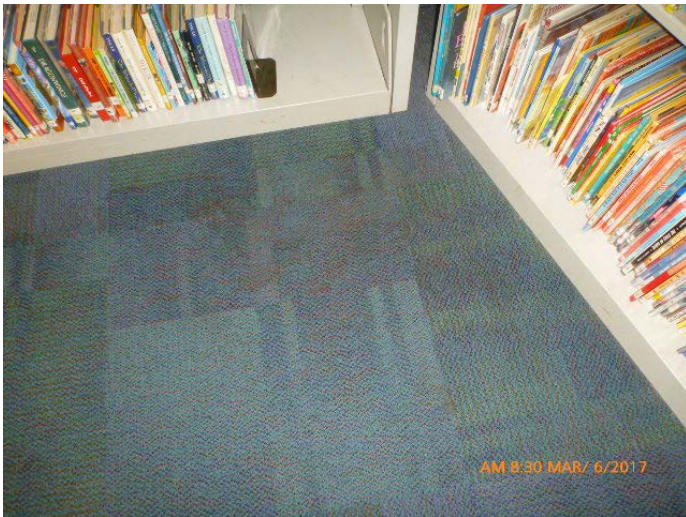
Photo #29: Overview of stained carpet in NW corner

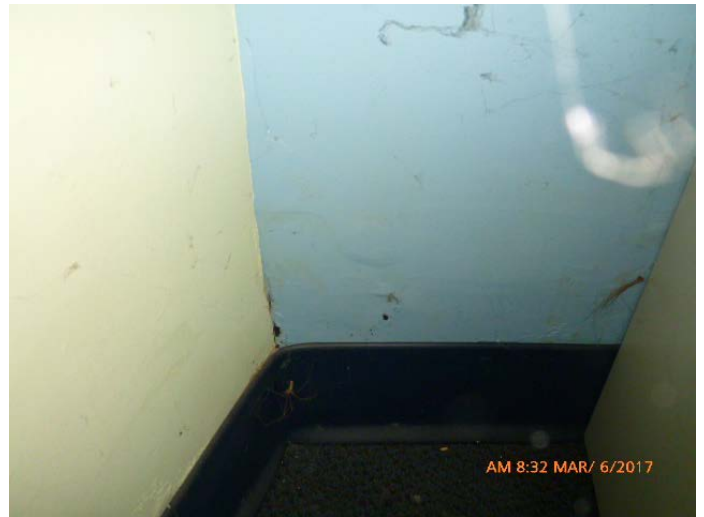
Photo #30: Overview of moisture damage along base of
walls in NW corner

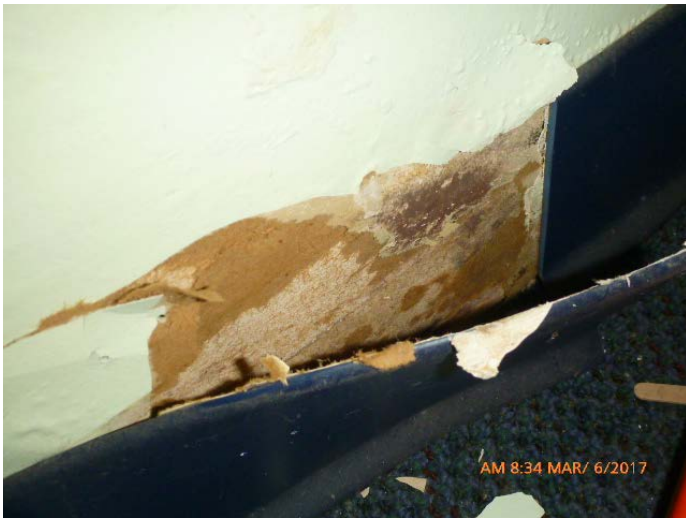
Mold growth observed behind base-cove on west wall.				31	
		Overview of circulation desk along north perimeter (impact area 2).	\	\	\	32	
		Stained carpeting observed along north perimeter. The carpeting was dry at time of FACS assessment.	\	~4 ft. ² (stained)	\	33

Photo #31: Mold growth observed behind base-cover on west wall

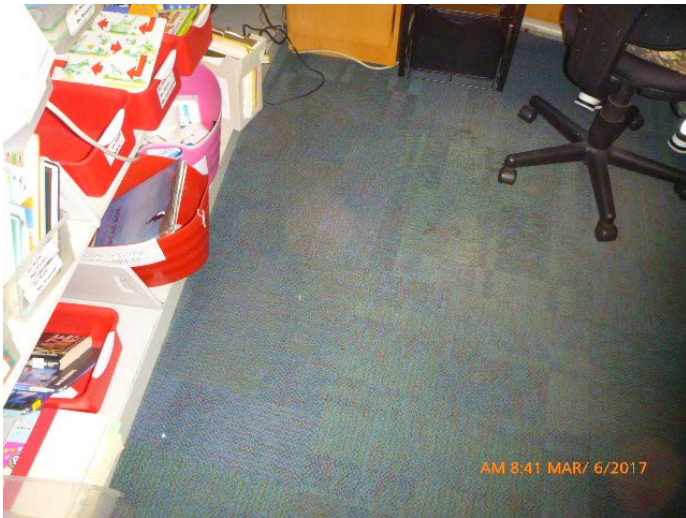
Photo #33: Stained carpeting observed along north perimeter

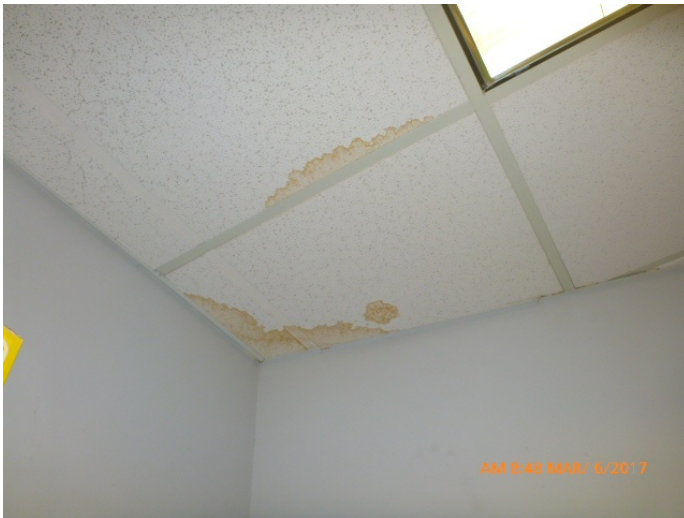
Photo 35: Stained ceiling tiles observed in SW corner

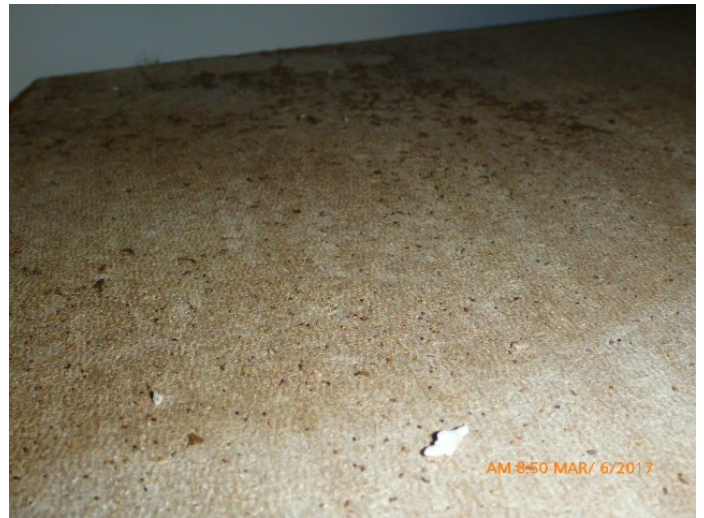
Photo 36: Overview of top of ceiling tile and staining/debris

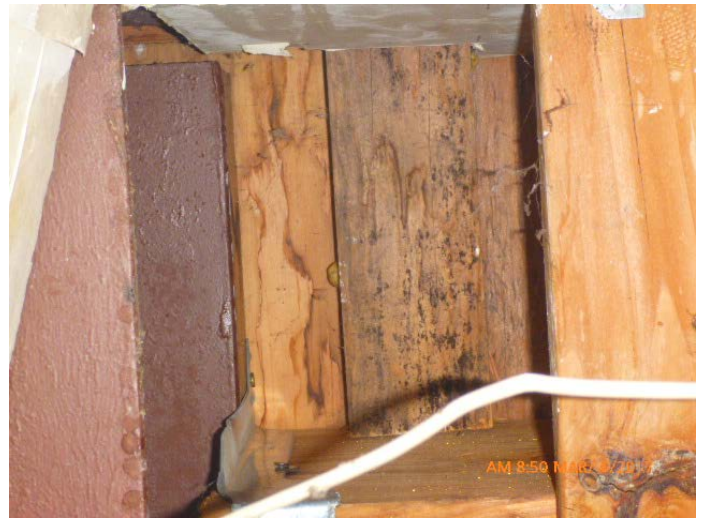
Photo 38: Close-up of staining on wooden beams

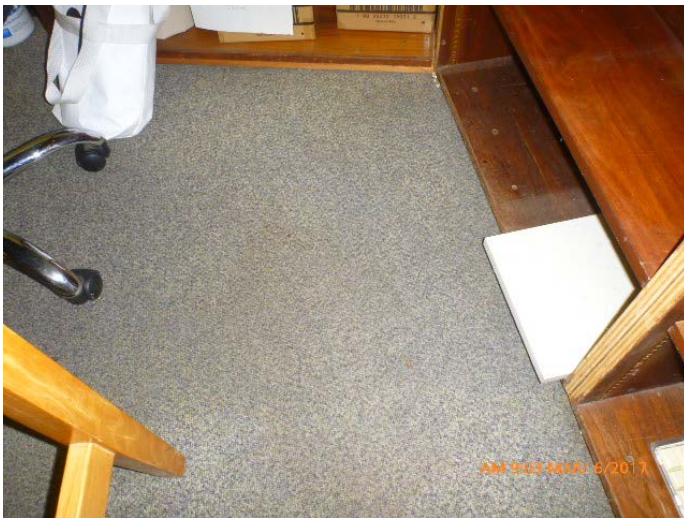
Photo 43: Stained carpeting observed along south perimeter

Photo 42: Stained ceiling tile observed along south perimeter

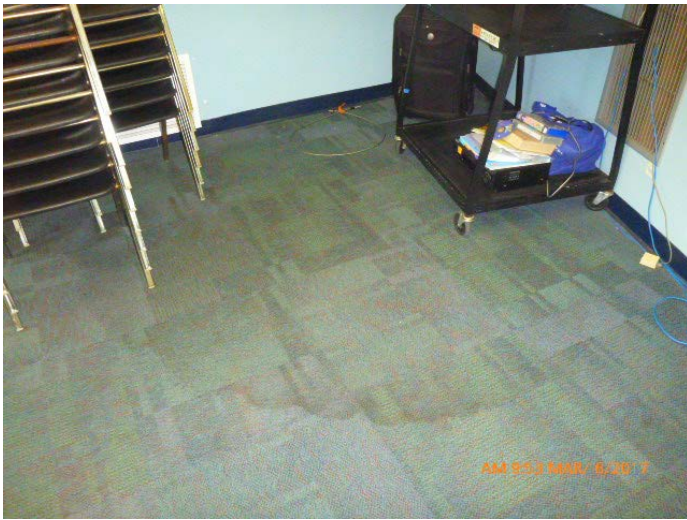
Photo 45: Large area of stained carpeting observed in SE corner

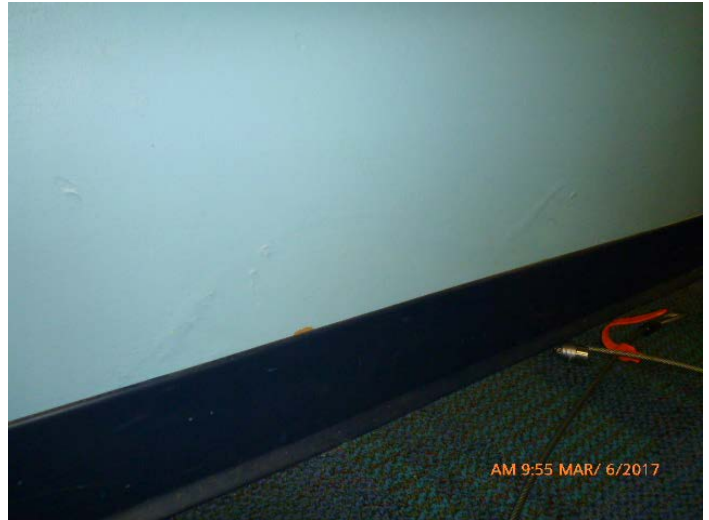
Photo 46: Moisture impact (e.g. bubbling) observed along base of south wall

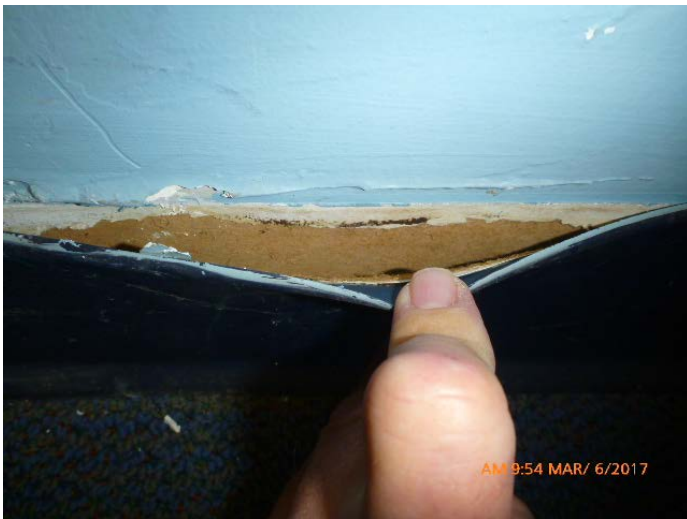
Photo 47: Mold growth observed behind base-cove on south wall

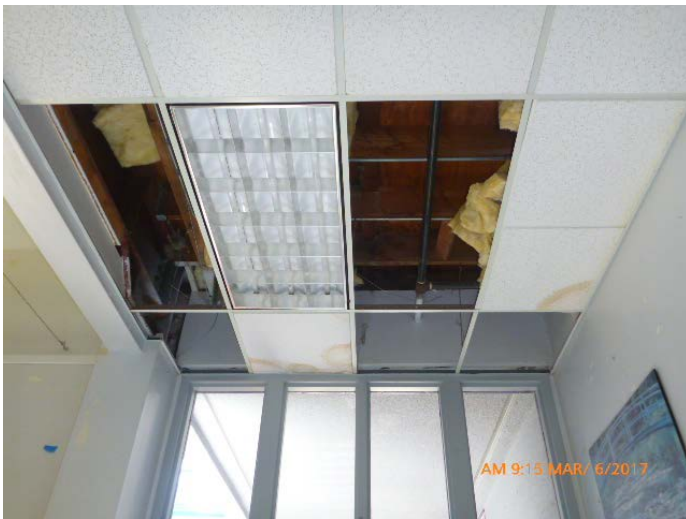
Overview south including entry and bathroom in corner.	\	\	\	50	
		Missing and stained ceiling tiles observed in southwest corner adjacent entry. Roof drain observed above area.	\	>2 ft. ² (stained)	\	51	
		Staining observed on exposed roofing materials.	\	>10 ft. ² (stained)	\	52	
		Staining observed approximately 3 ft' up along west wall outside bathroom.	\	>2 ft. ² (stained)	\	53

Photo 51: Missing and stained ceiling tiles observed in SW corner Adj. entry

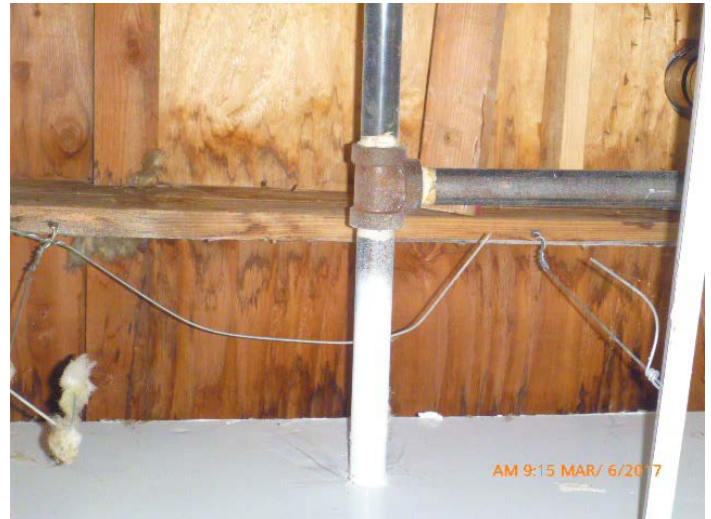
Photo 52: Roof drain and staining observed on exposed roofing materials

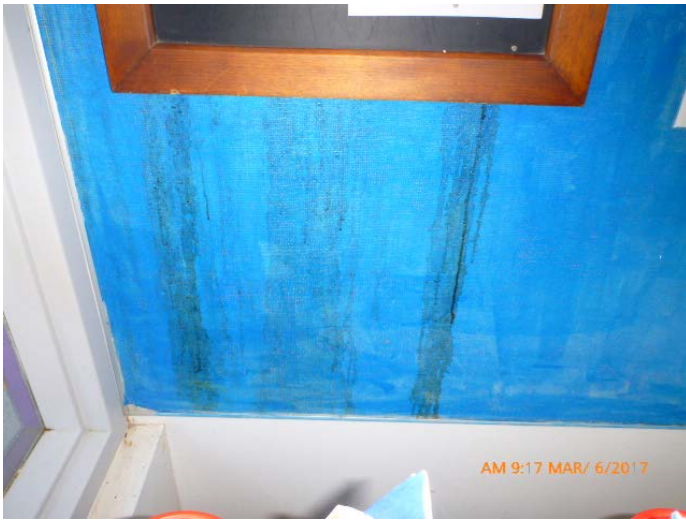
Photo 53: Staining observed approximately 3 ft' up along west wall outside bathroom

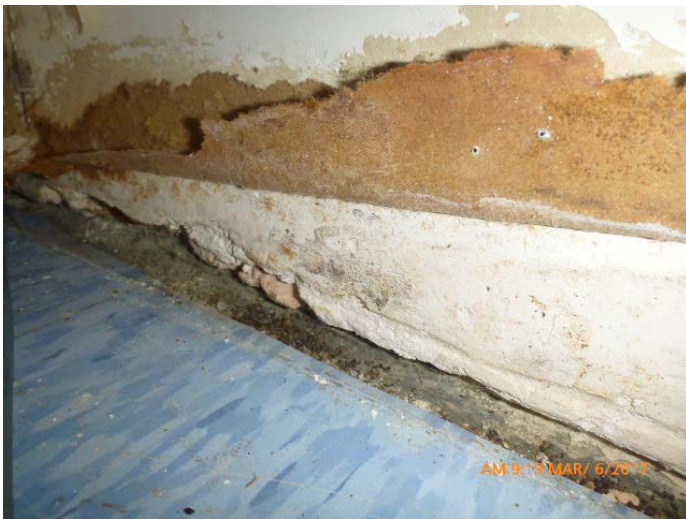
Photo 55: Mold growth and strong musty odors observed along base of west and south walls (both sides of ext. door)

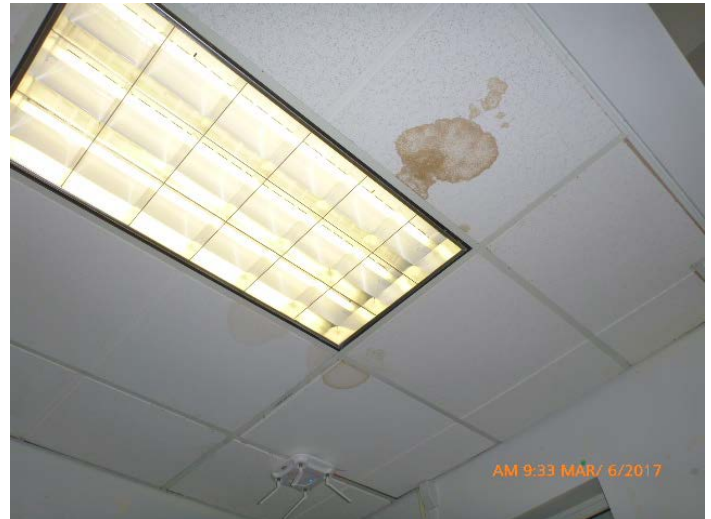
Photo 56: Stained ceiling tiles observed along north perimeter

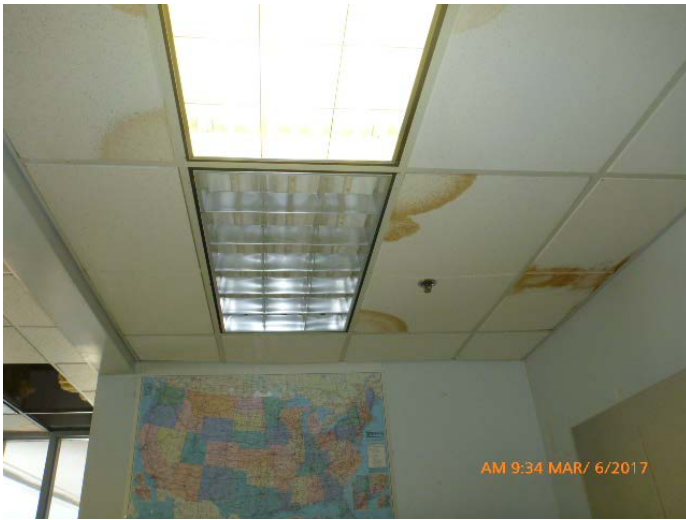
Photo 57: Additional stained ceiling tiles in SW corner adj. bathroom

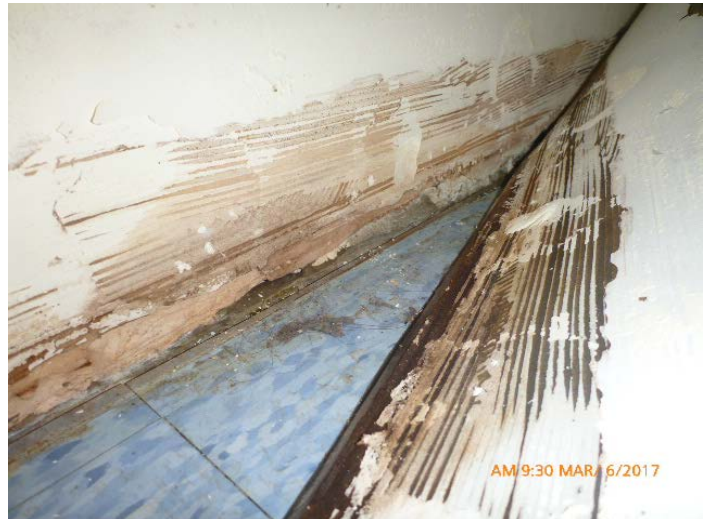
Photo 60: Moisture impact and mold growth observed along base of south and west walls

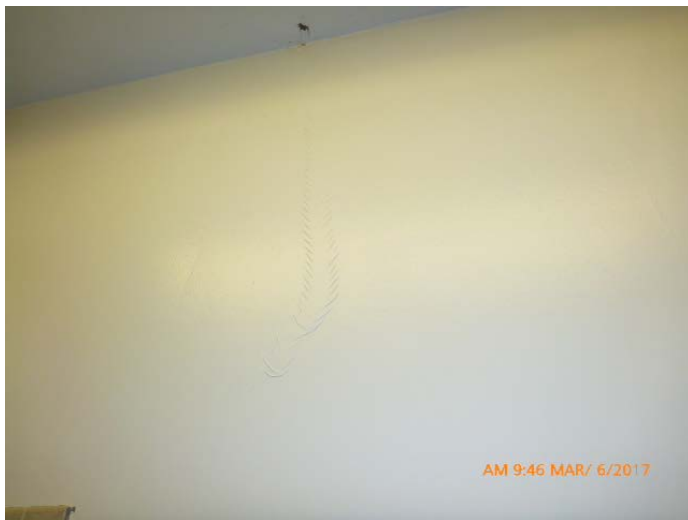
L	Classroom 205 – Bathroom	Moisture impact (e.g. bubbling paint) observed along west wall in bathroom.	\	~1.5+ ln ft (damage)	0.3% (gypsum)	61	
		Moisture impact (e.g. damage) observed to ceiling in bathroom. Moisture measurements of ceiling materials significantly elevated along approximately the western half.	\	>10 ft. ²	>6.2% (gypsum)	62	
		No visible mold growth observed.	\	\	\	\

Photo 61: Moisture impact (e.g. bubbling paint) observed along west wall in bathroom

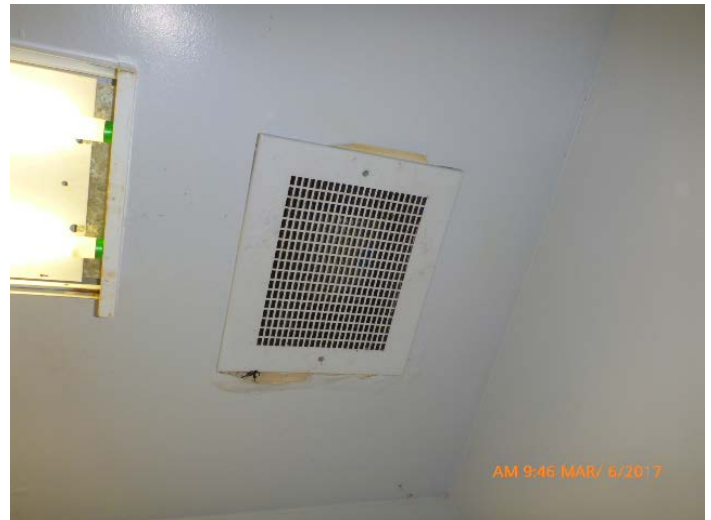
Photo 62: Moisture impact (e.g. damage) observed to ceiling in bathroom
