SMASH-Muir Elementary School

**Structural Assessment
Due to Water Intrusion**

2526 6th Street
Santa Monica, CA 90405

June 29, 2022

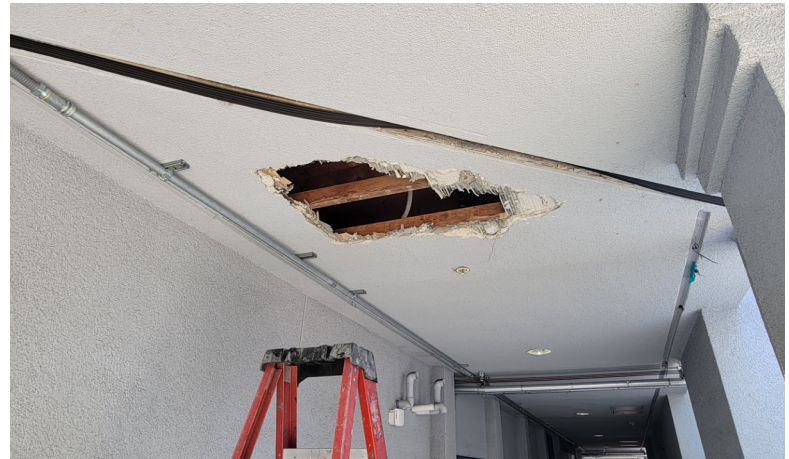
Underside of existing plaster soffit exposed adjacent to an existing seismic joint. Small opening provided for access to ceiling and floor framing from underside. Ceiling joists are in good condition, no signs of rot or damage. Adjacent plywood shearwall was visible and some water staining and minor rusting at nails but very minor and no damage to plywood overall. The 4x12 diagonal beam at the east side of the joint had water damage and appeared the hanger supporting the floor joist is crushing the top of the beam, due to water having softened and compromised the wood.

Photo 01: Opening in Existing Soffit

Strengthen the damaged 4x12 beam by adding a piece of 2x12 sister joist/ledger approximately 4' long and screwing members together. Ceiling and floor to be temporarily shored while strengthening is done and joists to be re-supported on the sister joist.

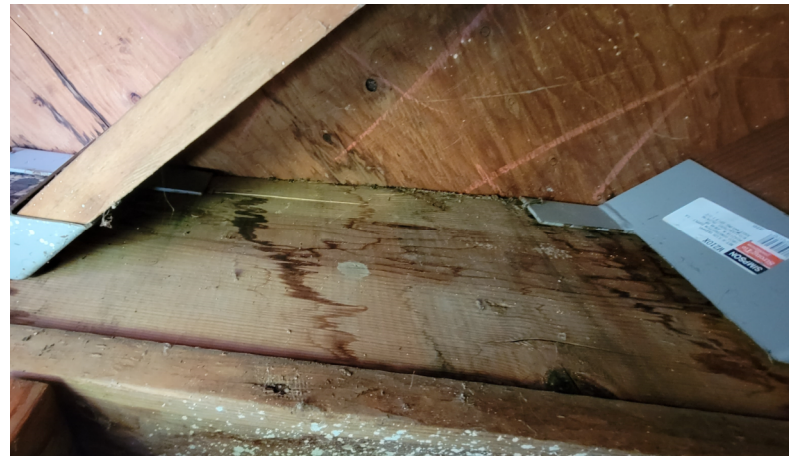
Photo 02: Damaged Beam at Existing Soffit

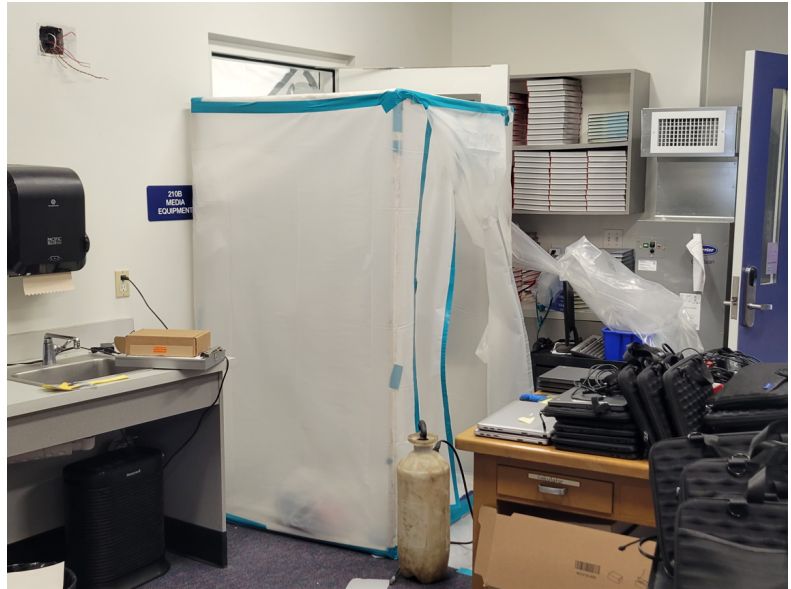
Underside of existing framing was exposed by removing ceiling tiles. No structural damage observed. Minor water staining on joists and underside of plywood.

Photo 03: Room 210B Containment

No structural work required.

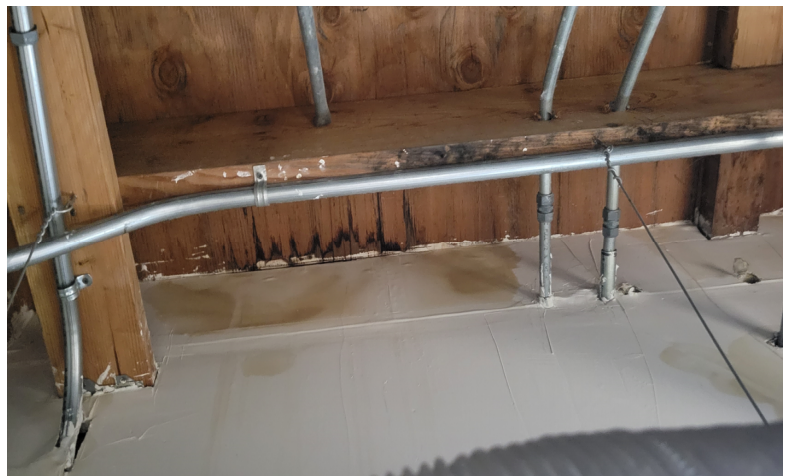
Photo 04: Room 210B Staining of Lumber

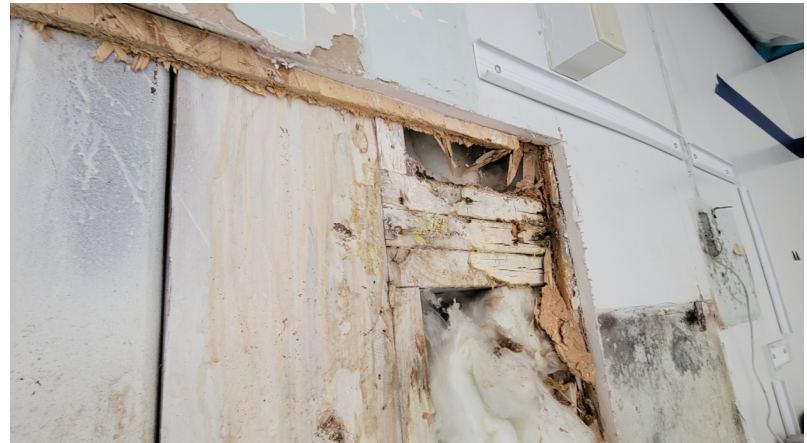
South wall of classroom was observed. Mold was visible on the interior side of the drywall, under the marker board and speaker box. Mold was also observed inside the wall cavity (see NV5 commentary). Drywall was removed for most of the wall length and full height of the wall; interior plywood removed as well. There was significant water damage and rotted lumber in this area starting about 4' from the southwest corner of the room and extending along the wall for approximately 6' or so, full height of exposed wall framing. Some wood was wet to the touch and included sill plate, studs, blocking and plywood on both faces (double sided shearwall). The insulation was wet, and studs were painted white from a prior encapsulation project. This area of wall is directly below a doorway above at room 480 which was also observed and noted as a source of water entry. There were some irregular shaped holes in the plywood but may have been at knots that fell out or plywood could have been damaged during installation.

Photo 05: Room 415 Rotted Framing

The 6' section of wall framing has been damaged and requires replacement. This will require all finishes on interior and exterior be removed completely and full height. Shoring to be installed and all lumber replaced in kind to original condition. Reinstall sill plate, studs, blocking and plywood to match existing.

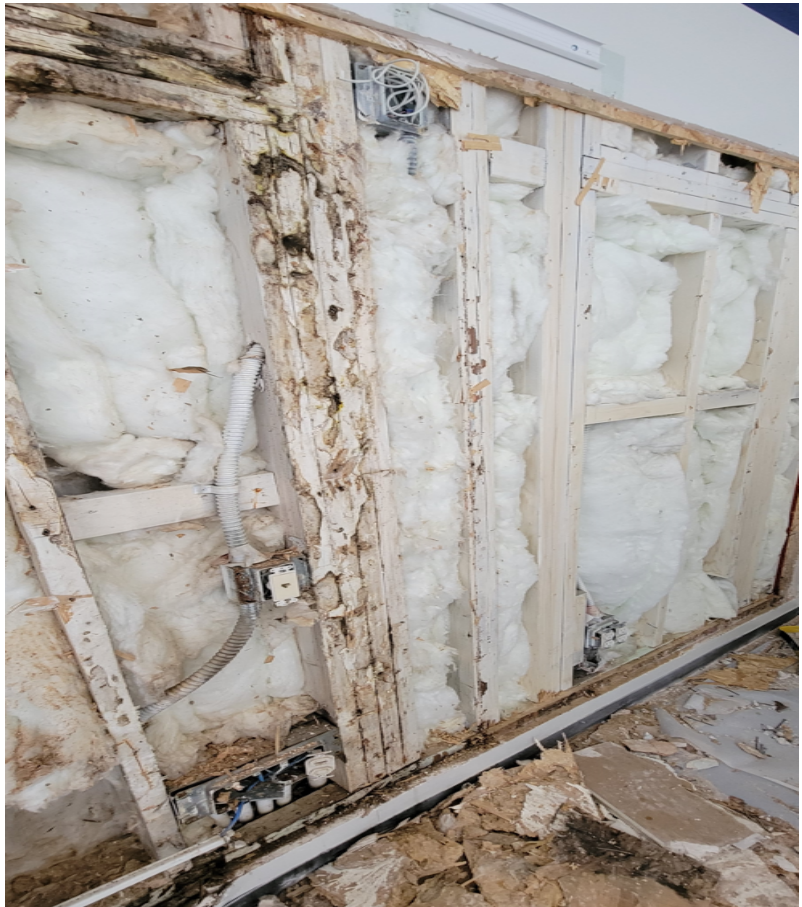
Photo 06: Room 415 Rotted Framing

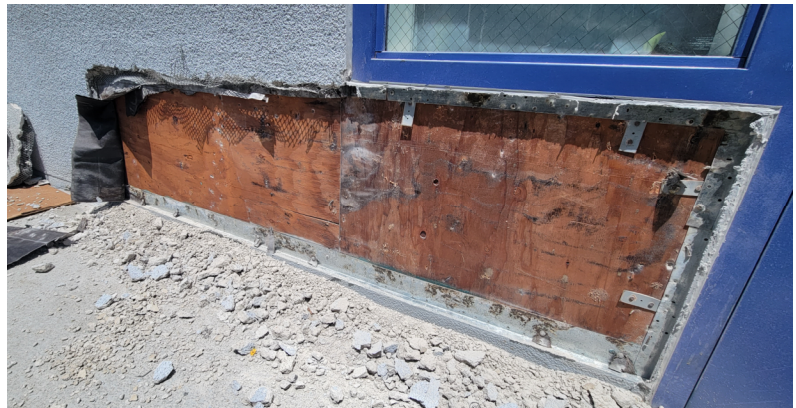
South wall of classroom was observed. This occurs directly below room 415 water damaged wall. Contractor removed finish for team to observe flashing, paper, mold and potential source of water entry. Plywood was exposed and determined to be in dry condition and no apparent damage above the floor. Some evidence of termites was observed. Structurally there is no concern about damage at this location.

Photo 07: Room 415 Exposed Flashing

No structural work required.

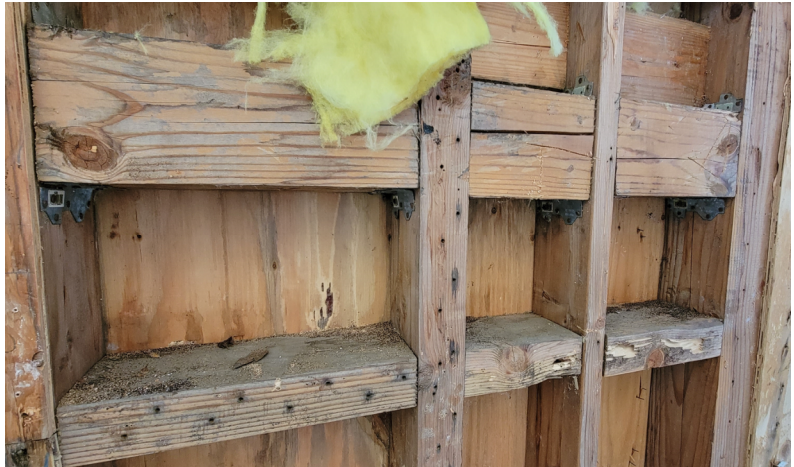
South and west walls of classroom was observed. Drywall was removed and framing exposed. Wood appeared dry and no dry rot. There was evidence of termites. Structurally there is no concern about damage at this location.

Photo 08: Room 400 Exposed Framing Dry

No structural work required.

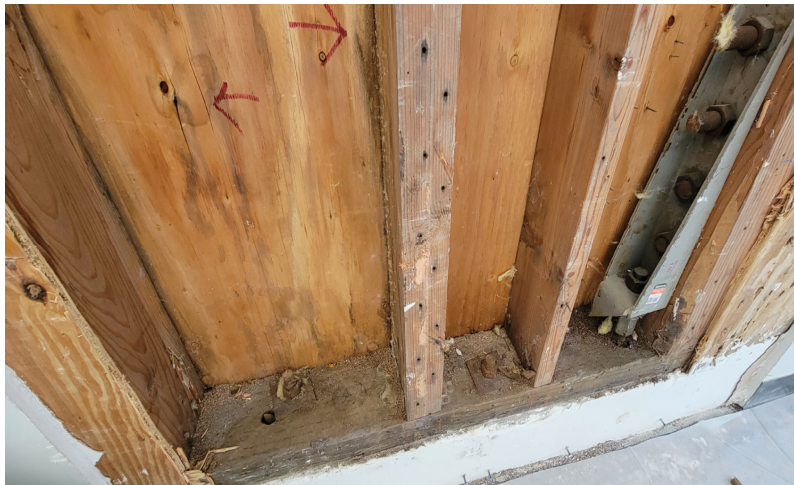
Photo 09: Room 400 Exposed Framing Dry

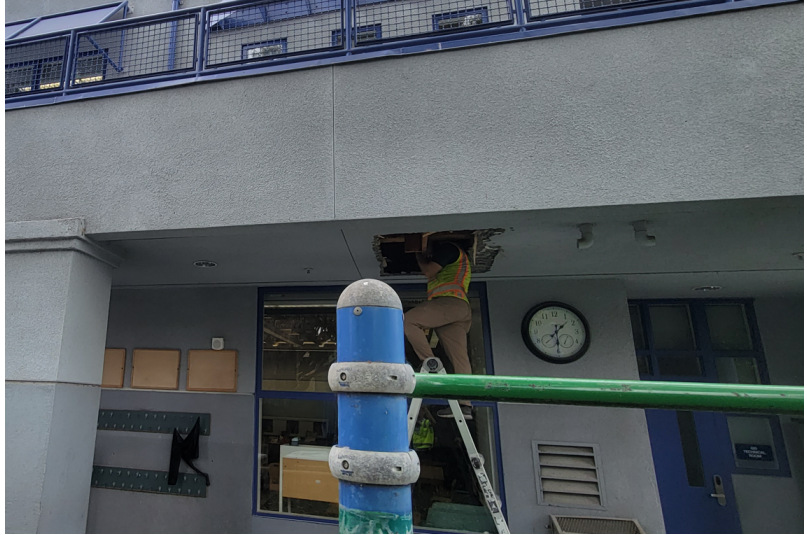
An opening was cut in the overhead plaster soffit to the west of classroom 405. The location is below the exterior walkway above and near some rotted parapet framing. The opening allowed for observation of the ceiling joists, floor joists, and edge beam framing. All framing appeared to be structural sound and undamaged. However there was evidence of water staining on the framing throughout and some rust was present on the steel framing which confirms moisture. Structural framing does not appear compromised but waterproofing above should be addressed.

Photo 09: Soffit Removed at Room 405

No structural work required. Waterproofing above to be addressed.

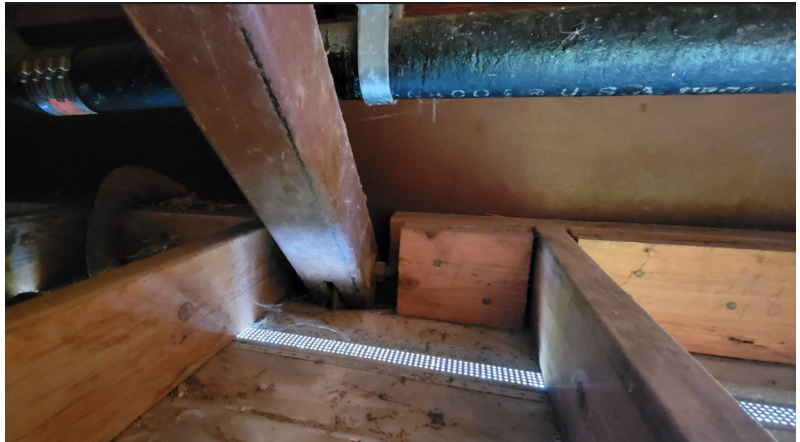
Photo 10: Rust Visible at Soffit Framing

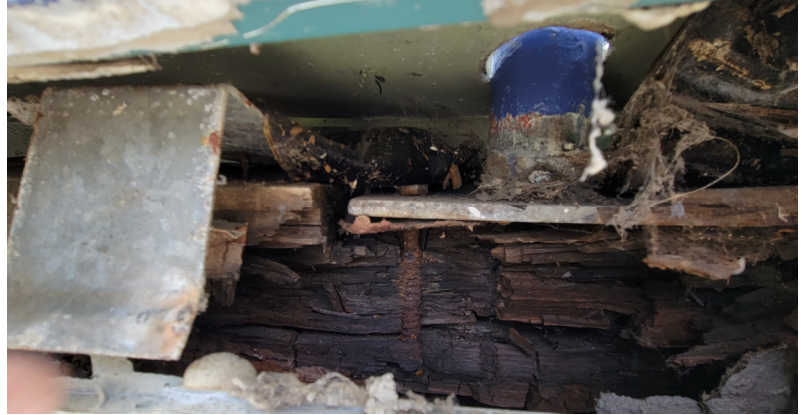
The historical photographs showed wood rot at the parapet framing around the campus alongside the exterior elevated walkways. We removed sheet metal caps in six locations to get a representative sampling. In all locations, the wood has rotted and to different degrees. Building B has some of the most significant rotted parapet framing along the south side over the Kindergarten Room 400. The exposed framing showed severely deteriorated wood top plates and studs such that the screws for the guardrail posts are compromised. Similar rotting in other locations extending to Buildings A, C, and D. This is a systemic deficiency.

Photo 11: Parapet Plate Rotted

All parapet framing to be exposed (remove finish both sides) and replace framing in kind to restore to original condition.

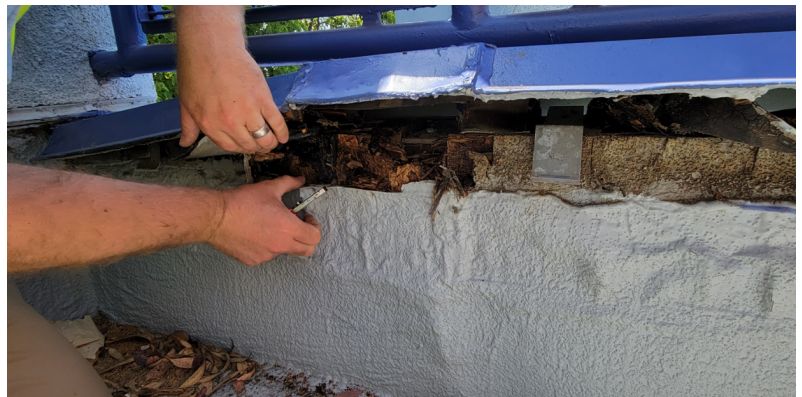
Photo 12: Parapet Plate Rotted

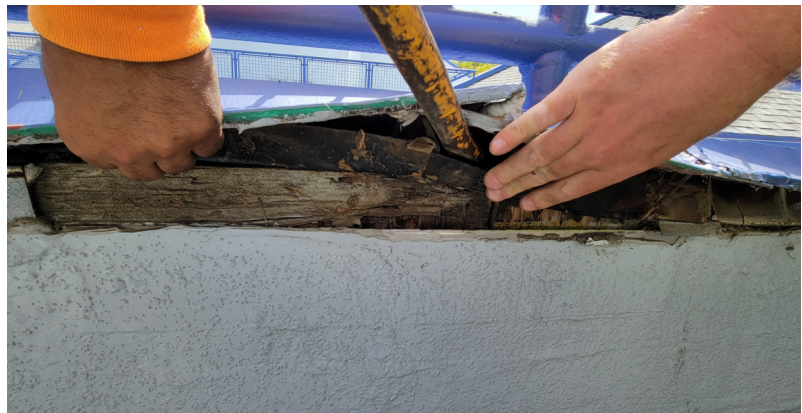
Photo 13: Parapet Plate Rotted

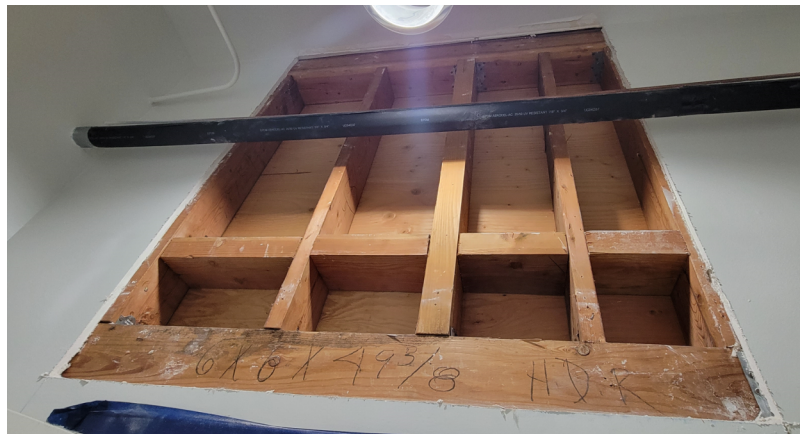
The wall framing in this location was exposed and all lumber appeared dry and undamaged. There was no sign of water staining or rot.

Photo 14: Room 513 Framing

No structural work required.

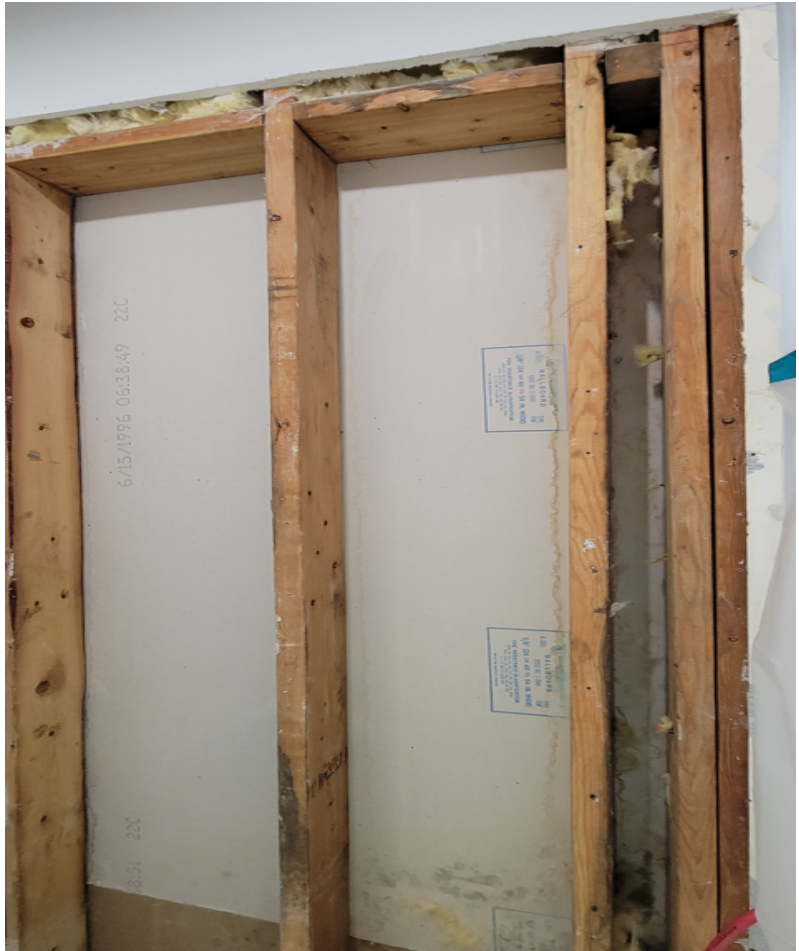
Photo 15: Room 513 Framing

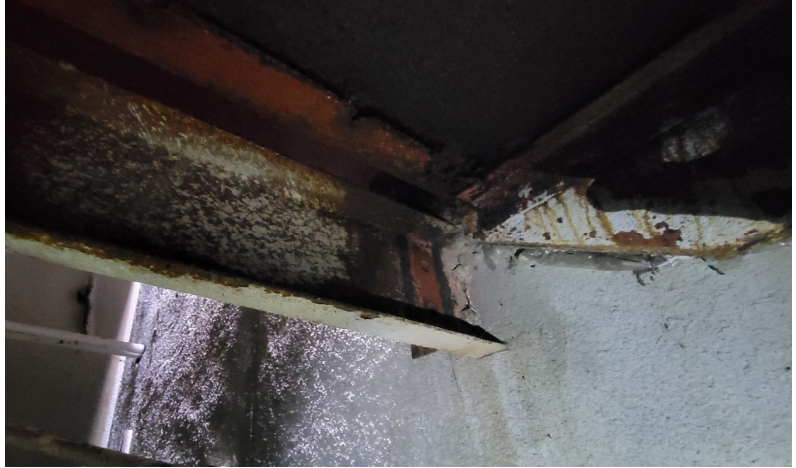
While observing Room 513, we accessed the underside of the exterior stair to the west. The underside was severely corroded (and unprotected, just shop primer) and rust was significant. There were a couple of small holes in the steel pans which showed daylight. A number of the welded connections at the landing and top/bottom of stairs show extensive corrosion.

Photo 16: Exterior Stair Corrosion

Clean steel back to solid substrate and sample material thickness to determine if any structural degradation has occurred and if strengthening is required. Install flashing at stringers to building to prevent further water intrusion. Consider galvanizing paint for areas that are not fully waterproofed.

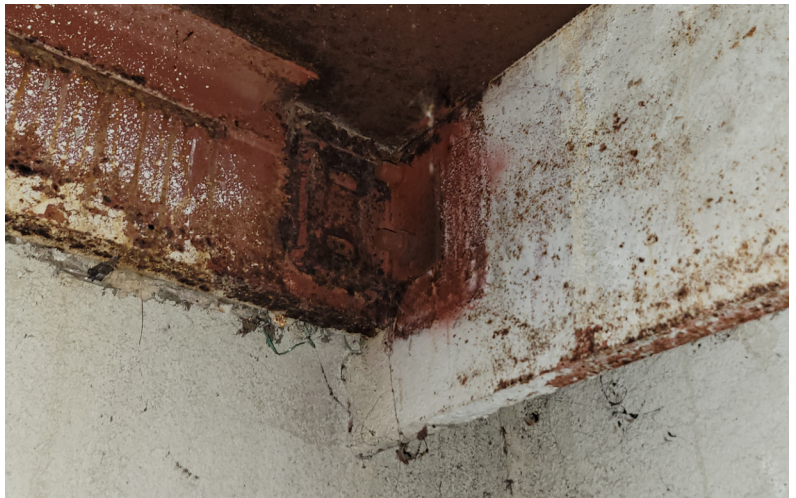
Photo 17: Exterior Stair Corrosion

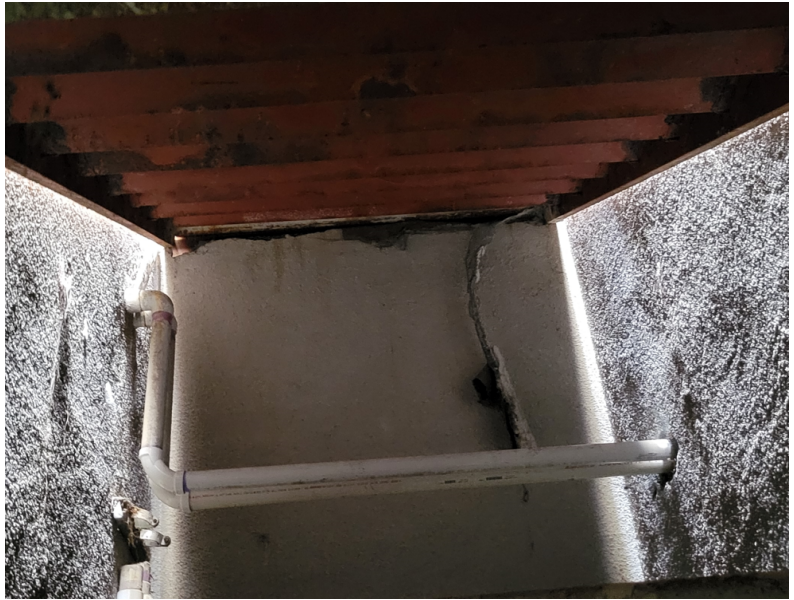
Photo 18: Exterior Stair Corrosion
