SANTA MONICA-MALIBU UNIFIED SCHOOL DISTRICT 1717 4TH STREET SANTA MONICA, CA 90401

> prepared by: NAC 837 N Spring St, 3rd Floor Los Angeles, CA 90012 (323) 475-8075

> > AUGUST 11, 2023 Final

1.2 EXECUTIVE SUMMARY

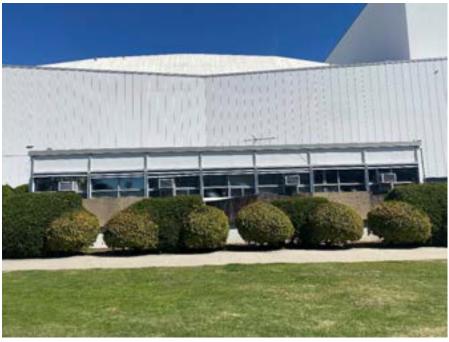
Exterior façade of the West Wing is concrete. Above the windows is plaster and below the windows is exposed concrete. In the as built drawings, the west elevation has aluminum louvers in front of the windows. It appears many of the louvers have been removed and air condition window units placed in portions of the windows. The lower portion of the windows are boarded up. A similar condition exists on the south elevation. Louvers remain over a portion of one window while they are missing over the second window which also has a window-mounted unit in it.

Photo showing West Wing (Administration) building

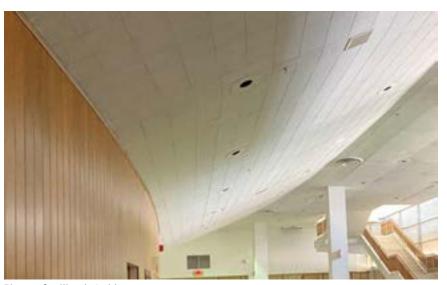
The ceiling appears to be the original acoustic tile on plaster as noted in the as-built drawings.

Photo of ceiling in Lobby

The team recommends replacing the existing acoustic tile on plaster ceiling as some pieces are missing or have fallen off.

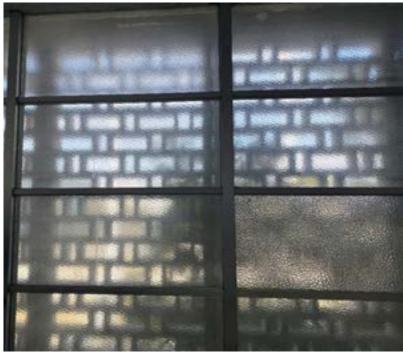
The Concourse is accessed by the Stairs # 1 and Stair #2. The exposed storefront glazing on the Concourse level is textured glass. There appears to be some textured glass panels that have been replaced with a textured glass varying slightly from the original. The ceiling appears to be the original.

Photo of textured glazing. Replacement of one panel is apparent in photo.

The exposed concrete walls and the storefront system are both character defining features of the building. The team recommends cleaning and painting the existing exposed concrete to return it to the original design. It is recommended to keep the storefront but replace the clear and textured glass with laminated and tempered glass. The clear glass would be made up of two layers of 1/8" thick tempered glass laminated with a low e interlayer. The textured glass would be 1/4" thick tempered with a texture pattern resembling the original textured pattern as much as possible.

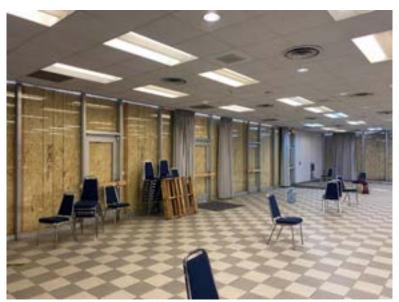
Photo of storefront in East Wing (Committee) building

If the decision is to keep the wing, maintain the existing storefront and replace the glass with two 1/8" thick layers of tempered δ laminated glass with a low-e interlayer. The doors would be replaced with code compliant doors and hardware. Their profile and frame finish should match the existing. The glazing in the door should be tempered δ laminated glass.

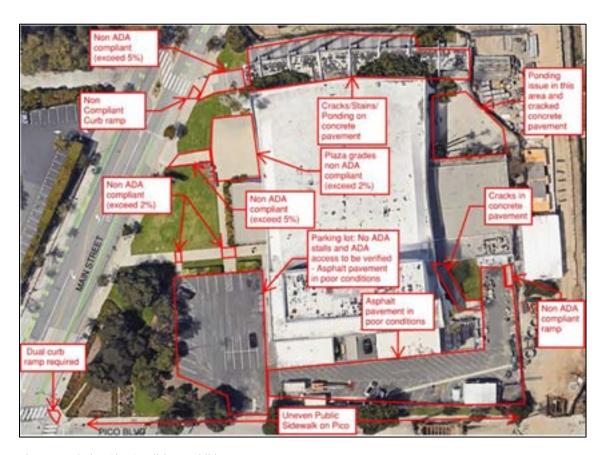
Figure 1. Existing Site Conditions Exhibit

observed on the public sidewalk along the project site. Refer to Figure 1 below for additional information.

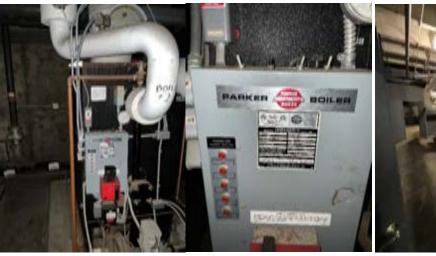
The original drawings indicated 4 gas fired boilers manufactured by Bryan, with a combined output of 130 tons. It appears that these boilers were replaced around 2002 2003 With non condensing Parker boilers. These boilers had an expected useful life of 10 15 years remaining when the civic center closed. and will require service prior to startup.

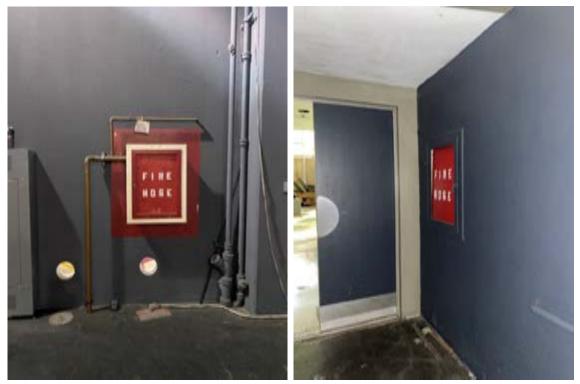
Figure 4.5.5 – Fire Hose Cabinets

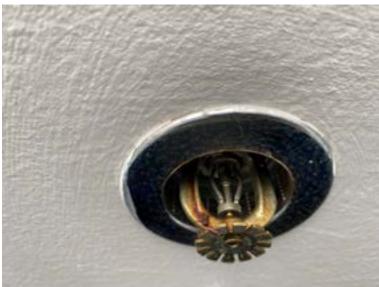
Figure 4.5.6 – Obstruction Below Soffit Not Sprinklered

Figure 4.5.7 – Corroded Sprinkler Head

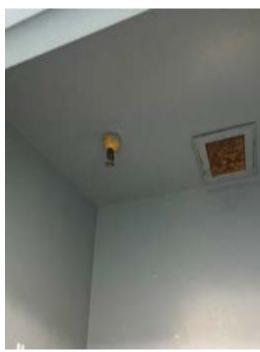
Figure 4.5.8 – Painted Sprinkler Head

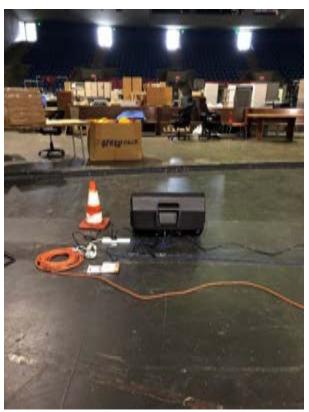
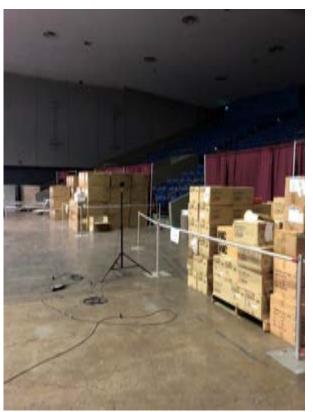
Photo 1 Photo 2

It should be noted that there were lots of boxes etc. being stored within the auditorium space at the time of these measurements. See Photos 1, 2 and 3 below. Please note that the reverberation time would be higher without the presence of these boxes etc. within the space. Similarly, the reverberation time of the space when in use will be reduced with increasing occupancy (people absorb sound), likewise chairs deployed on the main level would be expected to absorb sound and reduce the reverberation time to some extent.

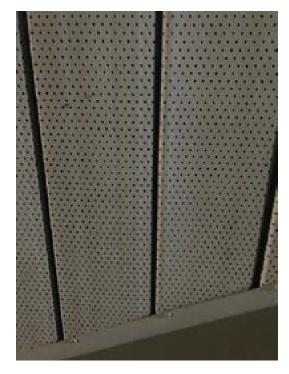
It is understood that the side wall acoustical paneling, see Photo 4 below, is a historically listed feature. According to the drawings these metal wall panels are non perforated towards the stage and perforated elsewhere. As seen in Photo 4, where the panels are perforated, the area of the perforations ('free area') is relatively low. The team estimates about 4%. Where the team could perform a visual inspection, there appeared to be an air gap immediately behind the perforations. The architectural drawings indicate that there is acoustical fill beyond this airspace.

Photo 4: Auditorium Wall Acoustical Panels

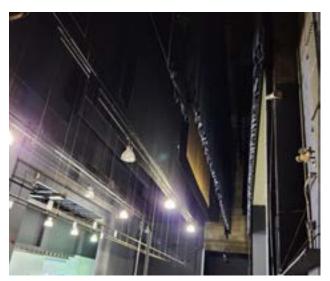
The stage has a full height fly tower with manual counterweight rigging. The rigging system was renovated in 1992, which means the ropes and other moving parts are likely around 30 years old. Most of the steel elements appear to be original. Due to the theatre being dark for 10 years, most of the linesets have spent a long period of time in one position. This can lead to flat spots or weak spots in ropes and head blocks, which can become a point of failure.

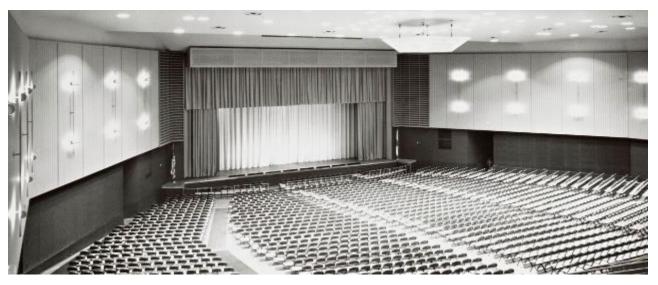
When the floor is tilted, it meets the front of the orchestra pit at a variable height due to the curvature of the front wall of the pit/front edge of the slab. The pitch of the slope is within ADA guidelines for a ramp but exceeds guidelines for a sloped floor. The slab length, front to back, is more than twice the allowable distance for a ramp without a landing. When the floor is in the sloped position, there is no flat area at the front that could be used for ADA seating. Historical photos show folding chairs set up on the slope for audience seating.

This would be problematic under modern codes due to issues with the chairs sliding down the slope. Photos also show the orchestra pit lift in a mid-position, providing a flat floor area at the front of the seating. This would allow for ADA seating at the front of the main floor but would make the sightlines unworkable for several rows behind them.
