## **AHERA THREE-YEAR RE-INSPECTION**

Juan Cabrillo Elementary School  
30237 Morning View Drive  
Malibu, California 90265

Project No.: 110-0006  
Date: May 17, 2010

**Ref: Three-Year Re-inspection**  
**Juan Cabrillo Elementary School, 30237 Morning View Drive, Error! Reference source not found., Malibu, California 90265**

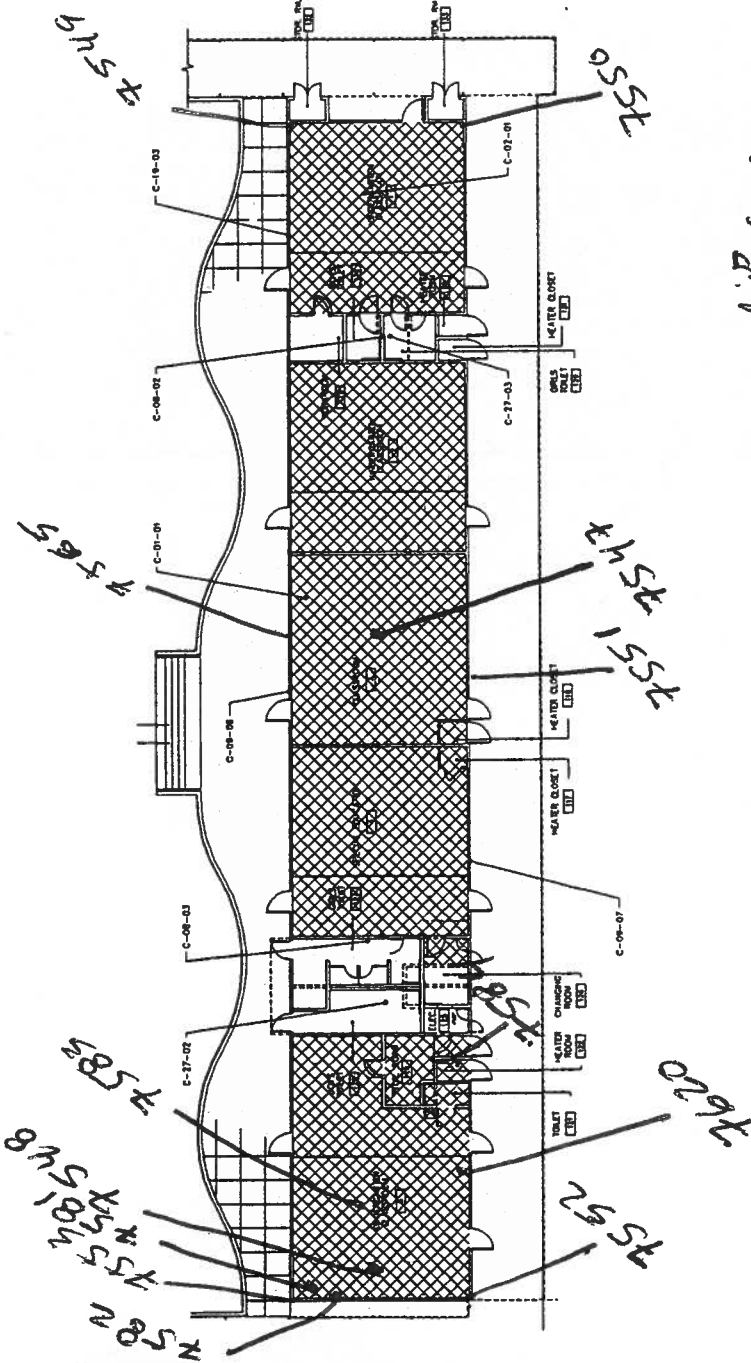
**BUILDING "B" FLOOR PLAN**  
**SCALE: 1/8" = 1'-0"**

ASBESTOS-CONTAINING 9" x 9"  
FLOOR TILE AND MASTIC

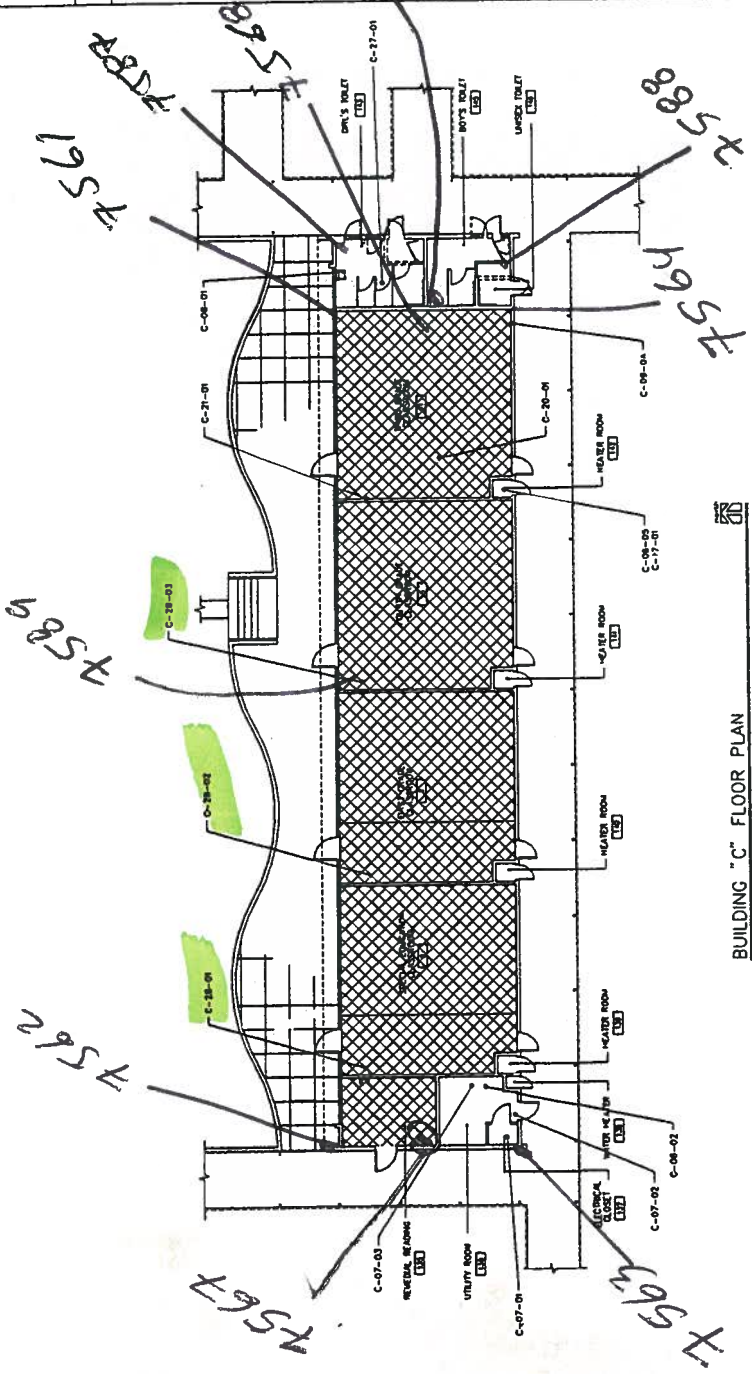
BUILDING "C" FLOOR PLAN  
SCALE: 1/8" = 1'-0"

ASBESTOS-CONTAINING 9" x 8"  
FLOOR TILE AND MASTIC

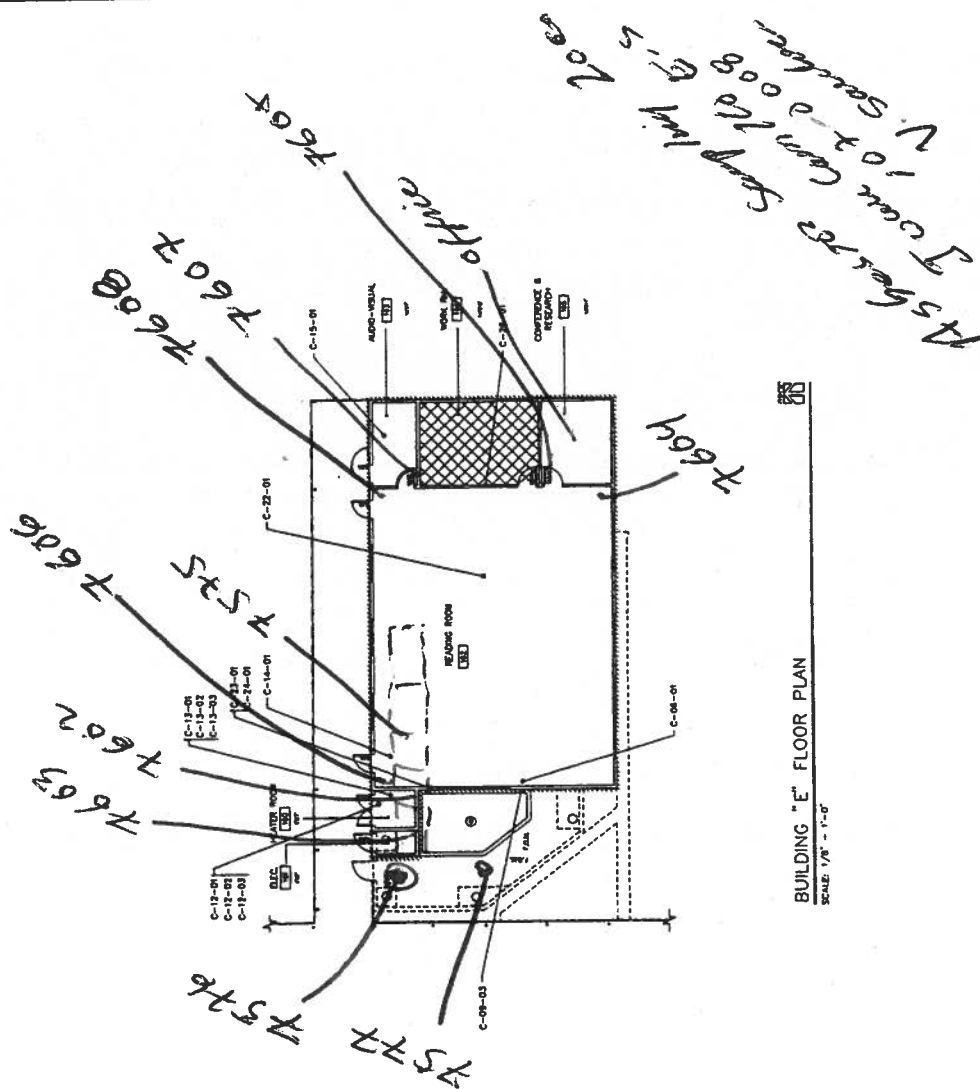
BUILDING "E" FLOOR PLAN  
SCALE: 1/8" = 1'-0"

| | ASBESTOS-CONTAINING DETERIOR<br>STUCCO |
| | ASBESTOS-CONTAINING 4" x 9"<br>FLOOR TILE AND MASTIC |

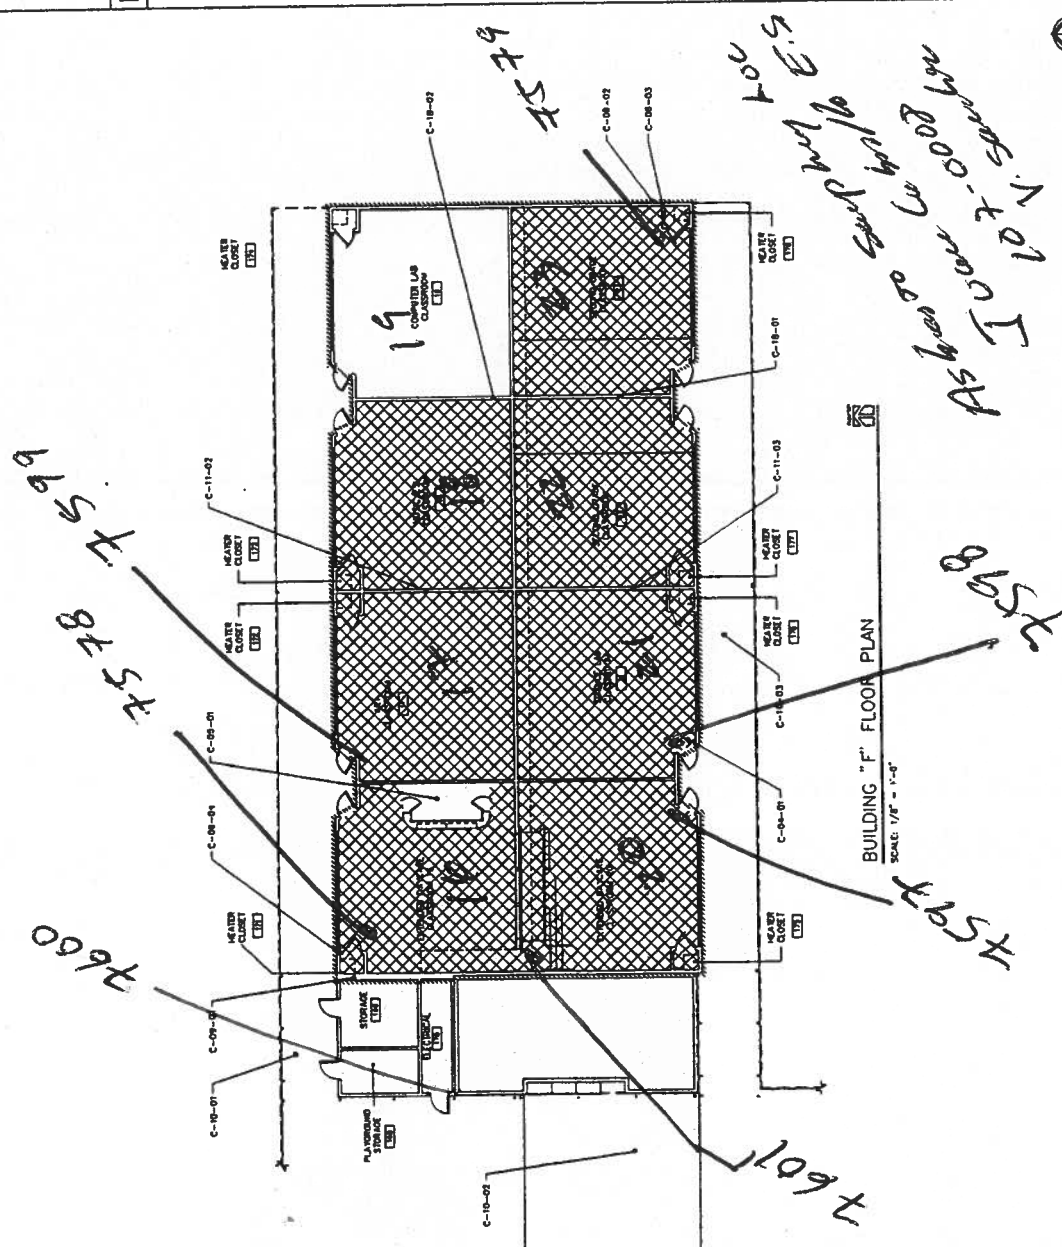
BUILDING "F" FLOOR PLAN

ASBESTOS-CONTAINING INTERIOR  
STUCCO
