**ASBESTOS SURVEY
PROJECT RECORD**

**Juan Cabrillo Elementary School
30237 Morningview Drive
Malibu, California 90265**

**CTL Environmental Services
24404 South Vermont Avenue, Suite 307
Harbor City, California 90710
(310) 530-5006**

March 20, 2007
CTL Project No. 107-0008

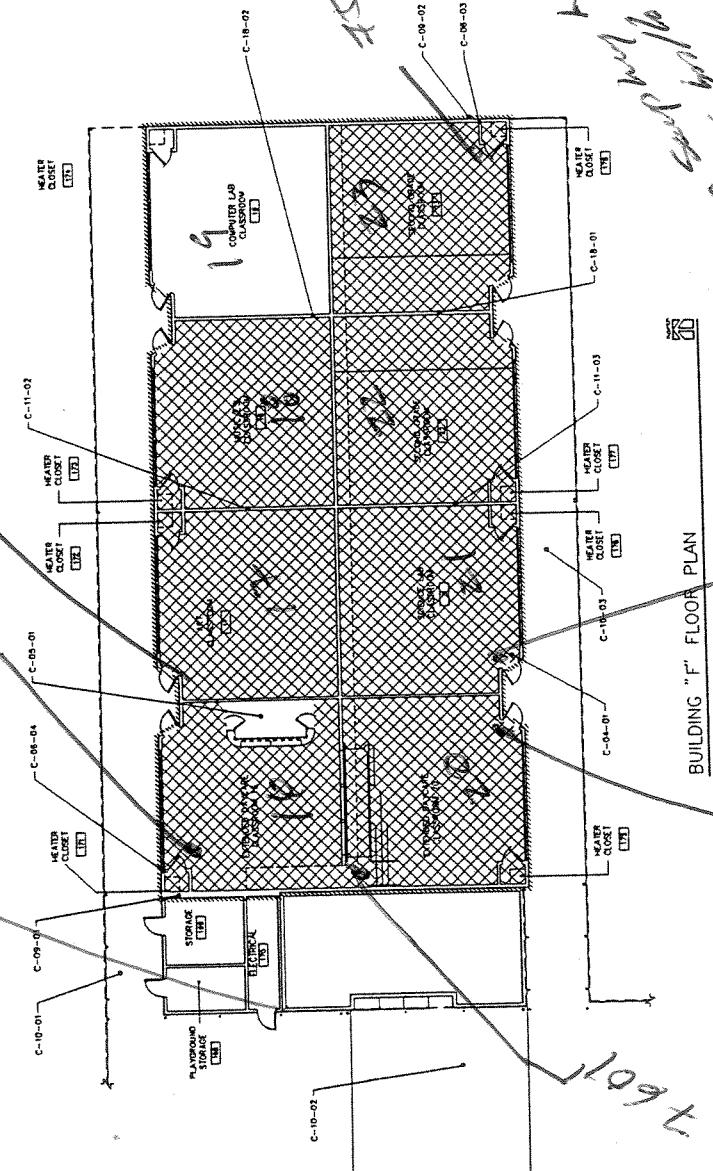
BUILDING "F"

LEGEND:
[Symbol] ASBESTOS CONTAINING DETERIORATING
STUCCO
[Symbol] ASBESTOS CONTAINING VITRIFIED
FLOOR TILE AND MARBLE
