**LEAD ABATEMENT  
PROJECT RECORD**

**Juan Cabrillo Elementary School  
30237 Morningview Drive  
Malibu, California 90265**

January 24, 2007  
CTL Project No. 106-0537

**RE:** **Lead Monitoring and Contractor Observation**  
**Juan Cabrillo Elementary School – exteriors**  
**30237 Morningview Drive**  
**Malibu, California 90265**

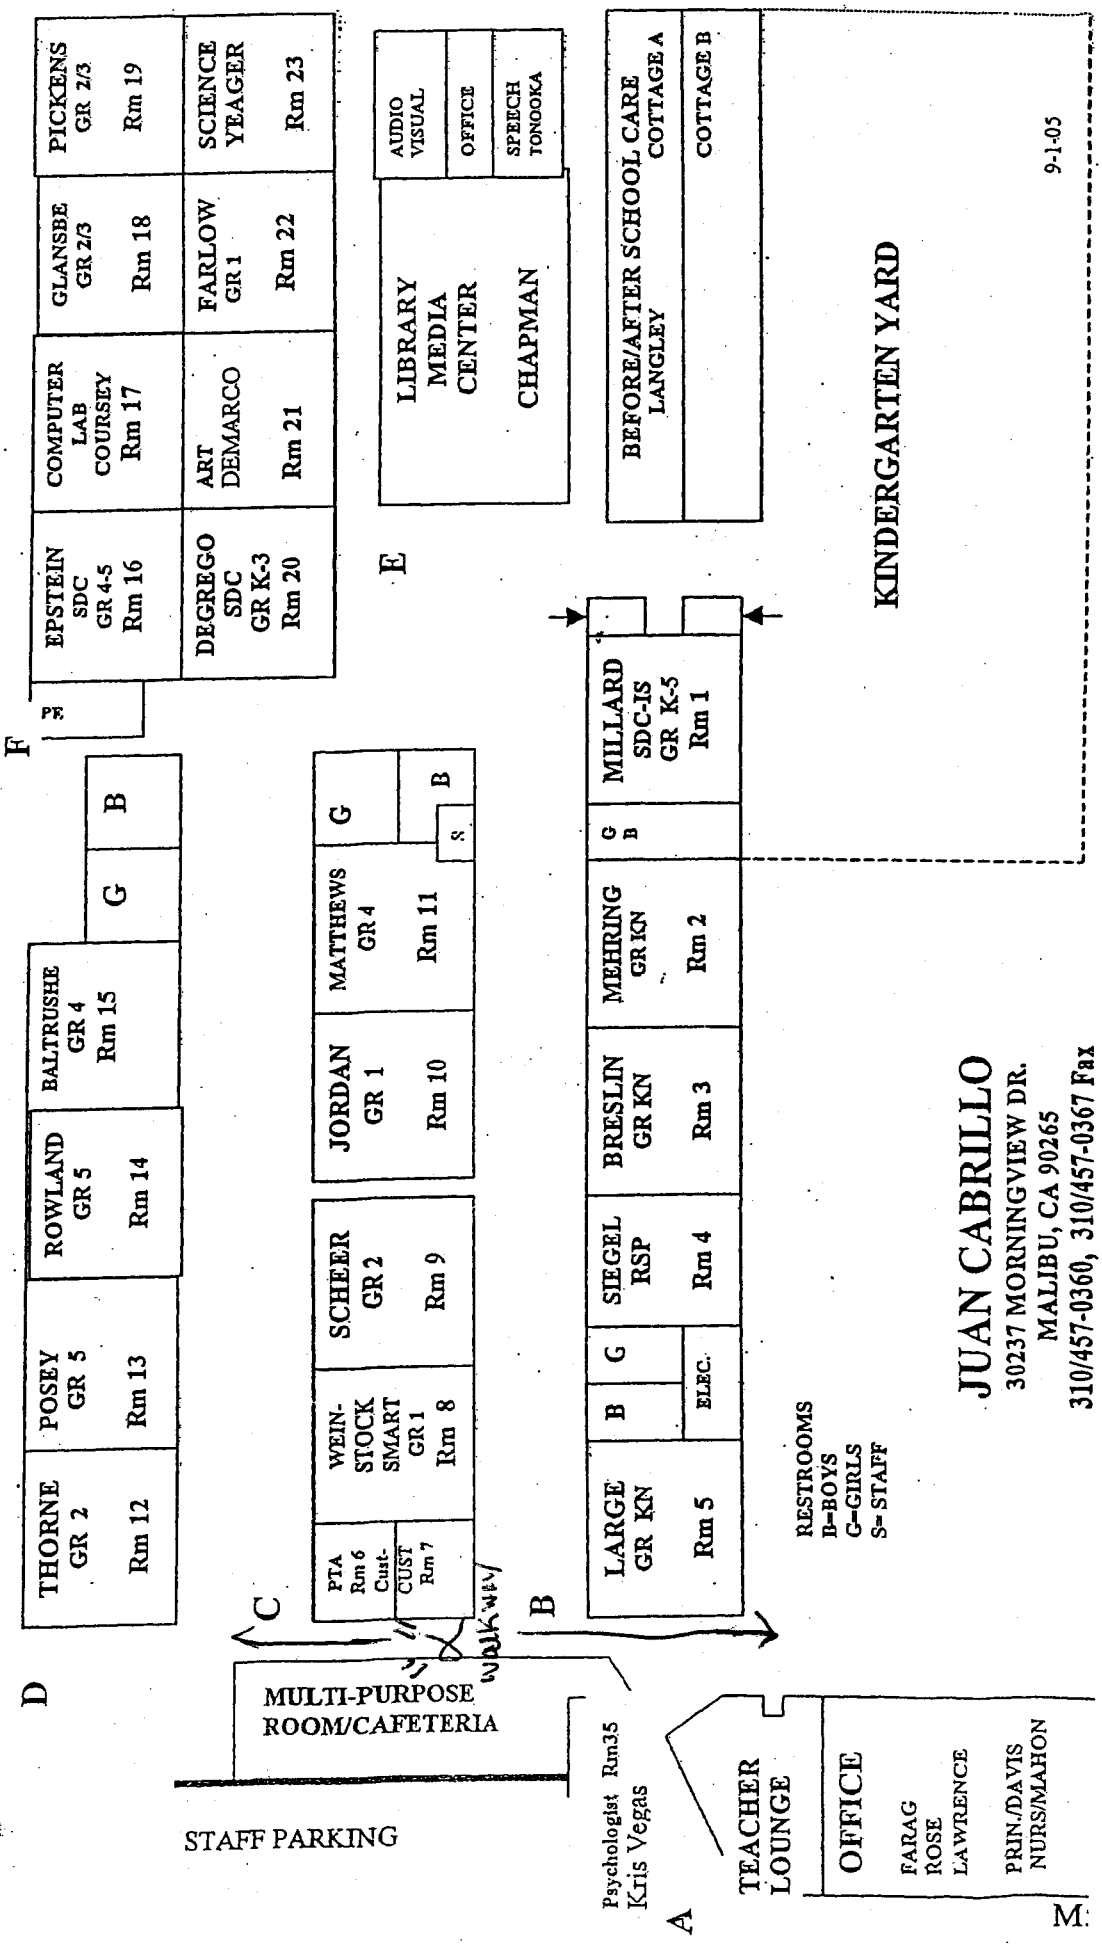
Work Area Map  
 Juan Cabrillo Elementary School  
 106-0537 1/4/07  
 James Choe

Exterior Surfaces Bldgs and walkway  
- currently S side of Bldg B has been set up.

At the request of Fix Paint, CTL Environmental Services conducted a visual inspection of the work area described above prior to the stabilization of ~~Pb~~ Pb-based and Pb-containing paint. Isolation is achieved with Pb warning barrier tape, and Pb signs are posted. Polyethylene sheeting drop cloth is set. The procedure may begin.
