**ASBESTOS SURVEY  
PROJECT RECORD**

**John Adams Middle School  
2425 16<sup>th</sup> Street  
Santa Monica, California 90405**

April 7, 2008  
CTL Project No. 108-0085

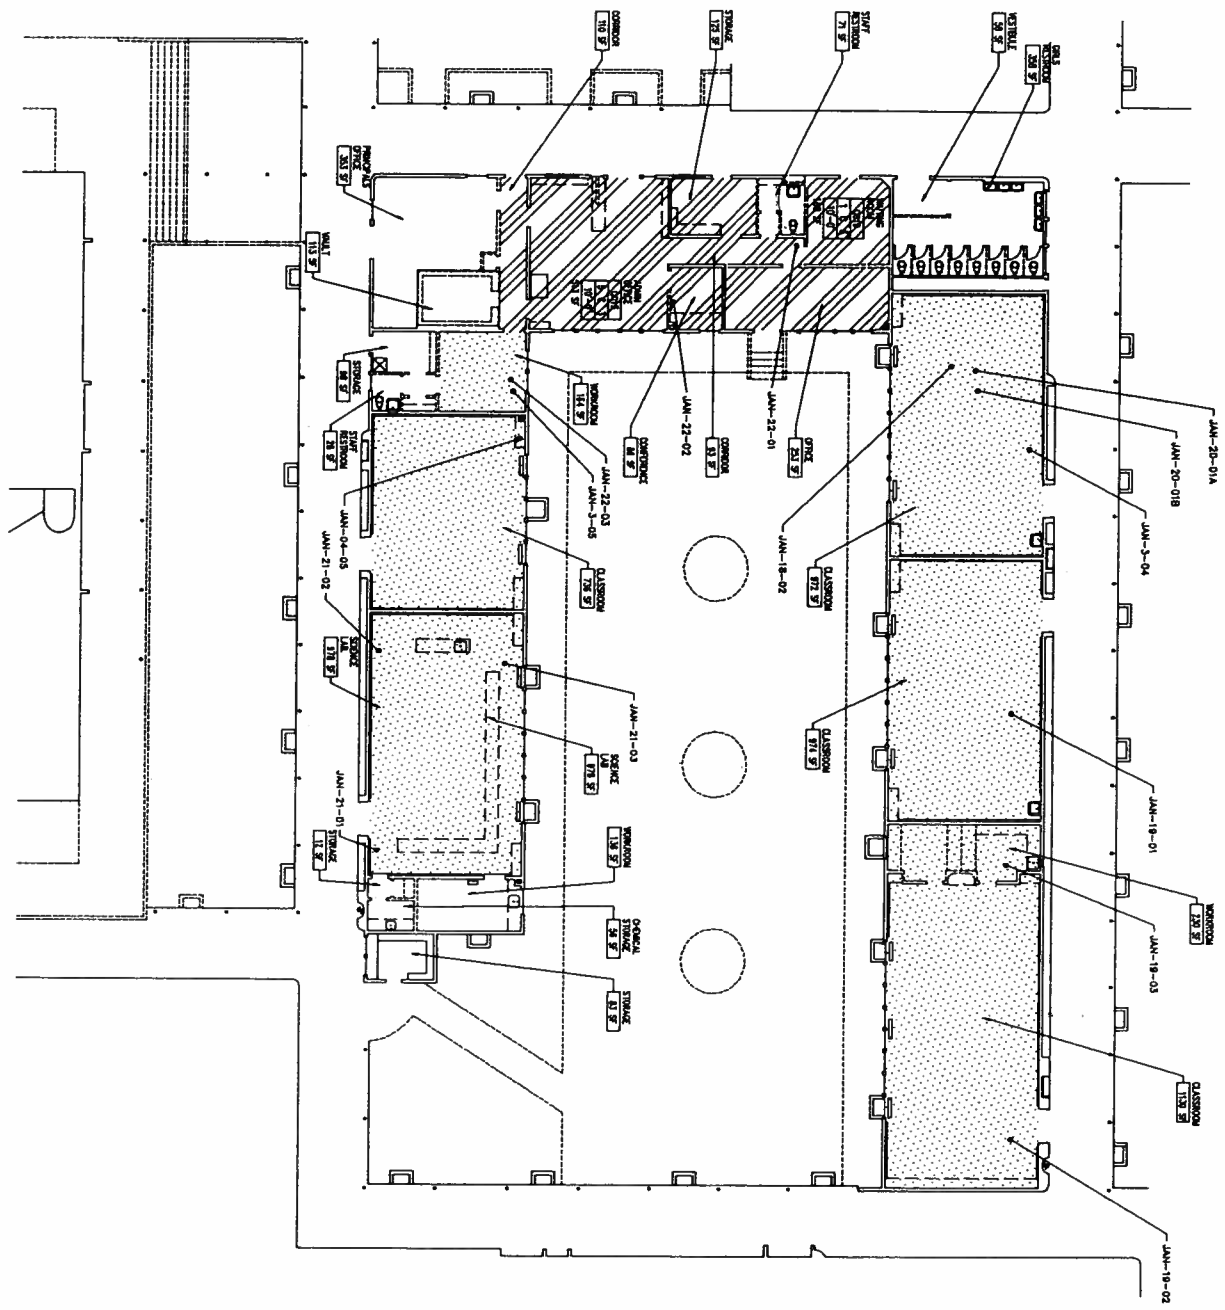
- LEGEND
- ASBESTOS-CONTAINING ACUSTICAL PLASTER CEILING.
  - ASBESTOS-CONTAINING 12" x 12" FLOOR TILE AND MASTIC.

- NOTES
1. ASBESTOS-CONTAINING FIBER ARE LOCATED IN THE CLASSROOMS.
  2. ASBESTOS-CONTAINING WINDOW PUTTY LOCATED ON EXTERIOR WINDOW FRAMES.
  3. ASSAULT ASBESTOS-CONTAINING CHALKBOARDS LOCATED IN CLASSROOMS.

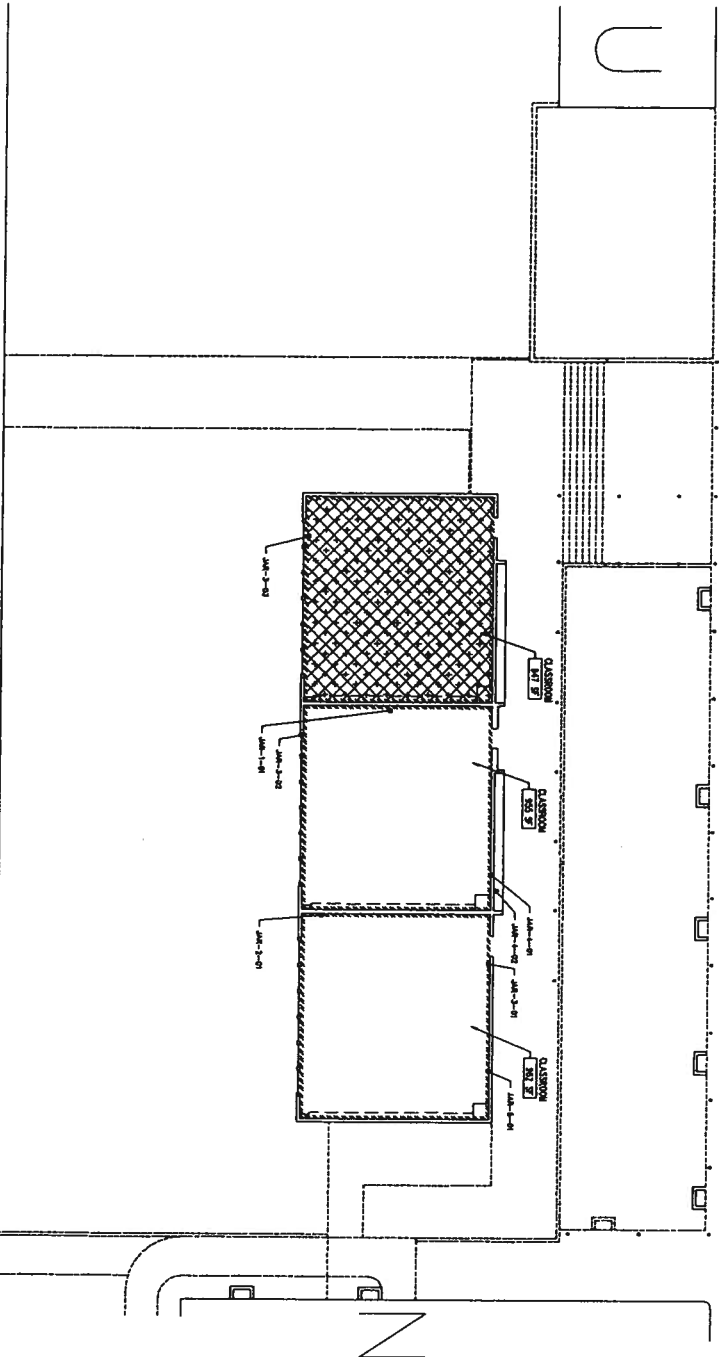
## BUILDING "R"

ASBESTOS-CONTAINING GYPSUM BOARD  
WALL AND JOINT COMPOUND

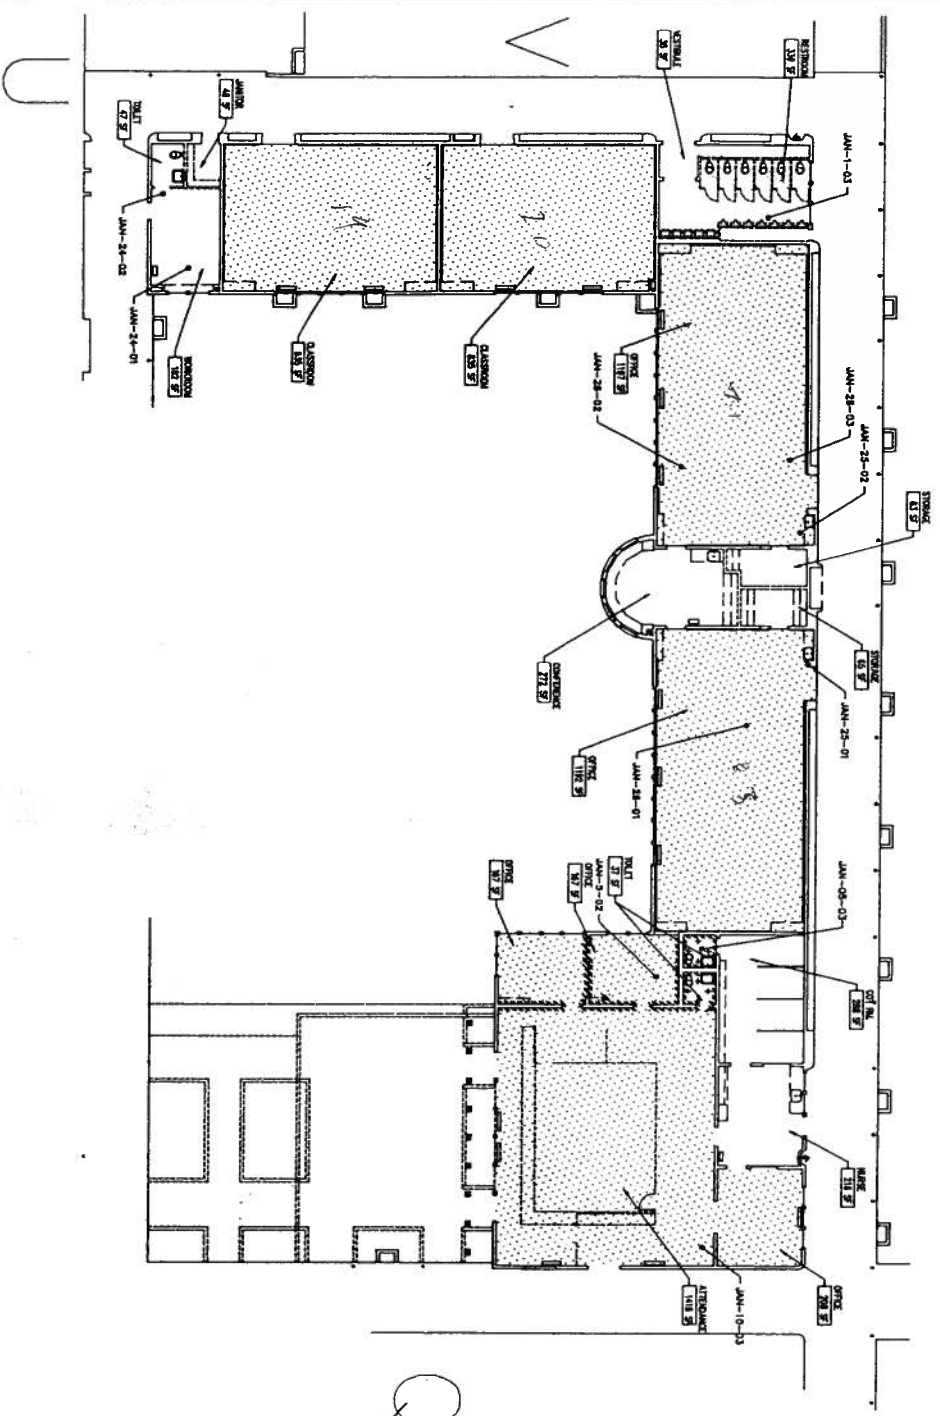
BUILDING "T"

| | ASBESTOS-CONTAINING GYPSUM CEILINGS AND JOINT COMPOUND |
| | ASBESTOS-CONTAINING VERMICULITE ROAD WALLS AND JOINT COMPOUND |
