SURVEY FOR ASBESTOS AND LEAD IN PAINT

Gymnasium Building
John Adams Middle School
2425 16th Street
Santa Monica, CA 90405

Project No.: SMSD-18-7431
Date: January 30, 2018

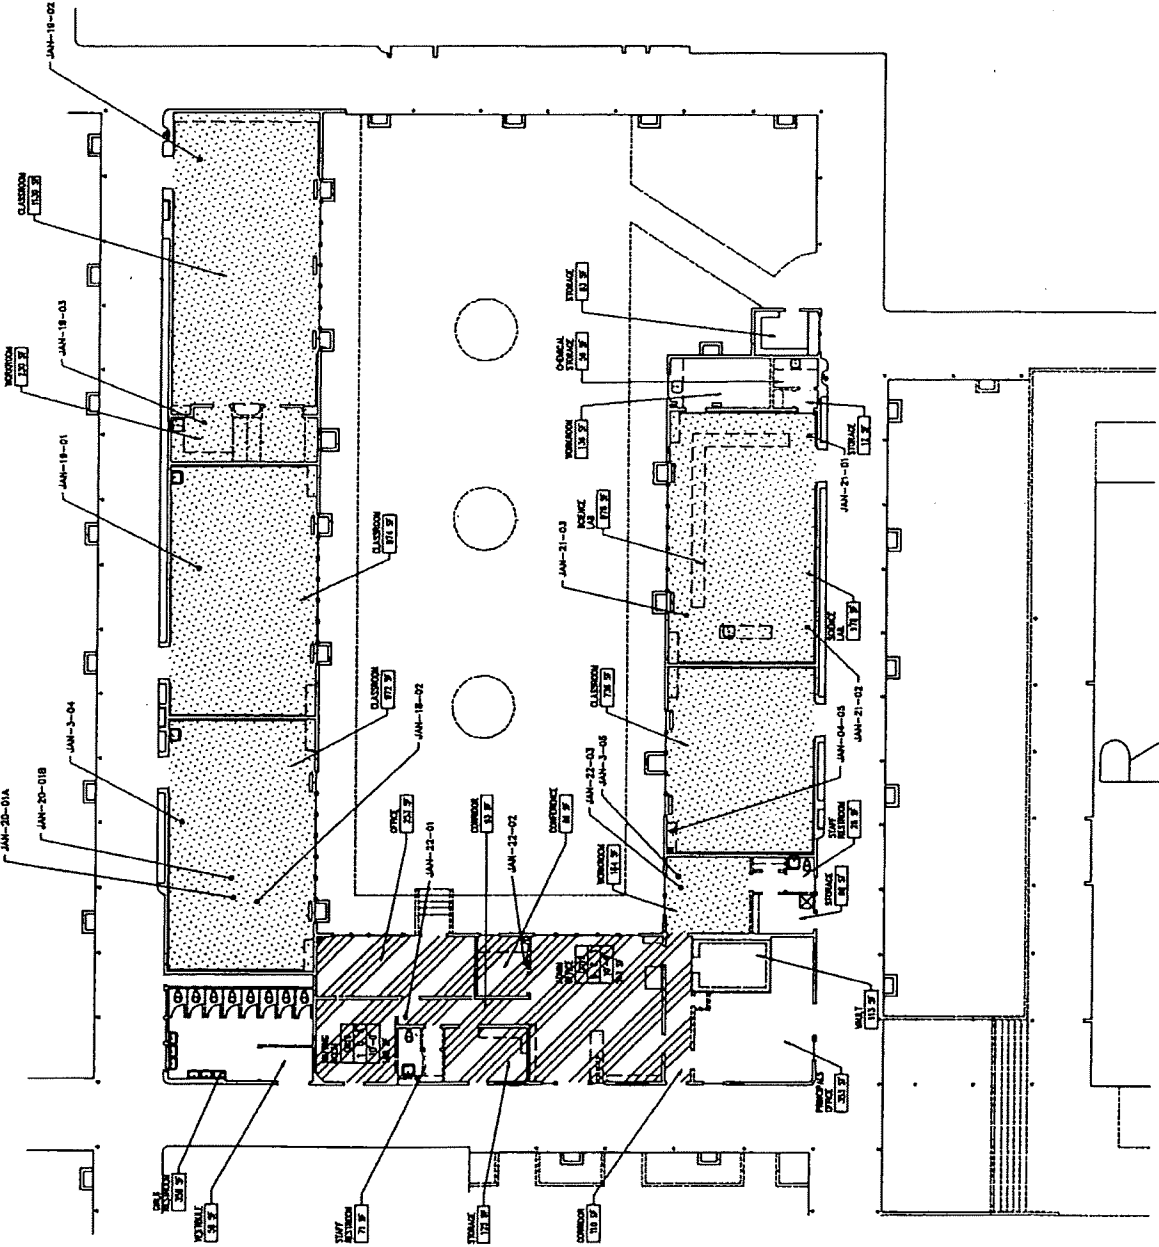
ASBESTOS-CONTAINING 12" x 12" FLOOR TILE AND MASTIC

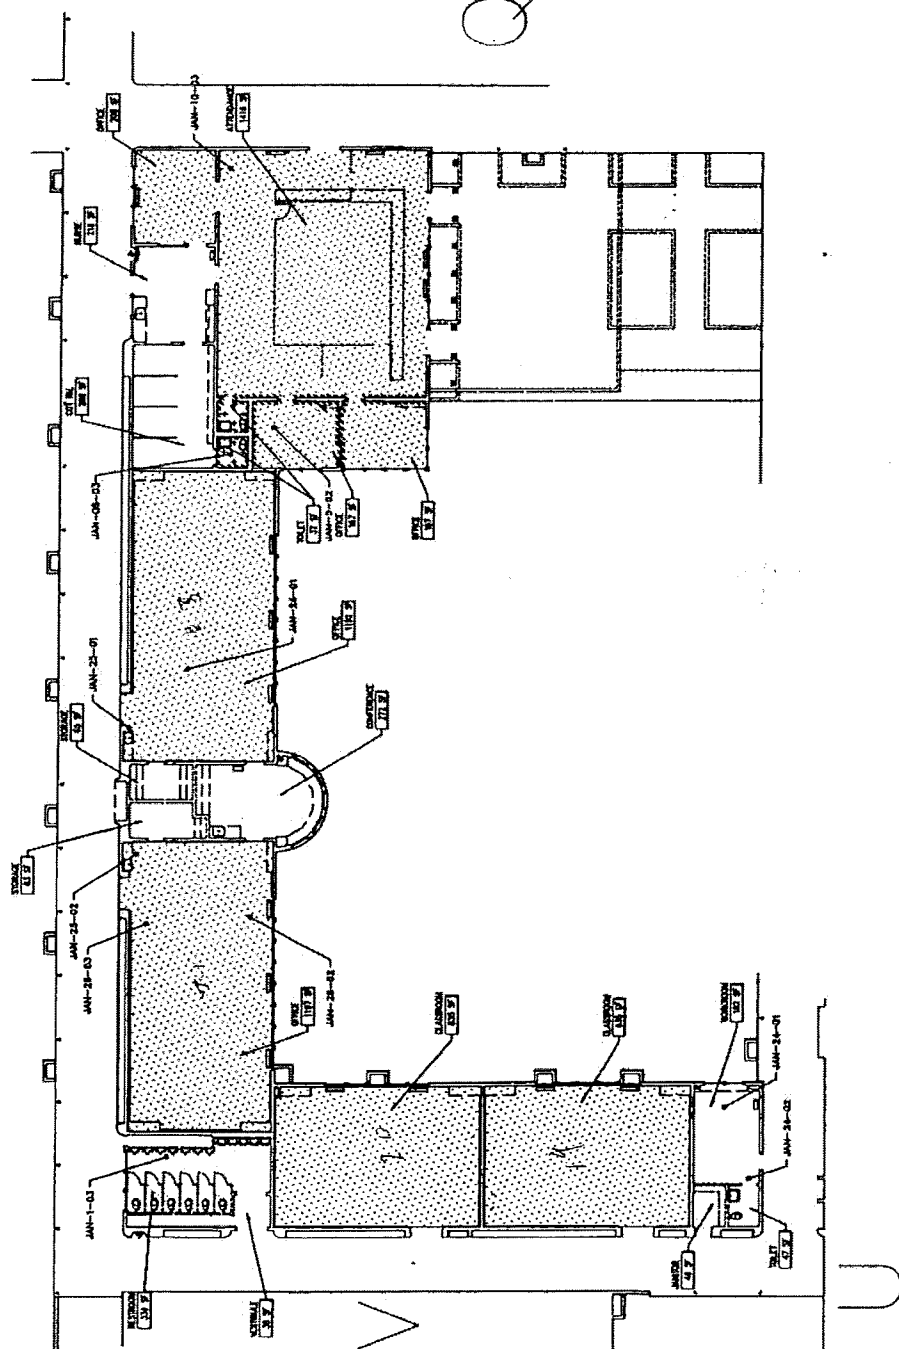
BUILDING "T"

1. ASBESTOS CONTAINING WINDOW PUTTY LOCATED ON EXTERIOR WINDOW FRAMES.
2. ASSUMED ASBESTOS CONTAINING CHALKBOARDS LOCATED IN CLASSROOMS.
3. ASSUMED ASBESTOS CONTAINING CEMENT PLUMES LOCATED IN BUILDING.
