**SUBJECT: SUMMARY REPORT OF PREVIOUS SITE INVESTIGATIONS AND CLOSURE
REQUEST FOR MALIBU PARK SCHOOL LOCATED AT 30215 MORNING VIEW
DRIVE, MALIBU, CALIFORNIA**

**SUMMARY REPORT OF PREVIOUS SITE INVESTIGATIONS AND
CLOSURE REQUEST FOR MALIBU PARK SCHOOL LOCATED AT
30215 MORNING VIEW DRIVE, MALIBU, CALIFORNIA**

**SANTA MONICA-MALIBU UNIFIED SCHOOL DISTRICT
1651 16TH STREET
SANTA MONICA, CA 90404**

AUGUST 21, 1996

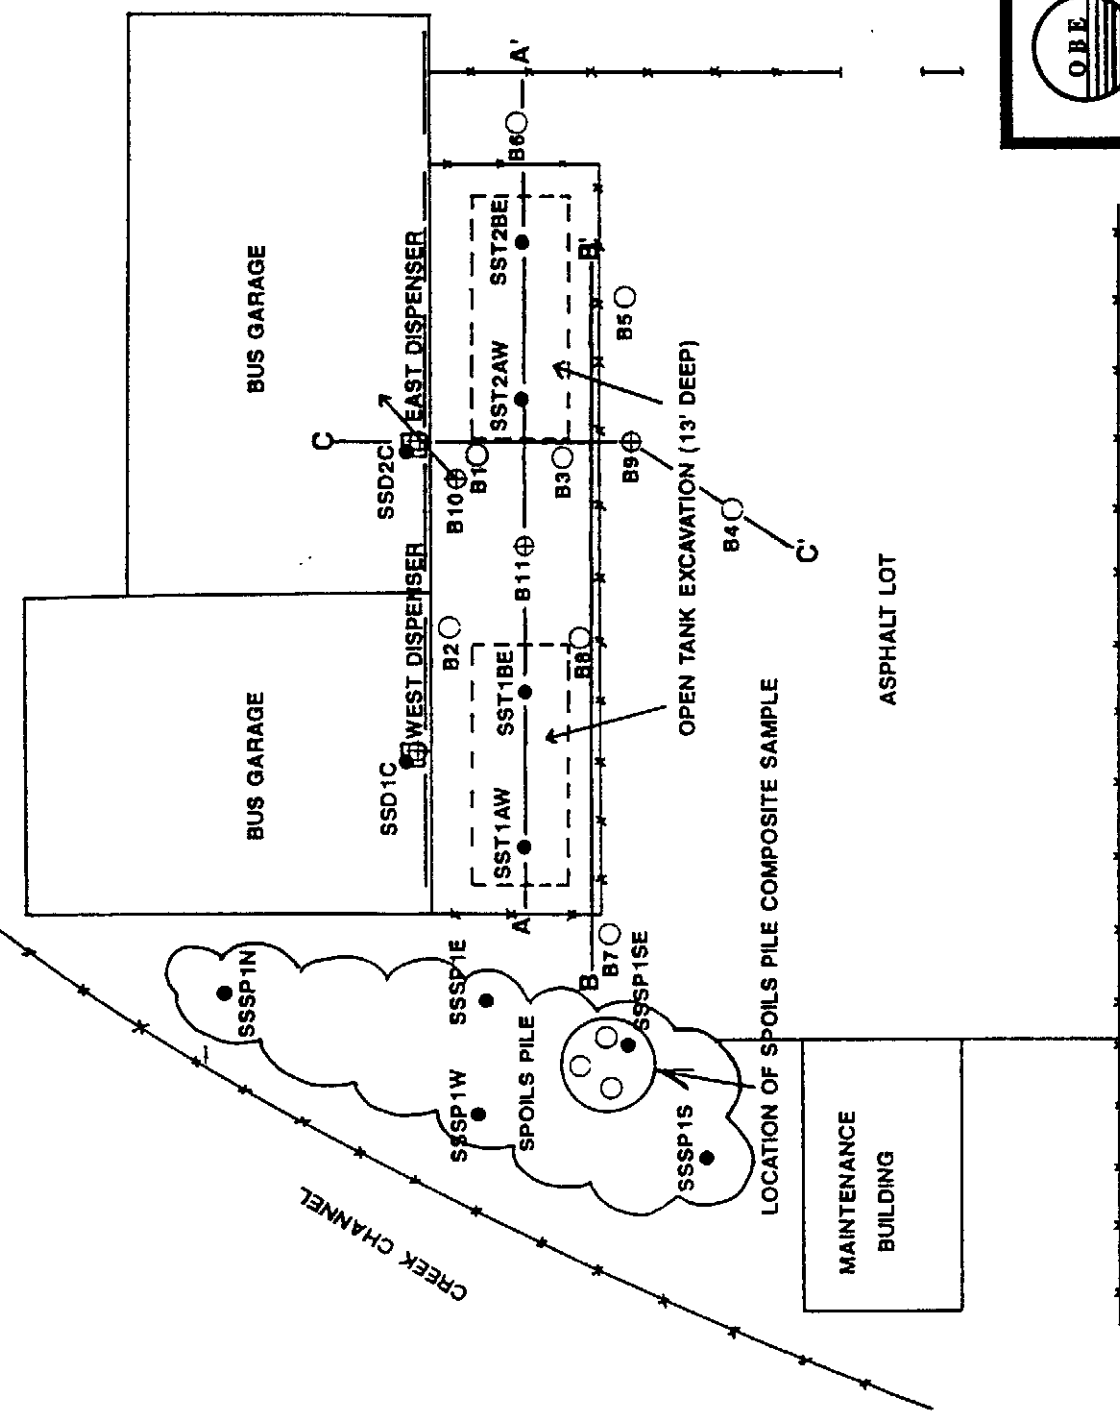
Drawing No. 4

FORMER TANK SITE
Showing the Boring Locations

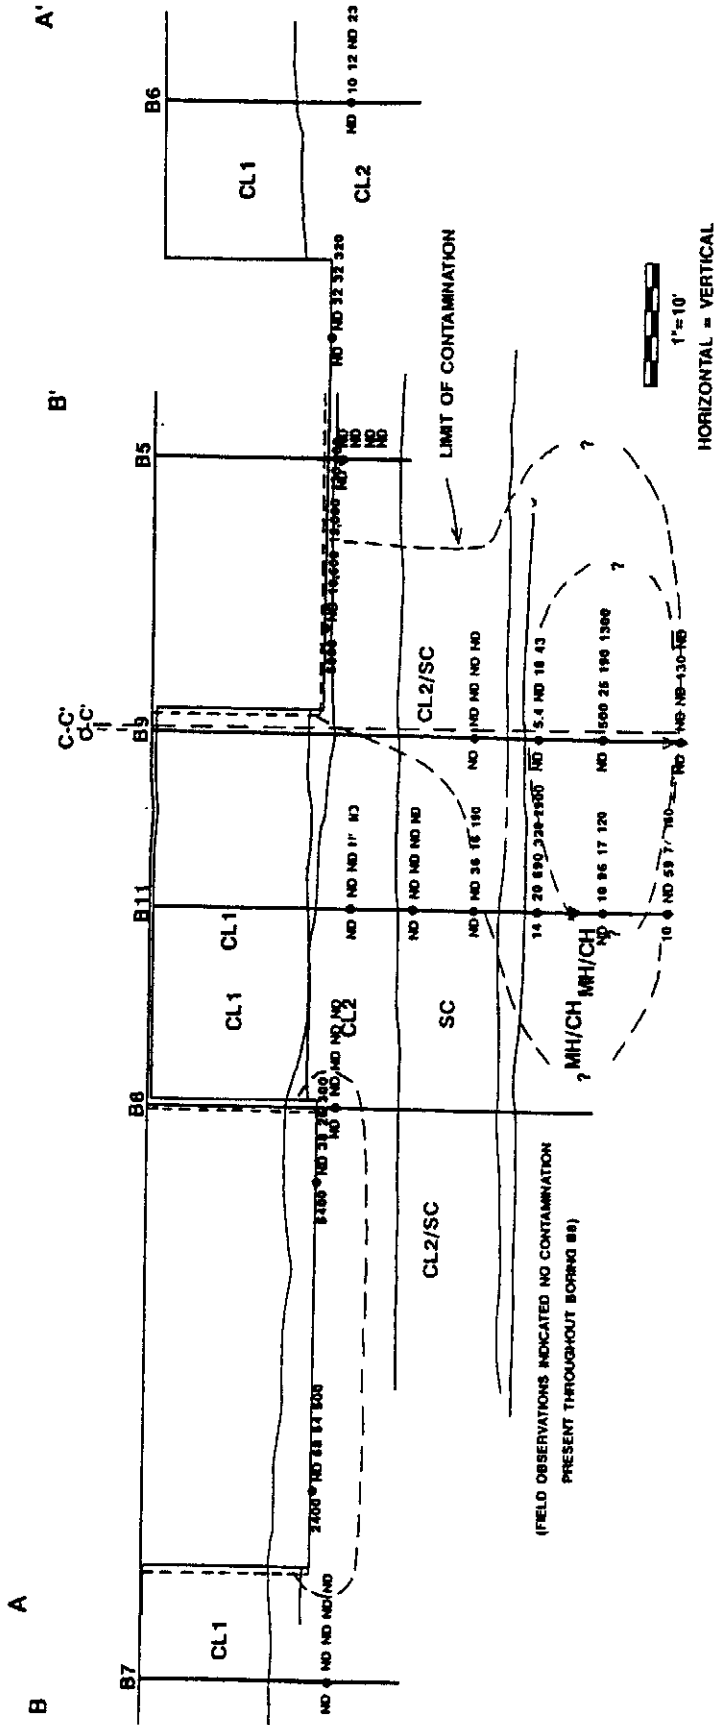
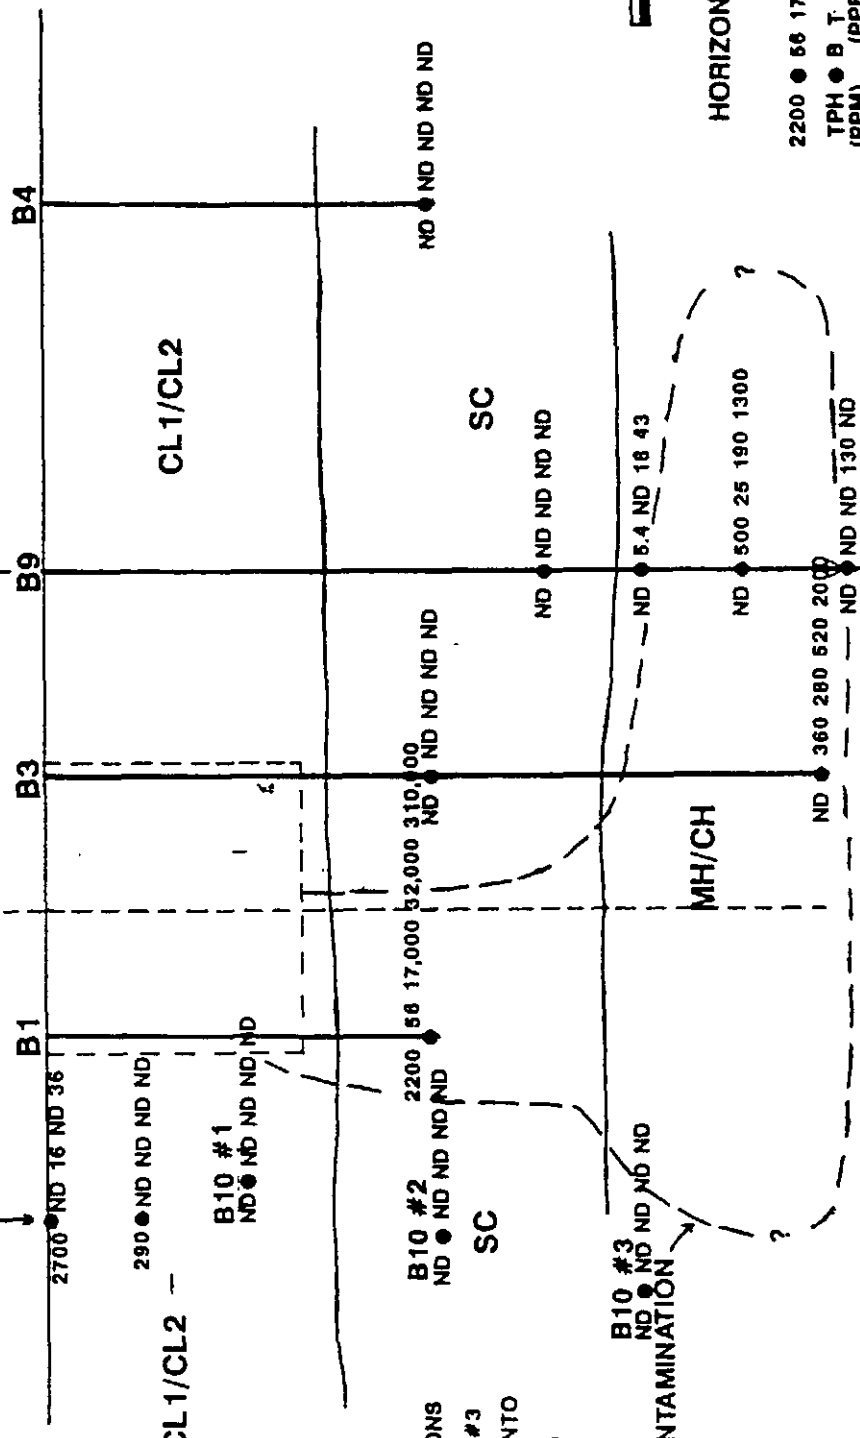
The analyses of a limited number of the samples showed that BTEX was present in low to moderately high concentrations in boring B9 at depths of 30, 35 and 40 feet and in boring B11 at depths of 25, 30, 35 and 40 feet. Low concentrations of TPH was detected underneath the dispensers. The groundwater showed the presence of elevated concentrations of BTEX. Approximate plumes of soil contamination were constructed as a result of the two investigations (3) and (4). Figures 5 and 6 enclosed in Appendix A present the cross sections of the referenced plumes.

Soil sampling and analyses around the eastern tank excavation (3) and (4) showed that relatively elevated TPH and BTEX concentrations were present in boring B1 at a depth of 19 feet. Low to moderately high concentrations of BTEX were detected in borings B3 at a depth of 39 feet, in boring B6 at a depth of 14 feet, in boring B9 at depths of 30, 35 and 40 feet, and in boring B11 at depths of 25, 30, 35 and 40 feet. Soil samples collected from the slant boring B10 showed that the contamination in the vicinity of the eastern tank has not migrated underneath the building. Based on these results, a plume of soil contamination associated with the eastern tank was constructed. Figures 5 and 6 show the approximate vertical cross sections of the plume associated with the eastern tank. Further soil sampling and analyses at the time of the installation of monitoring wells to the northwest (MW2) and southwest (MW3) of the eastern tank did not detect any TPH and BTEX to depths of 30 and 50 feet, respectively. Another attempt has been made to define the soil plume of contamination in relation to the eastern tank (9), but the outcome appears to be inadequate and does not enhance the previous approximate plume presented in Figures 5 and 6.
