## **MONITORING SERVICES DURING ASBESTOS AND LEAD-RELATED WORK, DEMOLITION PROJECT**

Building E Demolition  
Malibu High School  
30215 Morning View Drive  
Malibu, California 90265

Project No.: SMSD-17-6685  
Date: December 1, 2017

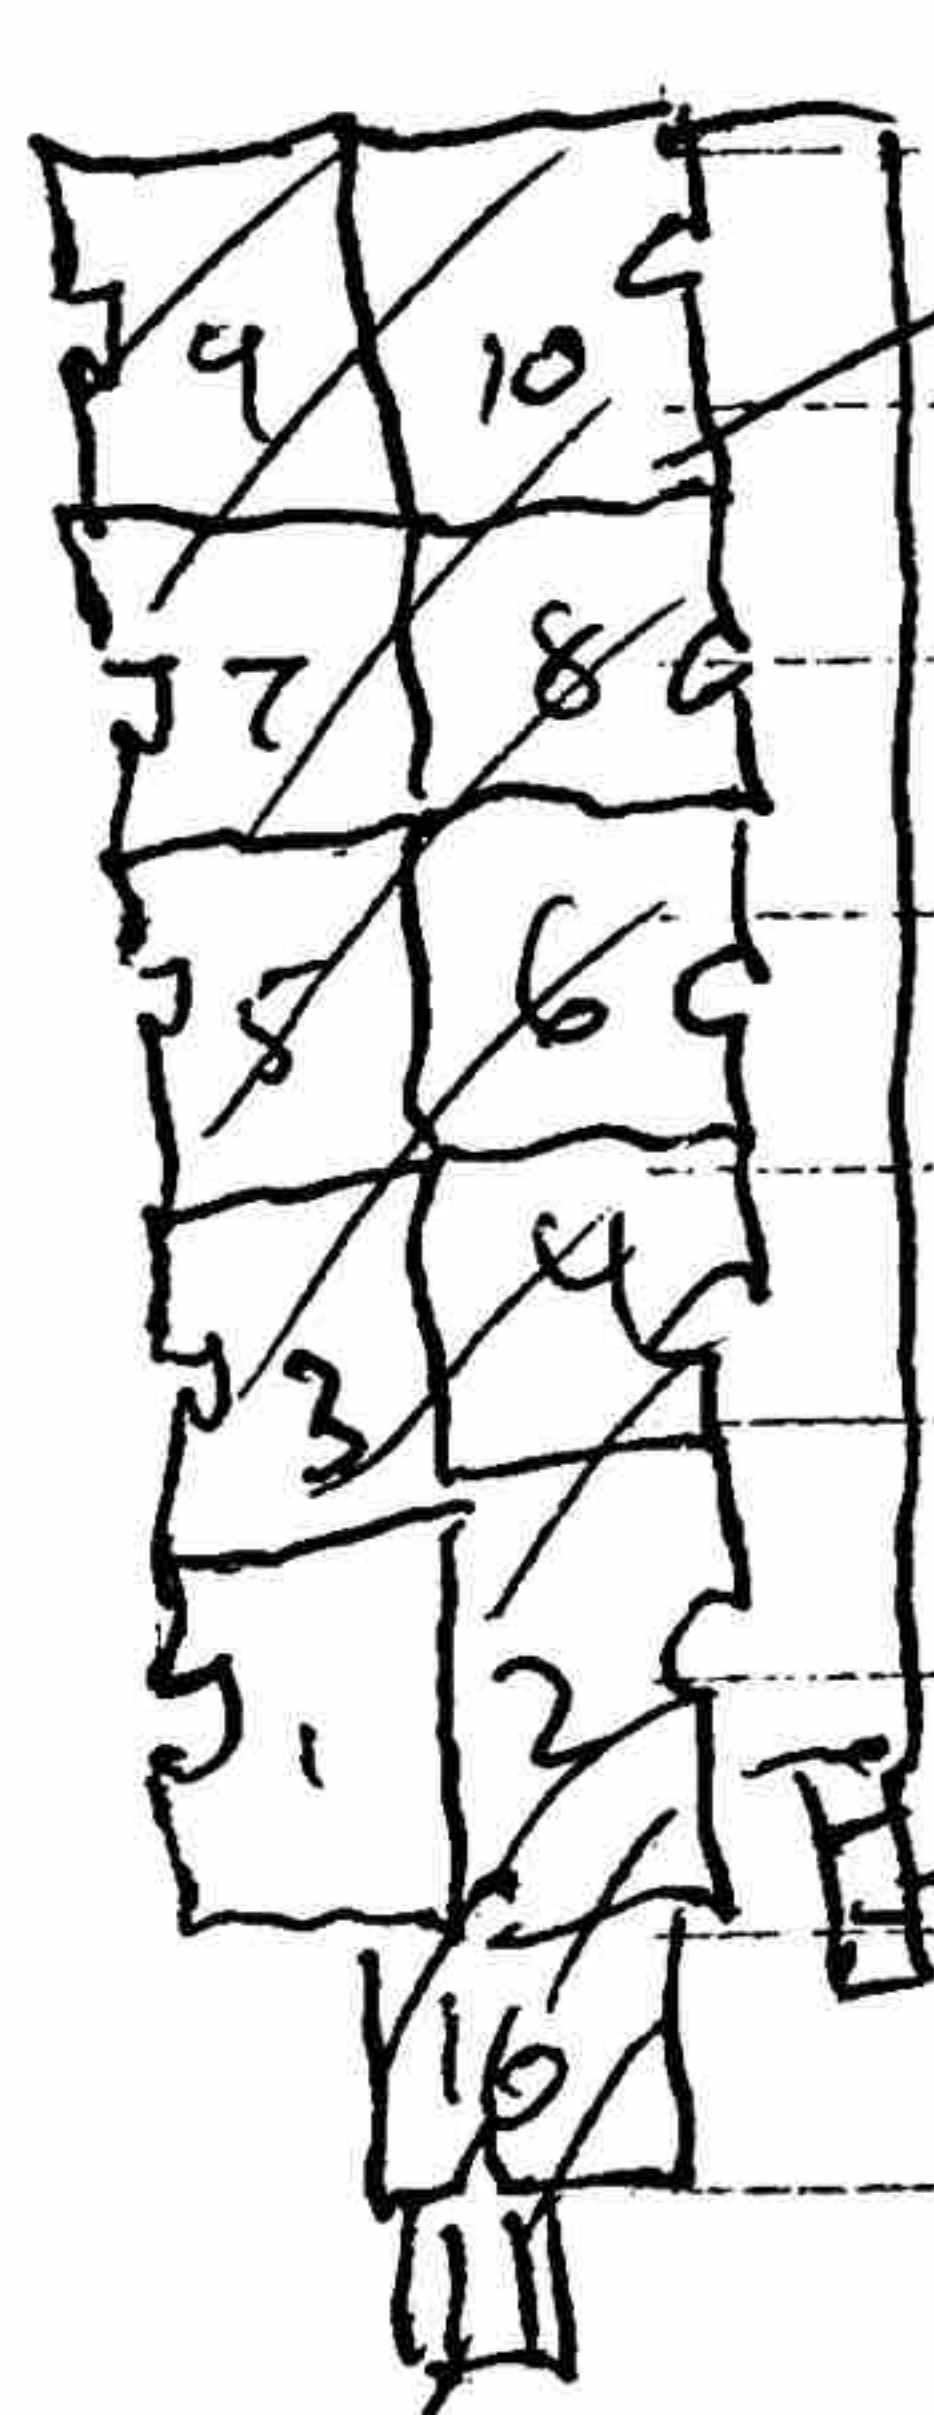
Removal Area

At the request of IPR Supervisor Perez, Alta rep. performed visual inspection at the above mentioned location following the removal of ACM Pipe Elbow insulation, and floor tile w/ Master. Alta observed that said materials were removed with no visible dust or debris remaining.

Following visual clearance, Alta collected clearance Air Monitoring in accordance with NIOSH 7400 Method (PCM). The results were consistent at less than 0.01 f/cc the area is cleared for tear down.
