## **PCB DELINEATION AND SOURCE BULK SAMPLING REPORT**

**Malibu High School**  
Building H (Cafetorium)  
30215 Morning View Drive  
Malibu, California 90265

Project No.: SMSD-17-7294  
Reported Date: May 1, 2018 (Final)

**REF:** PCB Delineation and Source Bulk Sampling Report  
Building H (Cafetorium)  
Malibu High School  
30215 Morning View Drive, California 90265

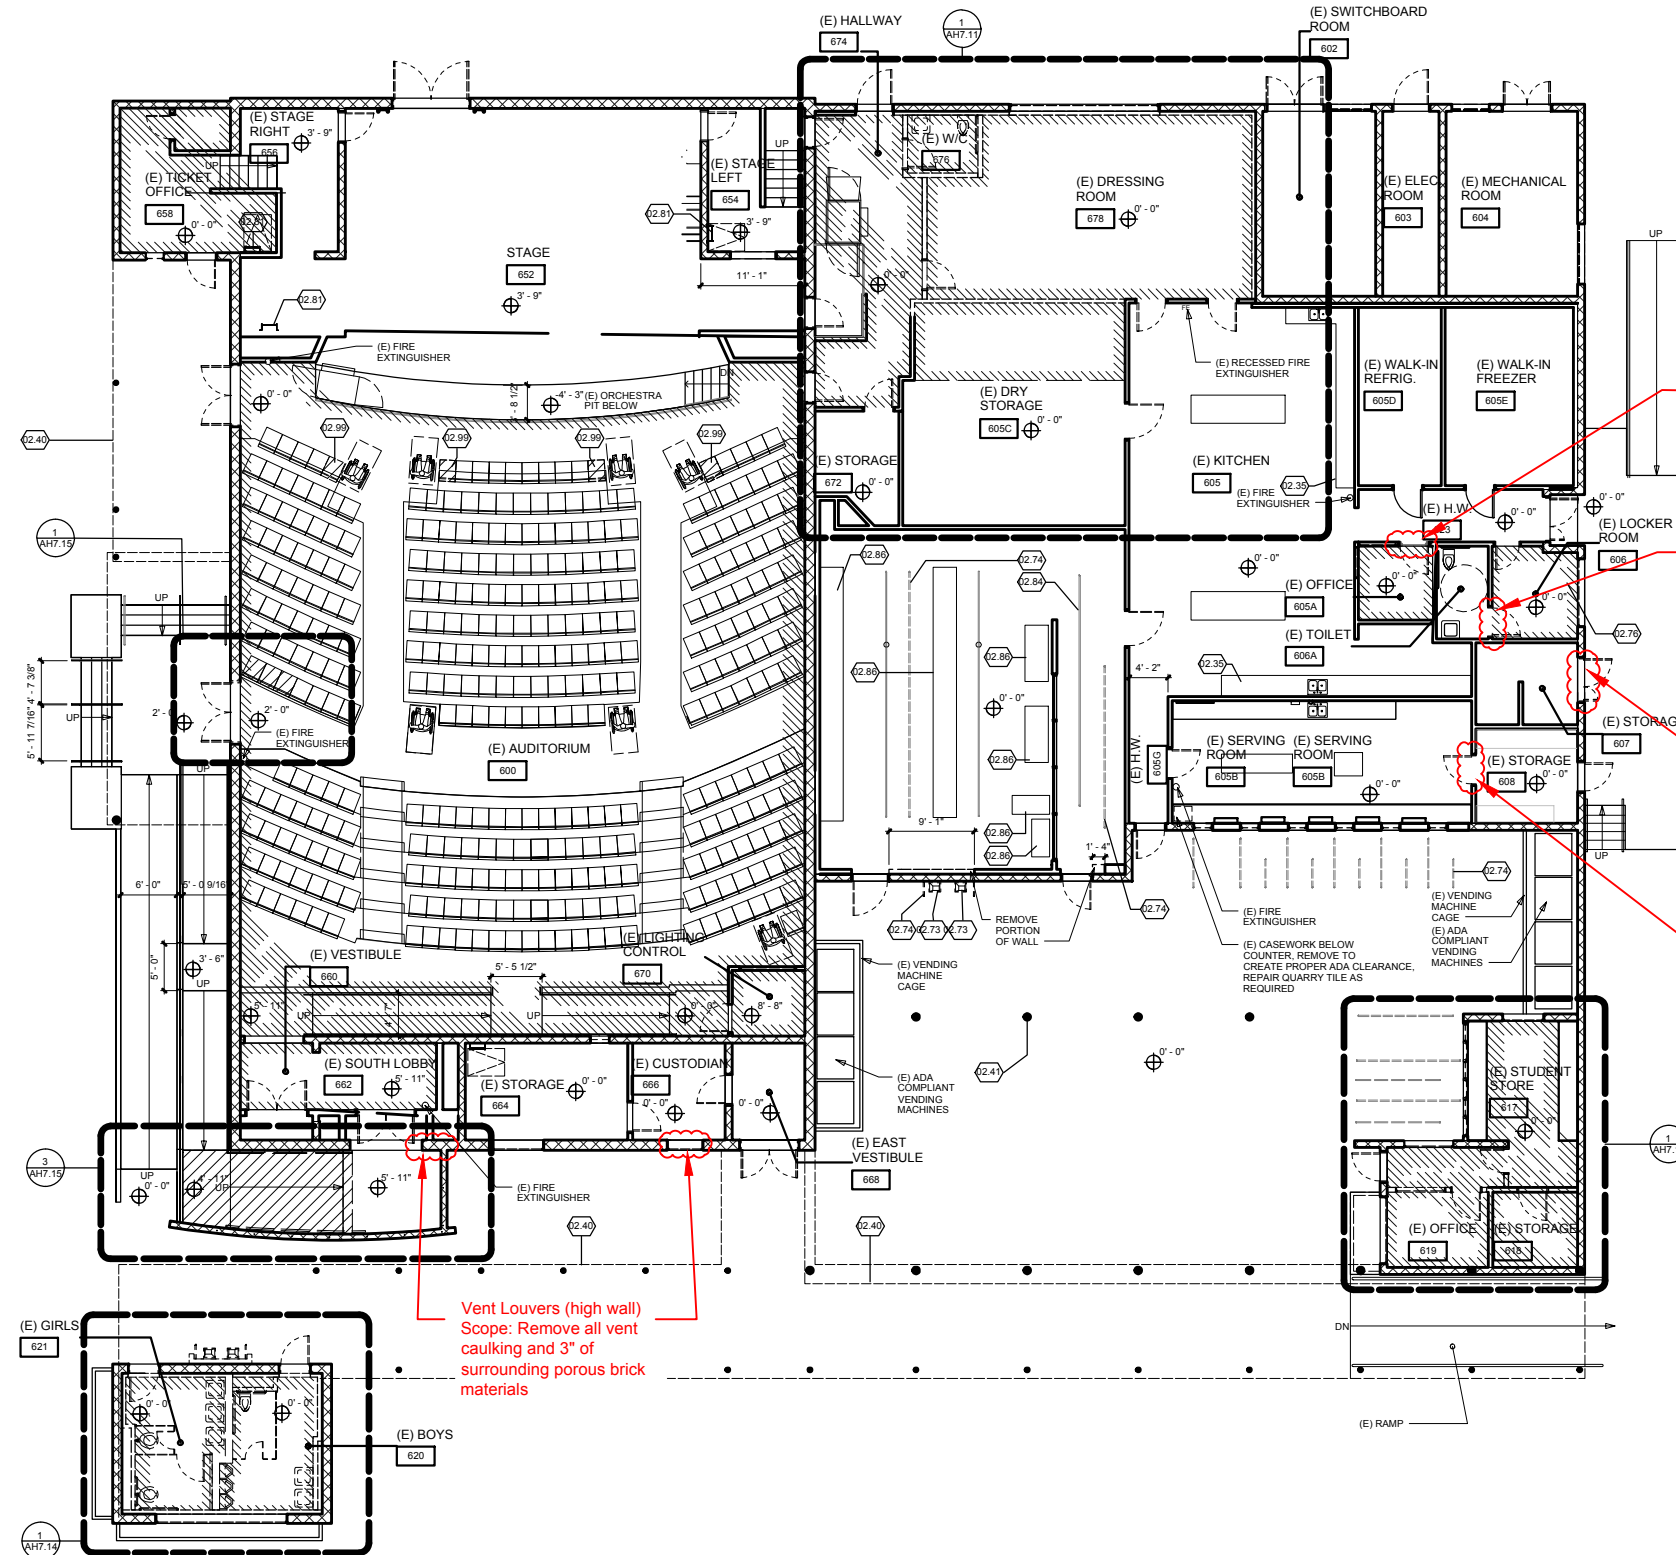
Door frame 605G and associated interior window frame caulking  
Scope: Removal all door and window caulking and 12 inches of surrounding wall plaster

Door frame 606B  
Scope: Removal all door caulking and 12 inches of surrounding wall plaster

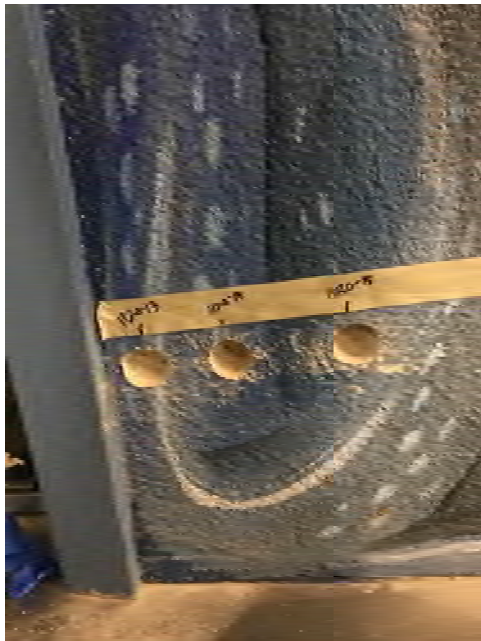
**1120-13 thru 1120-15**

2'x3' glass with frame (South Elevation)	6	Delineation Sample	1120-13 (1") / South elevation	Non-detected
		Source Bulk Sample (Caulking and glazing)	1201-03 / South elevation 1201-04 / South elevation 1201-05 / South elevation 1201-06 / South elevation 1201-07 / South elevation 1201-08 / South elevation	2.79 Non-detected Non-detected Non-detected Non-detected Non-detected
Vent louver (North Elevation)	4	Delineation Sample	1120-01 (1") / North elevation	Non-detected
		No vent caulking observed. No sampling required		
Vent louver (East Elevation)	1	Delineation Sample	1120-07 (1") / East elevation 1214-21 (6") / East elevation 1226-04 (9") / East elevation 1226-05 (12") / East elevation 1226-06 (15") / East elevation	Non-detected 2.99 ppm Non-detected Non-detected Non-detected

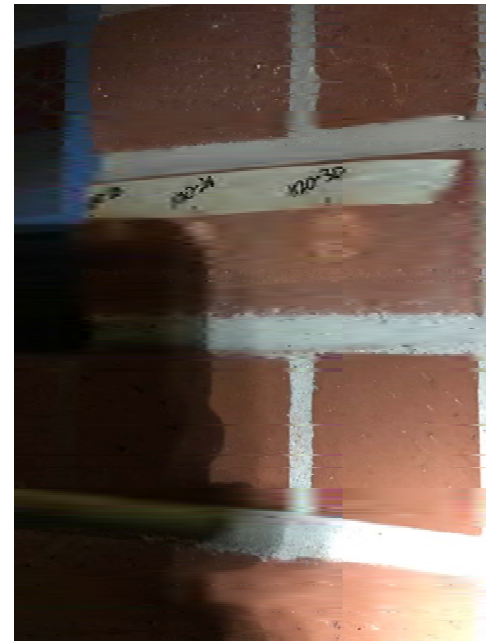
**1120-28 thru 1120-30**

Source Bulk Sample (caulking)	1214-20 / East elevation	Non-detected
Vent louver (South Elevation)	2	Delineation Sample	1120-28 (1") / South elevation 1120-29 (3") / South elevation, 1120-30 (6") / South elevation	3.25 ppm 0.922 ppm Non-detected
		Source Bulk Sample (caulking)	1201-12 / South elevation	118 ppm
Note: No vent louvers were observed on the West elevation				
Doorframe (A:S, and A:D)		Delineation samples	1120-22 (1") / 600J 1120-25 (1") / 600A 1116-32 (1") / 606A 1116-42 (1") 605B 1116-45 (1") / 603A	Non-detected Non-detected Non-detected Non-detected Non-detected
		Source door caulking	22718-SF21 / 600J 1201-27 / 600A 22718-SF08 /606A 22718-SF27 / 605B 22718-SF25 / 603A	Non-detected Non-detected 14.1 ppm 5.05 ppm 3.97 ppm
Doorframe (A:S, A:D and F:D)		Source door caulking	1201-14 / 610A 1201-15 / 620A 1201-16 / 681A 1201-17 / 654B 1201-18 / 605N 1201-20 / 658 A 1201-21 / 605 C 1201-22 / 609A 1201-23 / 605H 1201-24 / 668A 1201-25 652A 22718-SF01 /605A 22718-SF03 /608A 22718-SF04 /617B 22718-SF05 /617A 22718-SF06 /609C 22718-SF09 /605F 22718-SF10 / 605 NE 22718-SF11 / 605 North 22718-SF12 / 664A 22718-SF13 / 666A 22718-SF14 / 621A 22718-SF15 / 678 SW 22718-SF16 / 610A 22718-SF17 / 600K 22718-SF18 / 674A 22718-SF19 / 654A 22718-SF20 / 654B 22718-SF22 / 658B	Non-detected Non-detected Non-detected Non-detected 16.7 ppm Non-detected Non-detected Non-detected Non-detected Non-detected Non-detected Non-detected Non-detected 24.9 ppm 4.52 ppm 12.6 ppm Non-detected Non-detected 16.9 ppm 19.1 ppm 16.6 ppm 6.8 ppm Non-detected 1.74 ppm 0.67 ppm 1.62 ppm 2.65 ppm 4.18 ppm 2.16 ppm 2.37 ppm

6. Door caulking and associated window caulking around doorframe 605G, and at least 12 inches of surrounding interior plaster,
7. Door caulking around doorframe 606B, and at least 12 inches of surrounding interior plaster, and
8. Door caulking around doorframe 607A, and at least 15 inches of surrounding interior plaster, and one inch of exterior brick,
9. Door caulking around doorframe 608B, and at least 12 inches of surrounding interior plaster,
10. Vent louver caulking around two south vents (top of wall louvers), and 3 inches of surrounding brick.

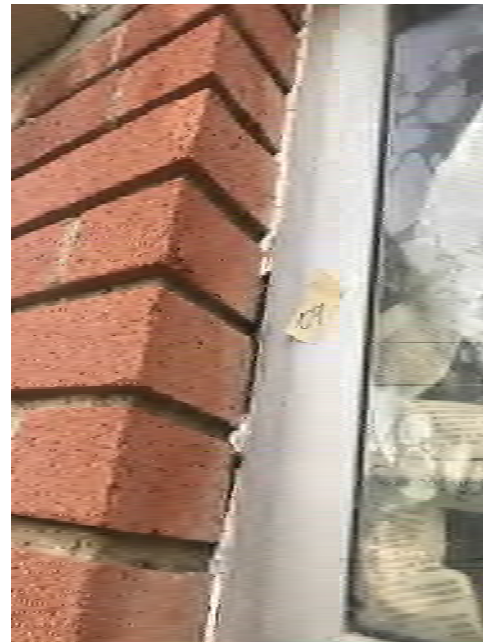
**1201-09**

Building H -Cafetorium (1931 Construction)				
Component Sampled	Total components to be removed	Sample Description	Sample Numbers/Sample Location	Result (PPM) (Aroclor 1254)
16'x4' glass with metal frame (North Elevation)	1	Delineation Sample	1120-04 (1") / North elevation	Non-detected
		Source Bulk Sample (caulking and glazing)	1201-10 / North elevation 1201-11 / North elevation	Non-detected Non-detected
Interior window	1	Delineation sample	1116-29 (1") 605G	Non-detected
		Source Bulk Sample (caulking)	1201-19 / 605G	50.8 ppm
Note: the interior window is embedded with door 605G forms one system (window and door). Sample #1201-19 was collected from the door caulking				
14'x2' glass with metal frame (South and East Elevation)	3	Delineation Sample	1120-10 (1")-South elevation 1120-16 (1")-East elevation 1120-18 (1")-East elevation	Non-detected Non-detected Non-detected
		Source Bulk Sample (caulking)	1201-01 / East elevation 1201-09 / South elevation	1.83 ppm 2.88 ppm

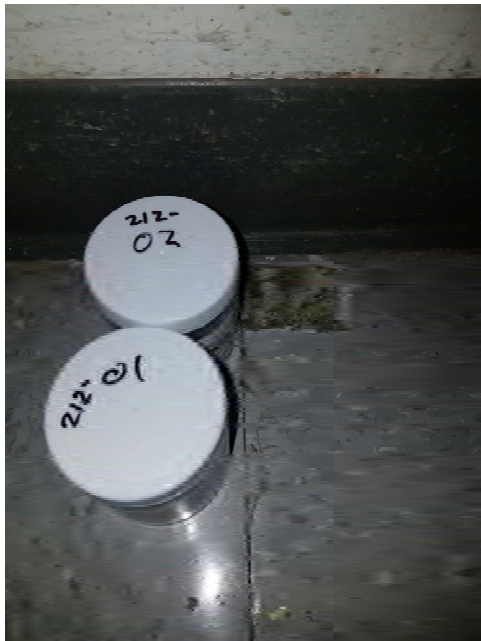
**212-01, 212-02**

22718-SF24 / 656A 22718-SF26 / 670A	1.86 ppm 1.75 ppm
Doorframe (A:S)		Delineation samples	No samples have been collected at this time. Assumed PCB containing the first 12 inches of surrounding porous materials	
		Source door caulking	1201-19 / 605G 22718-SF02 / 608B 22718-SF-07 / 606B	50.8 ppm 80.7 ppm 12,500 ppm
Doorframe (F:D)	2	Delineation Sample	1116-35 (1") exterior / 607A 1116-38 (1") interior / 607A 1116-40(3") interior / 607A 1116-41(6") interior / 607A 1214-13(9") interior / 607A 1214-14(12") interior / 607A 1226-01(15") interior / 607A 1226-02(18") interior / 607A 1226-03(22") interior / 607A	Non-detected 2.49 ppm 2.6 ppm 1.56 ppm 1.27 ppm 1.02 ppm Non-detected Non-detected Non-detected
		Source Bulk Sample	Not sampled / 607A	Assumed PCB
12"x12" grey marbled floor tile and yellow glue		Floor tile	212-01 / 674 212-03 / 679 212-05 / 672	Non-detected
		Yellow glue	212-02 / 674 212-04 / 679 212-06 / 672	Non-detected
