March 20, 2017

Mold and Moisture Investigation Report: Findings of Initial Assessment

**John Muir Elementary School
Classrooms 600, 615, 205 and the
Media Center
2526 Sixth Street
Santa Monica, CA 90405**

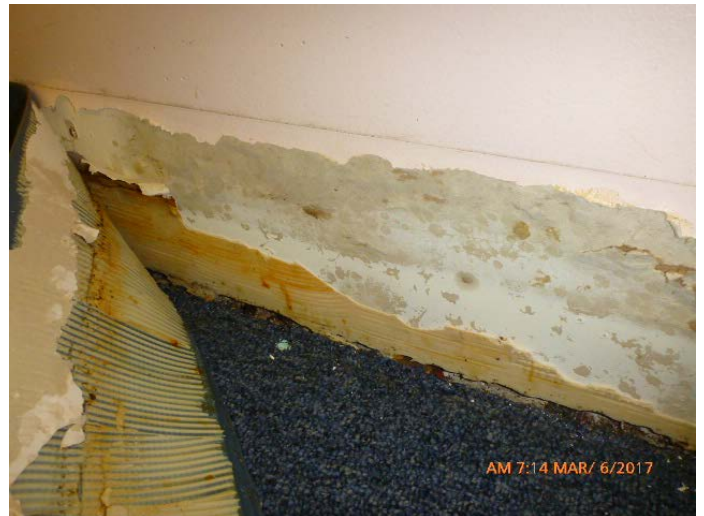
Photo #6: Close-up of base of north wall and moisture impact

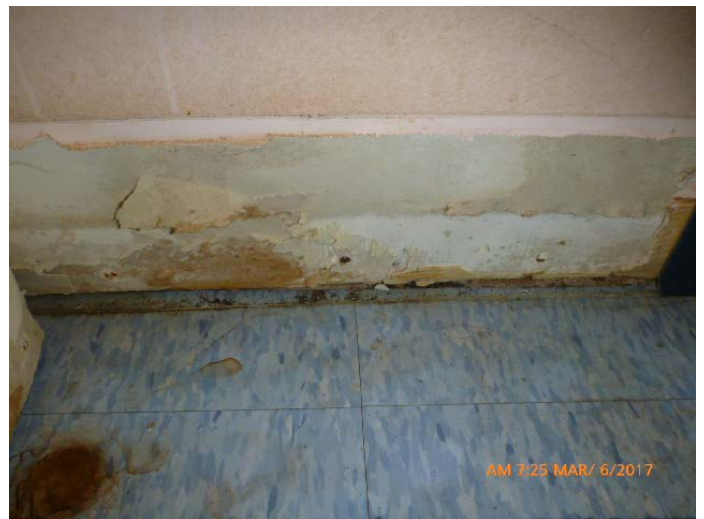
Photo #8: Close-up of base of wall and moisture impact.
Staining observed on vinyl floor tile

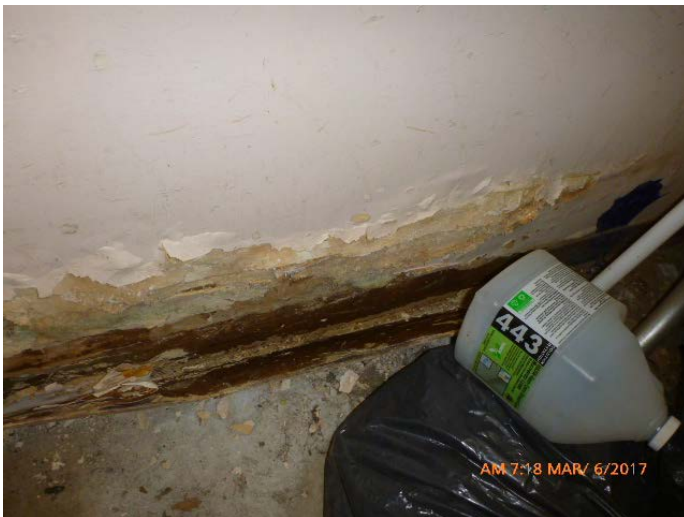
Photo #11: Heavy moisture damage, visible mold growth and elevated moisture along base of east wall

12. Inspect and repair any plumbing leaks at mop sink in custodial closet adjacent to classroom 615.

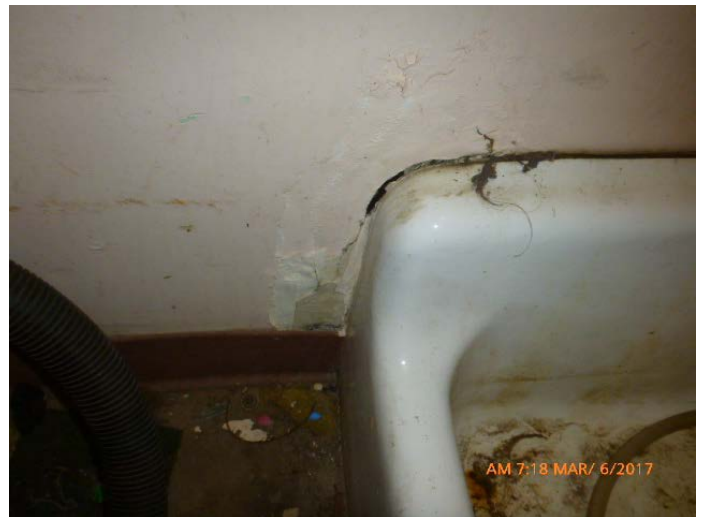
Photo #12: Additional moisture impact along north wall adjacent mop sink

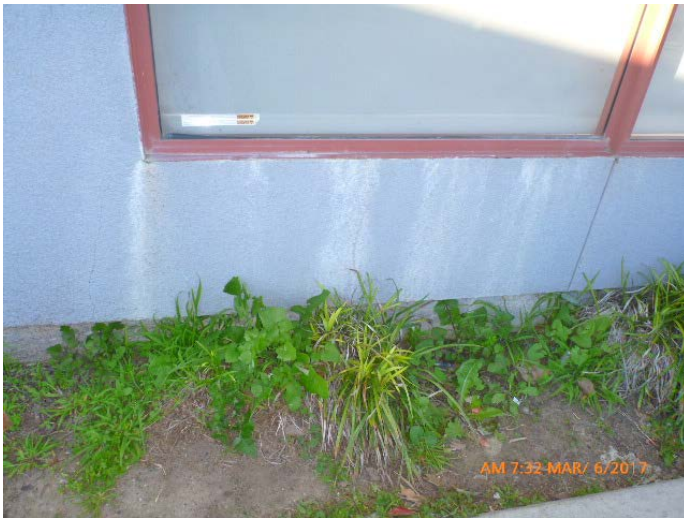
Photo #17: Staining observed below window along north perimeter

8. In consultation with an appropriately qualified construction professional, inspect classroom 600's north window. The window is suspected to leak based on visual findings.

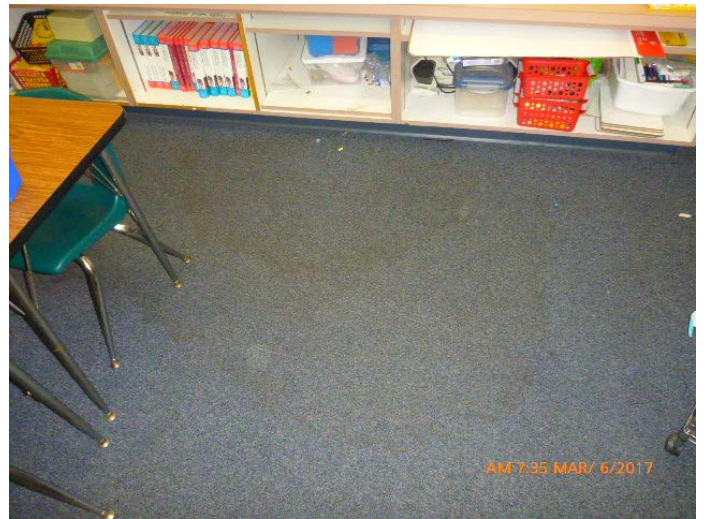
Photo #20: Stained carpeting along north perimeter

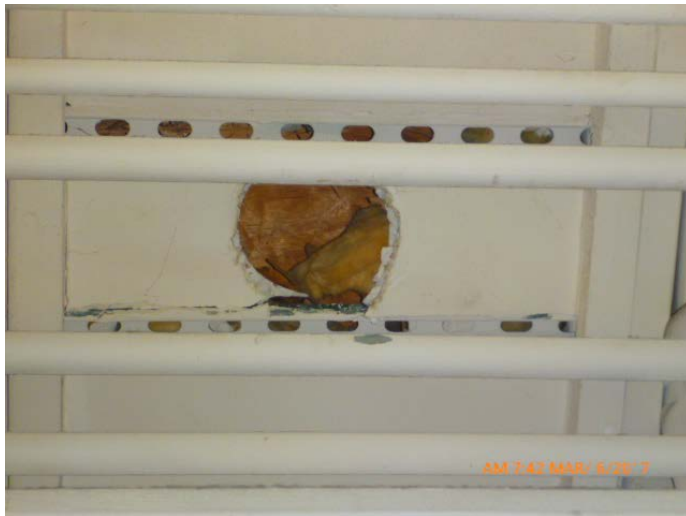
Photo #21: Hole observed in ceiling above stained carpet

9. Replace all moisture-impacted ceiling tiles and monitor during next period of heavy rains. If staining re-occurs, reassess and repair roof leaks.
10. Inspect and repair hole in ceiling of classroom 600. During this process, inspect the ceiling cavity for additional moisture issues including mold growth.

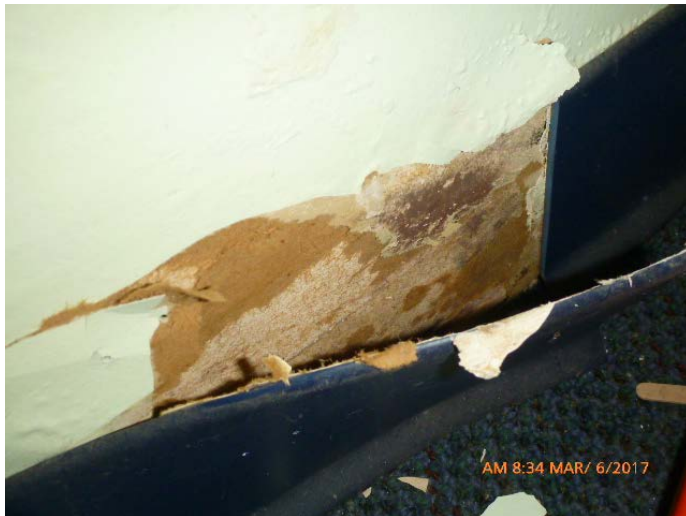
Mold growth observed behind base-cove on west wall.				31	
		Overview of circulation desk along north perimeter (impact area 2).	\	\	\	32	
		Stained carpeting observed along north perimeter. The carpeting was dry at time of FACS assessment.	\	~4 ft. ² (stained)	\	33

Photo #31: Mold growth observed behind base-cove on west wall

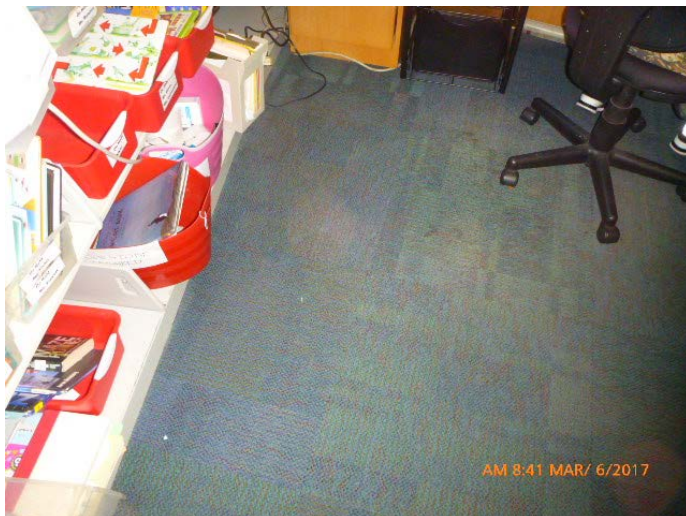
Photo #33: Stained carpeting observed along north perimeter

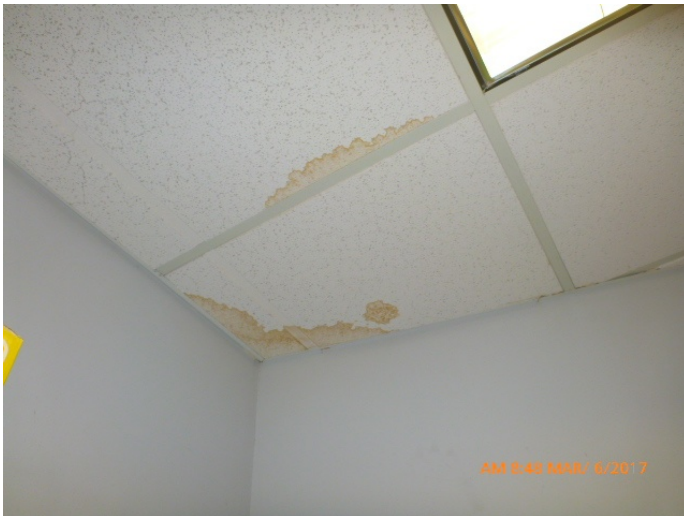
Photo 35: Stained ceiling tiles observed in SW corner

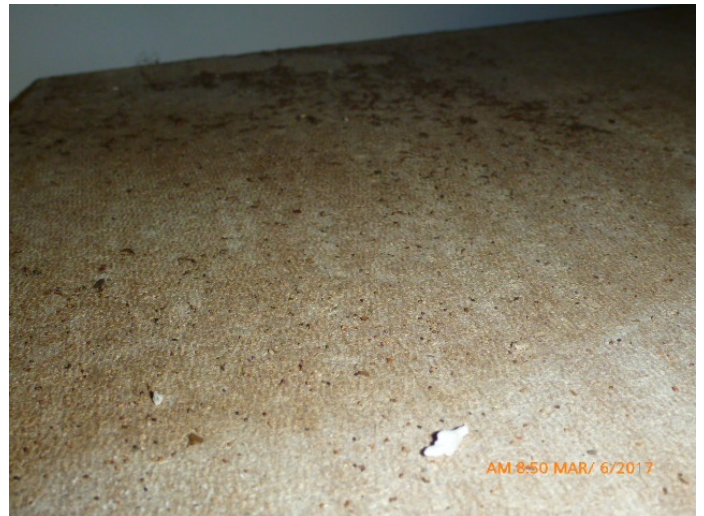
Photo 36: Overview of top of ceiling tile and staining/debris

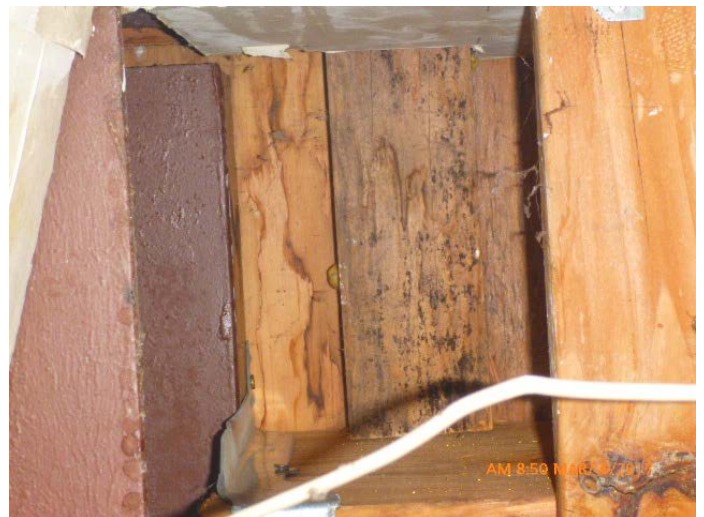
Photo 38: Close-up of staining on wooden beams

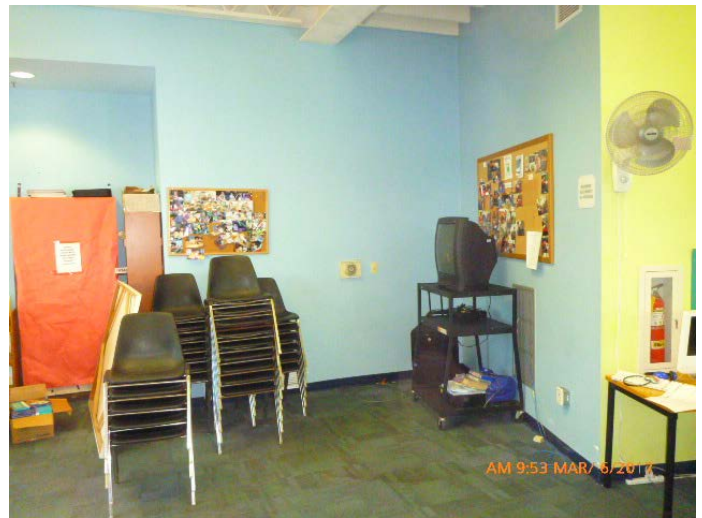
Photo 43: Stained carpeting observed along south perimeter

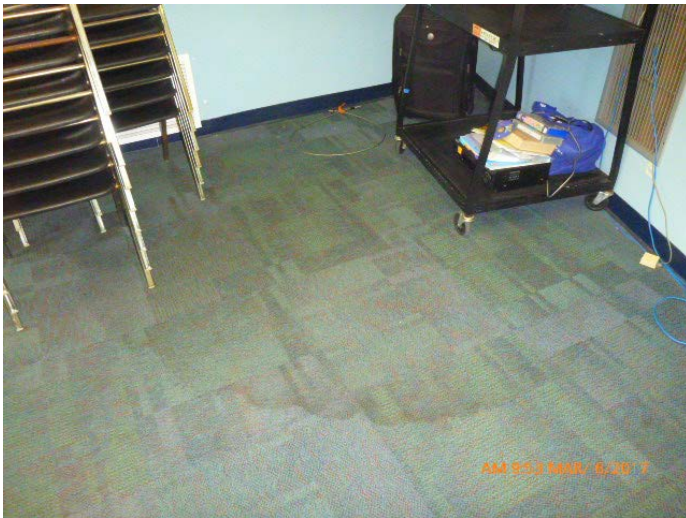
Photo 45: Large area of stained carpeting observed in SE corner

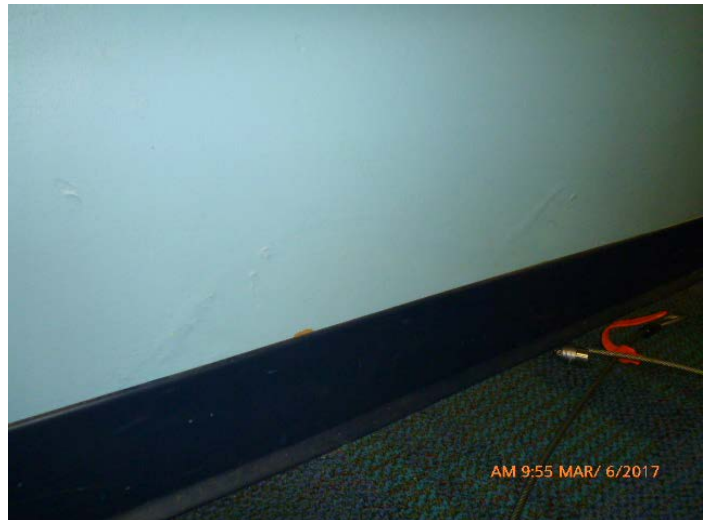
Photo 46: Moisture impact (e.g. bubbling) observed along base of south wall

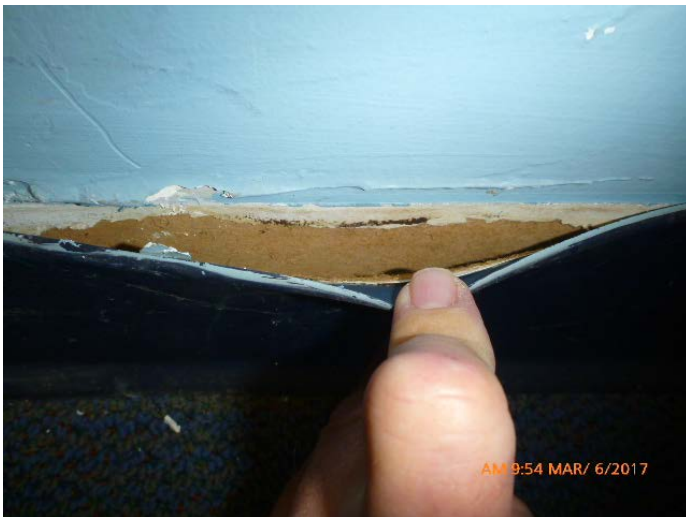
Photo 47: Mold growth observed behind base-cove on south wall

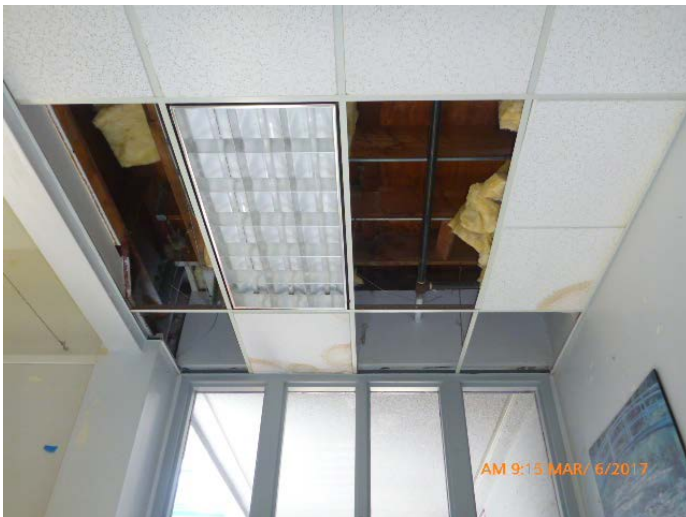
Photo 51: Missing and stained ceiling tiles observed in SW corner Adj. entry

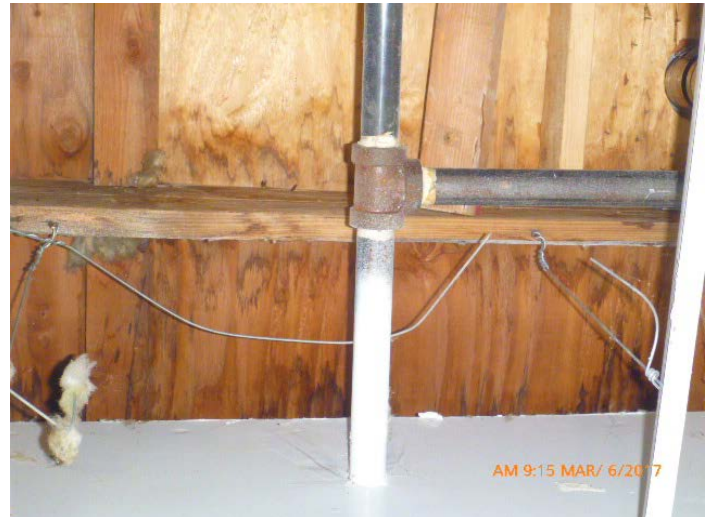
Photo 52: Roof drain and staining observed on exposed roofing materials

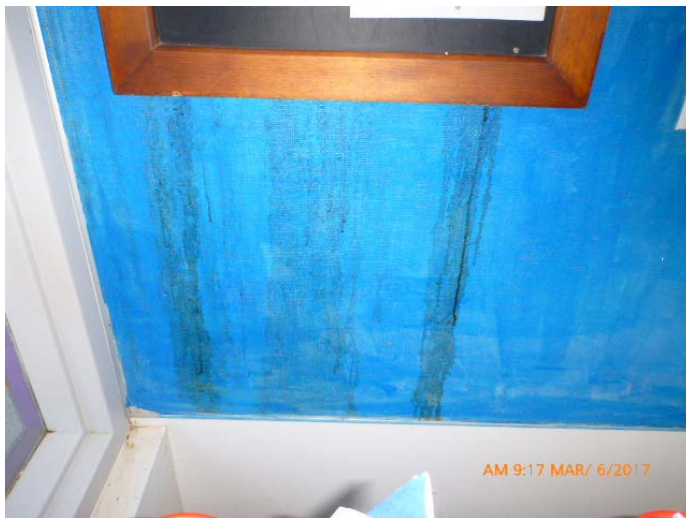
Photo 53: Staining observed approximately 3 ft' up along west wall outside bathroom

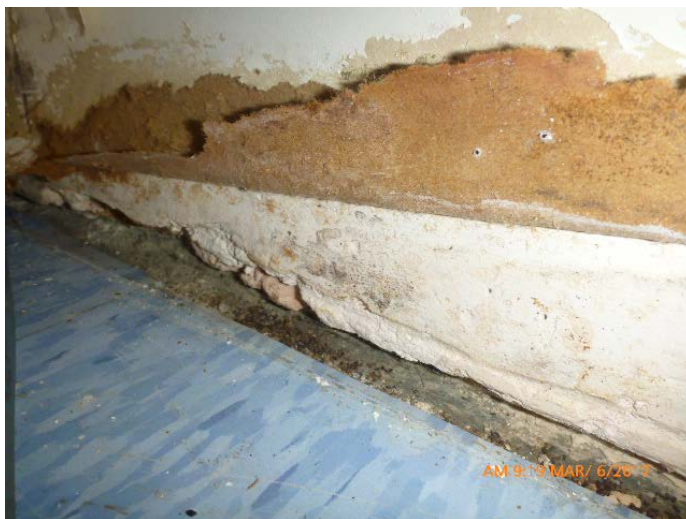
Photo 55: Mold growth and strong musty odors observed along base of west and south walls (both sides of ext. door)

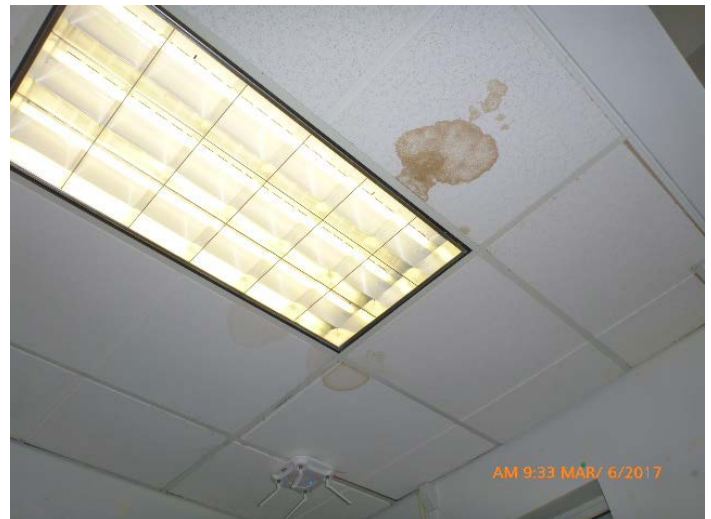
Photo 56: Stained ceiling tiles observed along north perimeter

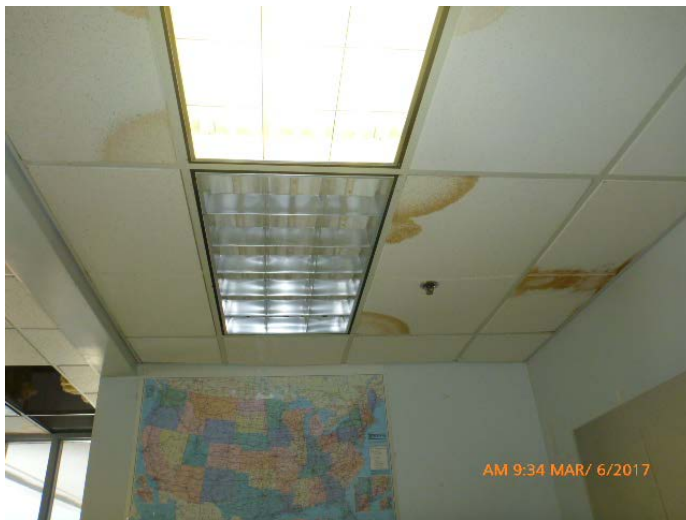
Photo 57: Additional stained ceiling tiles in SW corner adj. bathroom

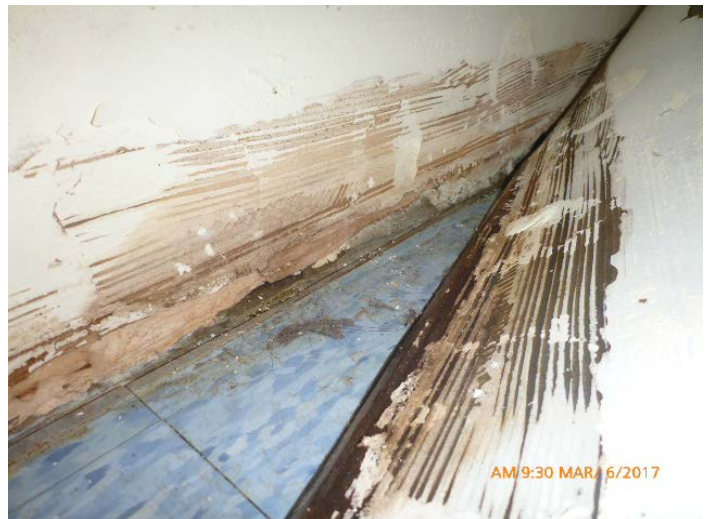
Photo 60: Moisture impact and mold growth observed along base of south and west walls

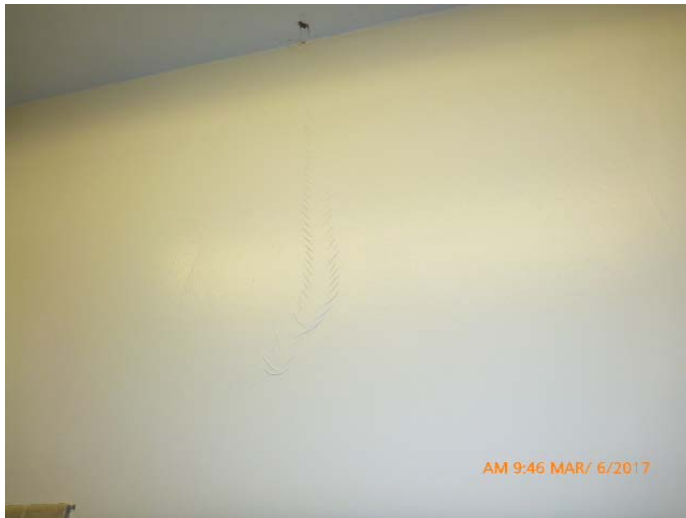
Photo 61: Moisture impact (e.g. bubbling paint) observed along west wall in bathroom

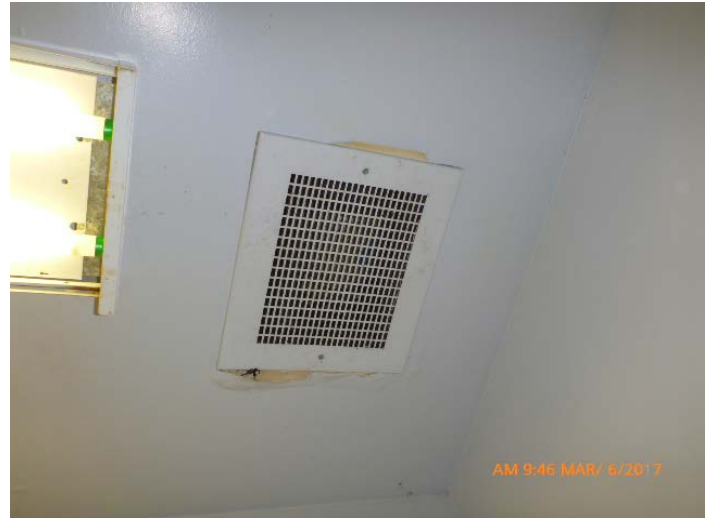
Photo 62: Moisture impact (e.g. damage) observed to ceiling in bathroom
