**Santa Monica-Malibu
Unified School District**
John Muir - SMASH Elementary School

Findings Report
Building Envelope Investigation

April 05 – 06, 2022

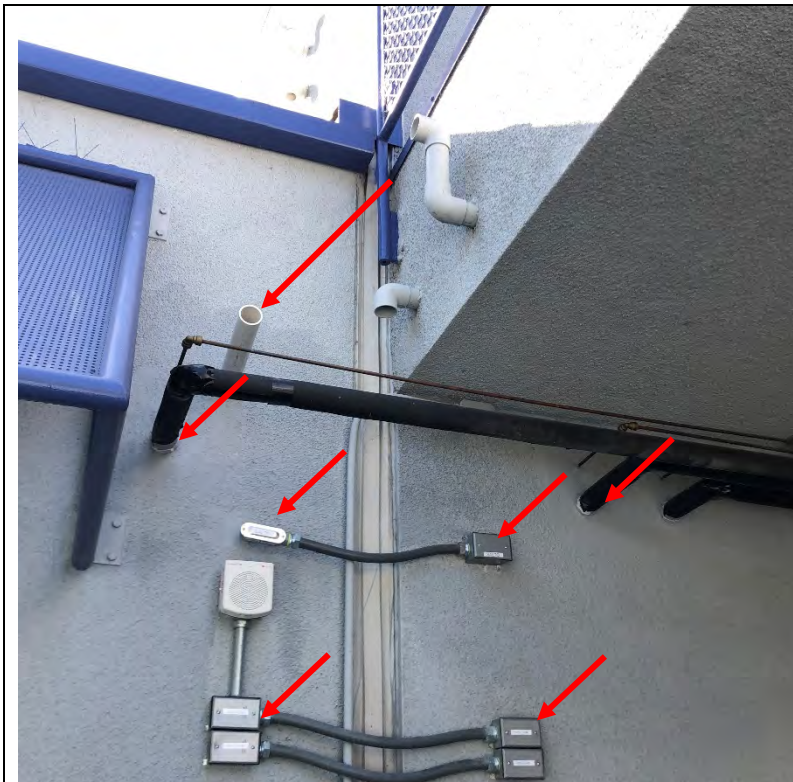
Photo 06:
Penetrations in the cement plaster assembly.

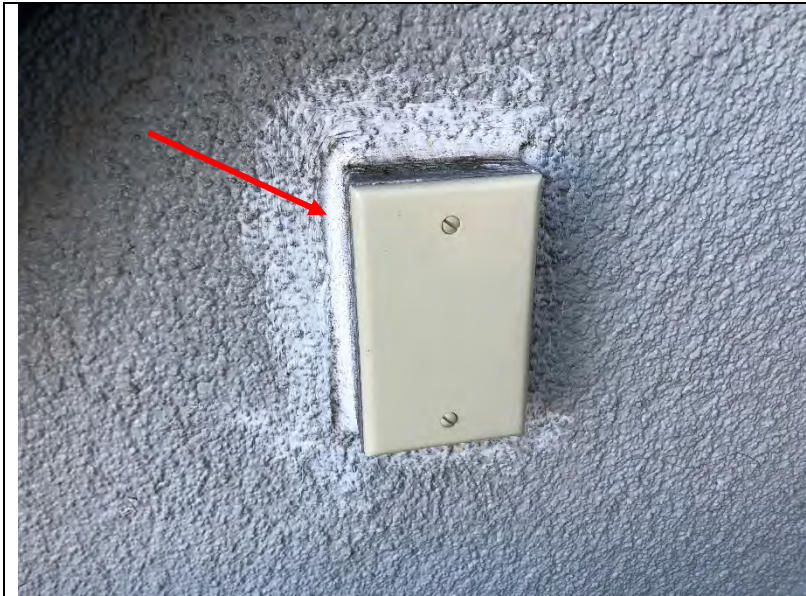
Photo 14:
A penetration in the cement plaster assembly with a new sealant application.

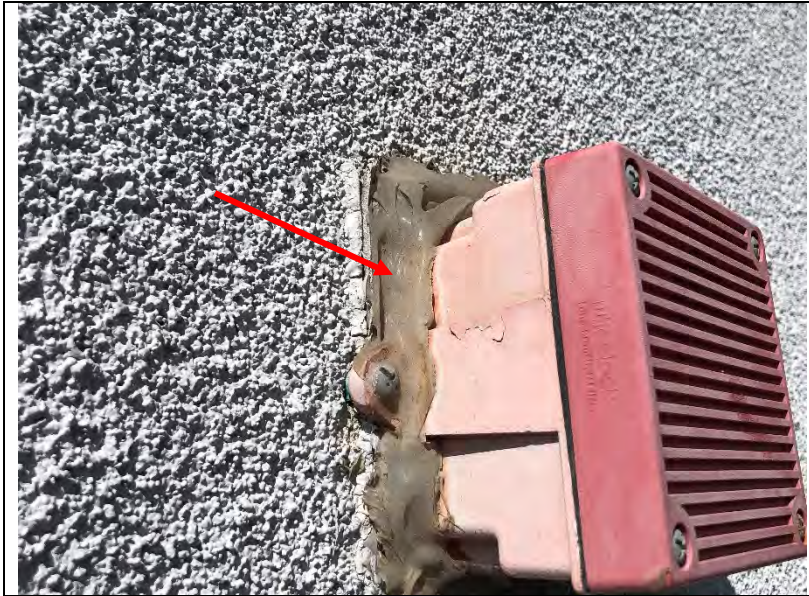
The exterior walls have numerous penetrations including electrical conduits, canopy mounting brackets, and HVAC and plumbing pipes. Many of the penetrations were not part of the original construction. In some locations (e.g. fire pull stations) sealant had been added to the perimeter of the penetrations. It is unclear if the sealant was applied due to water leaks or to aesthetically close the openings around the penetrations. In other locations, penetrations appeared to have been abandoned and not properly sealed (**Photos 06 – 15**). Some of the penetrations in the cement plaster assembly have been made for mounting items on the walls including hook and eyelet anchors, drywall fastener attachments, and coat racks attached to the walls with screws. Some of the penetrations appear to be part of the installation of new HVAC equipment and had not been connected to any equipment at the time of DTR's observations (**Photos 16 – 24**).

Photo 15:
A penetration in the cement plaster assembly with a failed sealant application.

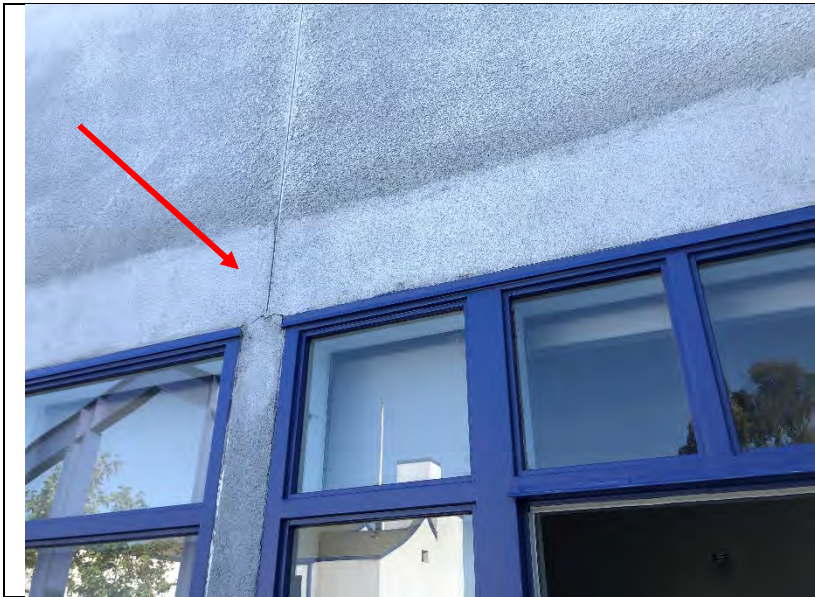
In several locations, new paint had been applied over the cement plaster. The new application of paint did not match the old finish in color or texture. It was unclear if this was done to cover previously repaired damage, to cover graffiti, or for other reasons (**Photo 32 – 36**).

Photo 34:
New paint had been applied to the cement plaster above two hollow metal frame assemblies.

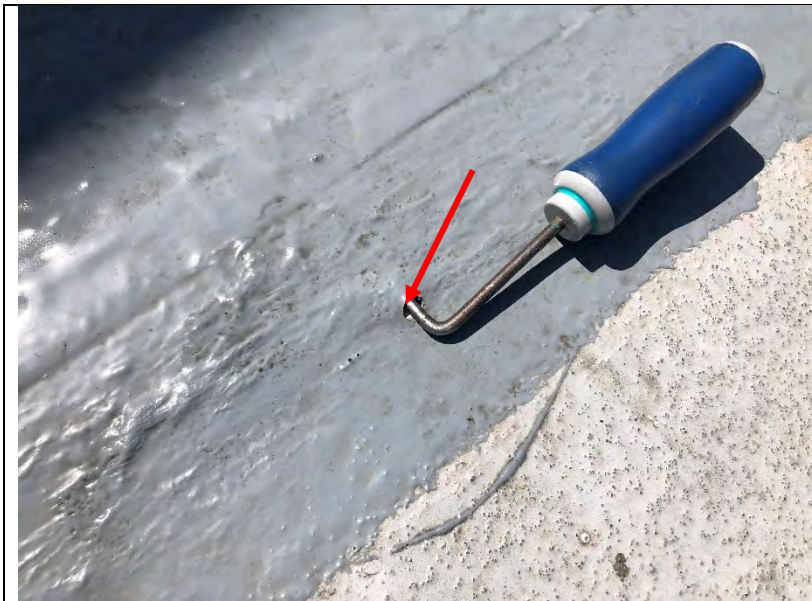
During the flood testing, one of the traffic coating patches outside classroom 555 became saturated. DTR observed that a deficient location on the surface of the patch was allowing water to enter under the waterproofing. No water was observed inside the building during the test (**Photos 63 – 64**).

Photo 64:
A failure in a traffic coating patch adjacent to a drain test.

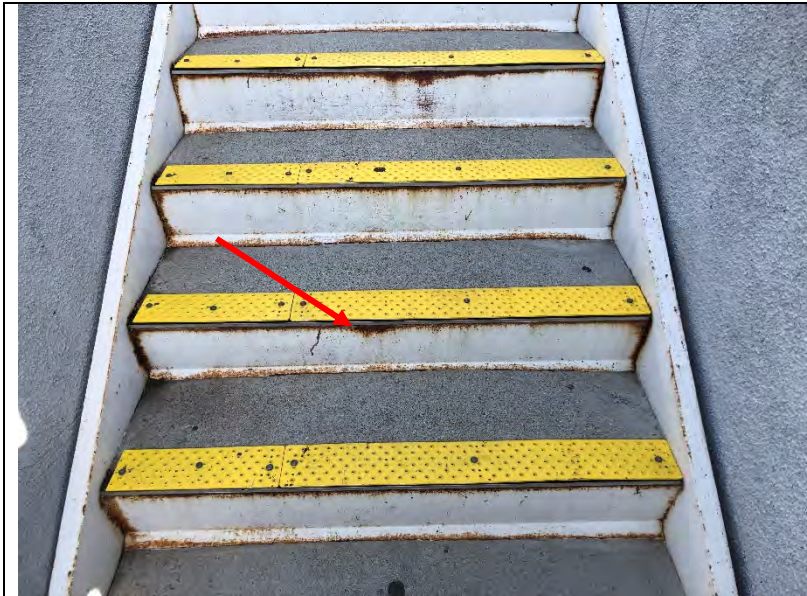
Photo 65:

and trim during the investigation. DTR did not observe any surface preparation taking place before the areas were painted. Corrosion damage was still visible in some locations after the new paint had been applied (**Photos 65 – 68**).

Corrosion was observed at the stairs prior to repainting.

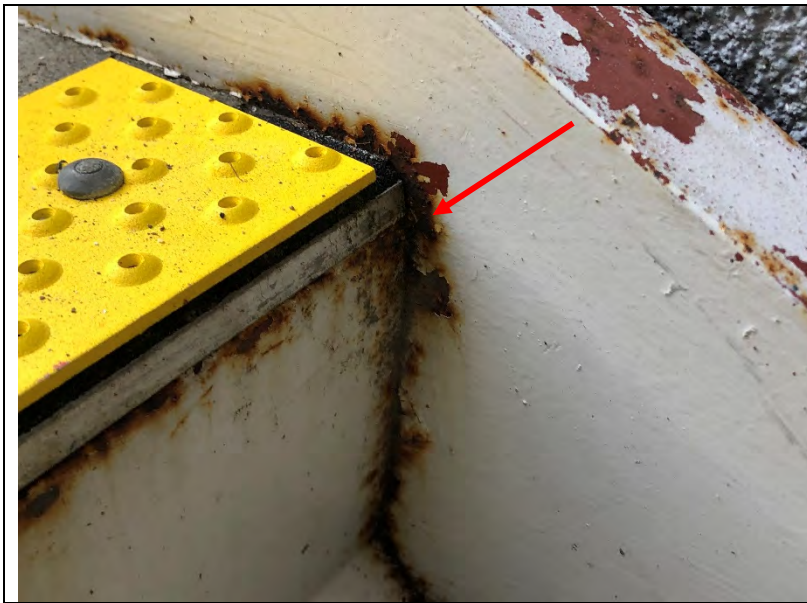
Photo 66:

Corrosion was observed at the stairs prior to repainting.

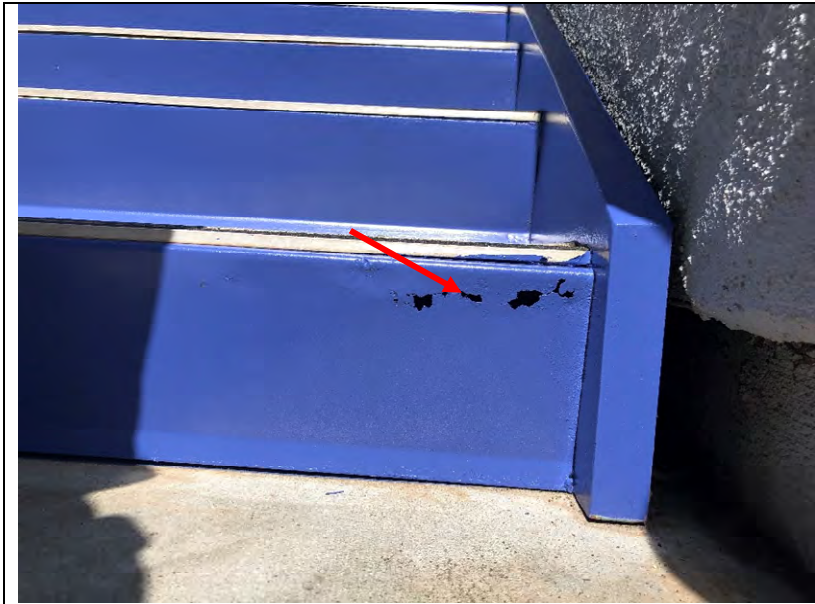
Photo 68:

Corrosion was observed on the stairs after repainting.

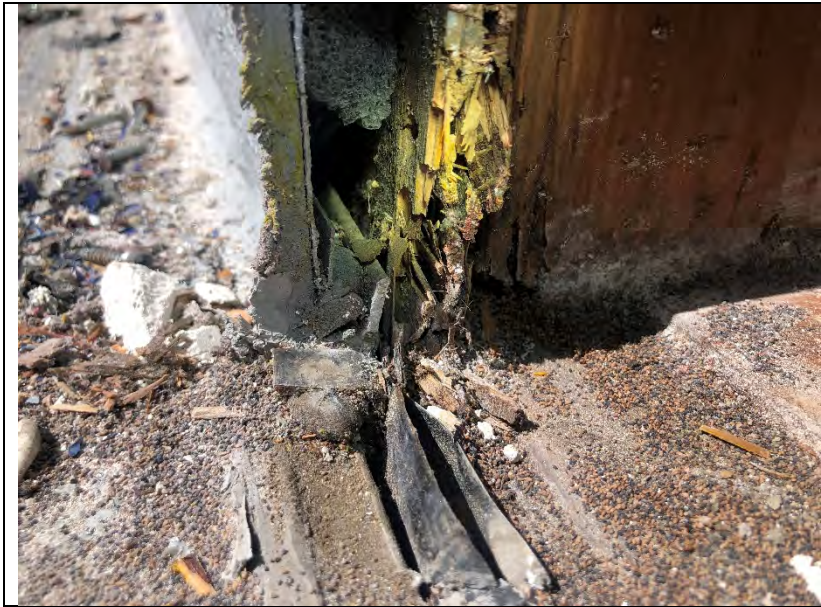
Photo 72:

Dry rot and damp wood within the wall assembly.

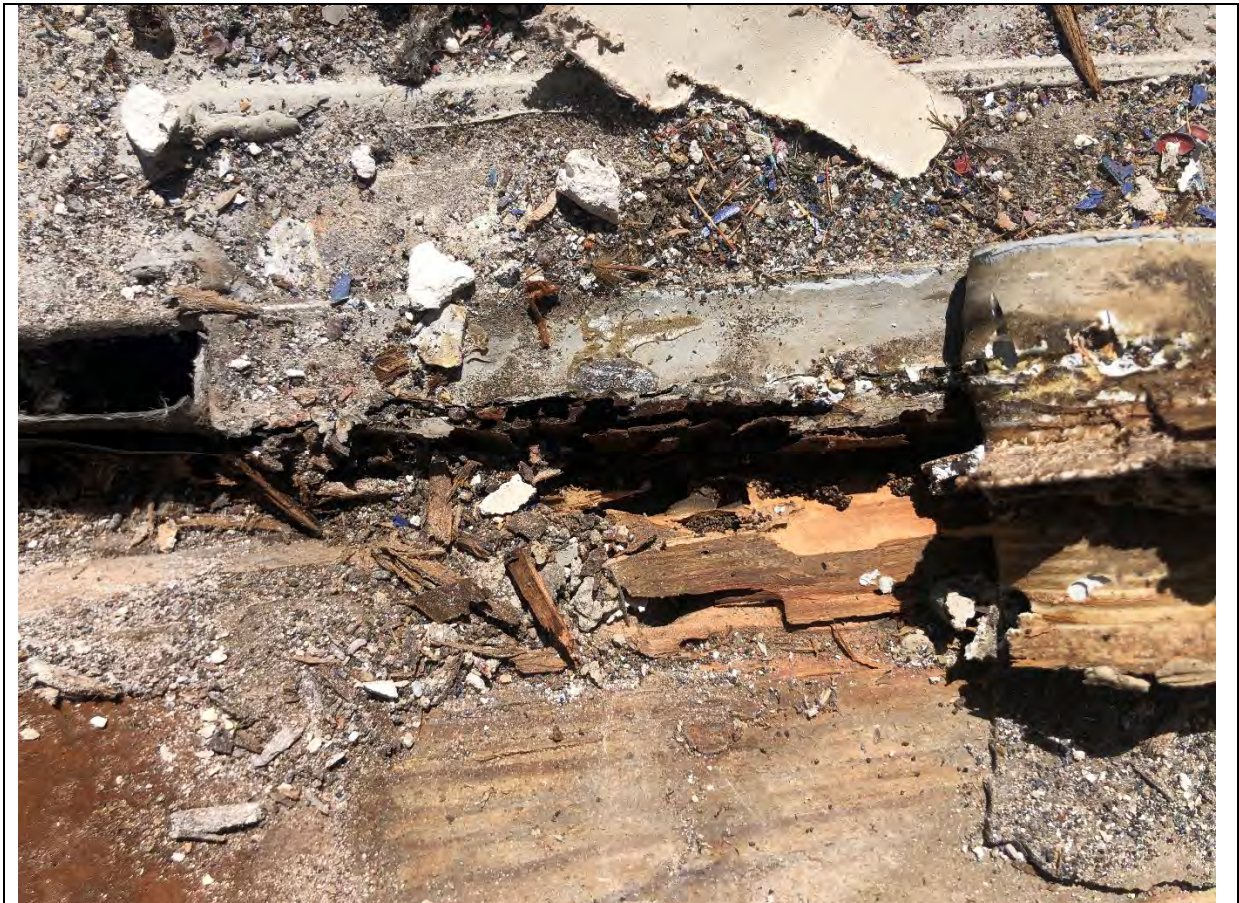
for the construction of the elevated walkways (**Photos 69 – 72 and Fig 02**). The exposed edge of the exterior plywood wall sheathing was damp to the touch. Moisture readings along the wood door sill framing ranged from 20.1 to 30.6 % moisture. These readings are high enough to result in wood damage. Dry rot and what appeared to be insect damage were also observed along the sill. Water damage was also observed at the upturn of the jambs (**Photos 73 - 79**).

Photo 73:
Dry rot, water damage, and suspected insect damage at the threshold of classroom 480

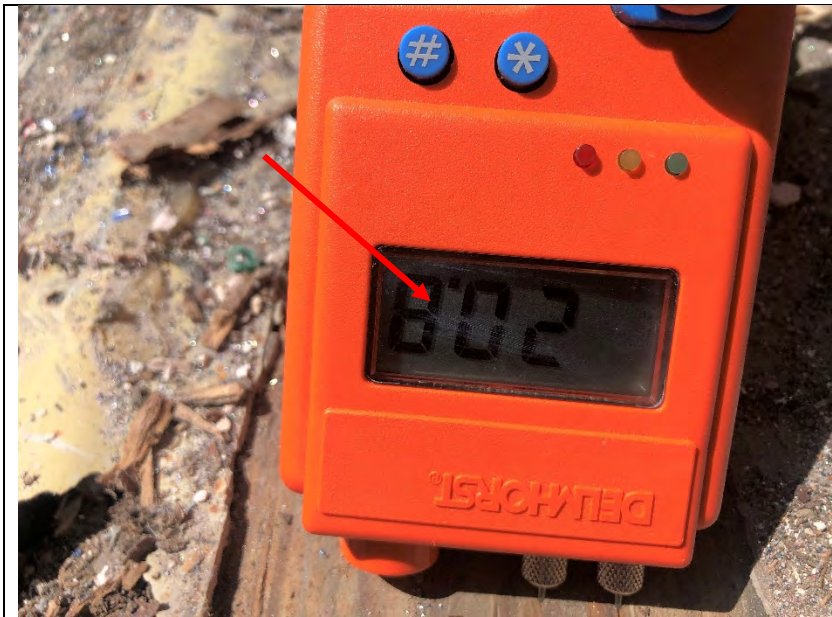
Photo 76:

Moisture reading of the wood at the threshold.

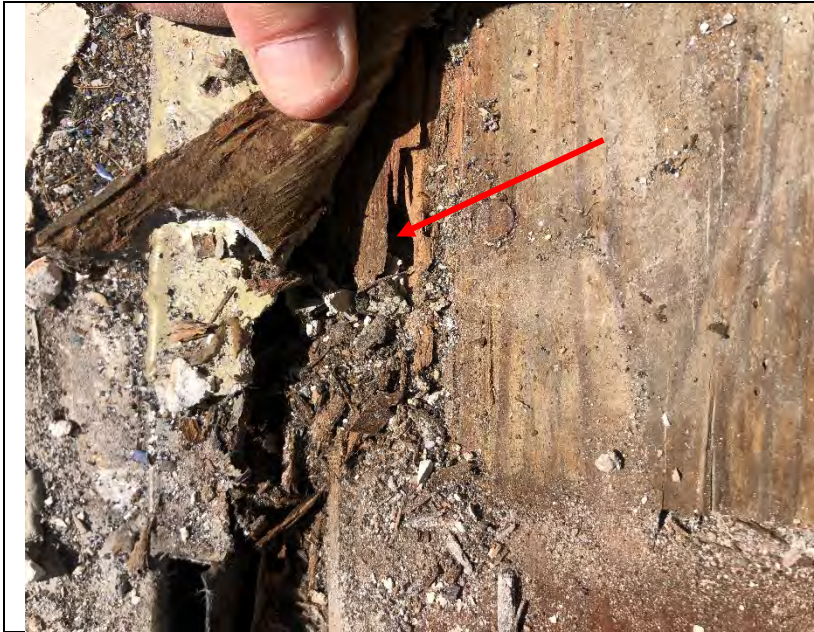
Photo 79:
Dry rot, water damage, and suspected insect damage at the threshold of classroom 480

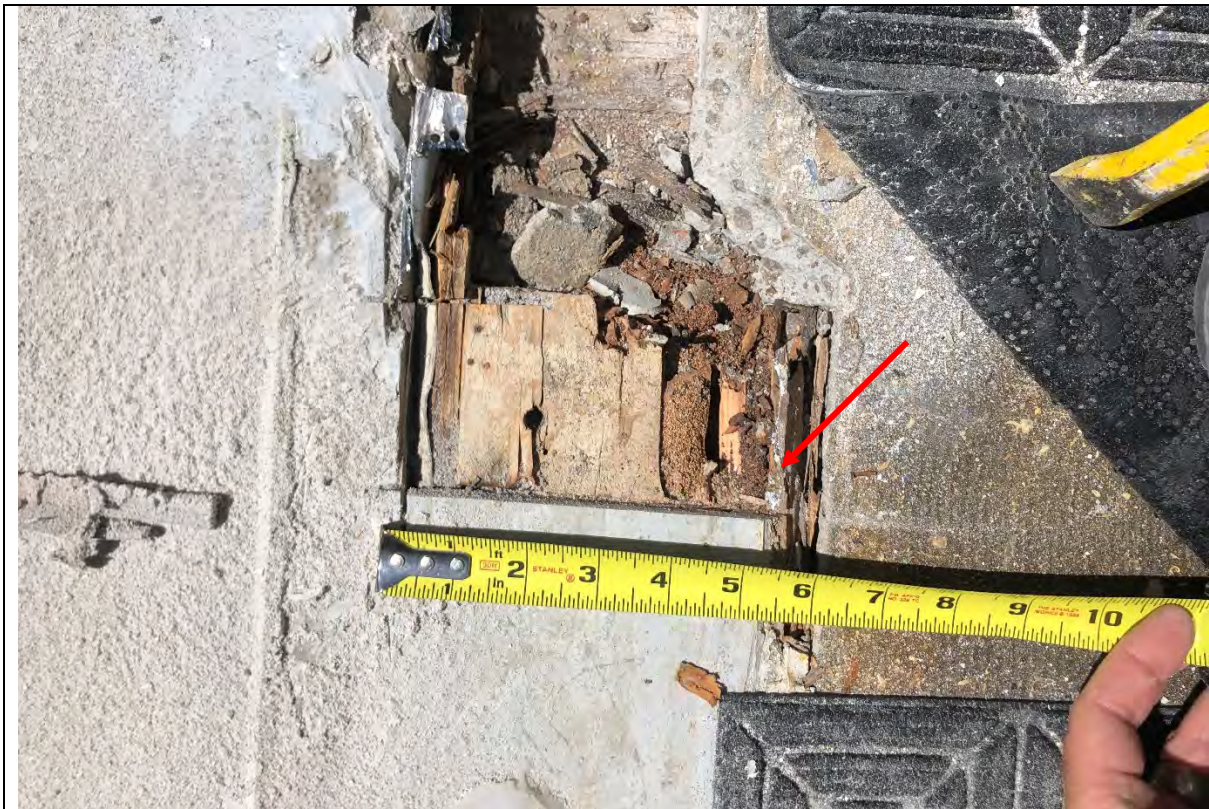
Photo 87:
Water damage at the jamb to sill juncture at the threshold. DTR requested that this area be cut and opened for further visual observation.

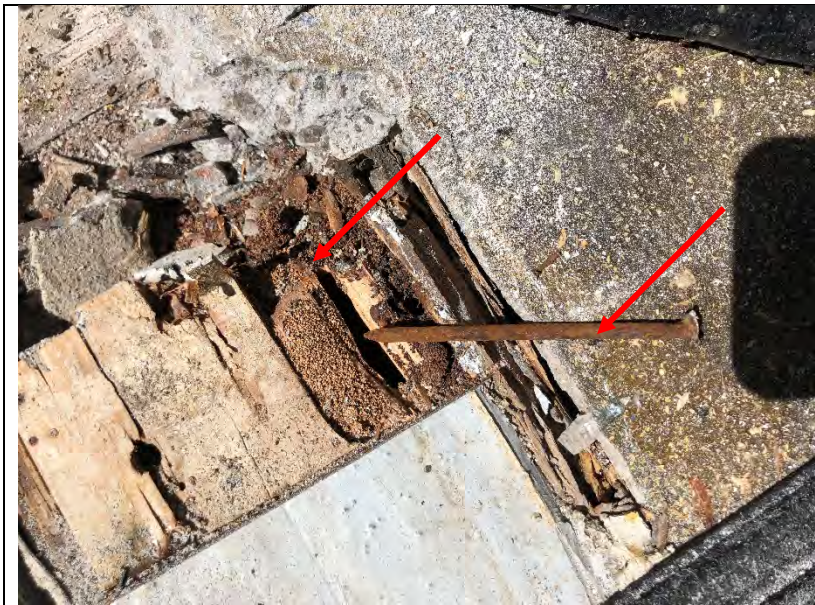
At the other three locations where hollow metal frames were removed, the transition of the deck to the walls did not incorporate an expansion joint. Similar water damage was observed at each threshold. In some locations, such as Classroom 455 and Workroom 252, damage at the transition from the sill to jamb was significant, suggesting that water was moving down between the rough opening and the jambs of the hollow metal frames and collecting on the sill at those corner locations. The exposed edge of the exterior plywood wall sheathing was damp to the touch. Dry rot and what appeared to be insect damage were also observed along the sill. Corrosion was visible at fasteners at the sills and jambs of each door (**Photos 80 – 88**).

Photo 88:
Dry rot, water damage, corroded fasteners, and suspected insect damage at the threshold

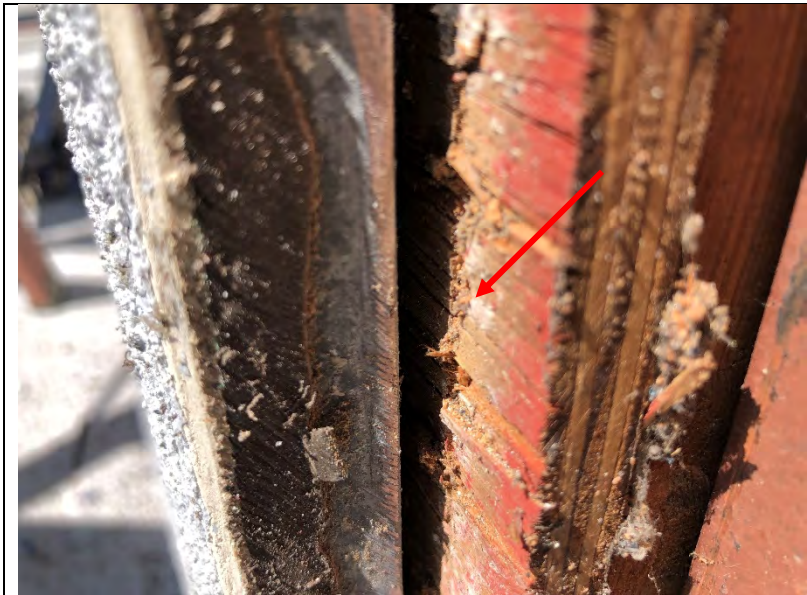
Photo 90:
Delamination of the exterior plywood sheathing was observed after the hollow metal frames were removed.

No flashing, waterproofing, or weather resistive barrier were observed at this location.

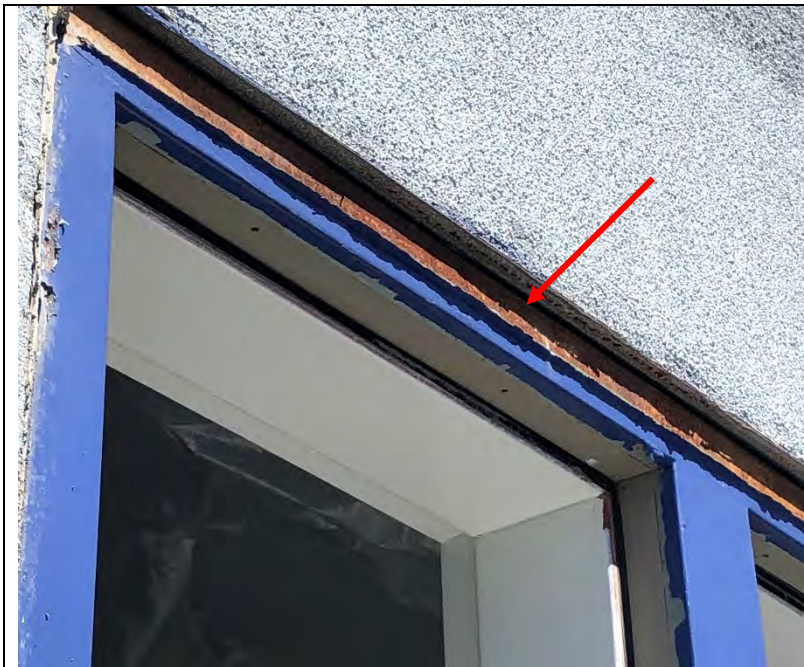
DTR observed that some of the hollow metal-framed doors had head flashing such as Technical Room 570, while others did not such as Classroom 480. When the head flashing above the door was removed at Technical Room 570, corrosion was observed along the head of the hollow metal frame. No weep screed was observed in the plaster stop at that location (**Photos 95 – 96**).

Photo 95:
Corrosion was observed behind a head flashing at one of the hollow-metal framed doors indicating moisture behind the flashing.

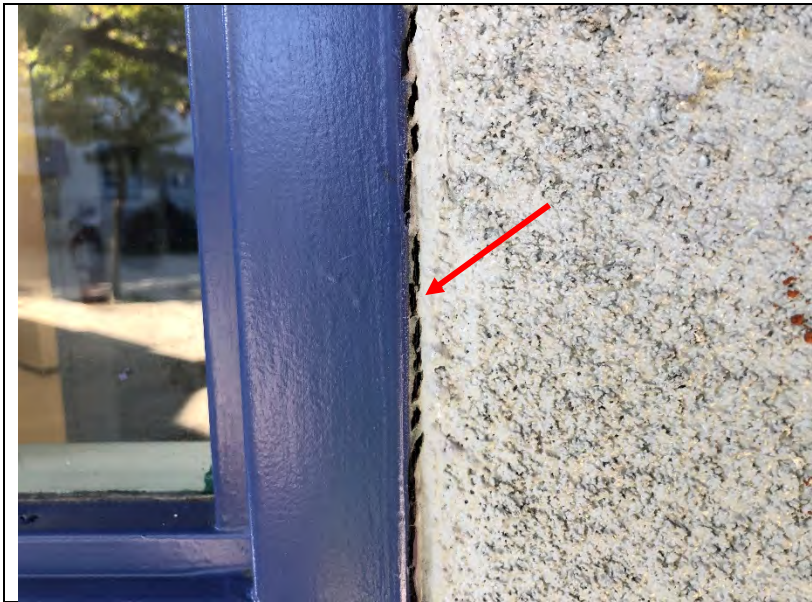
Photo 105:
A sealant failure at the perimeter of a hollow metal frame.

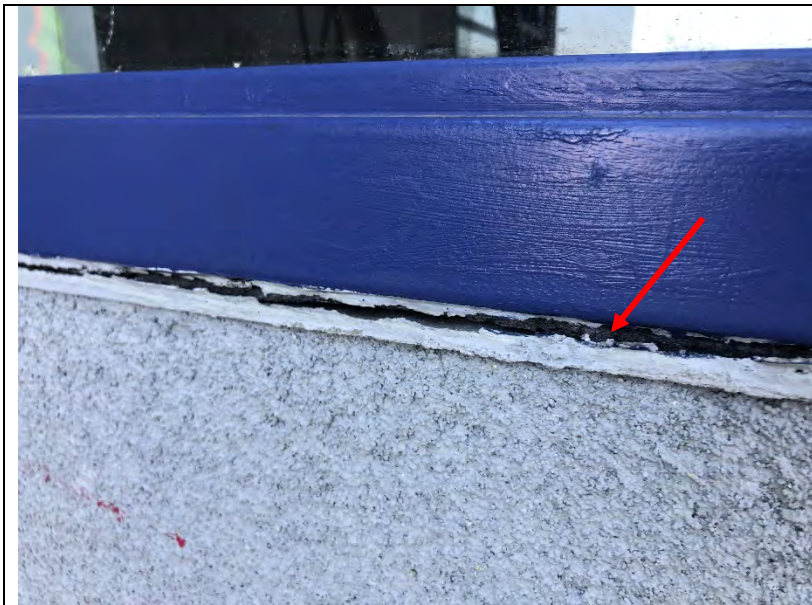
Photo 106:
A sealant failure at the perimeter of a hollow metal frame.

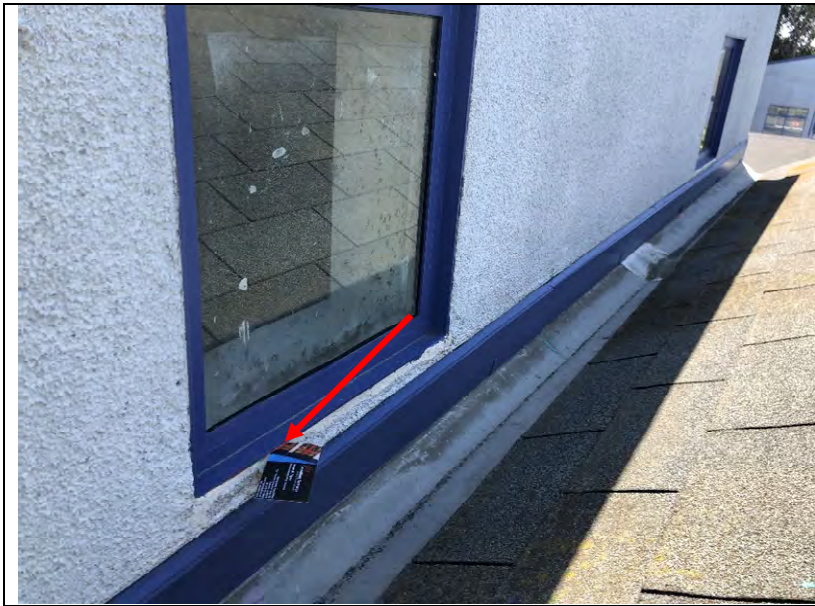
Photo 109:
A sealant failure at the perimeter of an aluminum-framed window at roof level.

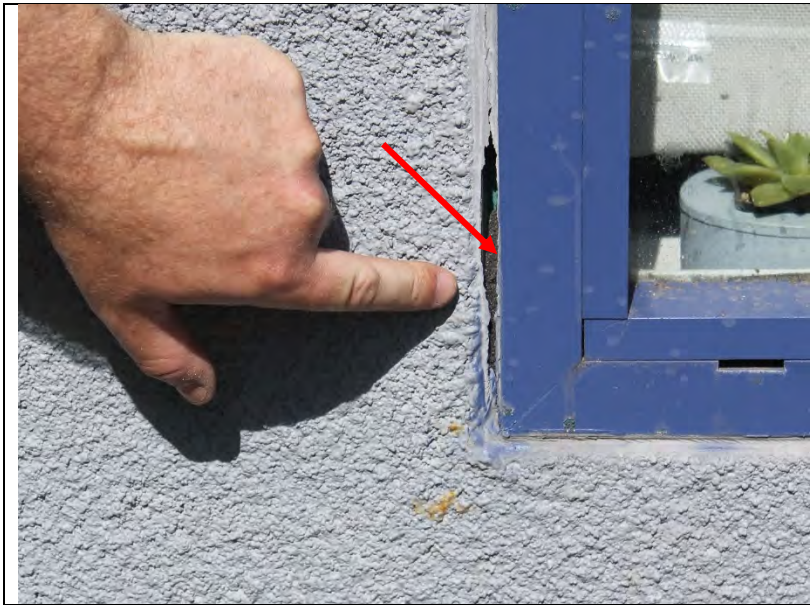
Photo 110:
A sealant failure at the perimeter of an aluminum-framed window.

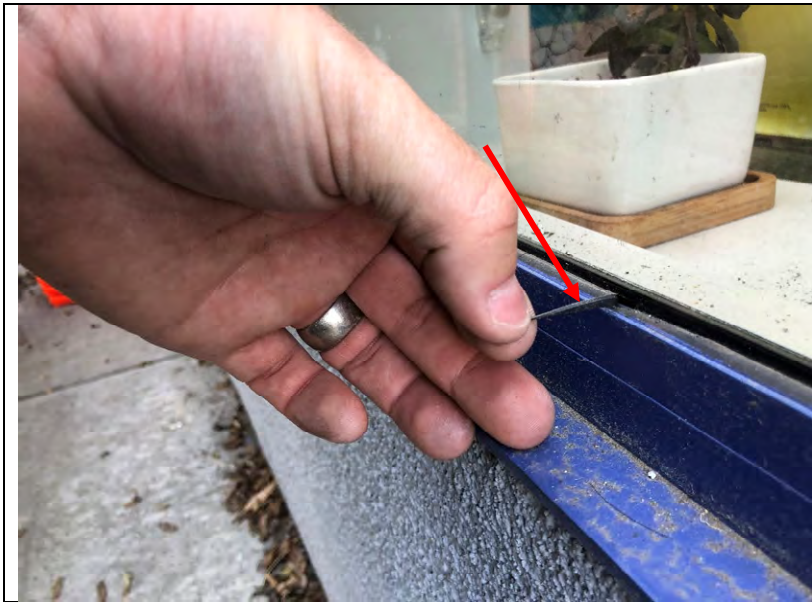
Photo 113:

A glazing gasket failure at the perimeter of the glazing at an aluminum-framed window.

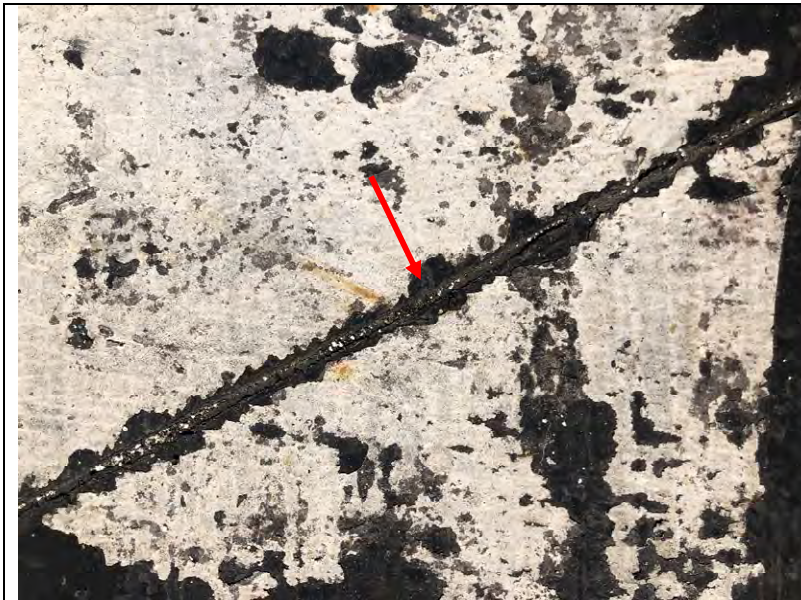
Photo 130:
A cut mark in the BUR roof over the multipurpose room.

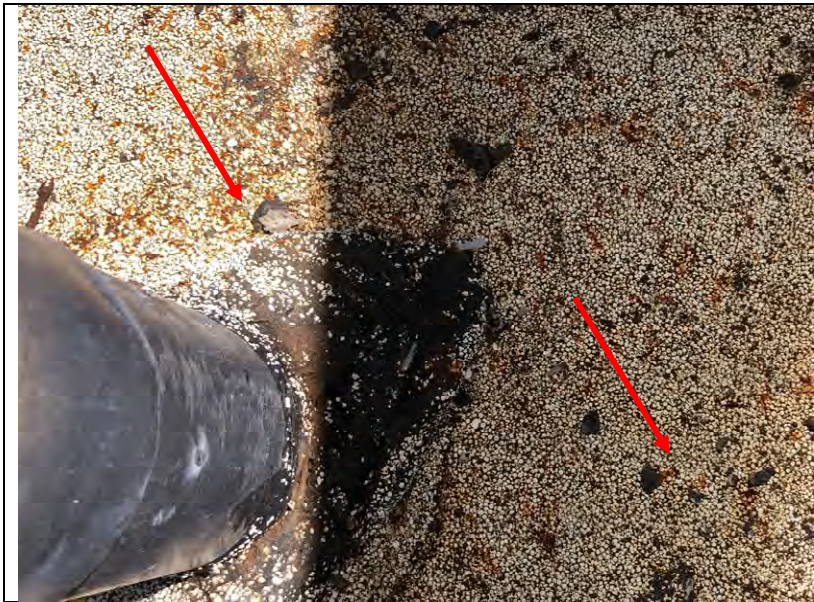
Photo 137:

Open seams were observed in the newly installed granulated cap sheet at the mechanical curbs. Spent tig welding rods were scattered around the roof as well as slag from the welding process. In some locations, small burn marks were also observed on the membrane. DTR suspects that these burn marks were caused by welding over the unprotected roof membrane by the HVAC installers (**Photos 135 – 137**).

Pock-marks and welding damage on the newly installed granulated cap sheet on the roof of the multipurpose room.

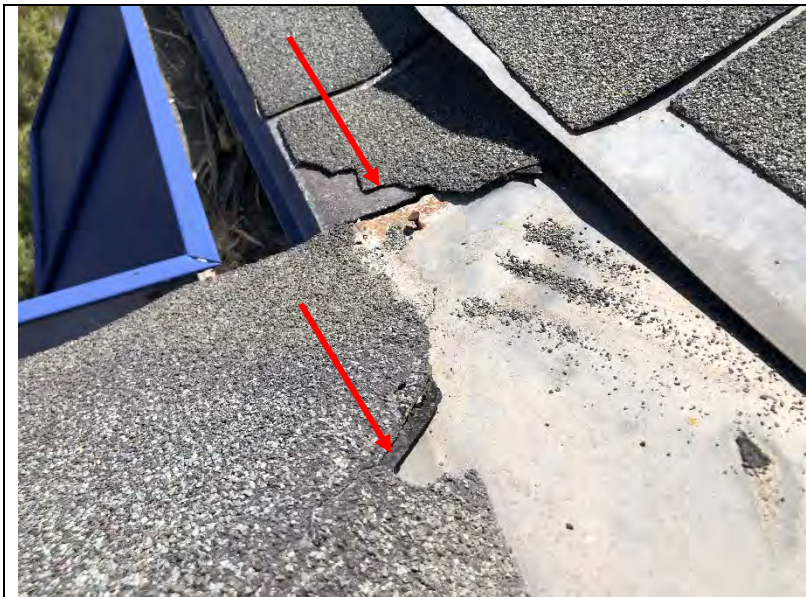
Photo 159:

Shingle tabs were observed on the roof deck, damages on the roof, or were missing altogether.

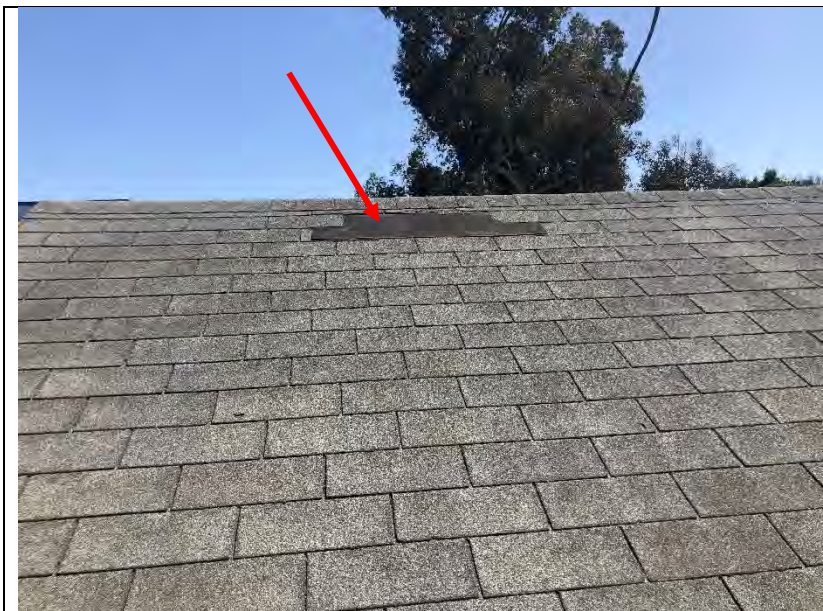
Photo 160:

Shingle tabs were observed on the roof deck, damages on the roof, or were missing altogether.

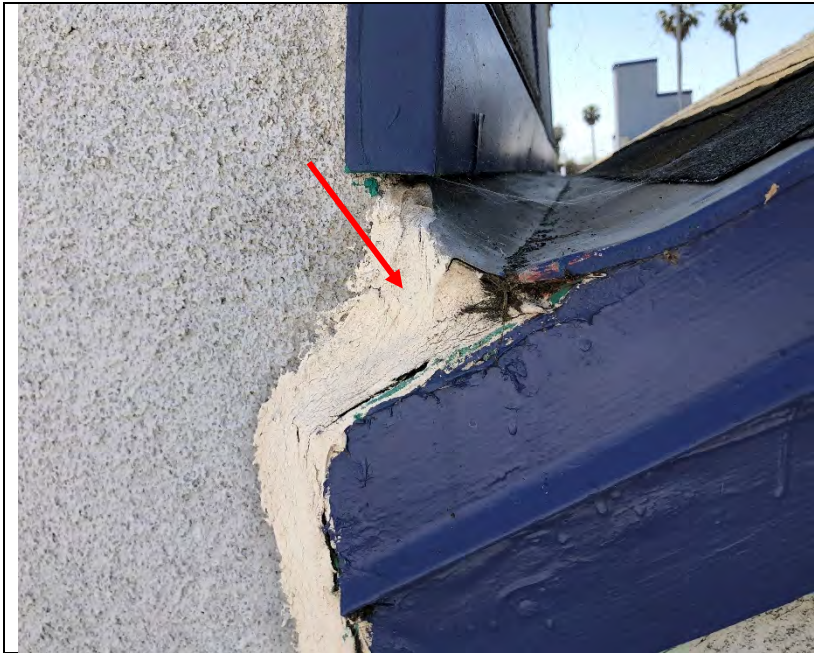
Sealant was observed at the ends of the sheet metal valley, at the downturn onto the wall. The sealant was cracked and openings were visible. This condition was systemic in many of the sawtooth valleys (**Photos 168 – 169**).

Photo 168:
Sealant was observed at the ends of the sheet metal valley

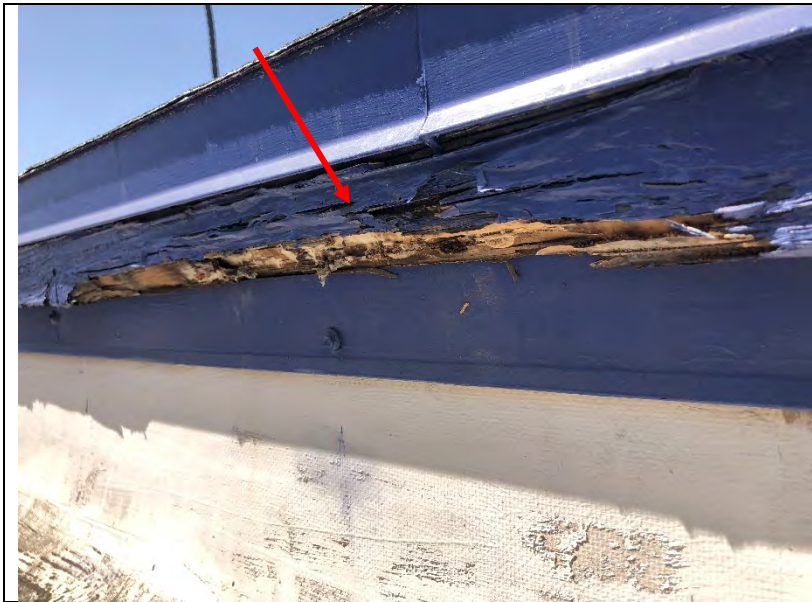
Photo 173:

Over the entire length of the wood trim of the sloped roofs, what appeared to be dry rot and insect damage was visible. In one location, approximately twelve (12) inches of trim had broken off the building. In some locations, it appeared that previously damaged areas had been painted over. Similar dry rot and suspected insect damage were observed at the edge-of-roof trim at the bathrooms near the outdoor lunch area. The trim was close to the awning structure and this damage was only visible from directly under the trim. These bathrooms were also reported by Little to have had mold remediation (**Photos 173 – 178**).

Dry rot and suspected insect damage at the wooden roof trim.

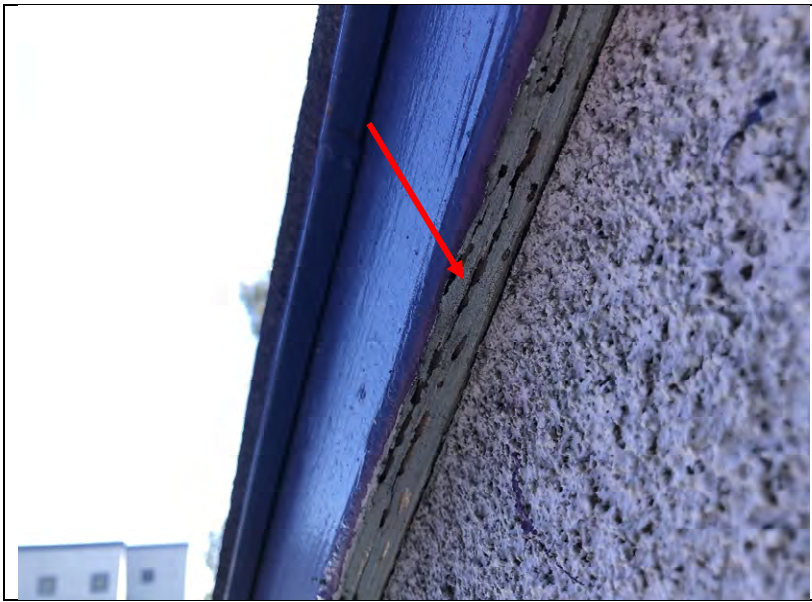
Photo 174:

Dry rot and suspected insect damage at the wooden roof trim.

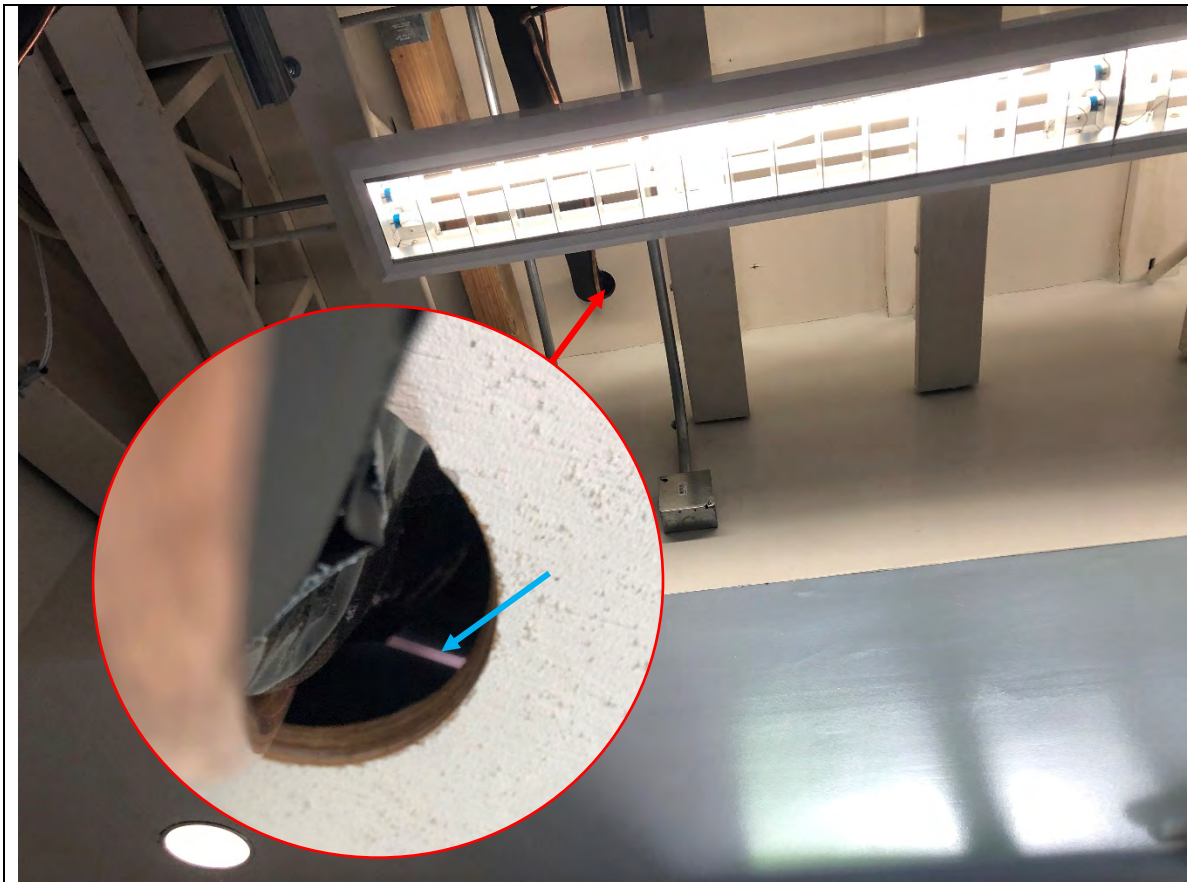
Photo 182:
Exterior light was visible through the wall system over the east entrance to the library. The location is a reported leak site.

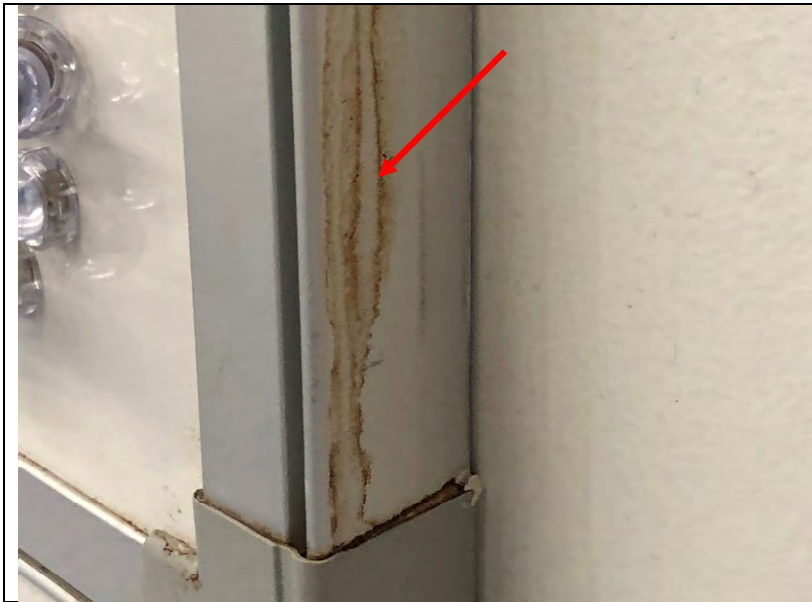
Photo 189:

Water stains on the whiteboard in classroom 415.

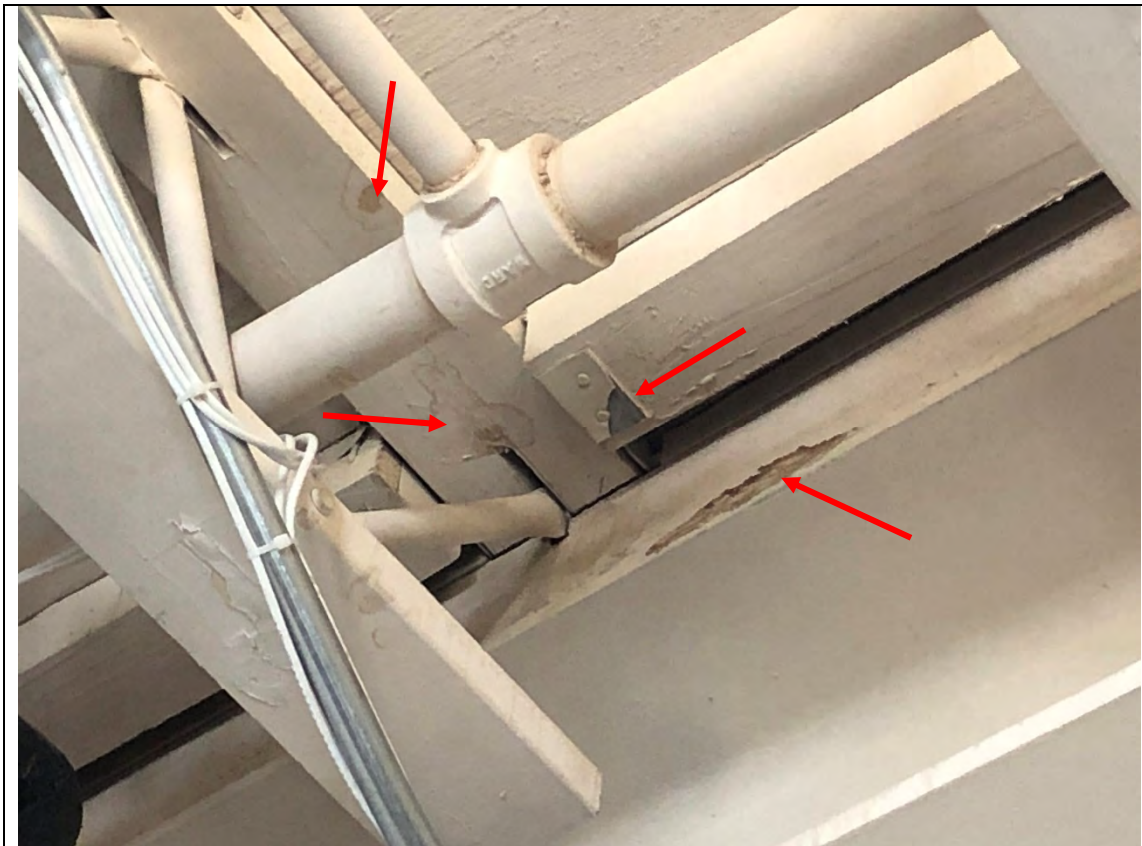
Photo 195:
Water stains and failing paint on the ceiling in the multipurpose room.

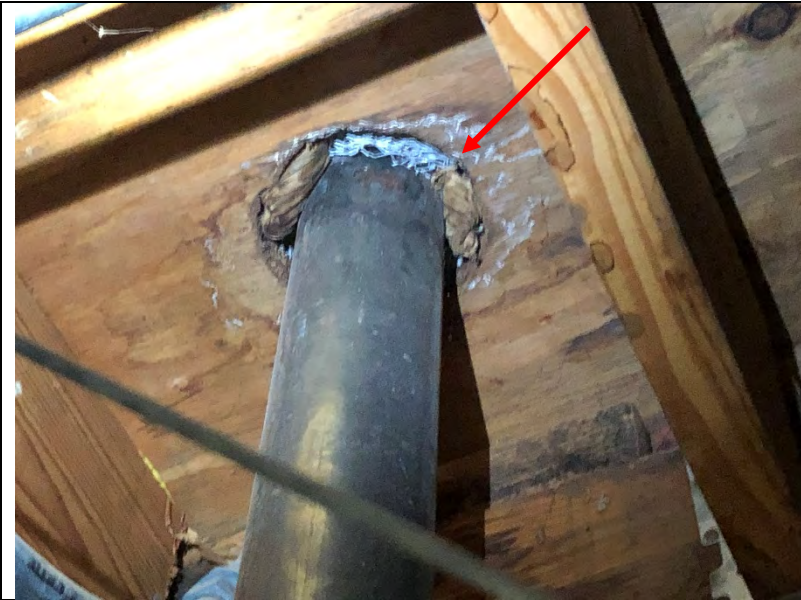
Photo 203:

Water damage and possible biological growth above the ceiling tiles in room 205 Teacher's Prep.

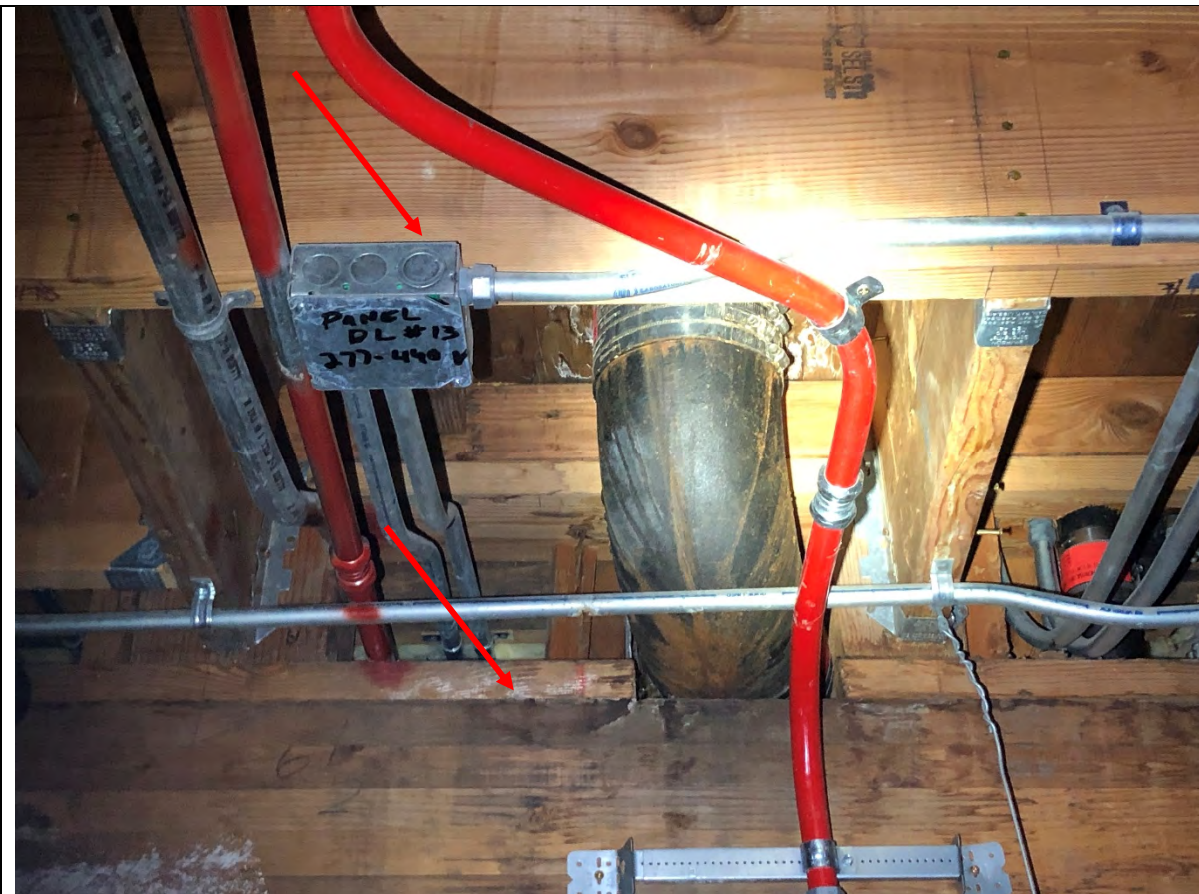
Photo 204:

Water damage and possible biological growth above the ceiling tiles in room 205 Teacher's Prep.

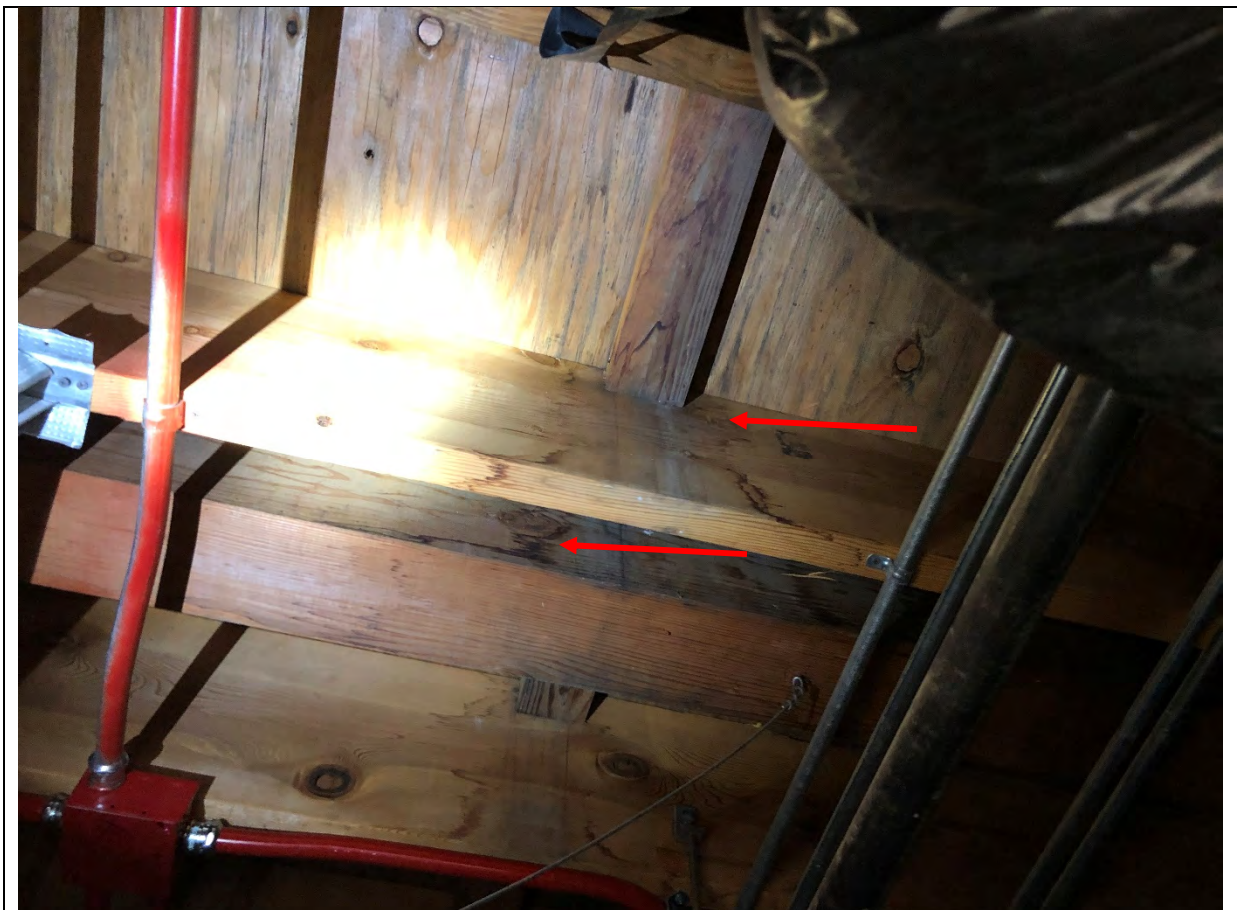
Photo 205:
Water damage and staining above the ceiling tiles in room 205 Teacher's Prep.

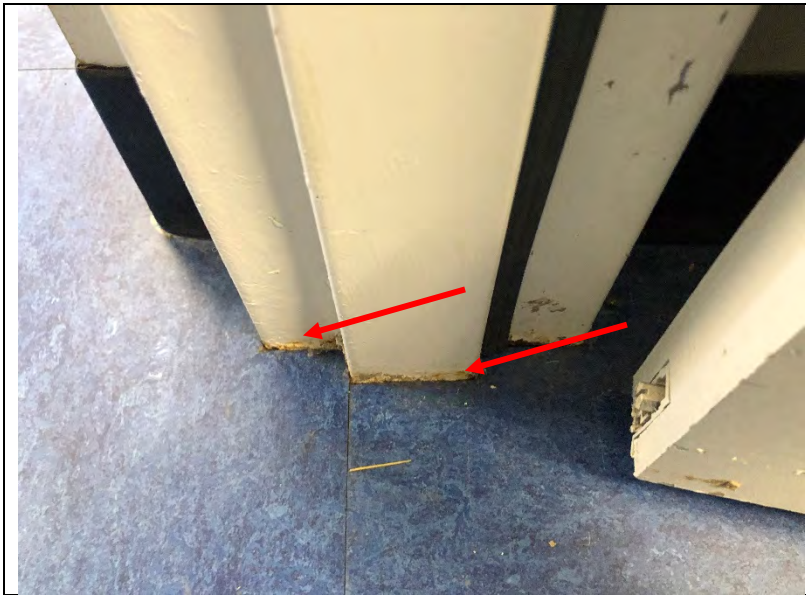
Photo 209:

Corrosion at the bottom of the door jamb at Room 403 Teachers' Prep.
