**Santa Monica-Malibu
Unified School District**
John Muir - SMASH Elementary School

Findings Report
Building Envelope Investigation

April 05 – 06, 2022

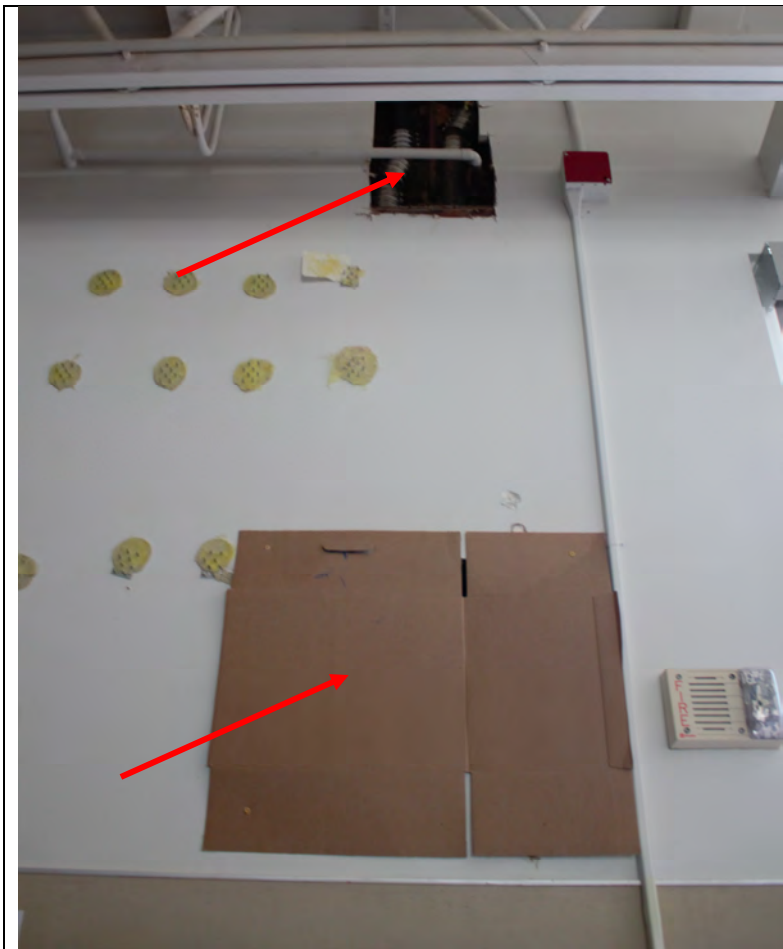
Photo 212:

Interior finishes had been removed at two classrooms in building D prior to the DTR site assessment, in an effort to address a leak at this location.

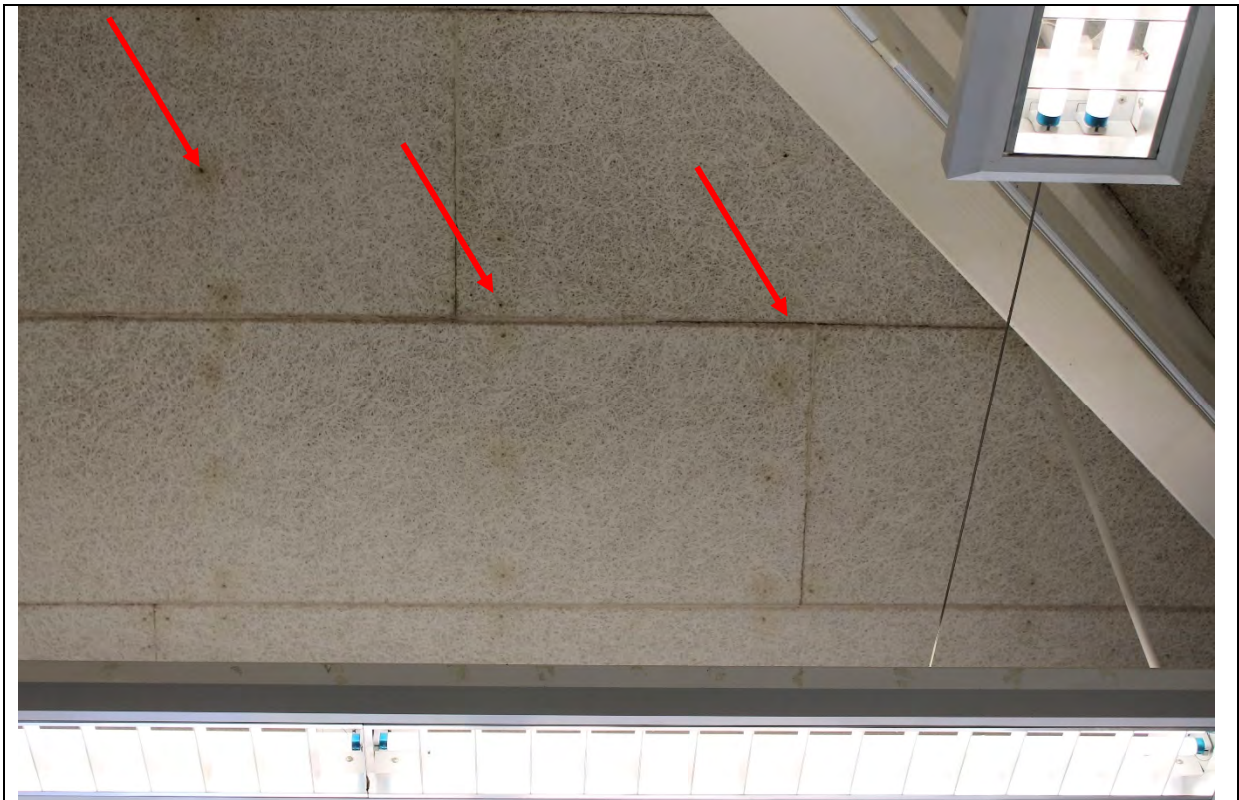
Photo 219:
Water marks and staining at the acoustical panels on the ceiling of the classrooms in building D.
