**EXTERIOR LEAD-BASED
PAINT SURVEY PROJECT RECORD**

**Point Dume Elementary School
6955 Fernhill Drive
Malibu, California 90265**

January 10, 2007
CTL Project No. 106-0531

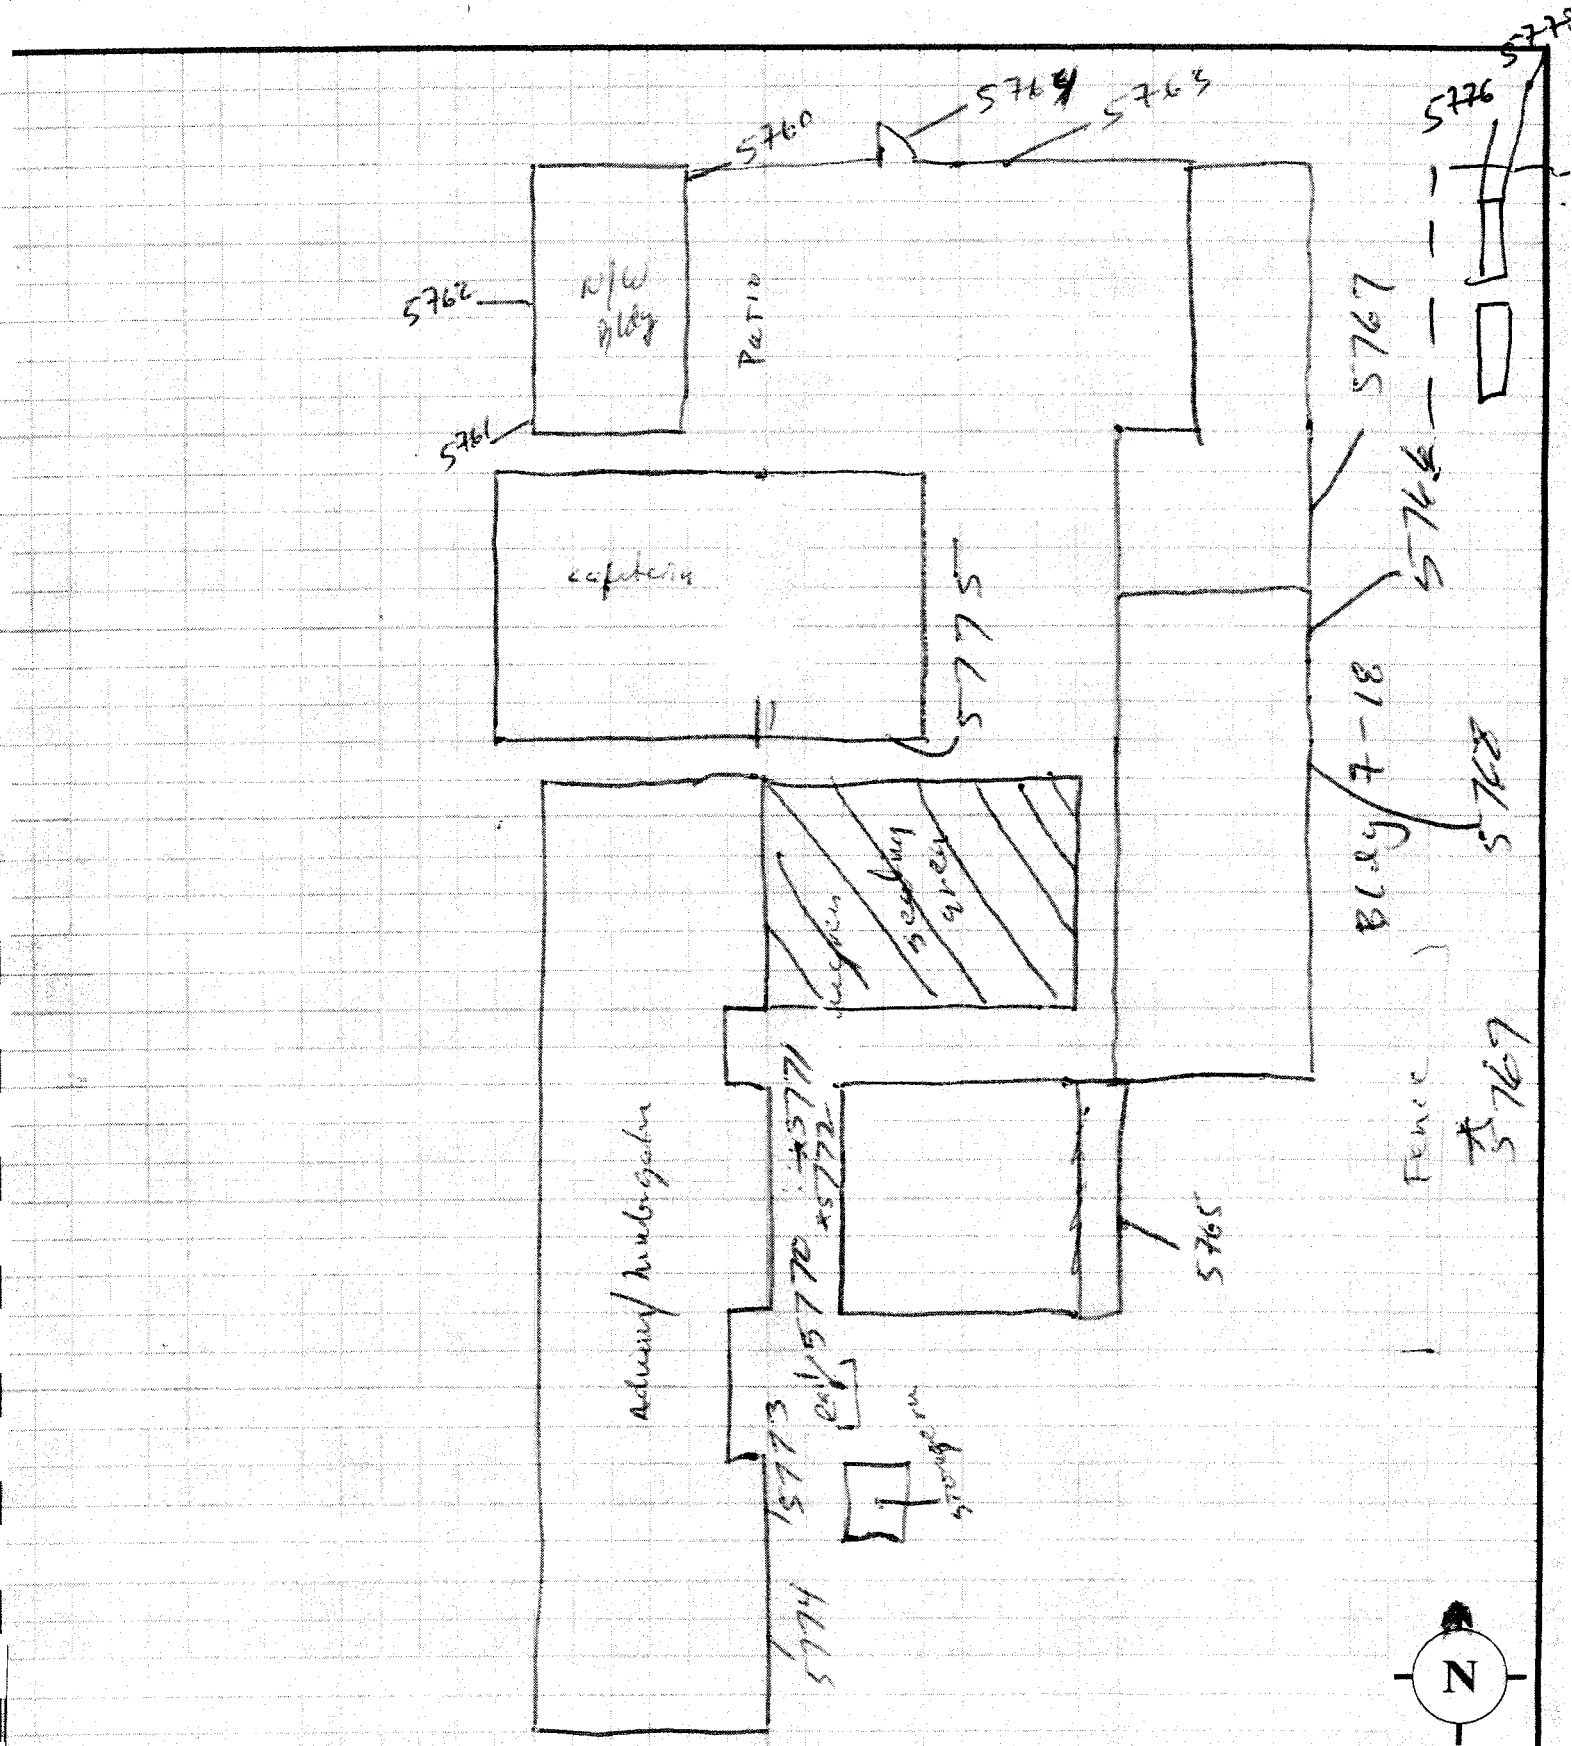
SAMPLE LOCATION MAP

Lead Point Chips location
