Native Tree Protection Plan

For: Point Dume Marine Science School - Malibu Schools Alignment Project

Prepared by: **Greg Applegate, RCA #365
Arborgate Consulting, Inc.
1131 Lucinda Way
Tustin, CA 92780
714/ 731-6240**

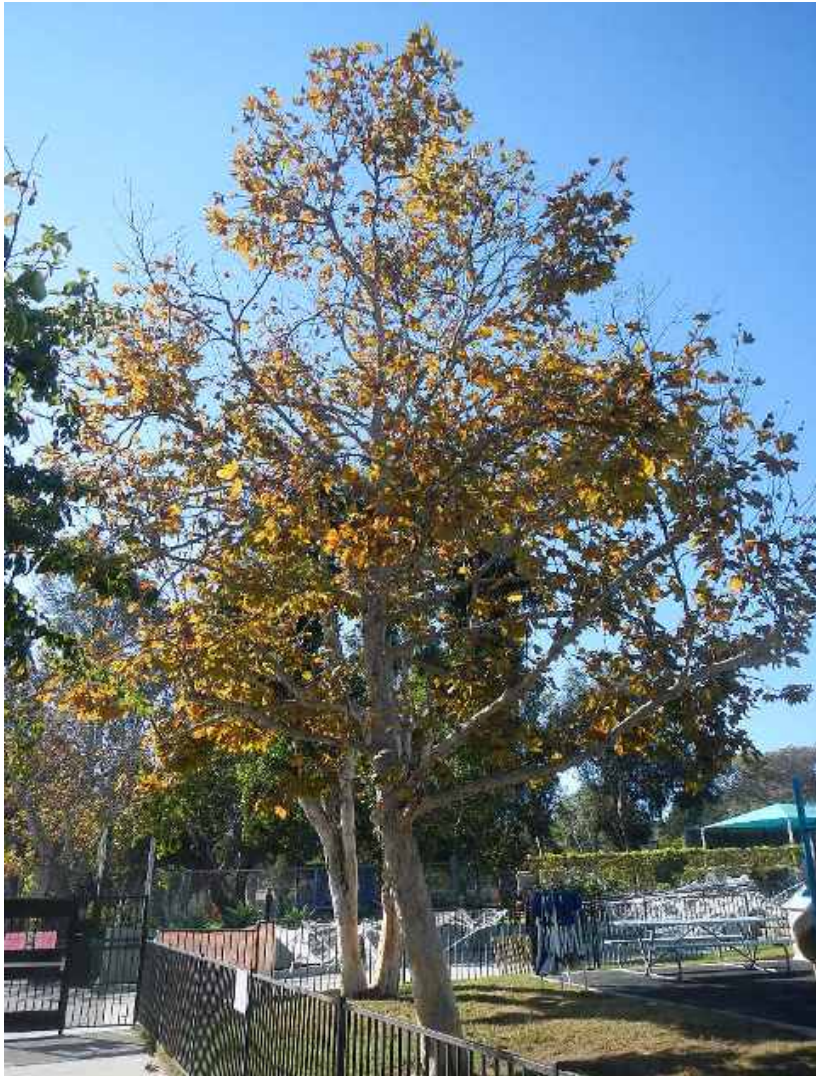
#2 Sycamore

Tree #2 is completely inside the little playground. It may have some minor impacts due to trenching along the sidewalk in front of it, but there is no work in its immediate vicinity. The existing fence will keep people away from it during construction.

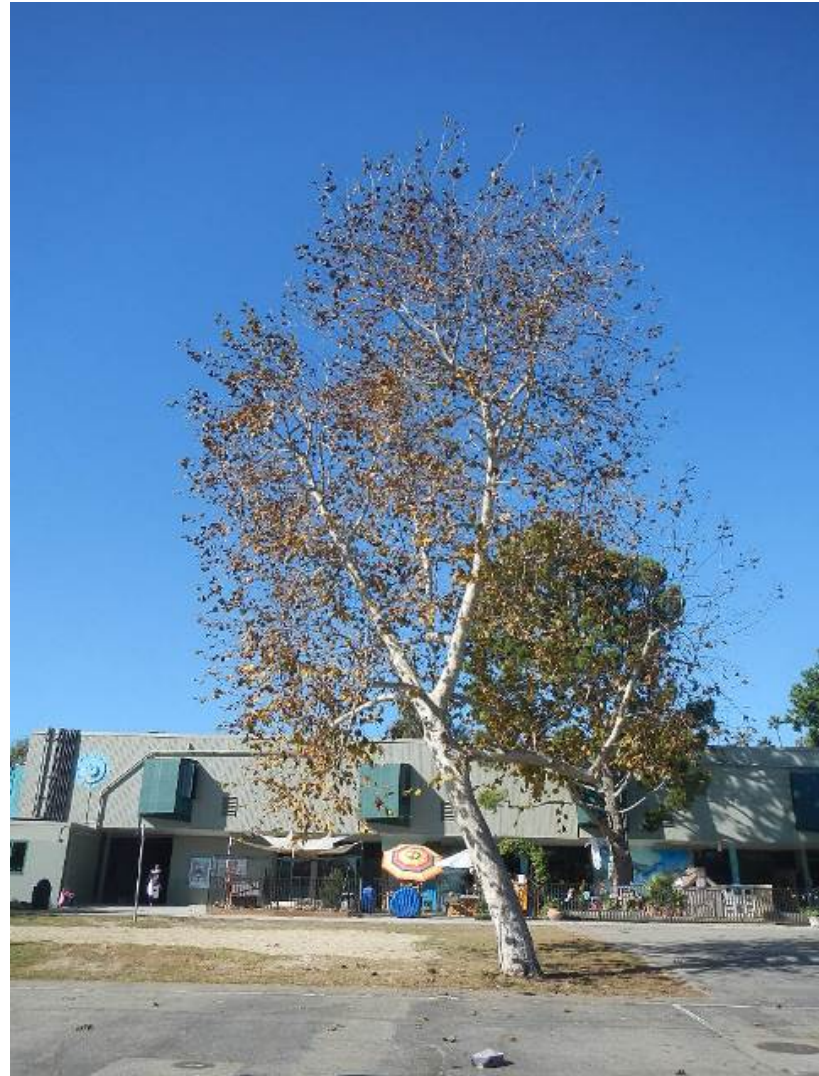
#11 Sycamore – note codominant limbs and leaning trunk.

Tree #11 is in the middle of everything and is trampled often, and may be by heavy equipment, if not protected. Tree #24 is unavoidably in the way. Tree #26 would be walked around often, and will need protection from some equipment coming and going near it.

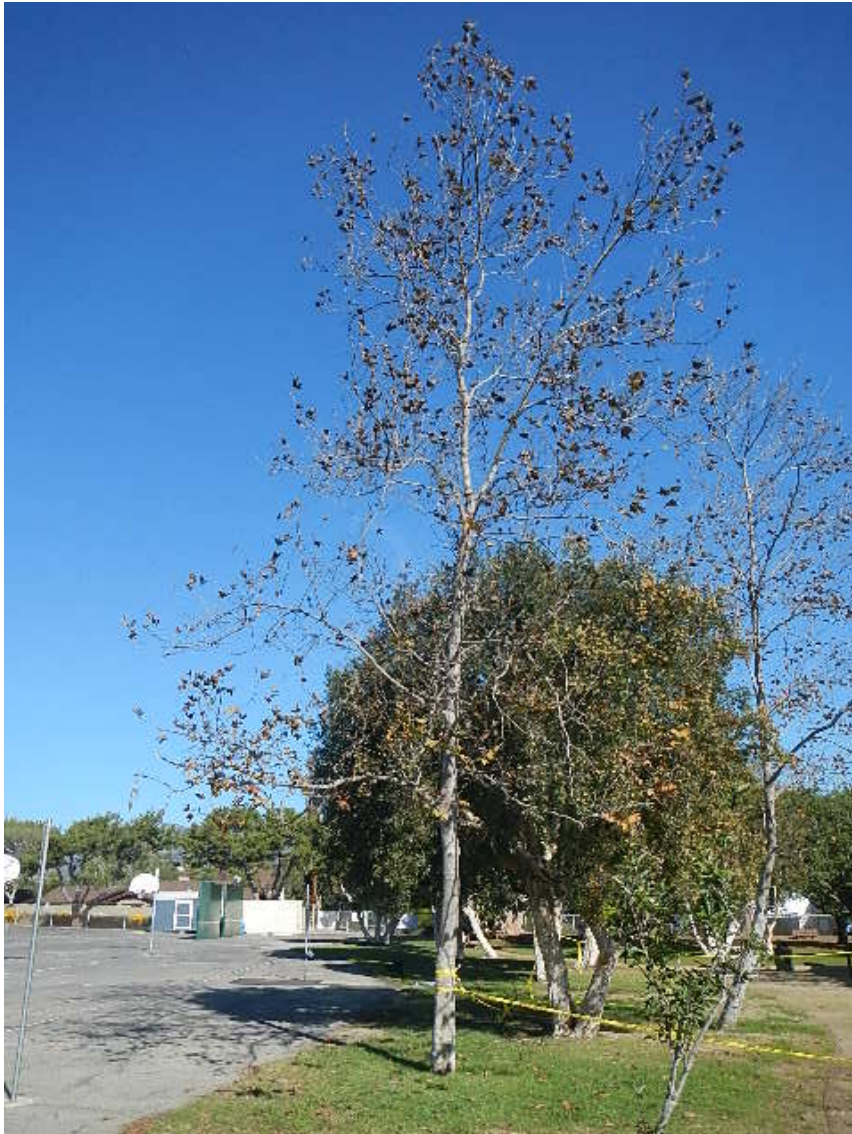
California sycamore #24 (left)

Despite this, the work area could not be shifted enough to entirely miss Tree #24. This sycamore is less than 7.5' from one of the portable buildings and the base of the tree would be buried in several feet of gravel and soil. It would not survive these changes to its environment.

The one California sycamore that is close to planned construction (#24) could remain in place if seven and a half feet of secure protection could be provided, but that is not possible. Other than transplanting, there are no alternative arrangements or siting alternatives that would allow tree #24 to remain. However, it is too late in the season to transplant this tree.

It is the District's intention to pay an in-lieu fee to the Native Tree Impact Mitigation Fund, in care of the Santa Monica Mountains Conservancy, in compensation for the District's loss of tree #24.

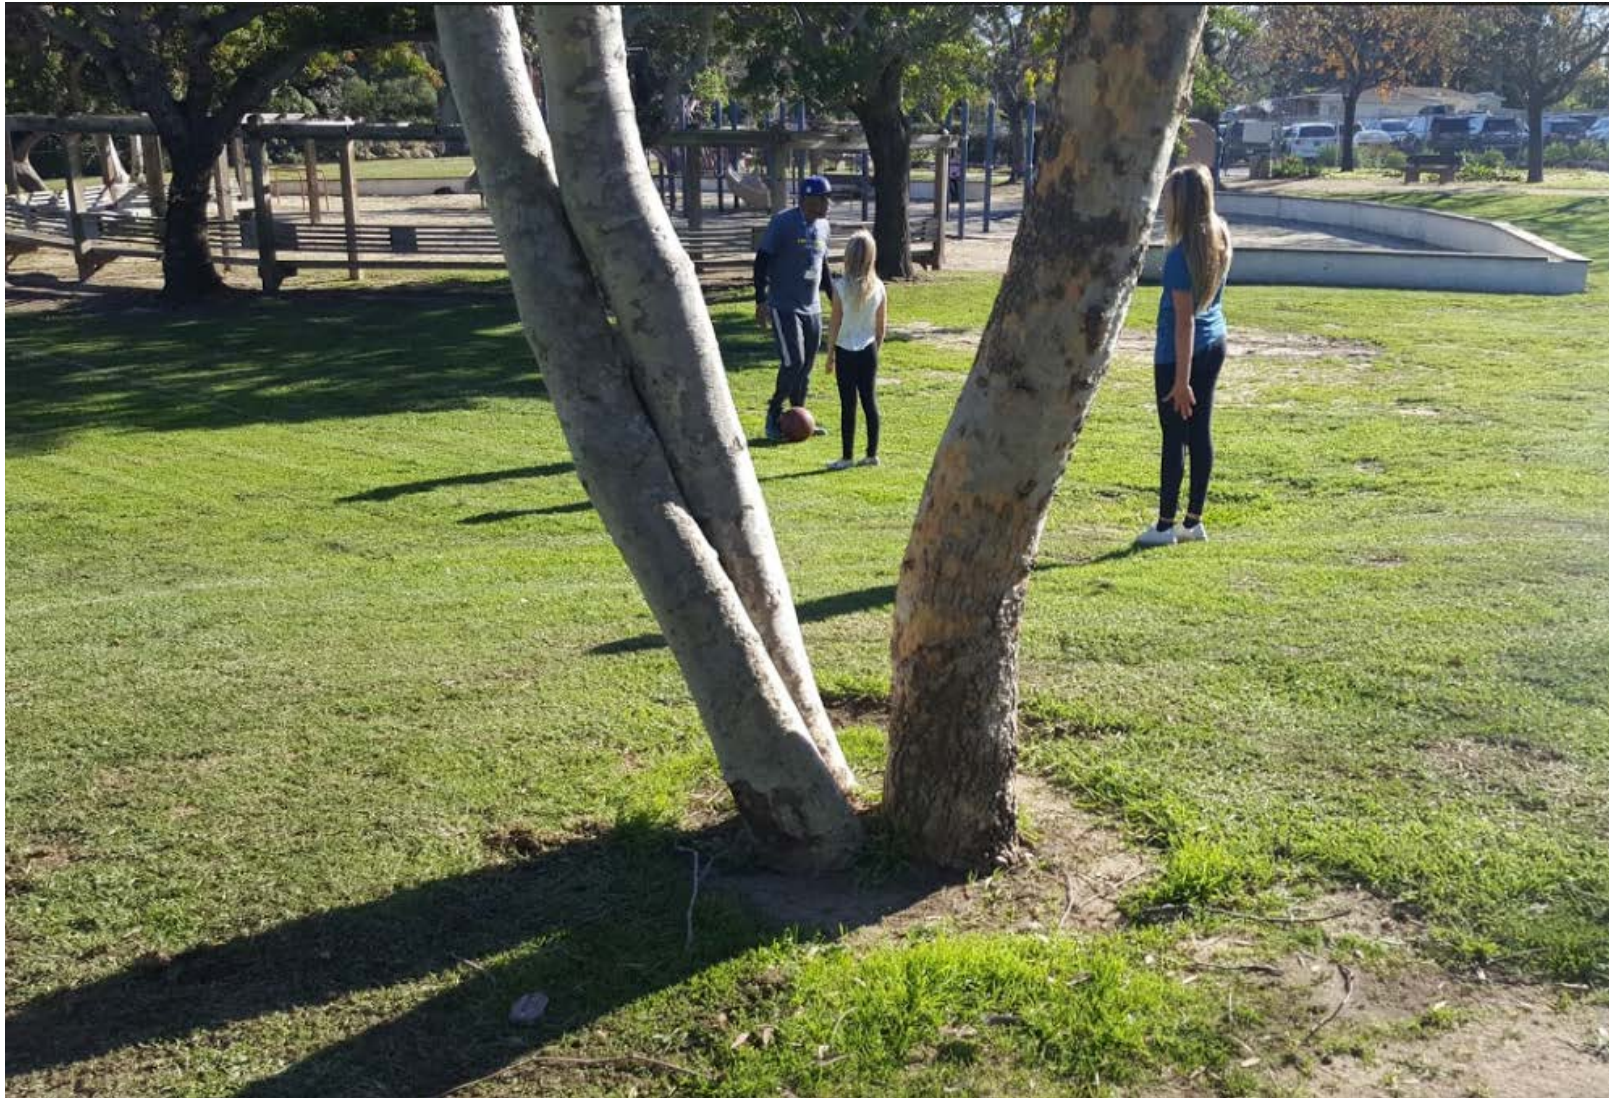
#43 Sycamore – note codominant and crossing trunks.

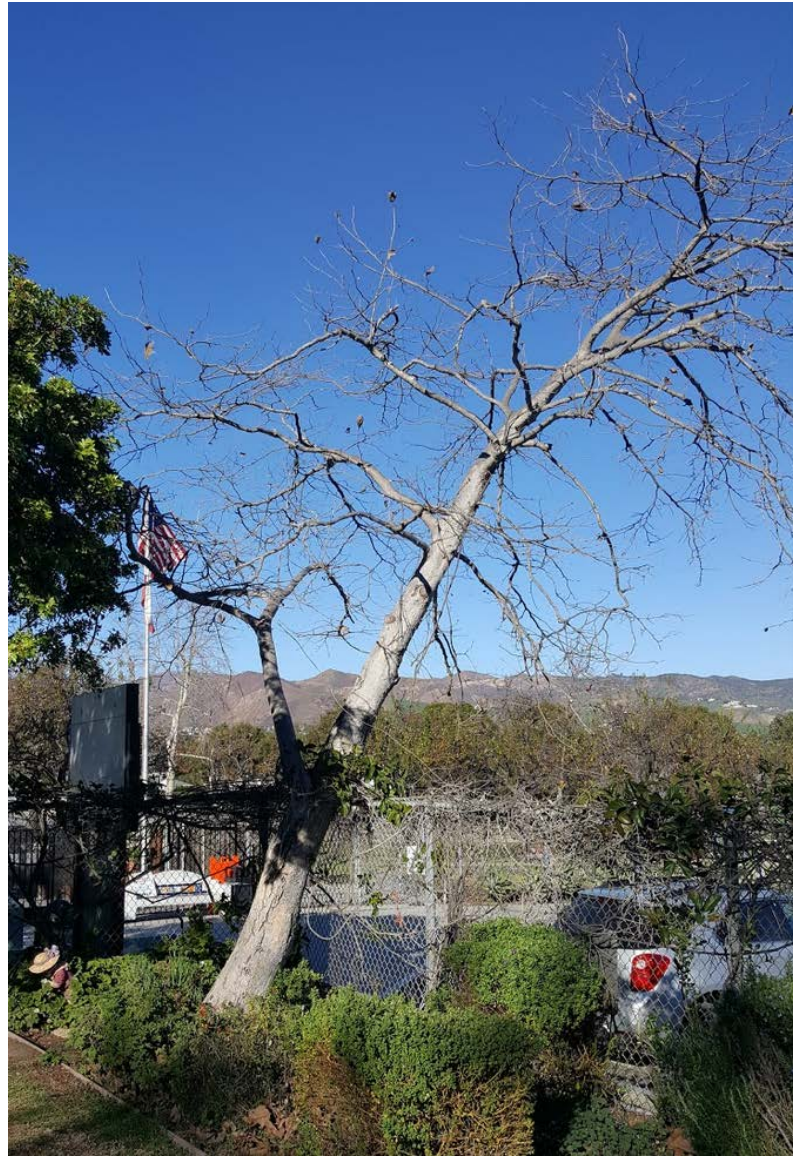
Sycamore #61

Trees #61 to 63 are at the edges of the raised kindergarten yard, and already have a landscape area around them. They could benefit from mulching, but none of the work actually calls for heavy foot or equipment traffic close to them. Tree #64 is almost clear of the construction zone, and will at worst have a small amount of its root area compacted under the new portable building. The protective construction fencing will help adequately protect #64. Tree #43 is fairly clear of the construction zone and probably won't see more foot traffic and trampling than it usually does.

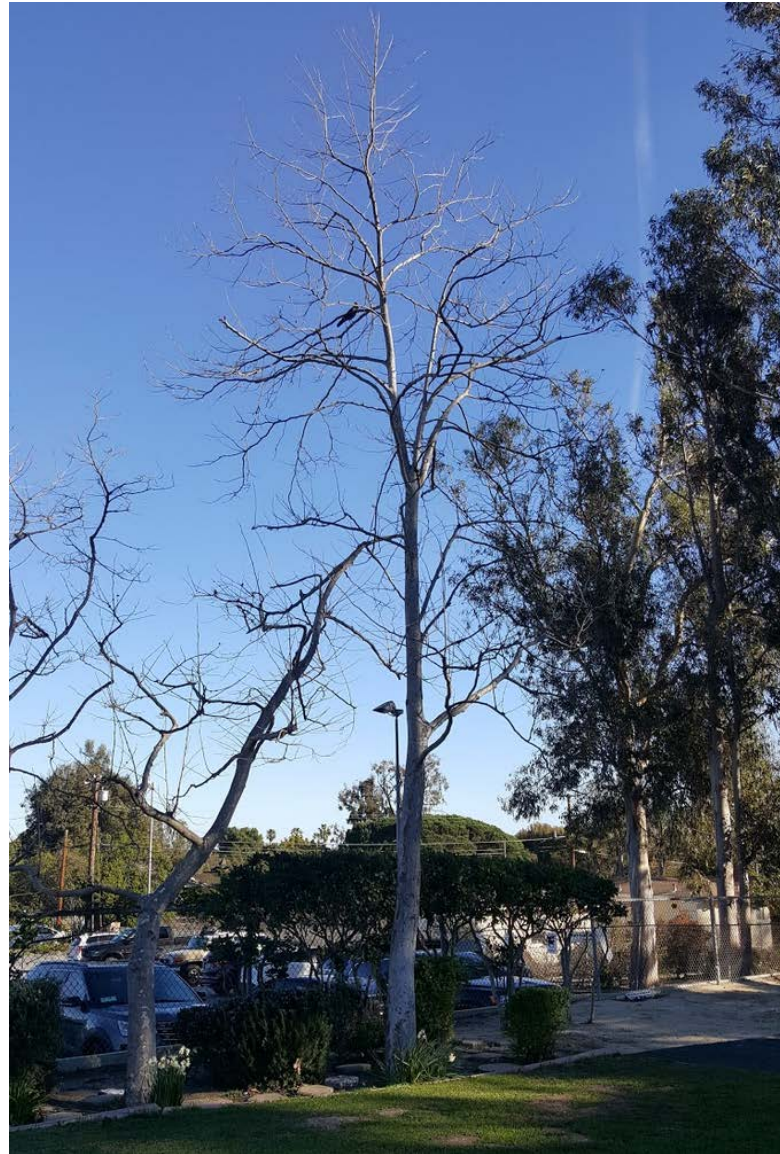
Sycamores #62 and 63 (left to right) – note dogleg trunk
