## **AHERA THREE-YEAR RE-INSPECTION**

Roosevelt Elementary School  
801 Montana Avenue  
Santa Monica, California 90403

Project No.: 110-0006

Date: June 4, 2010

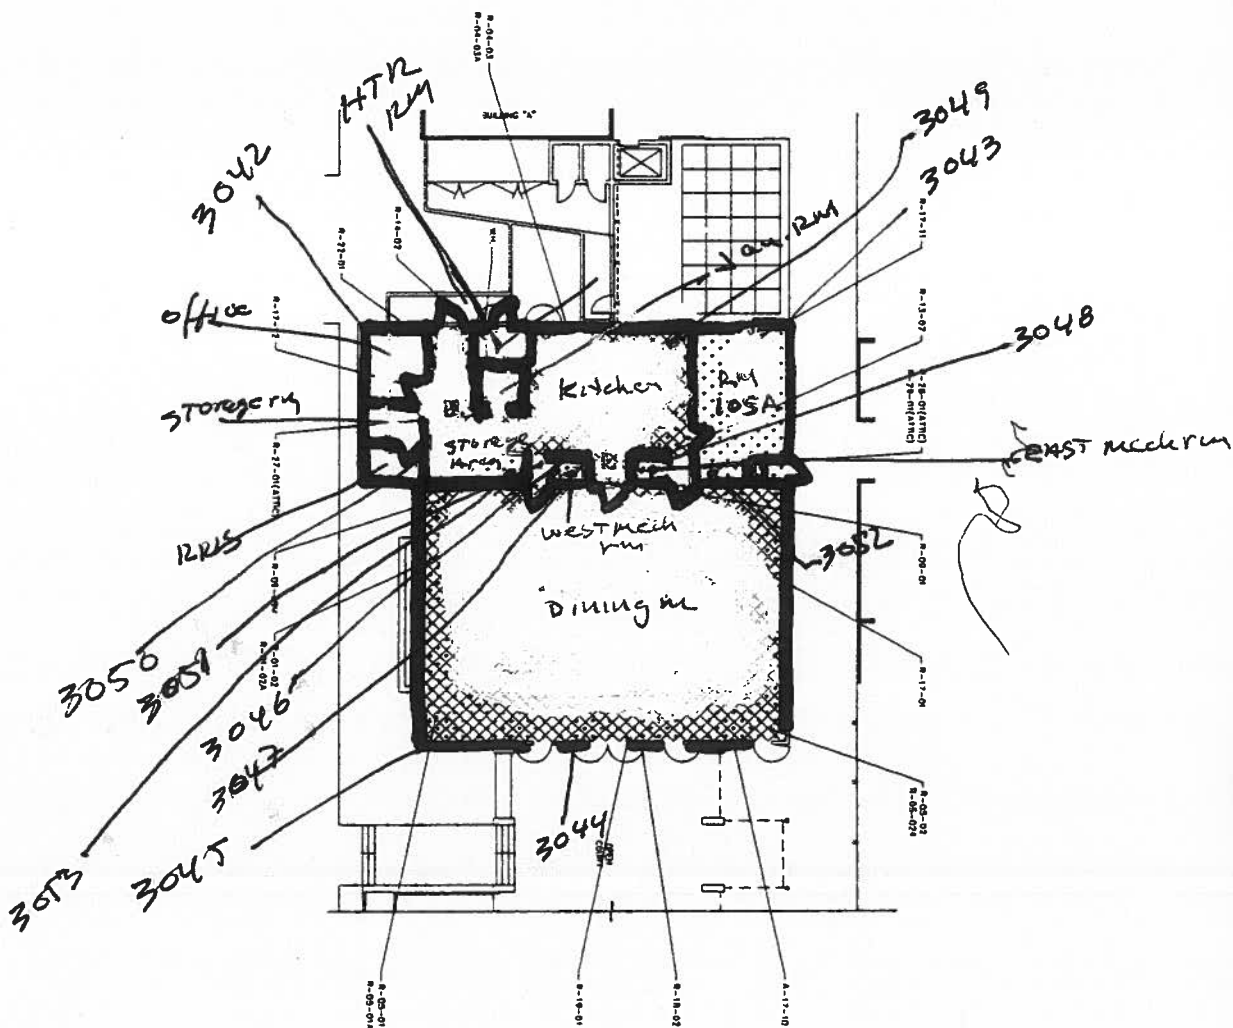
BUILDING "B"

- LEGEND**
- ASBESTOS-CONTAINING 8" x 8" FLOOR TILE AND Mastic
  - ASBESTOS-CONTAINING ROUGH CEILING PLASTER

- NOTES**
- ASBESTOS CONTAINING PAINT CASSETS LOCATED ON HVAC SYSTEM IN ATRC.
  - ASBESTOS CONTAINING MANTLE PIECE INSULATION LOCATED IN ATRC.
  - ASBESTOS CONTAINING INSULATING CARBONADO LOCATED ON HVAC SYSTEM IN ATRC.
  - ASBESTOS CONTAINING CEILING (MASONRY) ATRC.
  - ASBESTOS CONTAINING MANTLE PANELS LOCATED IN KITCHEN, SERVICE HALL AND DINING ROOM.
  - ASBESTOS CONTAINING PAINT LOCATED IN OFFICE.
  - ASBESTOS CONTAINING WINDOW PUTTY LOCATED AT MECHANICAL CLOSET.
  - ASBESTOS CONTAINING WINDOW PUTTY LOCATED ON EXTERIOR WINDOW FRAME.
  - ASBESTOS CONTAINING CEILING PANELS LOCATED IN BATHROOM.
