## **SURVEY AND SAMPLING OF DOOR CAULKING FOR PCB**

Doors D504A, D708A, and D708B  
Buildings E, and H  
**Roosevelt Elementary School**  
801 Montana Avenue  
Santa Monica, California 90405

Project No.: SMSD-17-6653  
Date: February 21, 2017

### **Alta Environmental**

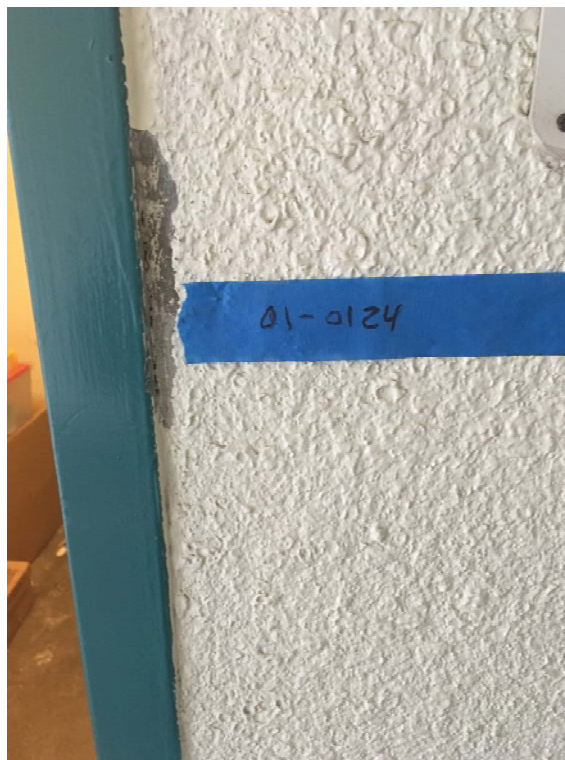
Photo 1

1. Door D504A; visible caulking was observed on the exterior side of the door. One bulk sample was collected and analyzed. The samples were reported as not-detected at a level above the laboratory reporting limit (RL).
2. Door D708A; no visible caulking was observed, both inside and outside of the door casing. No sampling was required.
3. Door D708B; no visible caulking was observed, both inside and outside of the door casing. No sampling was required.

Exterior door caulking  
sample #01-0124

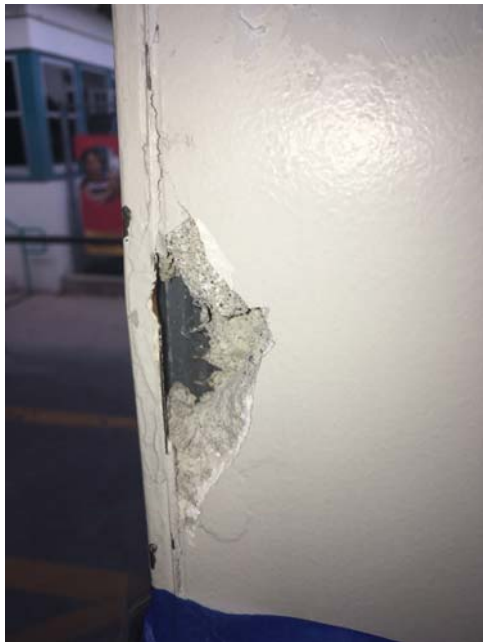
**Door D708A-interior (no visible caulking)-Photo 2**

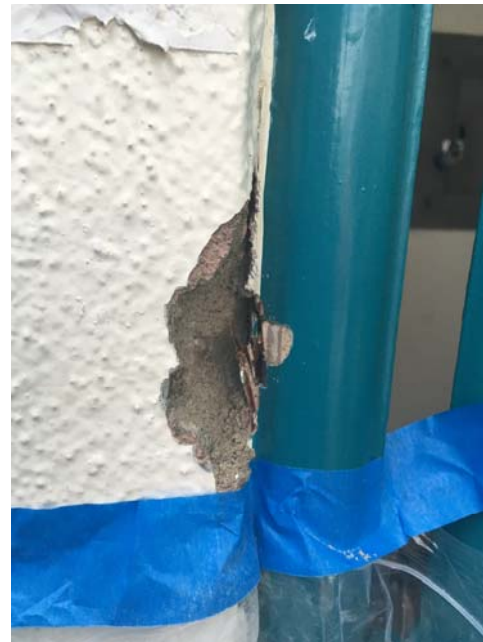
**Door D708A-exterior (no visible caulking) Photo 3**

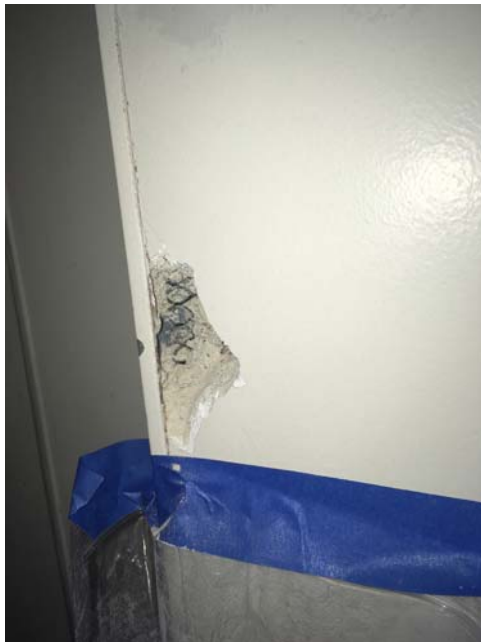
**Interior D708B-interior (no visible caulking) -Photo 4**

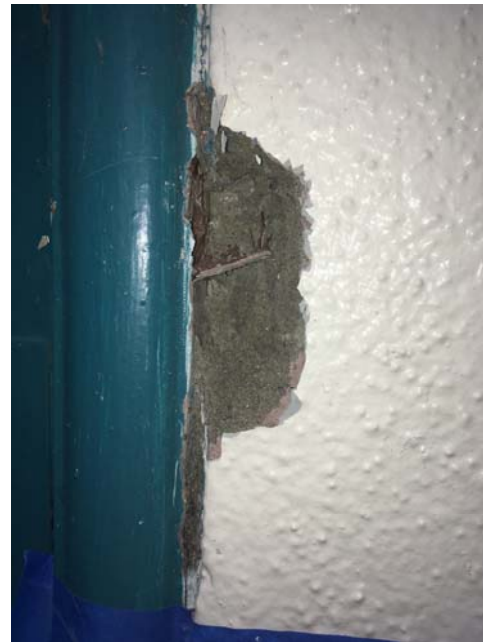
**Exterior D708B-exterior (no visible caulking) -Photo 5**
