Hazardous Building Material Survey

Santa Monica-Malibu Unified School District
Washington West Child Development Services
Windows, Paint, Flooring, and Doors Project
2802 4th Street
Santa Monica, California 90405

February 22, 2019 | Project No. 210957001

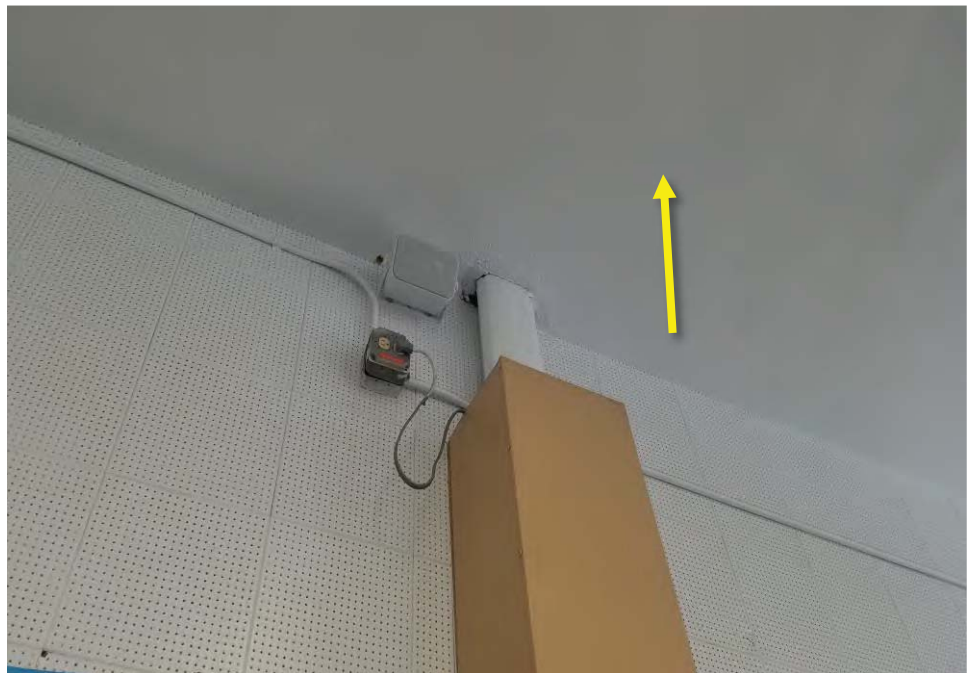
Photograph 2: Classroom Building: View of the asbestos-containing plaster ceilings throughout classrooms 1-4 and restroom.

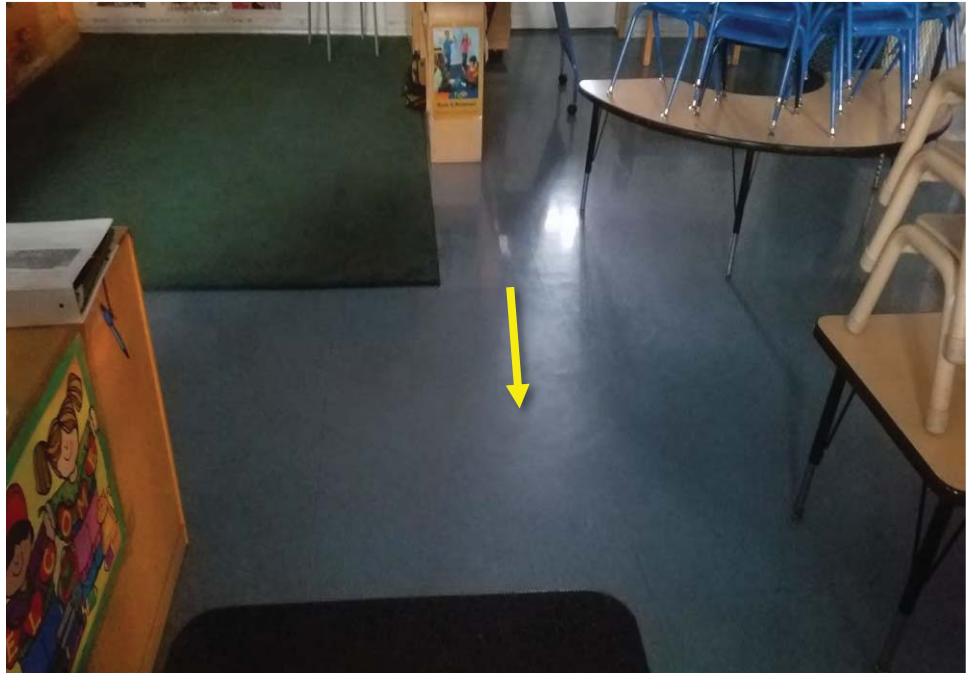
Photograph 3:

Classroom Building: View of asbestos-containing grey vinyl floor tile under 12" x 12" blue vinyl floor tiles in classrooms 1 and 2.

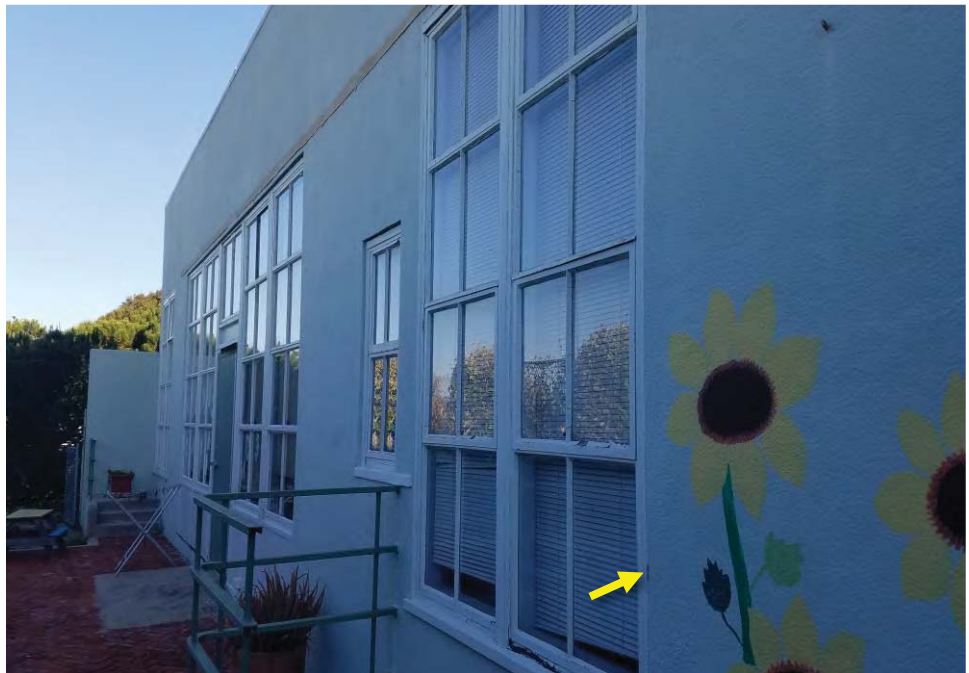
Photograph 4:

Classroom Building: View of asbestos-containing window caulking at exterior tall windows throughout.

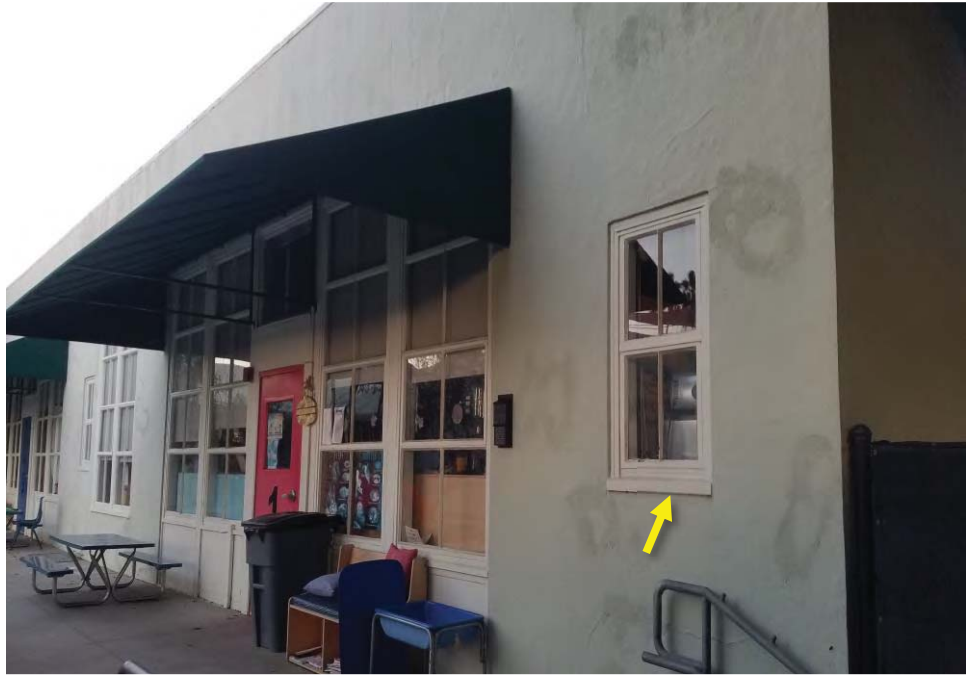
Photograph 5: Classroom Building: View of asbestos-containing window putty at exterior small windows throughout.

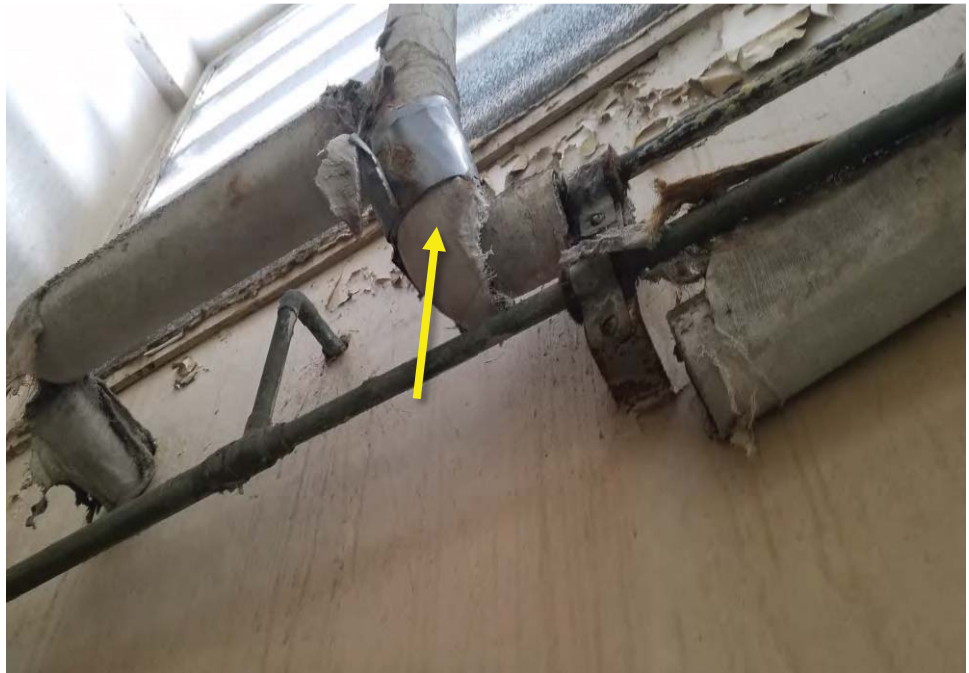
Photograph 6: Multipurpose Building: View of asbestos-containing TSI elbows in poor condition in storage room and throughout attic areas.

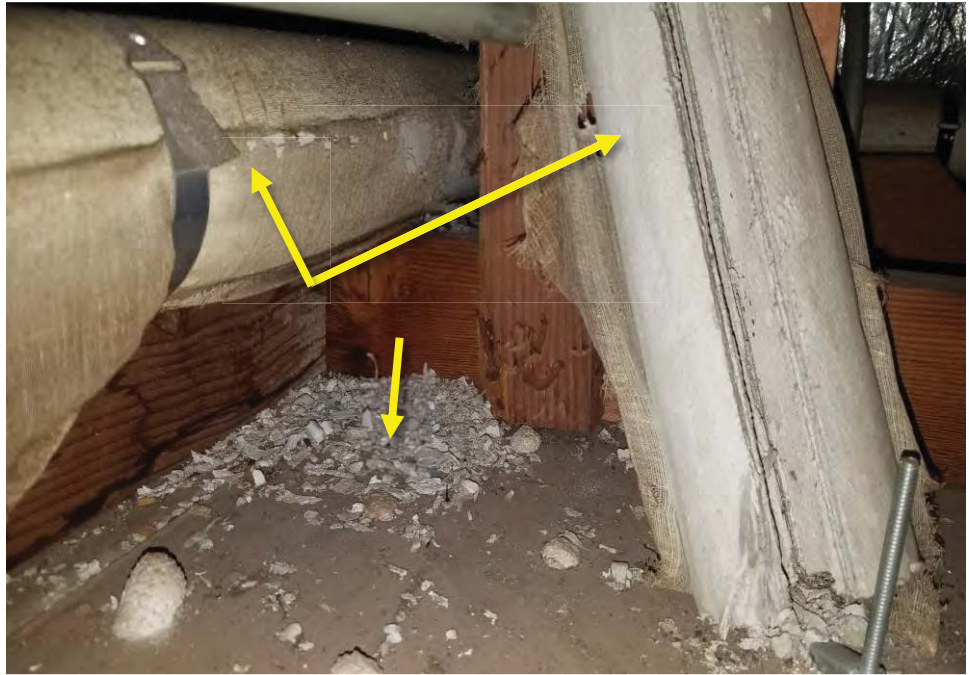
Photograph 7:

Multipurpose Building: View of asbestos-containing damaged TSI pipe runs and TSI debris in attic areas.

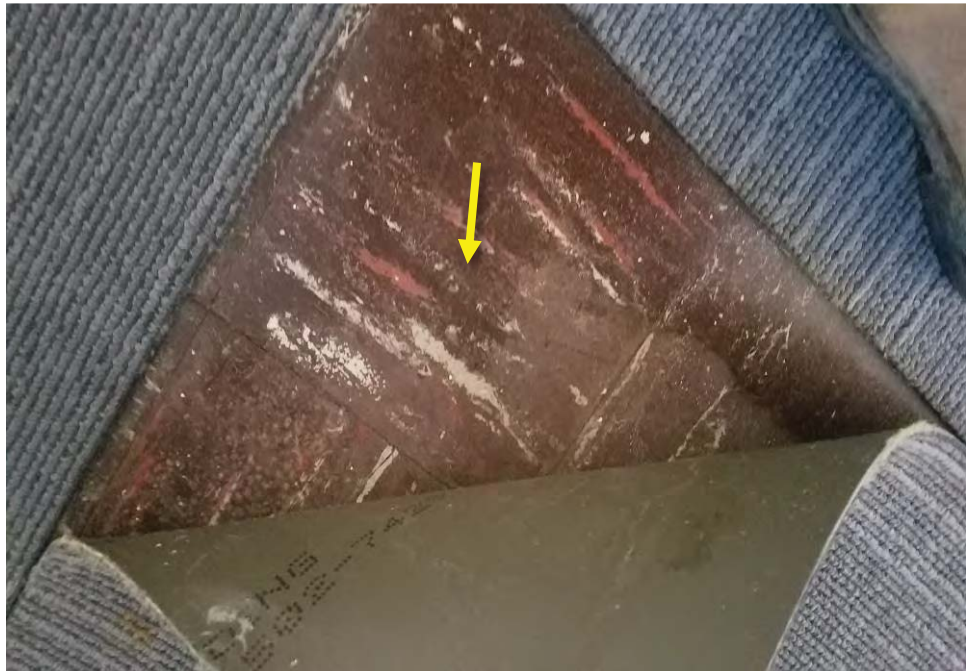
Photograph 8:

Multipurpose Building: View of asbestos-containing 9"x9" red vinyl floor tile under carpeting in the multipurpose room.

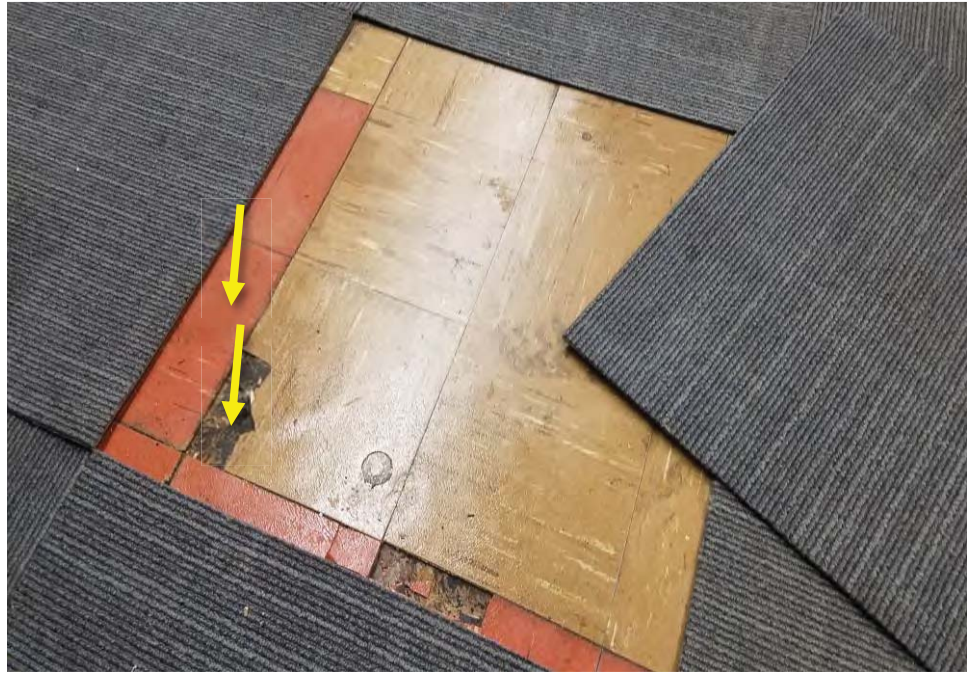
Photograph 9: Multipurpose Building: View of asbestos-containing 9"x9" Orange vinyl floor tile and asbestos-containing black mastic under both orange and beige floor tiles found under carpeting in library.

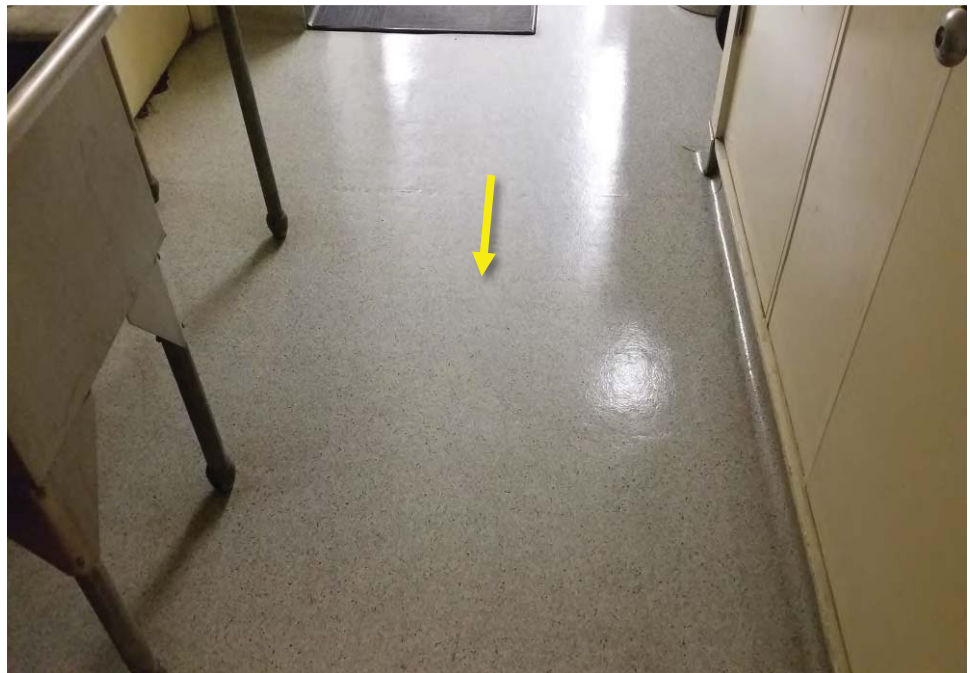
Photograph 10: Multipurpose Building: View of asbestos-containing 9"x9" grayish vinyl floor tile and mastic under vinyl floor sheeting in hallways and break room.

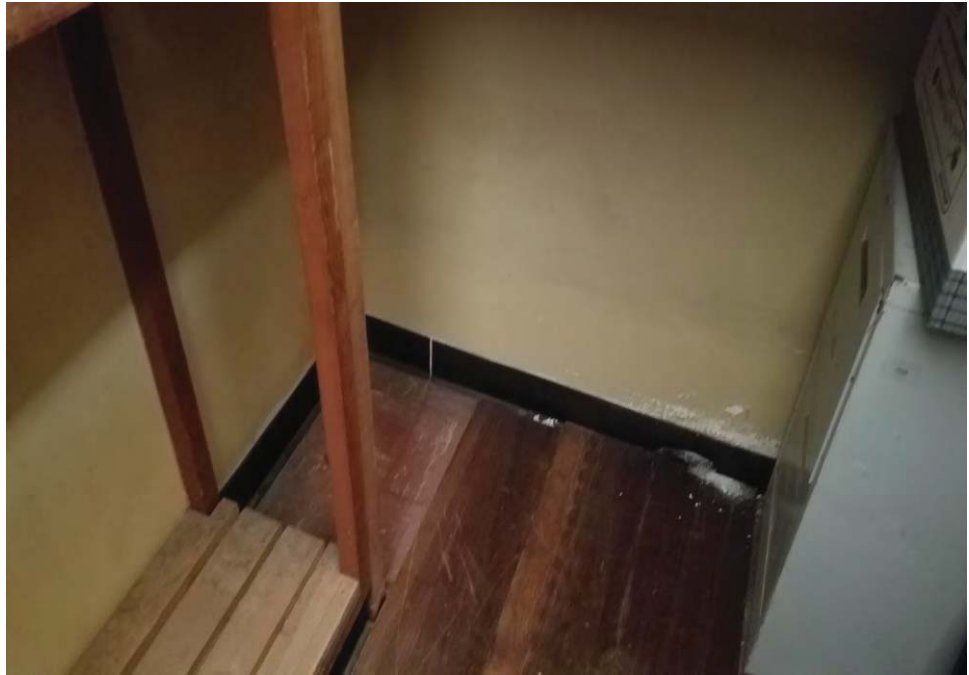
Photograph 11: Multipurpose Building: View of asbestos-containing black cove base in storage room 129.

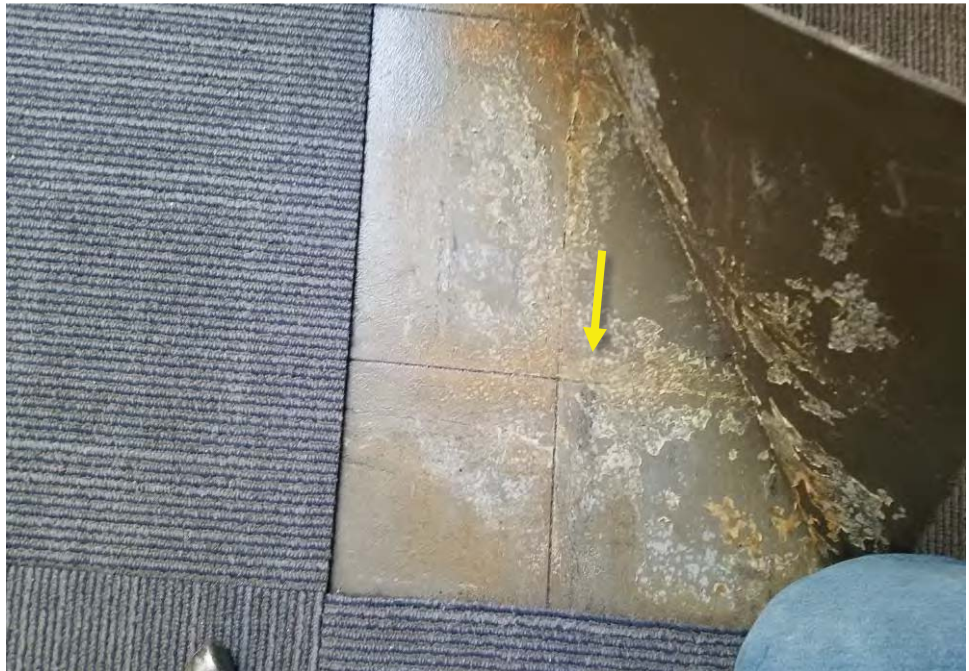
Photograph 12: Multipurpose Building: View of asbestos-containing 9"x9" gray vinyl floor tile and mastic under carpeting in the hallways and in storage room 128.

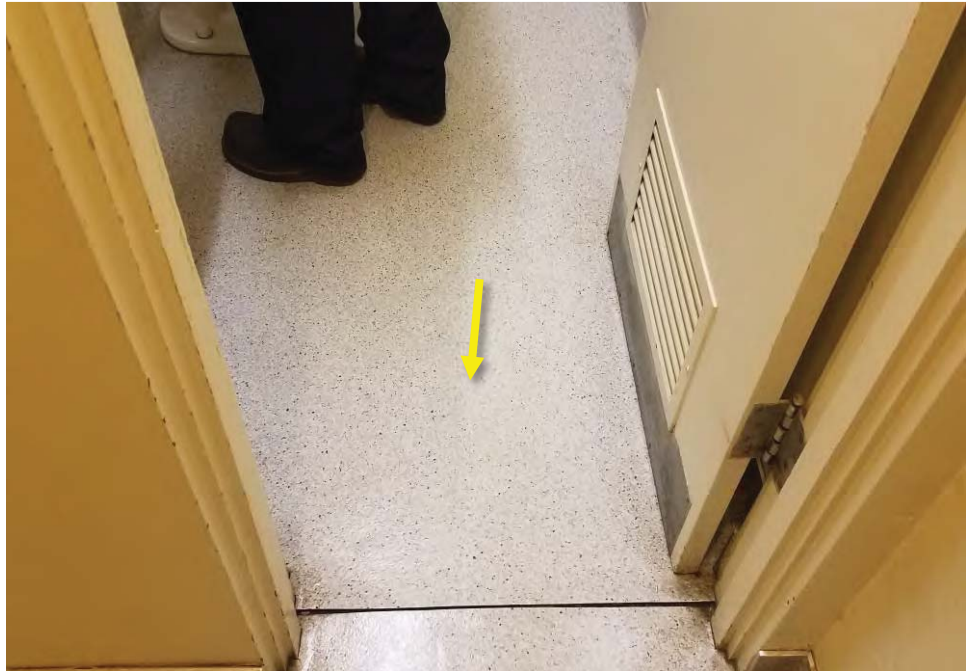
Photograph 13: Multipurpose Building: View of asbestos-containing 9"x9" green vinyl floor tile and mastic under vinyl floor sheeting in small restroom.

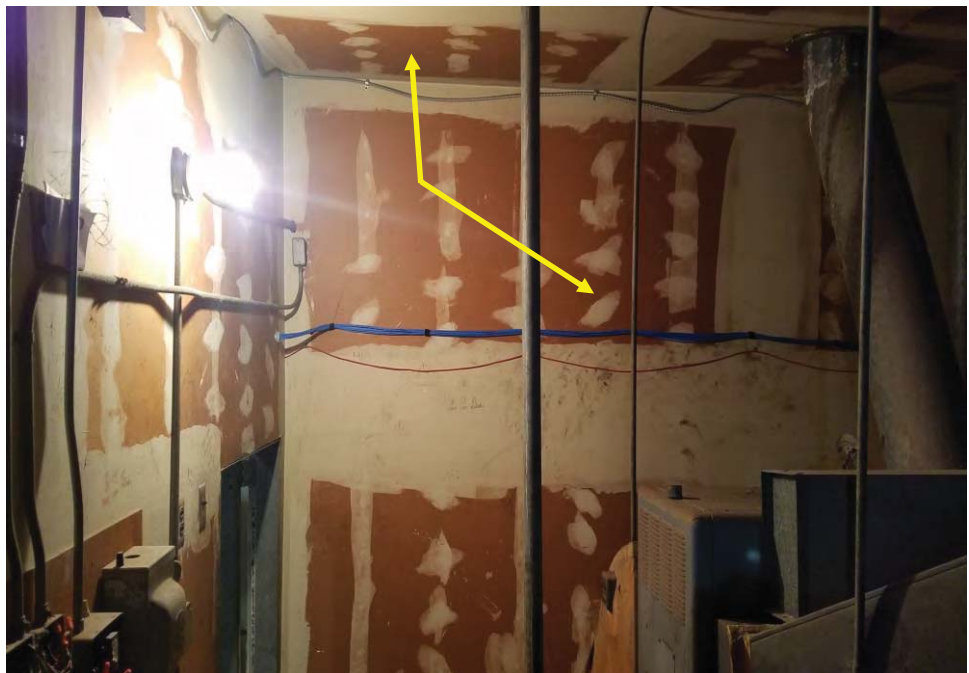
Photograph 14: Multipurpose Building: View of asbestos-containing drywall and joint compound in the mezzanine mechanical room.

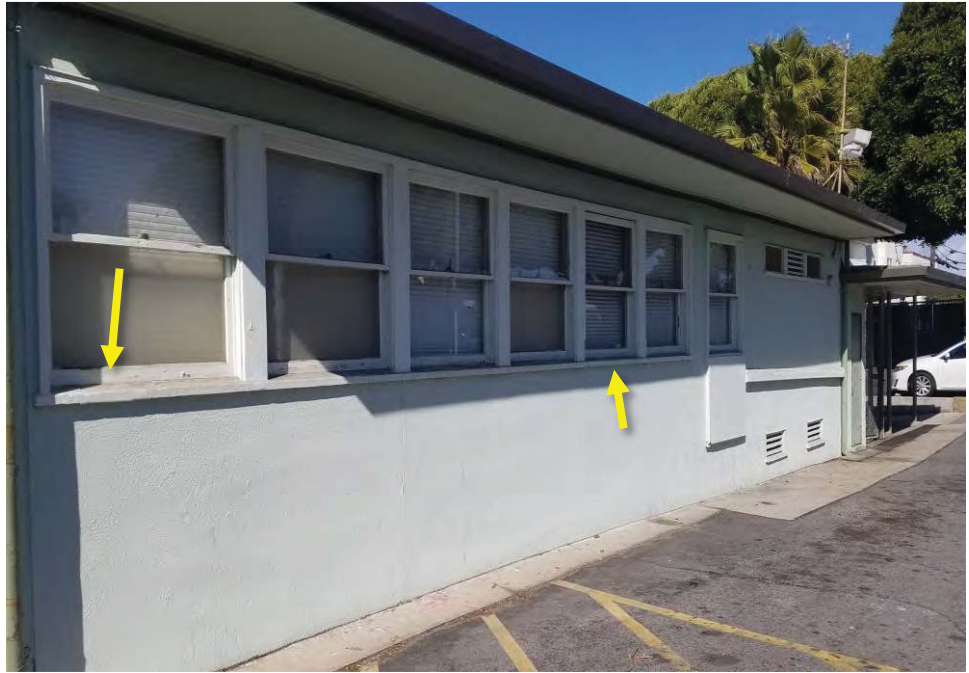
Photograph 15: Multipurpose Building: View of asbestos-containing exterior window putty and asbestos-containing window caulking.

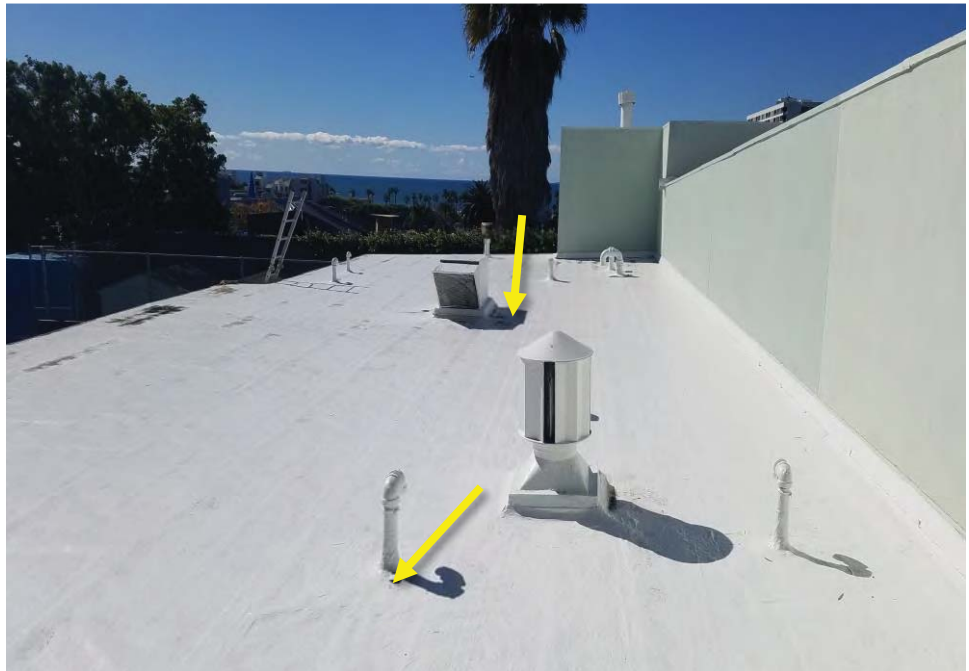
Photograph 16: Multipurpose Building: View of asbestos-containing vinyl rolled roof and roof penetration mastic at library roof areas only.

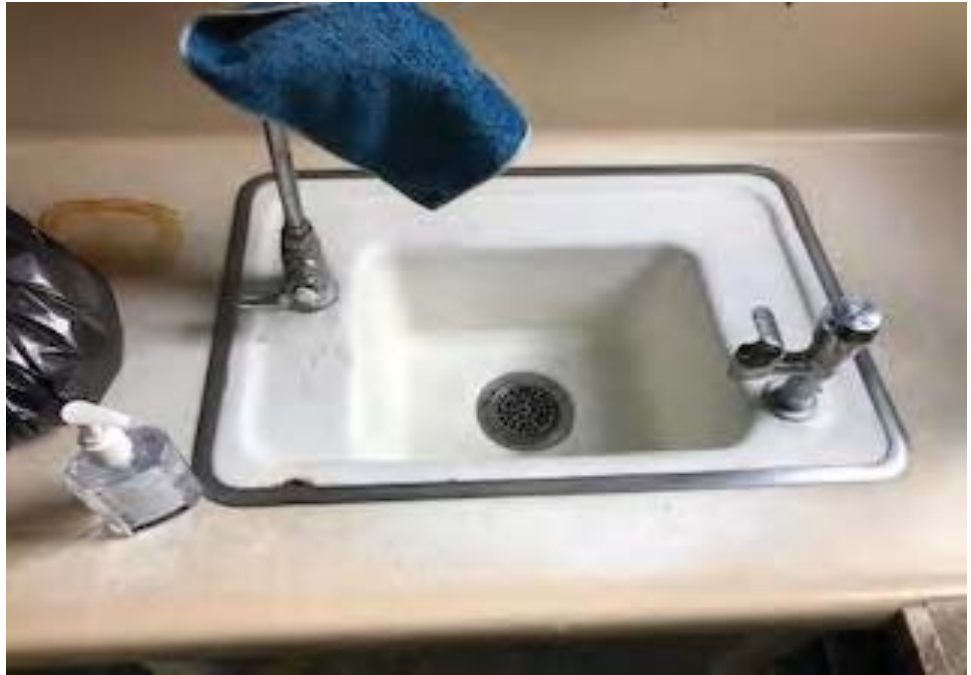
Photograph 1: Classroom Building: View of lead-containing sinks.

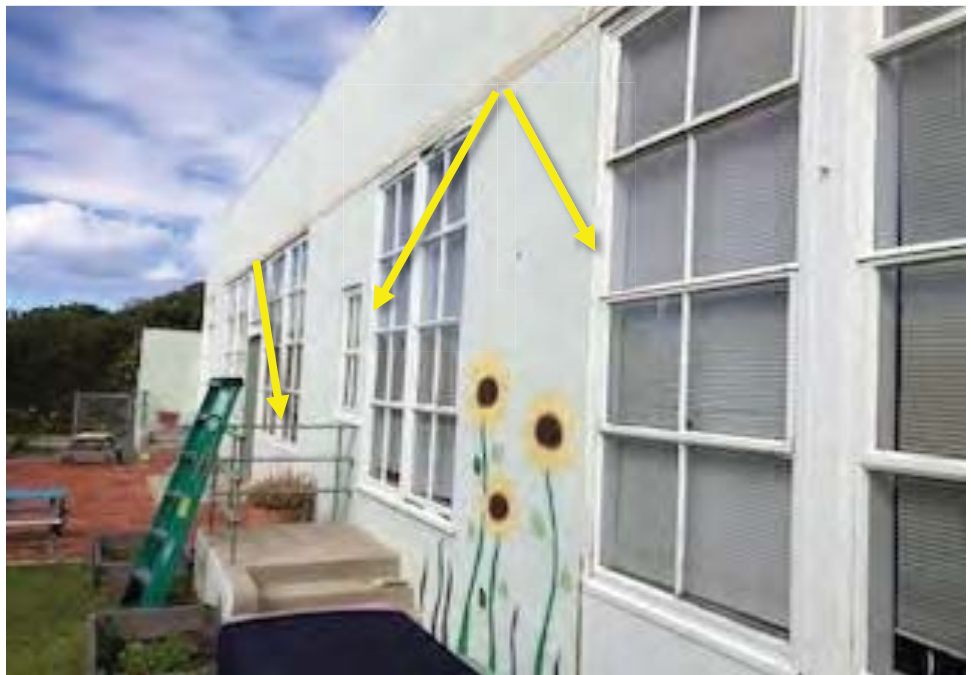
Photograph 2: Classroom Building: View of lead-containing exterior window frames and hand rails.

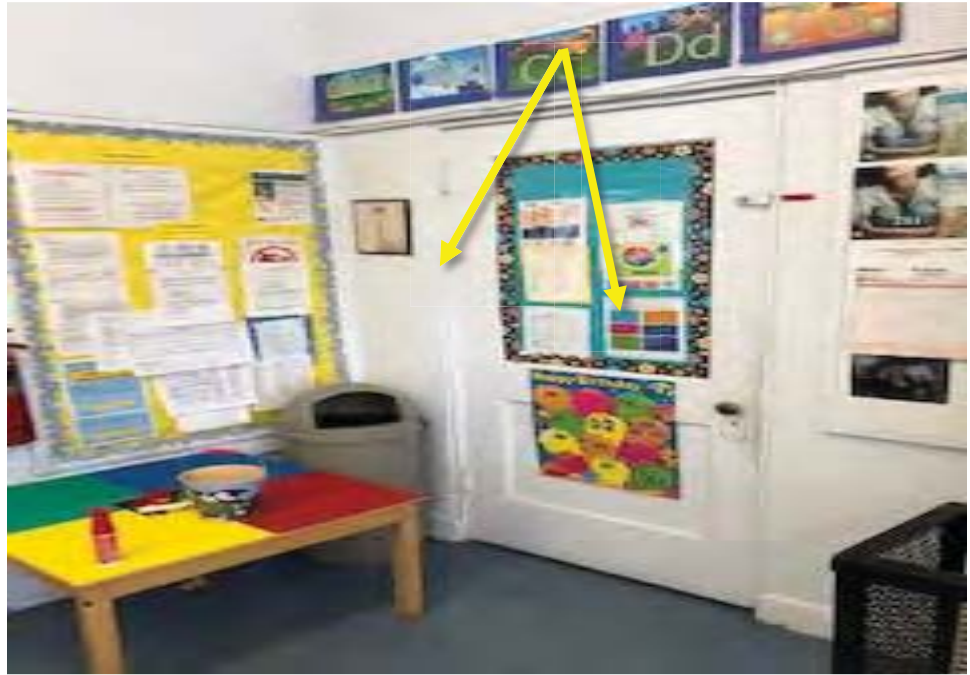
Photograph 3: Classroom Building: View of lead-containing door and door frames.

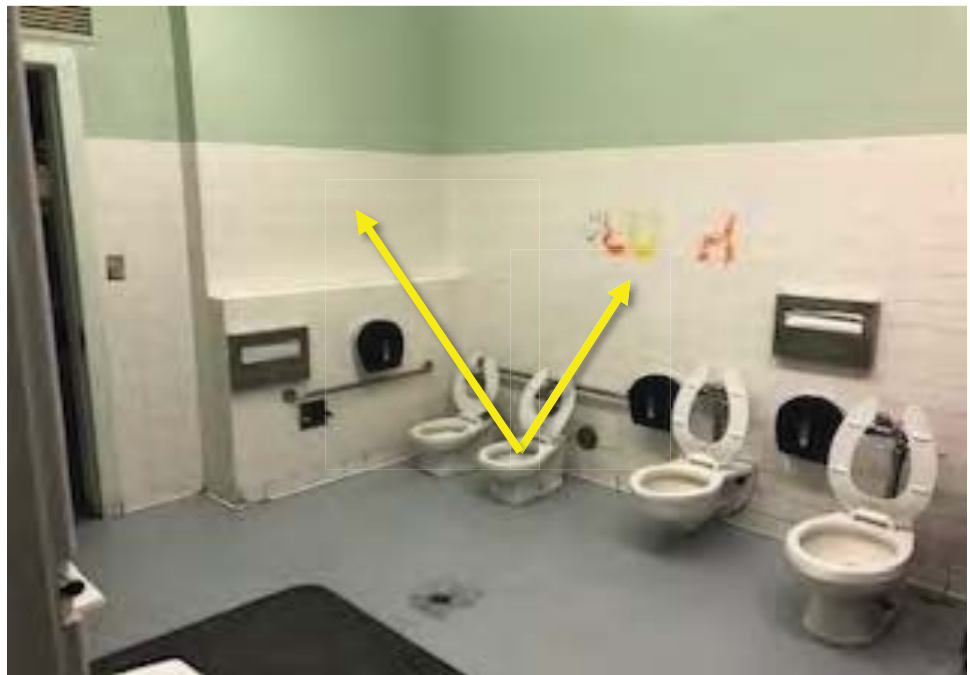
Photograph 4: Classroom Building: View of lead-containing ceramic wall tile.

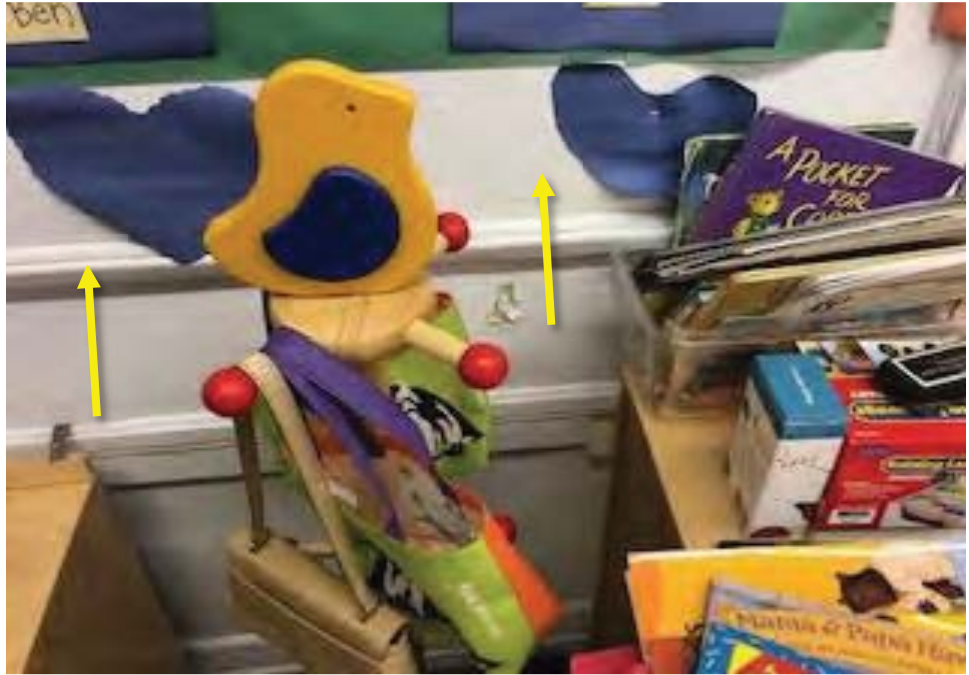
Photograph 5: Classroom Building: View of lead-containing cork board and cork board trim.

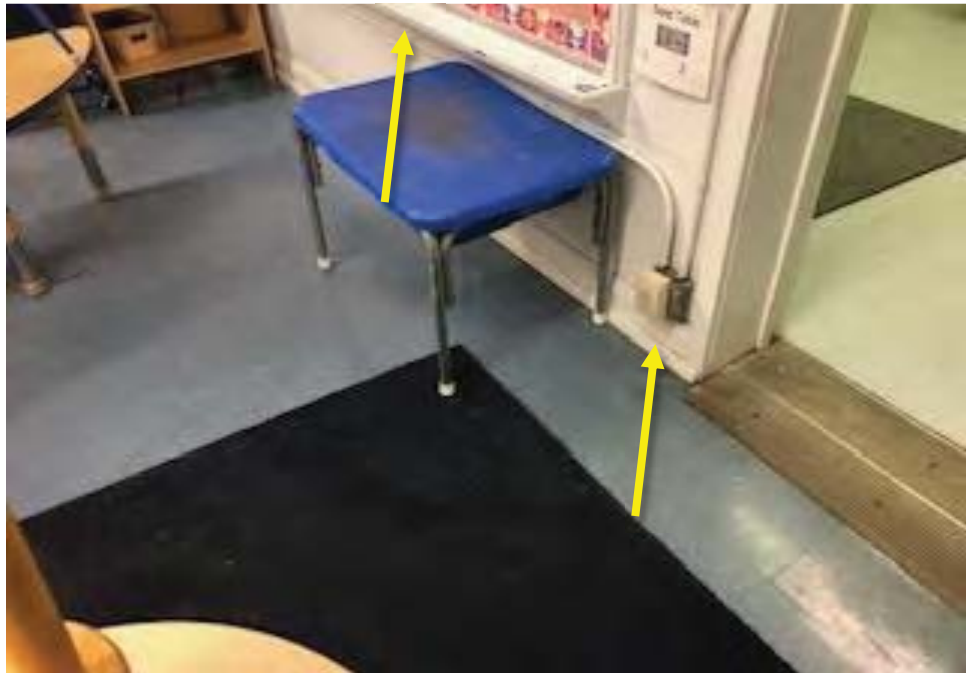
Photograph 6: Classroom Building: View lead-containing chalkboard and base board.

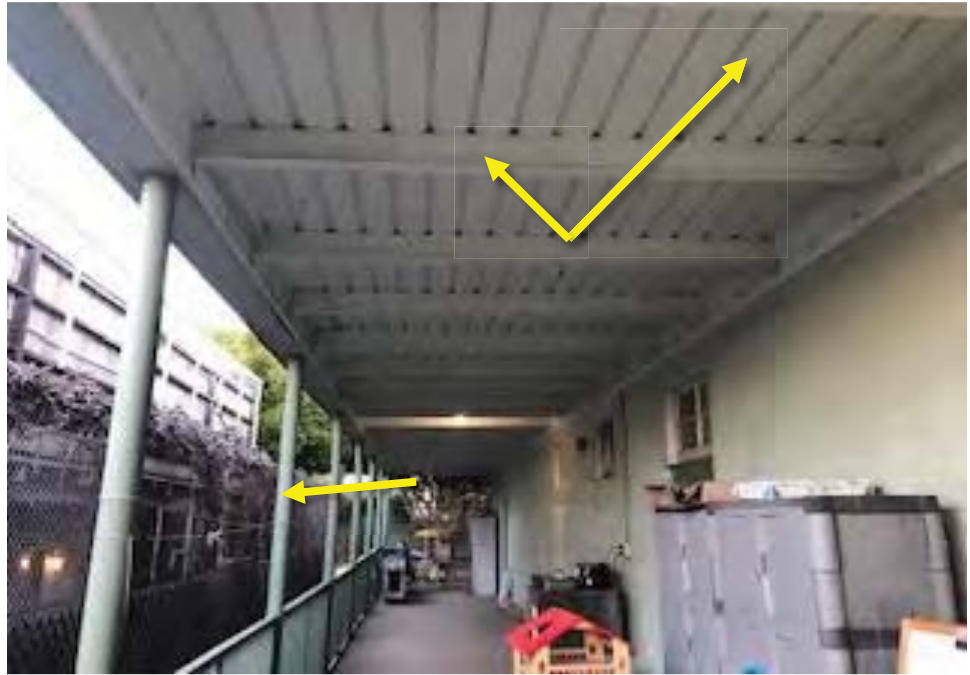
Photograph 7:

Classroom Building: View of lead-containing exterior deck, post and beams.

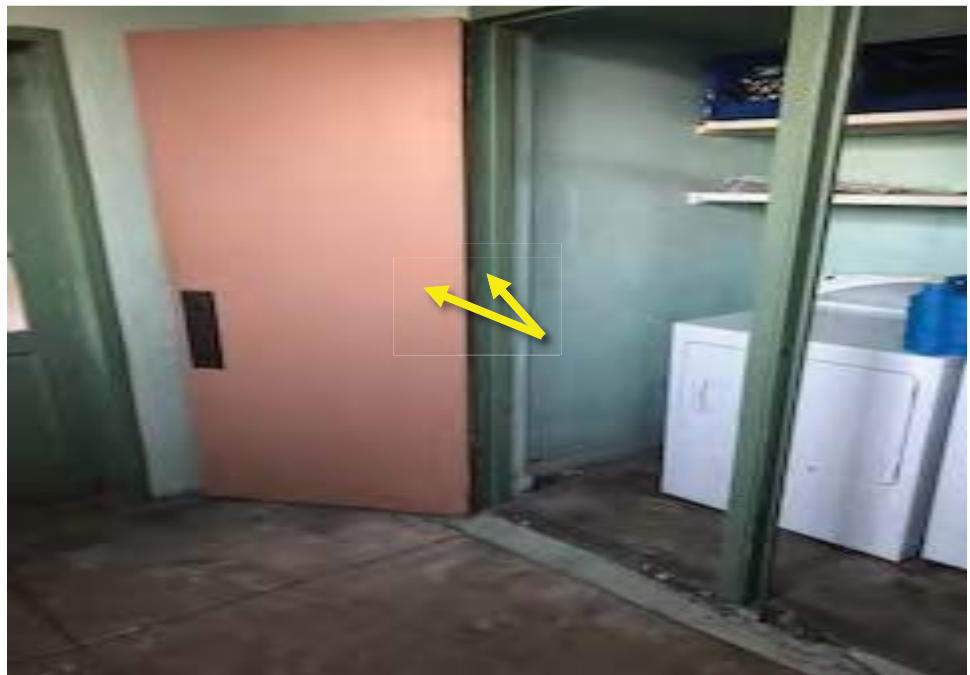
Photograph 8:

Classroom Building: View of lead containing door and door frame.

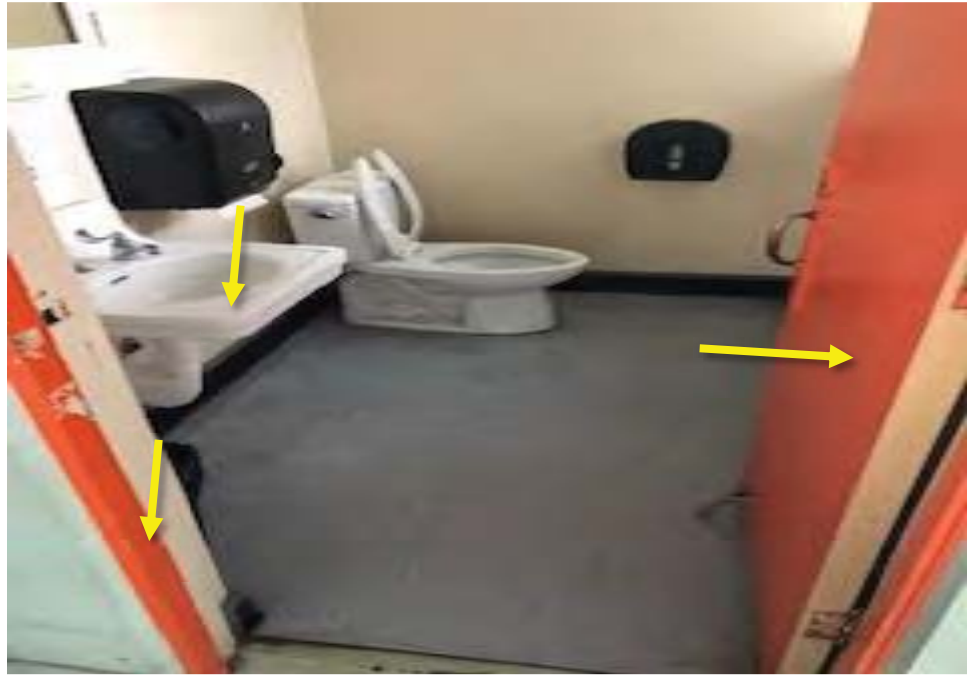
Photograph 9: Classroom Building: View of lead-containing door, door frame, and sink in small restroom.

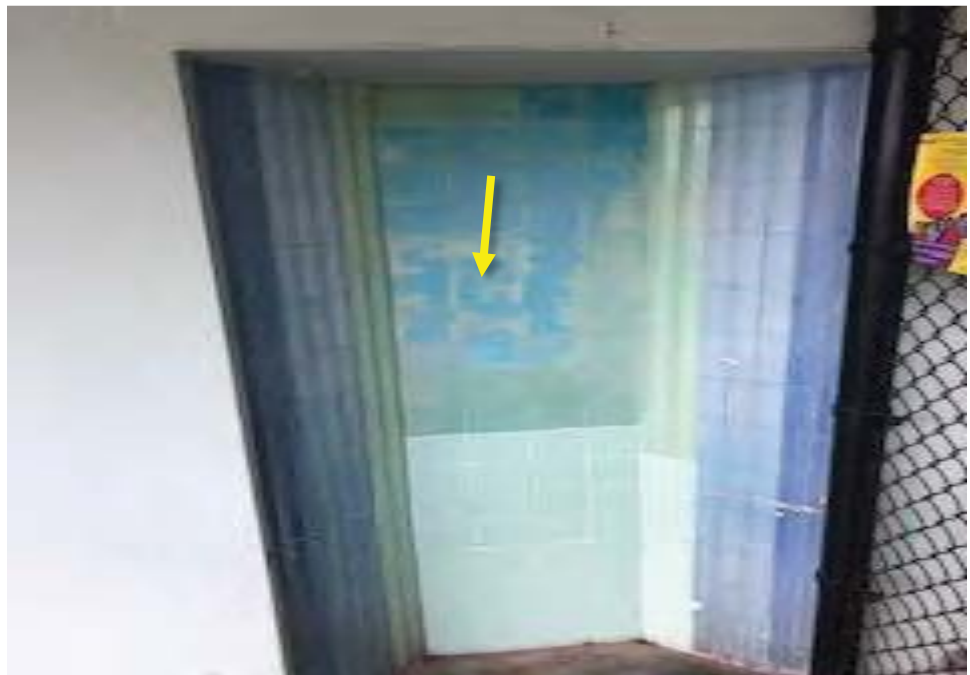
Photograph 10: Classroom Building: View of lead-containing exterior wall tile.

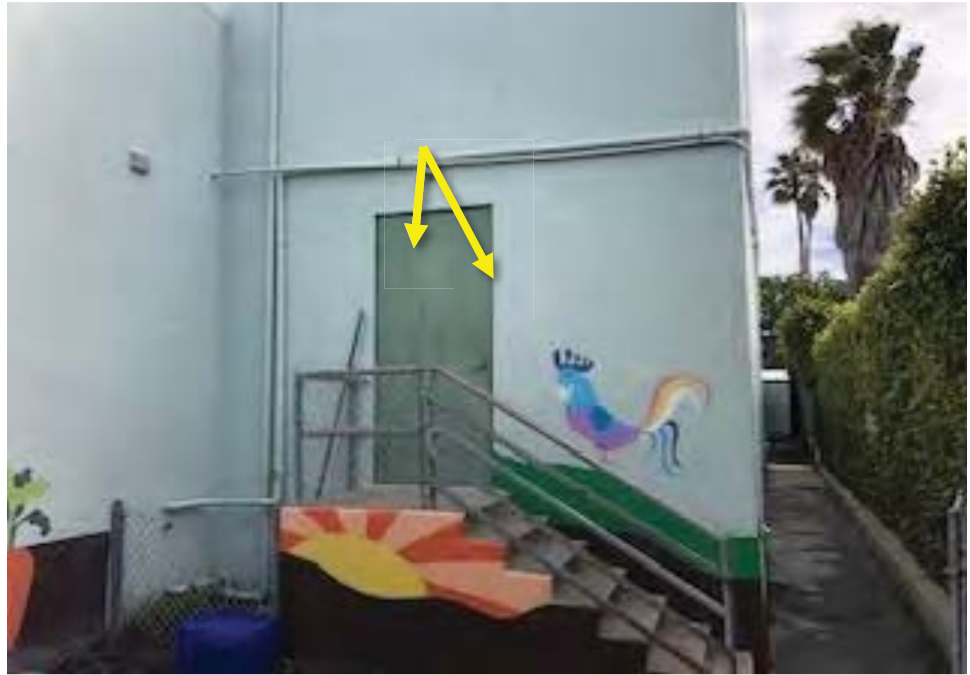
Photograph 11: Multipurpose Building: View of lead-containing exterior door and door frame.

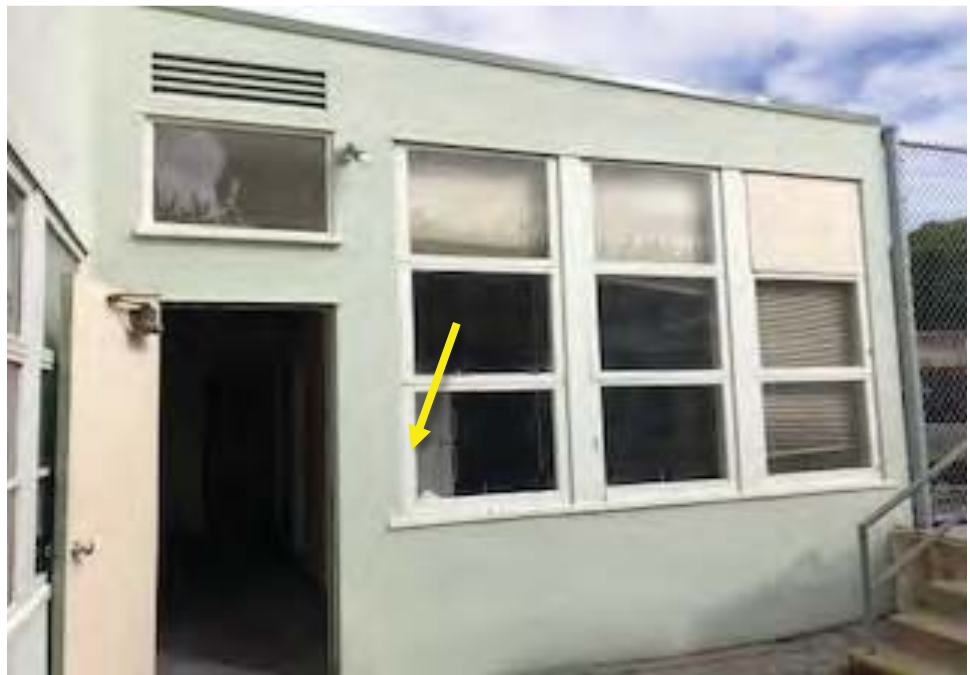
Photograph 12: Multipurpose Building: View of lead-containing exterior window frames.

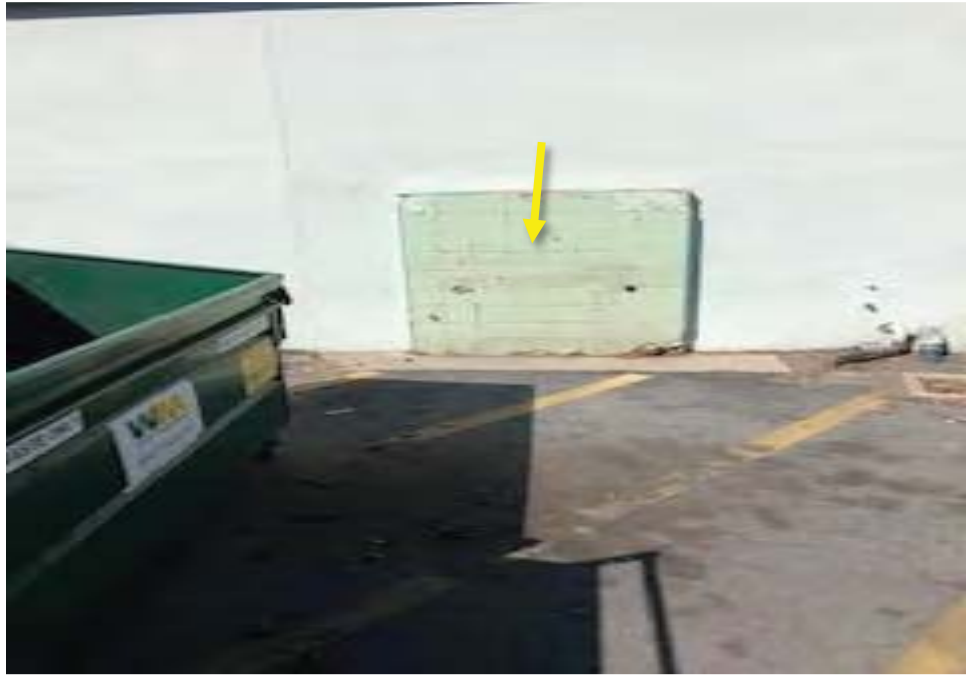
Photograph 13: Multipurpose Building: View lead-containing exterior ceramic wall tile.

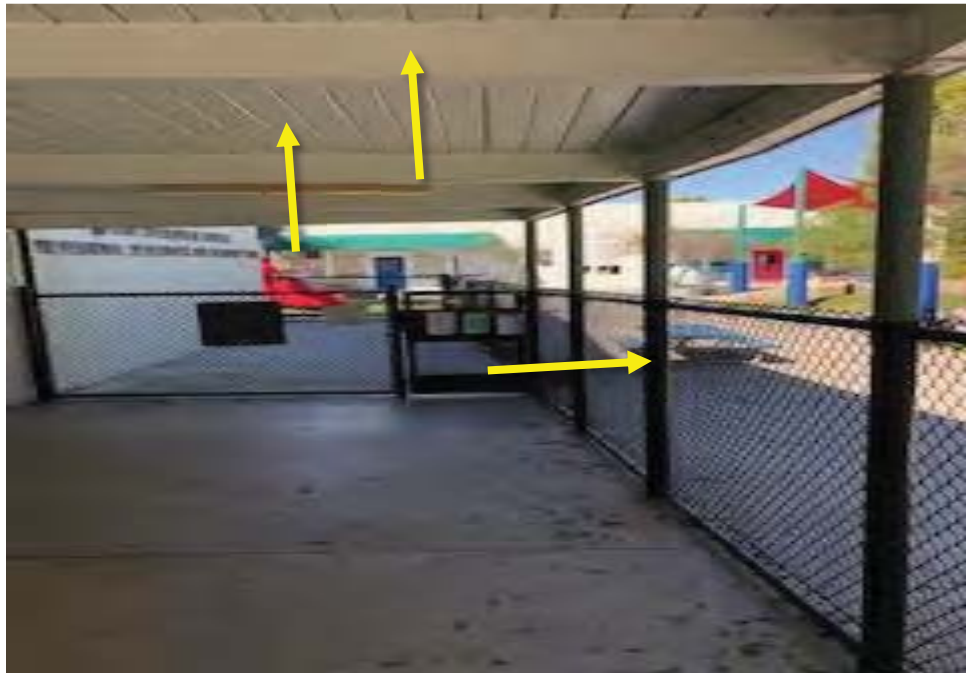
Photograph 14: Multipurpose Building: View of lead-containing beams, posts and decking.

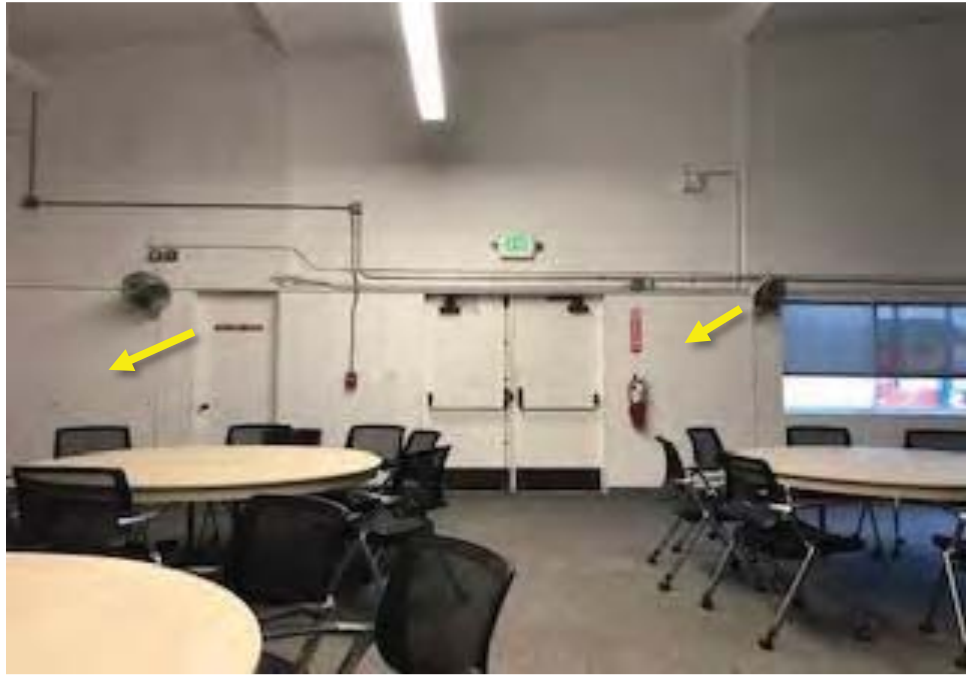
Photograph 15: Multipurpose Building: View of lead-containing plaster walls.

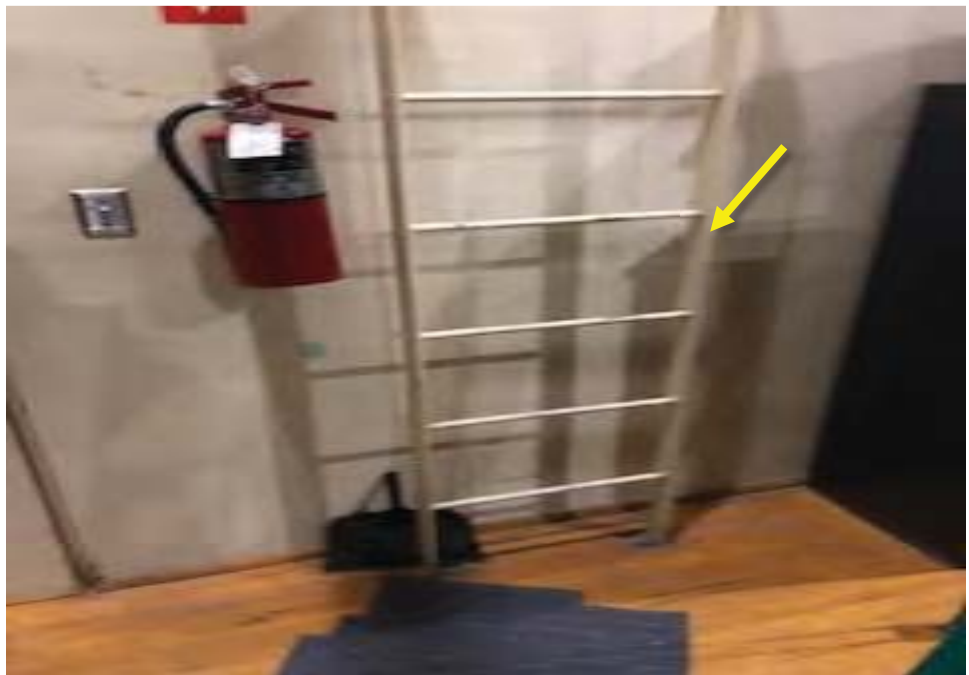
Photograph 16: Multipurpose Building: View of lead-containing stage ladder.

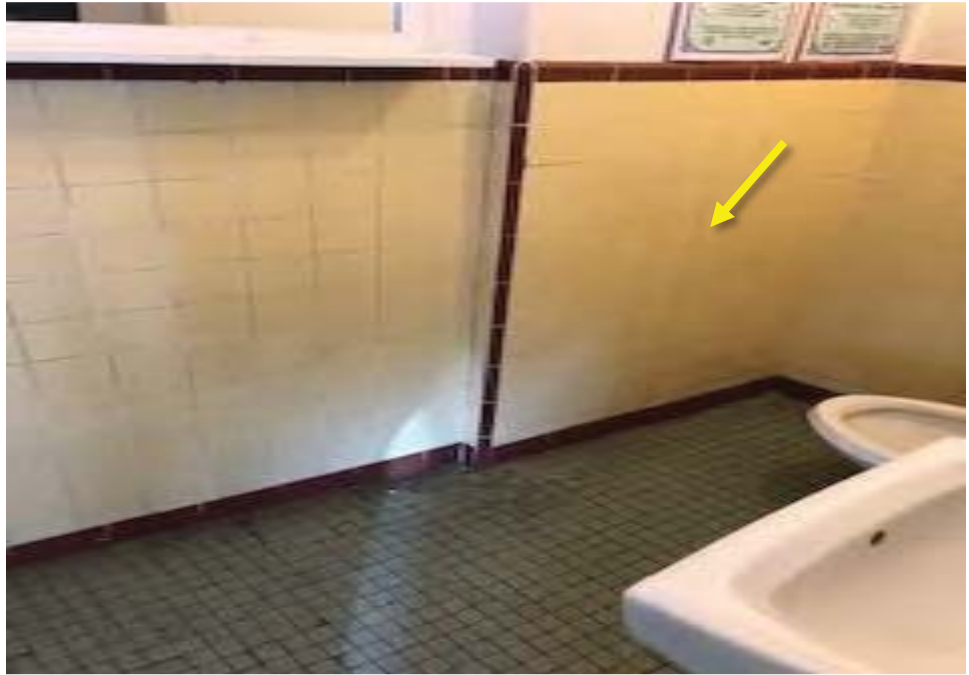
Photograph 17: **Multipurpose Building: View of lead-containing ceramic wall tile.**

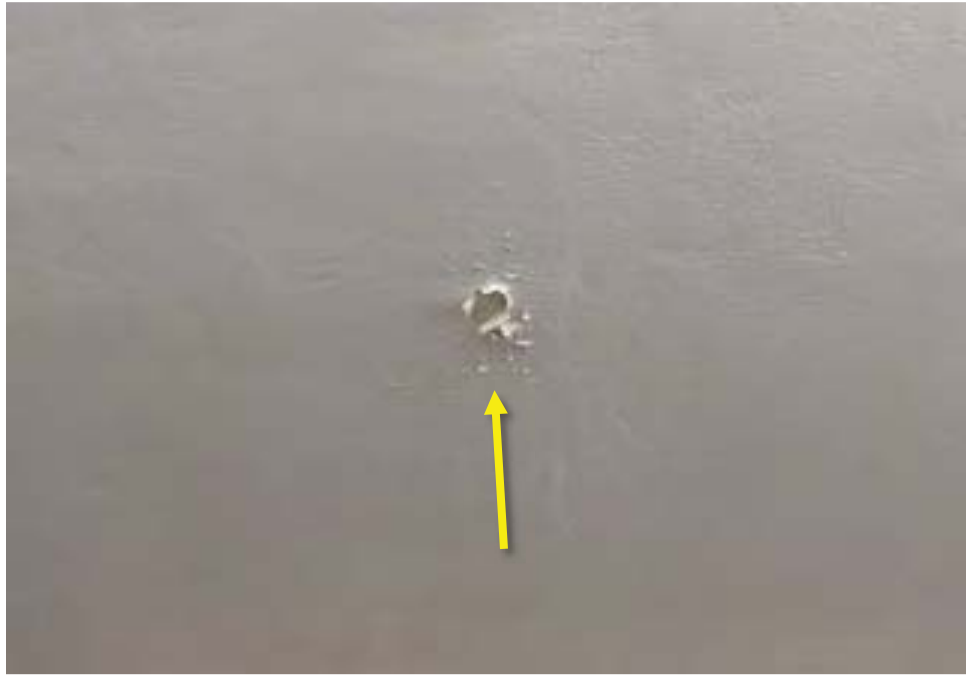
Photograph 1: Classroom Building: View of ceiling water damage in classroom 4.

- The water stained building materials found to be present in Classroom 4, and the Multi-purpose room main area ceiling, hallway attic, hallway ceiling and storage rooms should be replaced if possible. The source of water intrusion is most likely from a damaged roofing area which should professionally be evaluated and repaired.
