Hazardous Building Material Survey

Santa Monica-Malibu Unified School District
Washington West Child Development Services
Windows, Paint, Flooring, and Doors Project
2802 4th Street
Santa Monica, California 90405

February 22, 2019 | Project No. 210957001

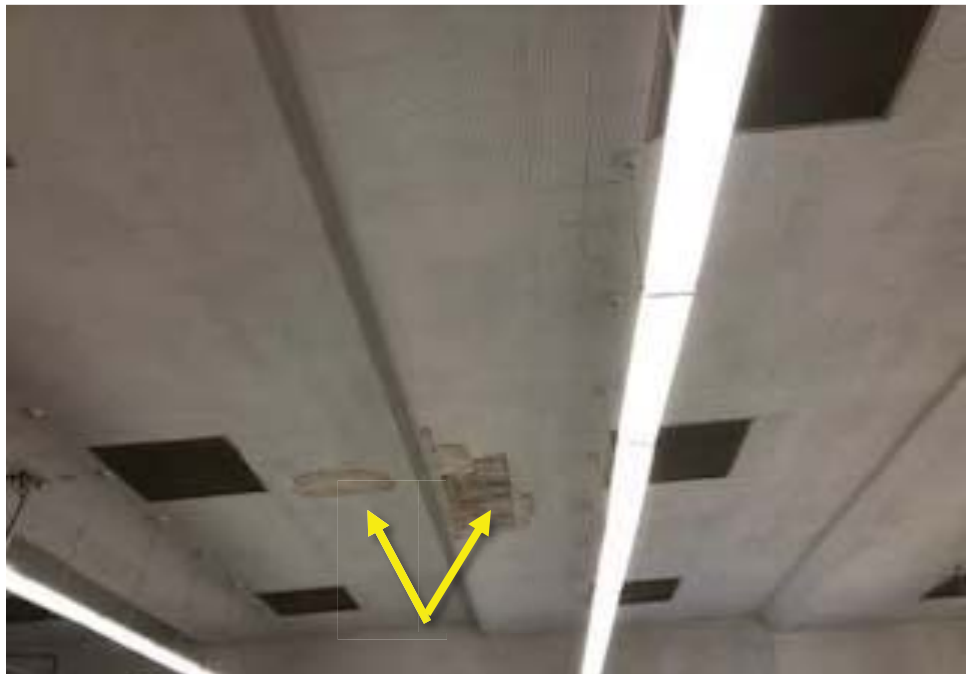
Photograph 2: Multipurpose Building: View of ceiling water damage in the MPR room.

- The water stained building materials found to be present in Classroom 4, and the Multi-purpose room main area ceiling, hallway attic, hallway ceiling and storage rooms should be replaced if possible. The source of water intrusion is most likely from a damaged roofing area which should professionally be evaluated and repaired.

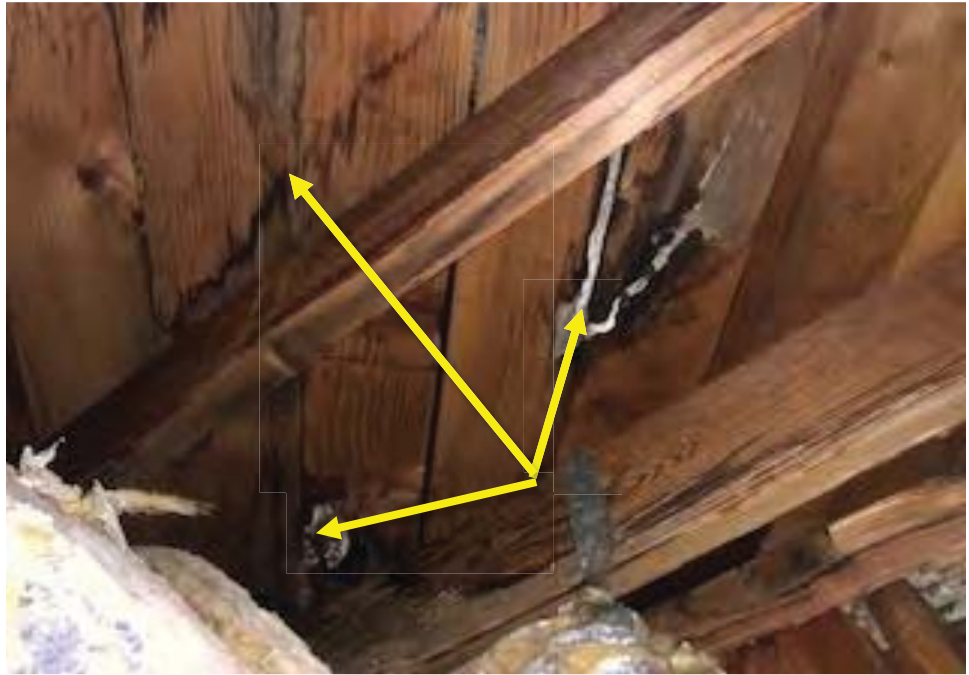
Photograph 3: Multipurpose Building: View of ceiling water damage in the hallway attic areas.

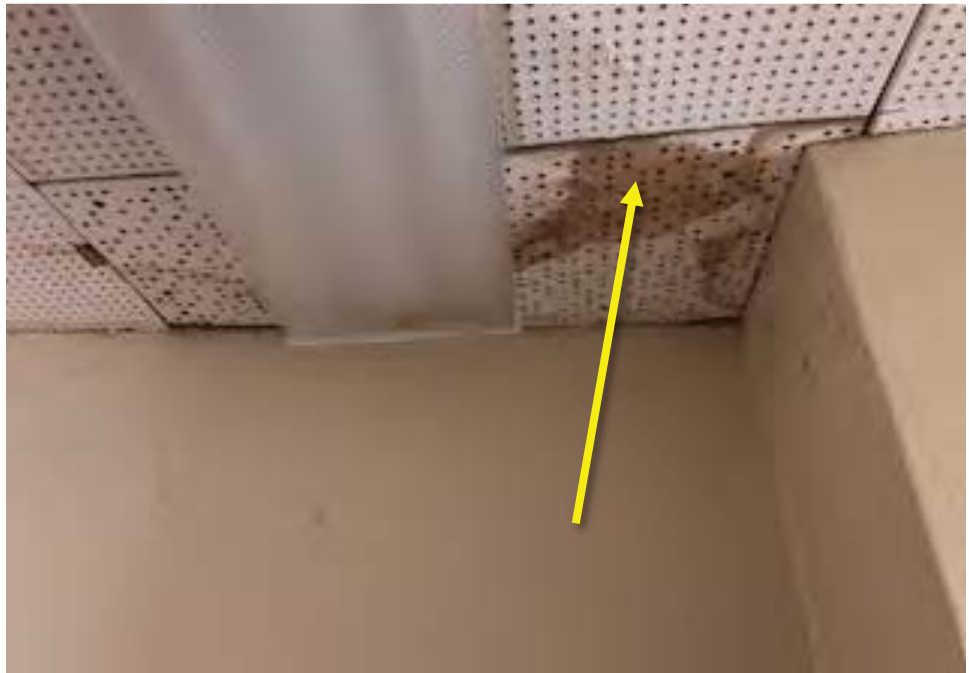
Photograph 4: Multipurpose Building: View of ceiling water damage in hallway areas.

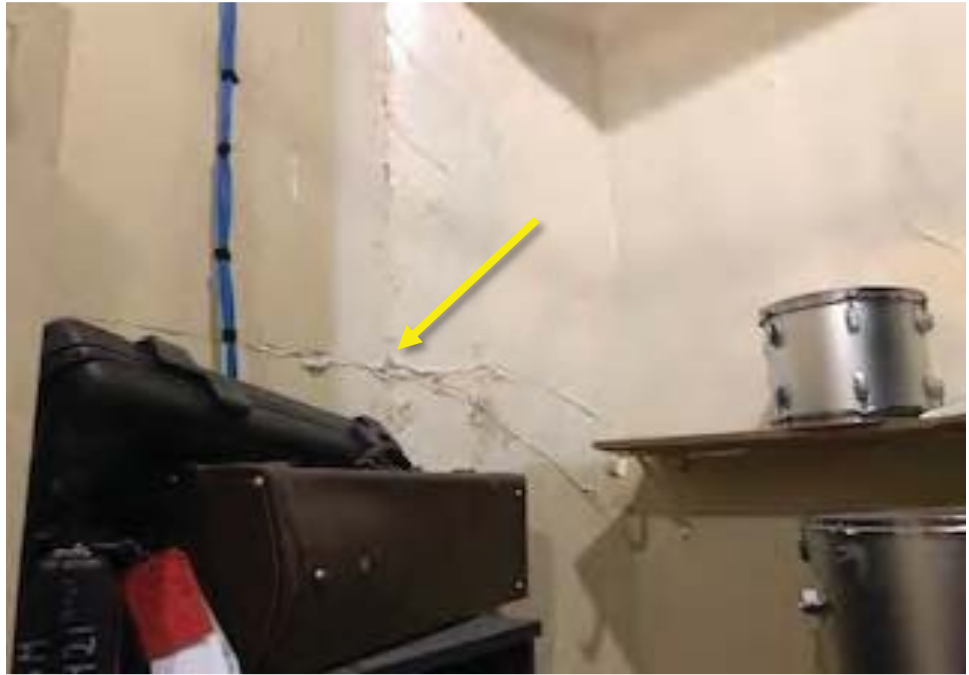
Photograph 5: **Multipurpose Building: View of wall water damage in storage room.**
