## **AHERA THREE-YEAR RE-INSPECTION**

Webster Elementary School  
3602 Winter Canyon Road  
Malibu, California

Project No.: 110-0006

Date: June 22, 2010

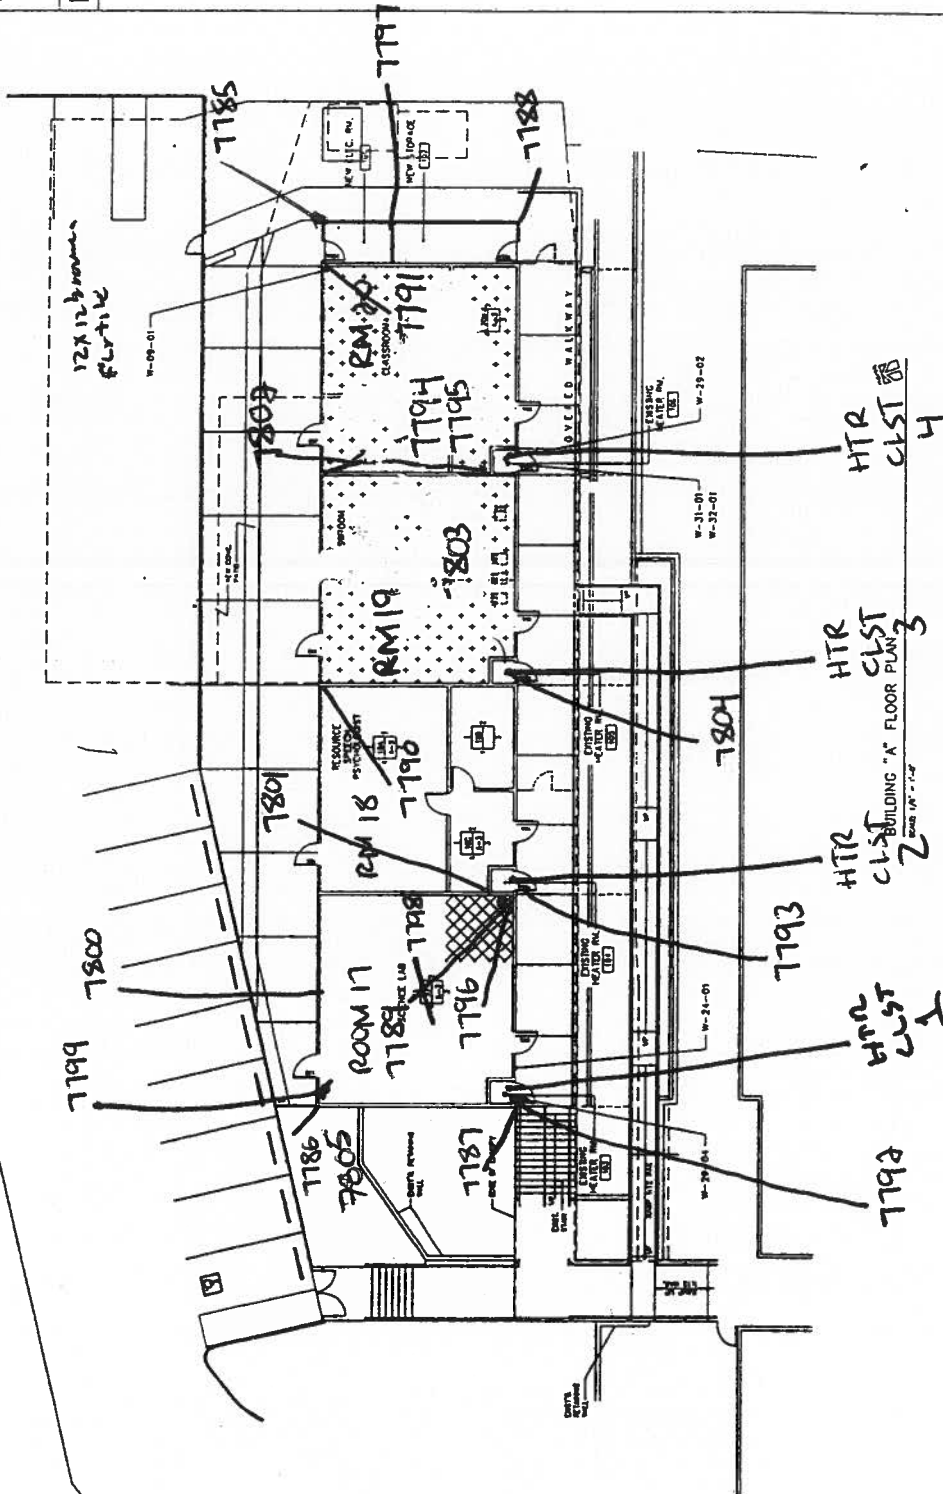
Fig 1A

| | ASBESTOS-CONTAINING 12" x 12" FLOOR TILE AND MASTIC. |
| | ASBESTOS-CONTAINING 9" x 9" FLOOR TILE AND MASTIC. |

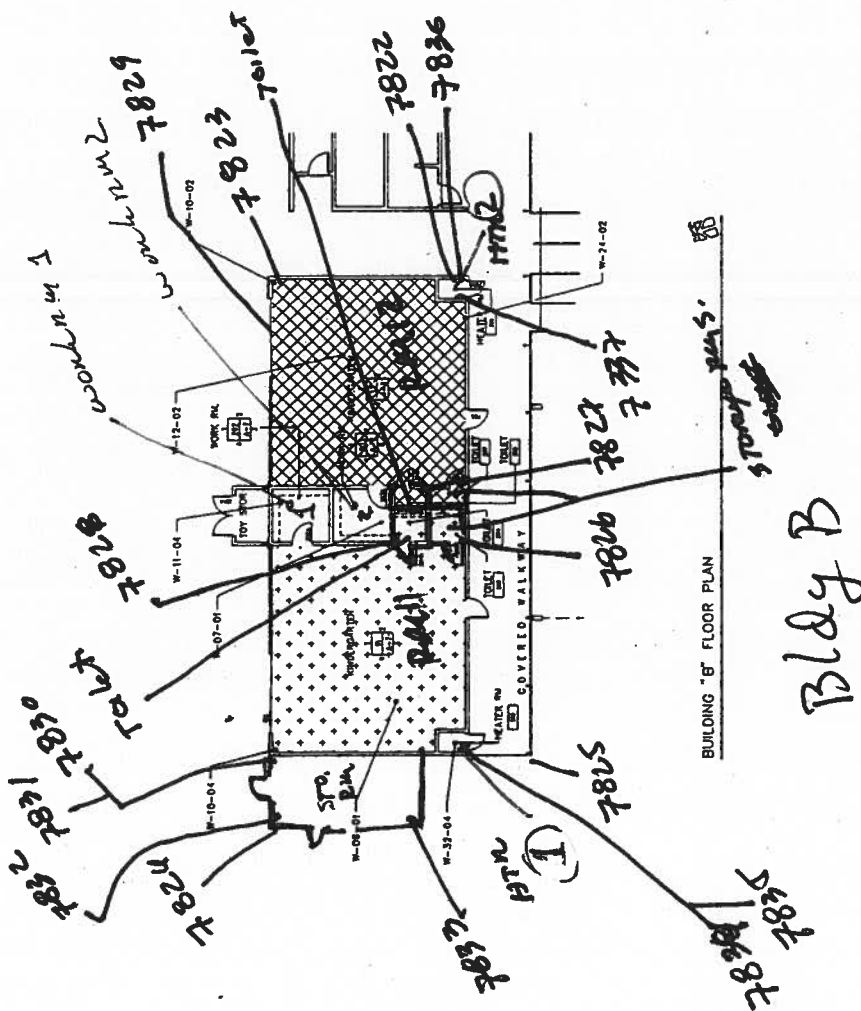
BUILDING "B" FLOOR PLAN

| | ASBESTOS-CONTAINING 12' X 12' FLOOR TILE AND MASTIC. |
| | ASBESTOS-CONTAINING 9' X 9' FLOOR TILE AND MASTIC |

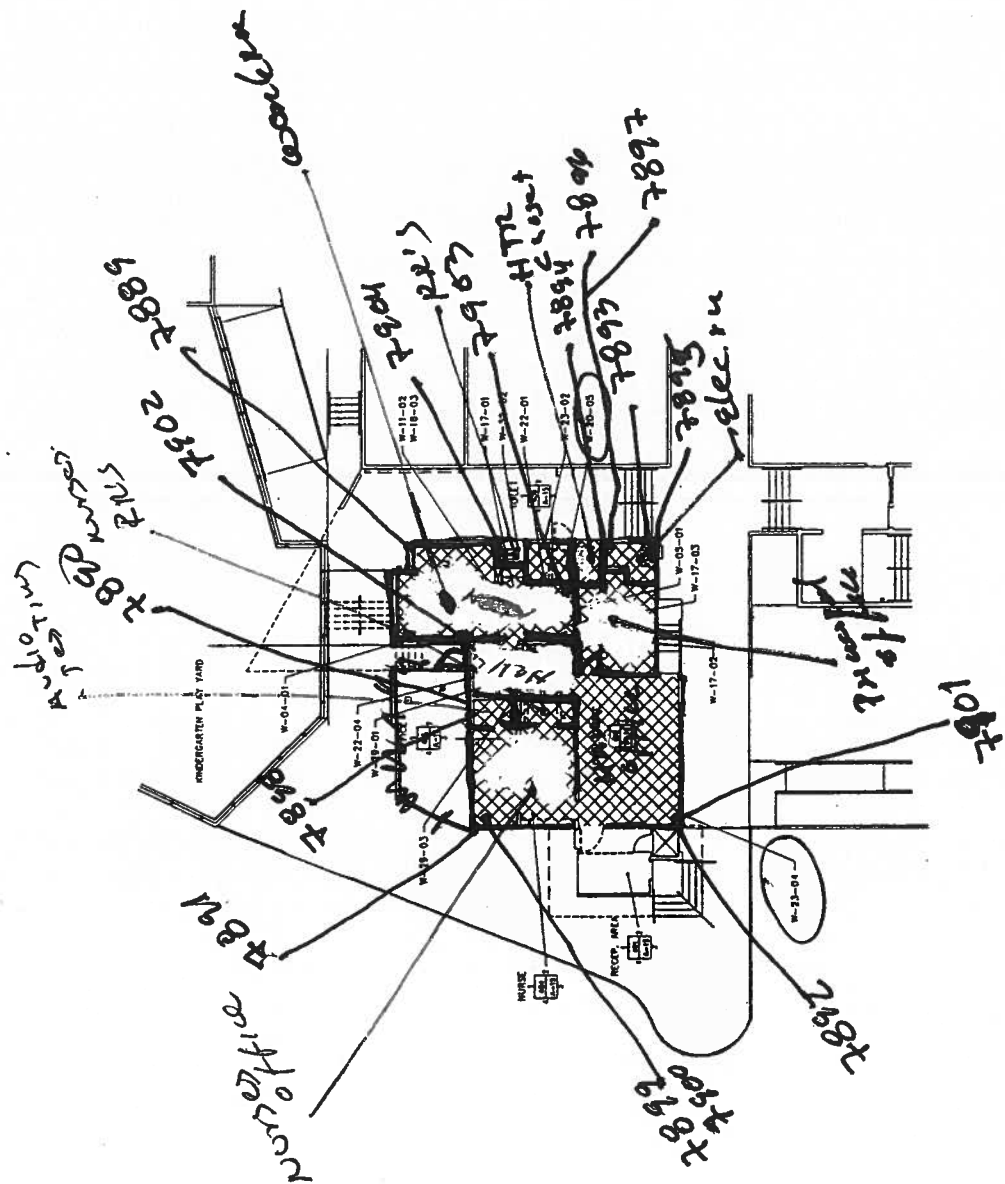
**BUILDING "D" FLOOR PLAN**  
**SCALE: 1/8" = 1'-0"**

ASBESTOS-CONTAINING 9" x 9"  
FLOOR TILE AND MASTIC

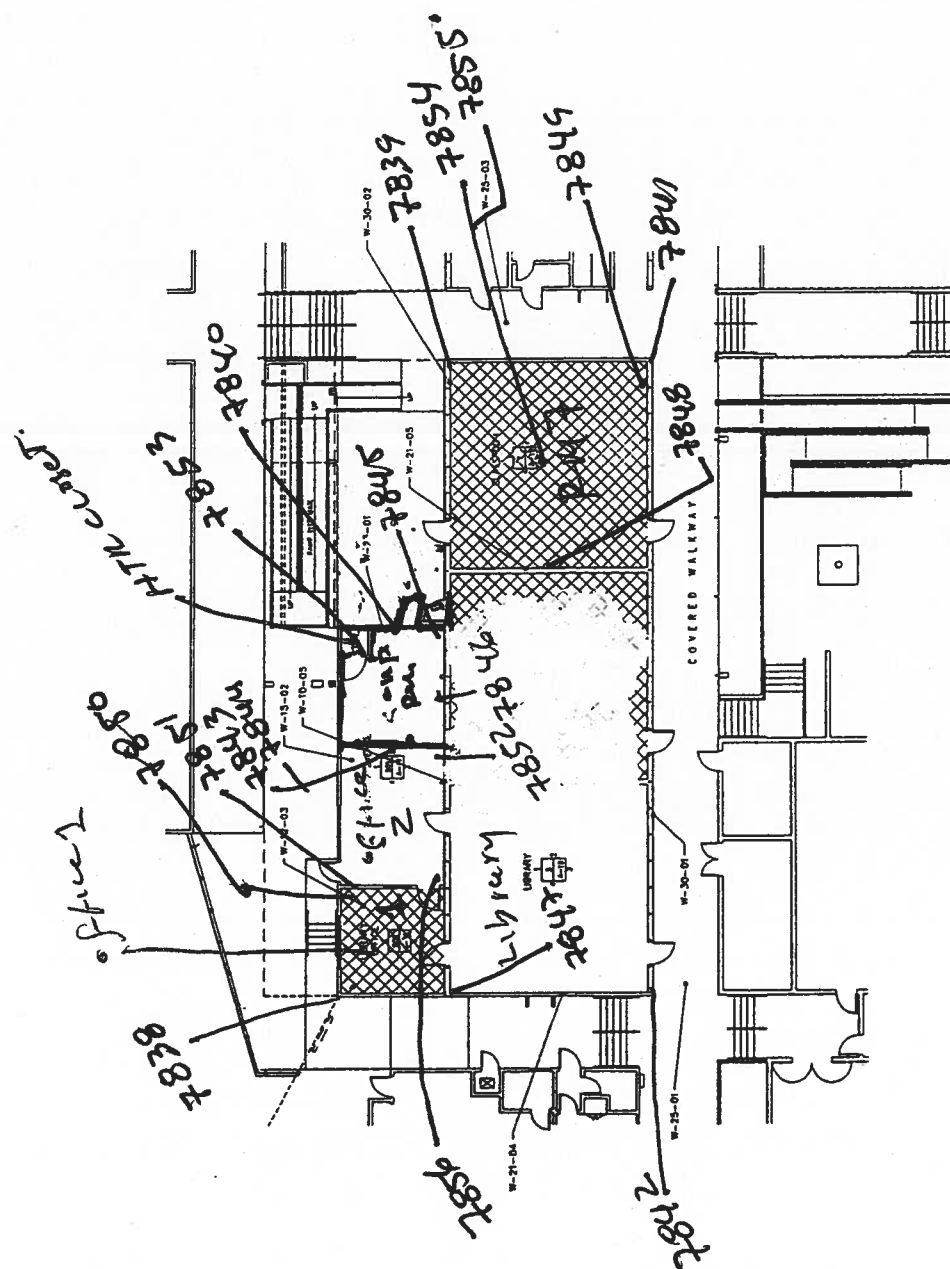
BUILDING "E" FLOOR PLAN

ASBESTOS-CONTAINING P.B. P.  
FLOOR TILE AND MASTIC

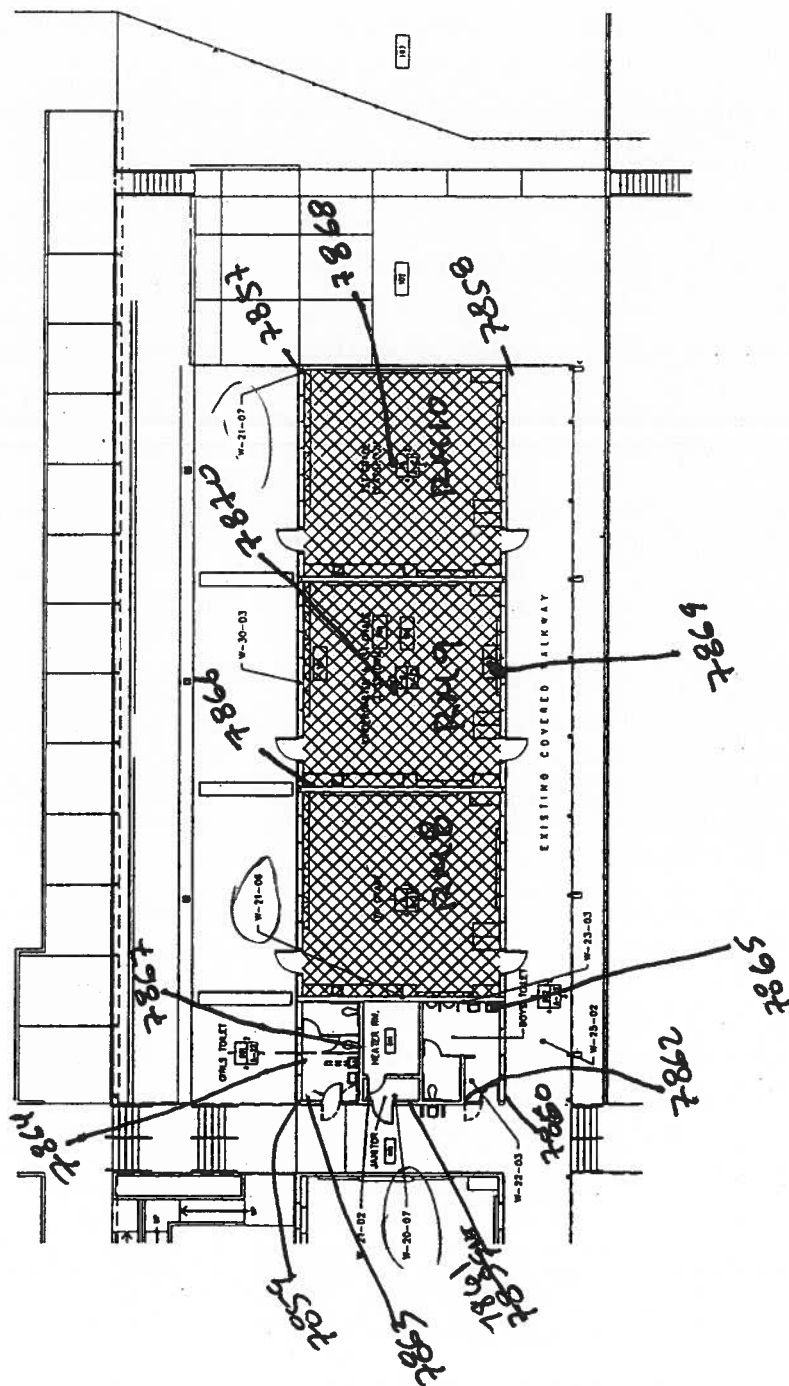
BUILDING "F" FLOOR PLAN

ASBESTOS-CONTAINING 9" x 9"  
FLOOR TILE AND MASTIC

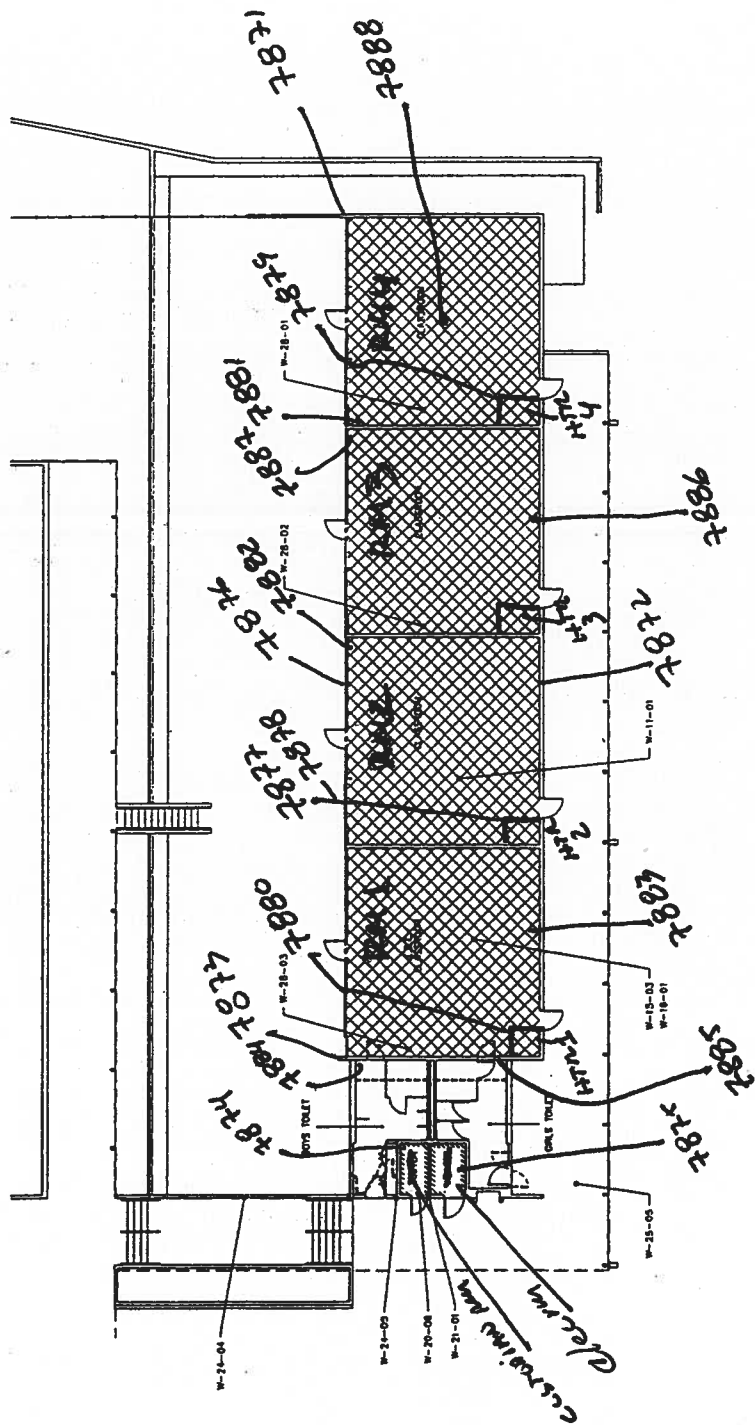
**BUILDING "H" FLOOR PLAN**

- ASBESTOS-CONTAINING 9" x 8" FLOOR TILE AND MASTIC
- ASBESTOS-CONTAINING INTERIOR WALL PLASTER
