June 5, 2019

Mold Investigation Report: Findings of Initial Assessment

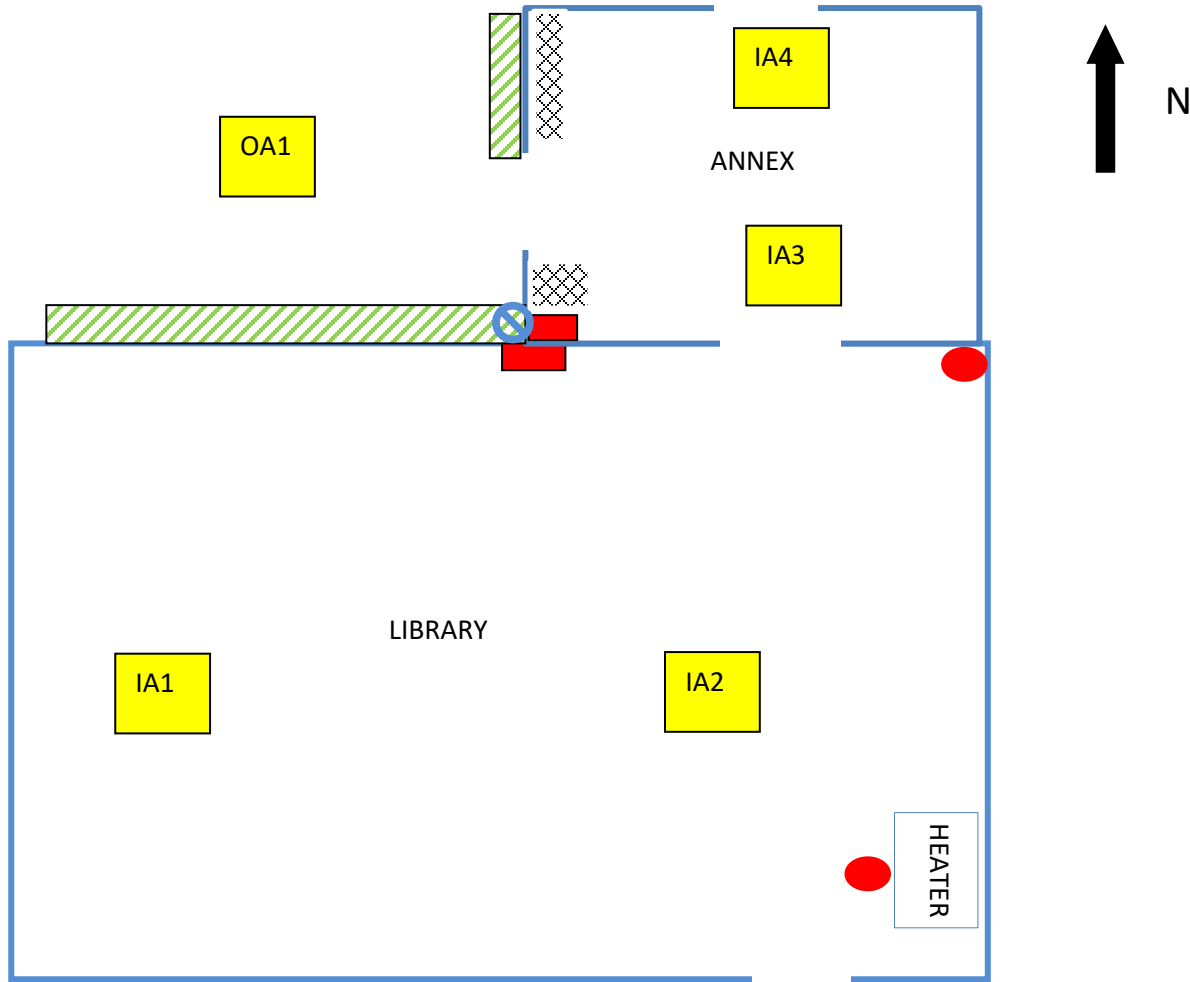
Appendix A Floor Plan

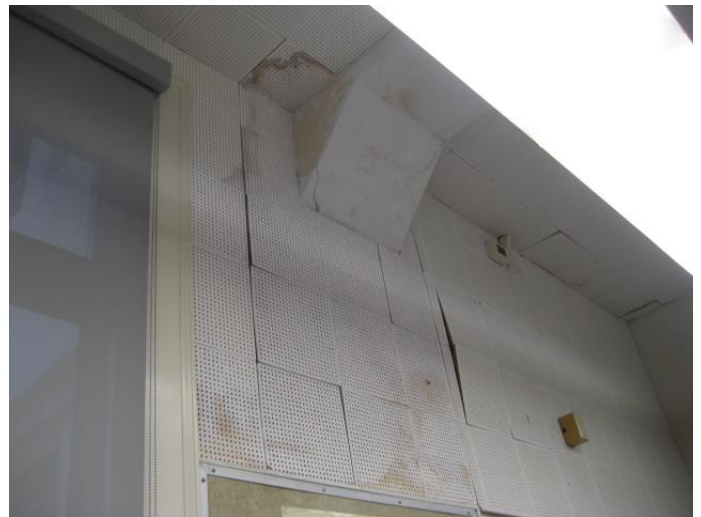
Photo #8: Library – overview of N wall – evidence of heavy moisture impacted building materials

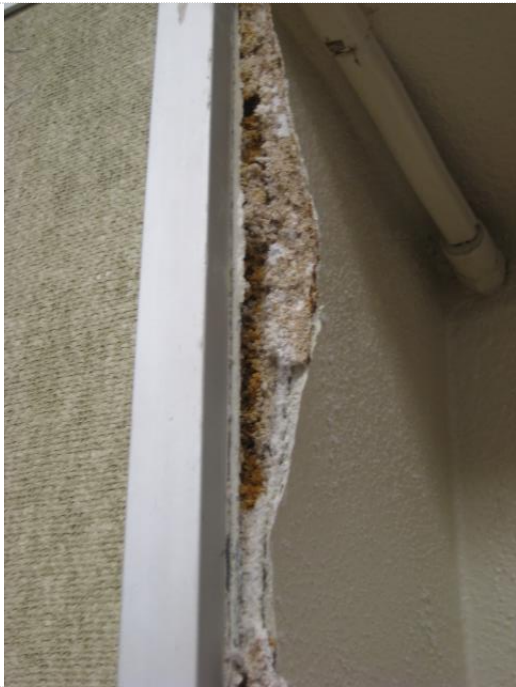
Photo #9: Library – N wall – close up of damage to building material

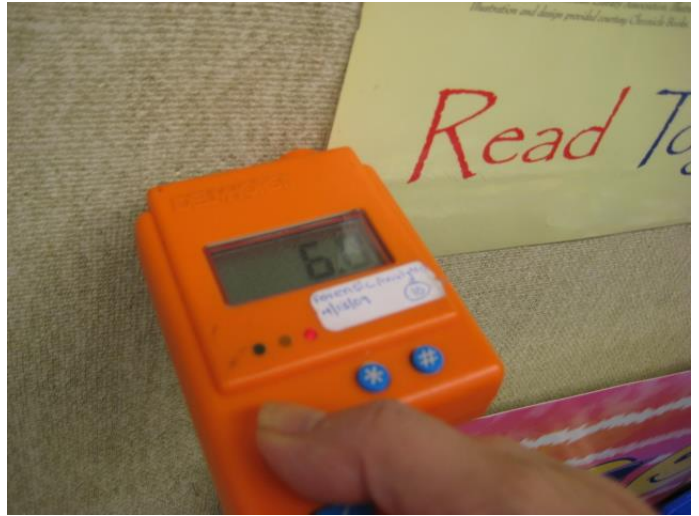
Photo #10: Moisture level readings measured at elevated levels in at N wall (pin board)

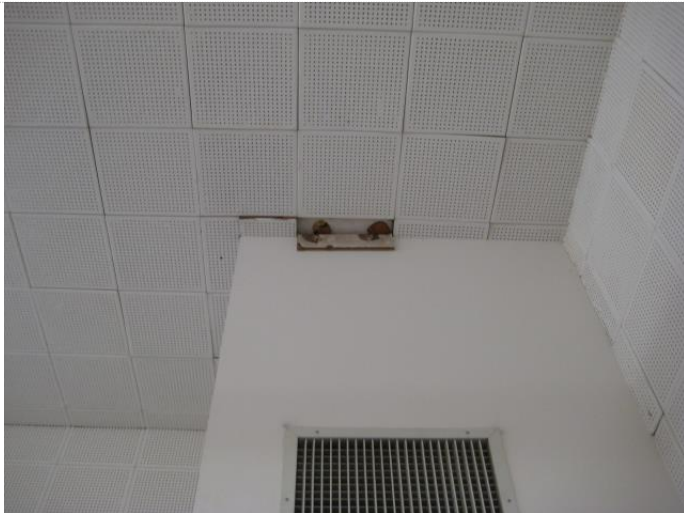
Photo #11: Library – damage/missing ceiling tile at SE corner (above the furnace closet)

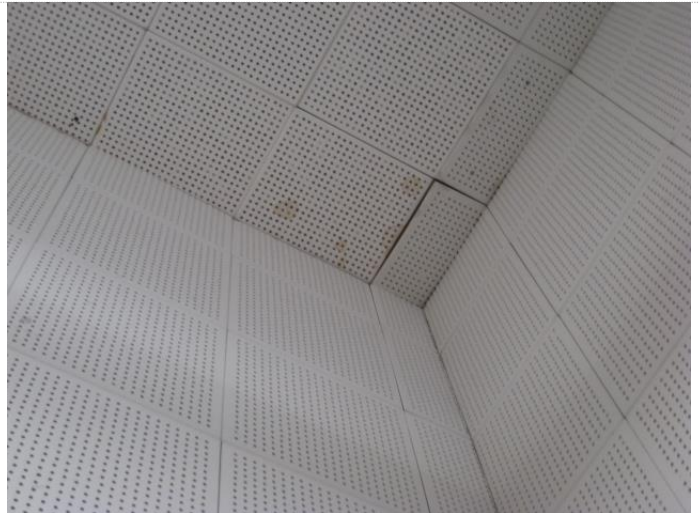
Photo #12: Library – moisture impacted ceiling tile at NE

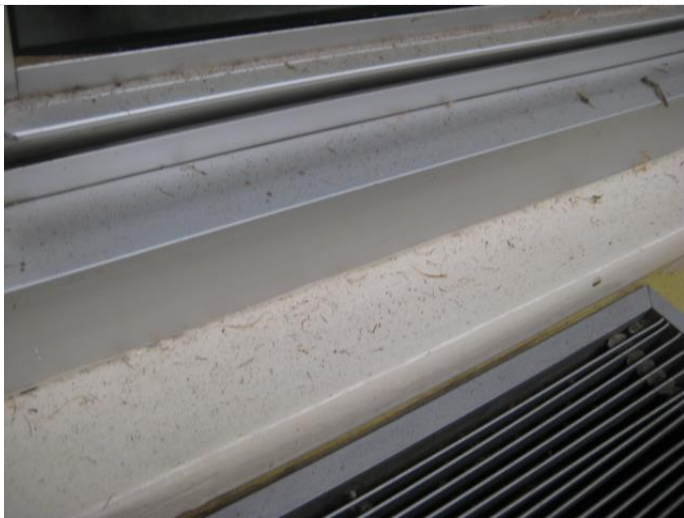
Photo #13: Library – heavy dust/debris deposition observed at N windowsill (adjacent N planter)

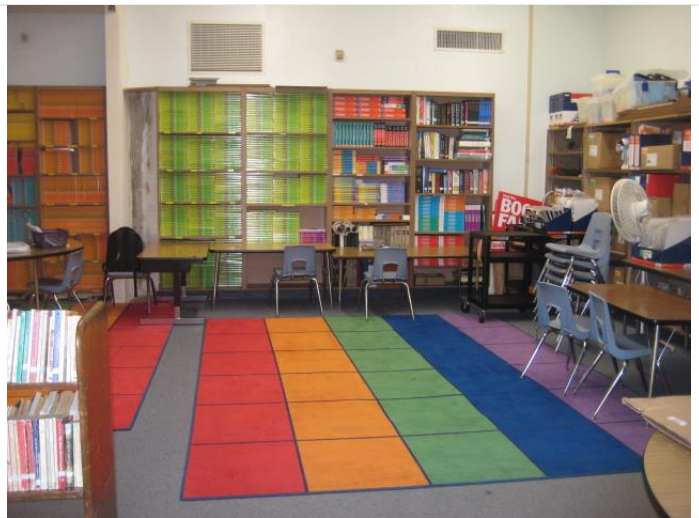
Photo #14: Overview – Annex space adjacent Library

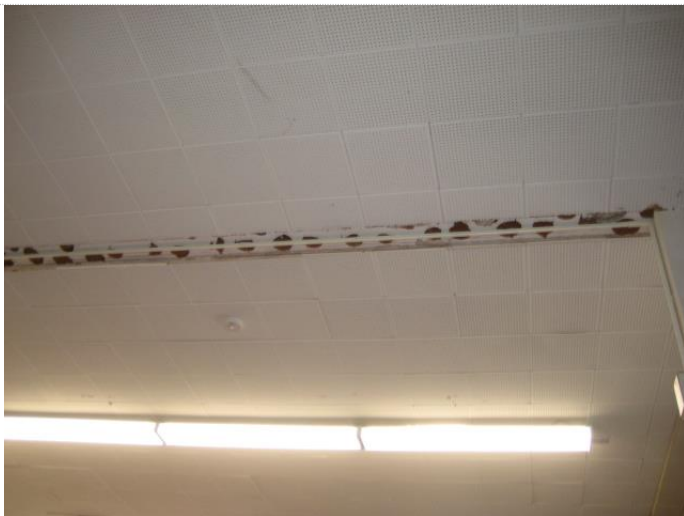
Photo #15: Annex – missing/damage ceiling tiles observed

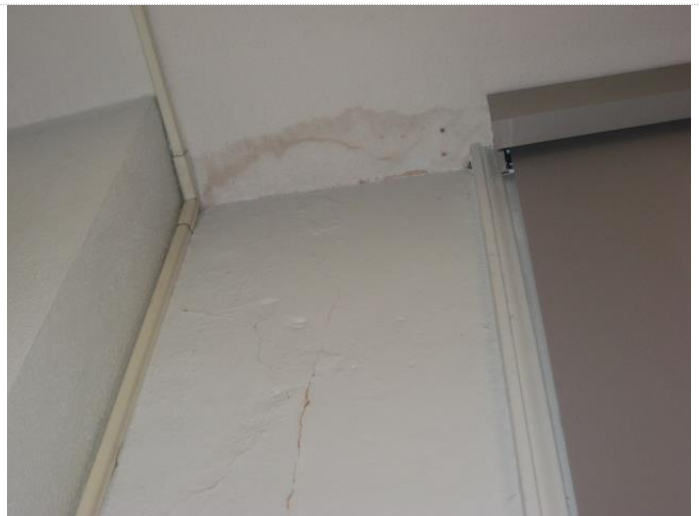
Photo #16: Annex – overview of SW upper wall – evidence of moisture impacted building materials at ceiling and upper wall (adjacent window)

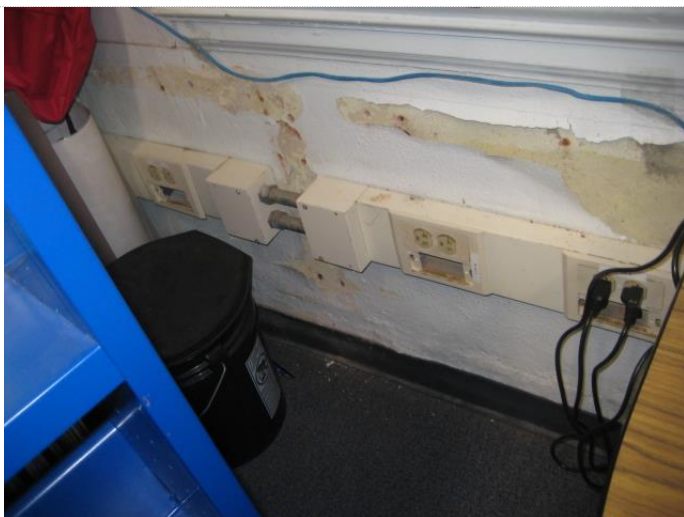
Photo #17: Annex – overview of SW lower wall – evidence of moisture impacted building materials (blistering paint, damage) below the window

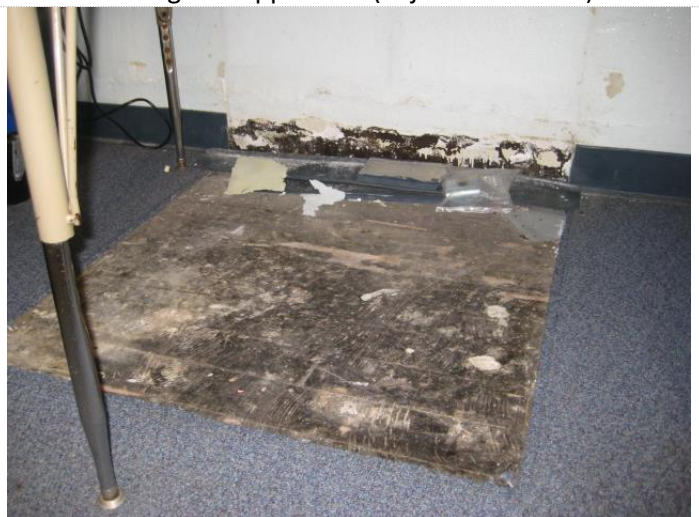
Photo #18: Annex – overview of SW lower wall – vinyl cove base and section of carpet flooring removed (note: black discoloration is mastic, not mold growth)

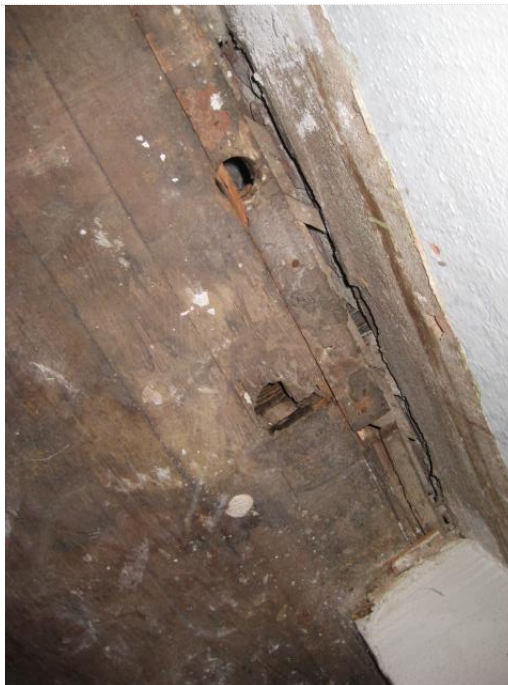
Photo #20: Annex – closeup of wood subfloor at NW wall – damage and warping of wood member observed

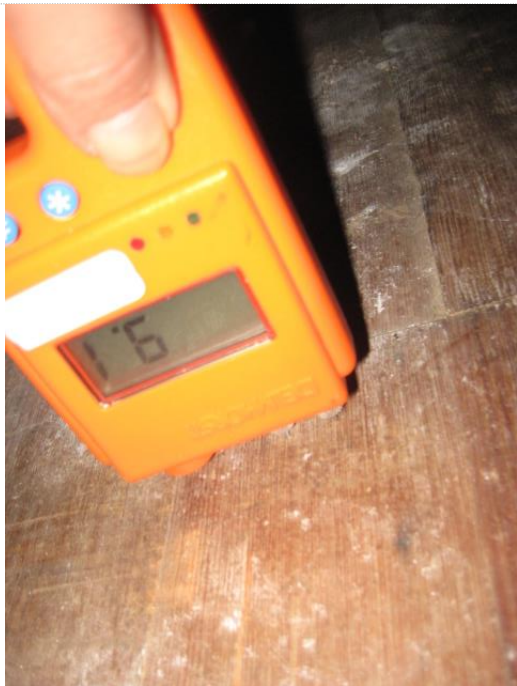
Photo #21: Moisture level readings measured at acceptable levels at the wood subfloor at NW wall
