Mold and Moisture Investigation Report: Findings of Initial Assessment

John Muir Elementary School & SMASH Elementary School Classrooms 205, 400, 415, 440, 600, 615, 660, and Media Center 2526 Sixth Street Santa Monica, CA 90405

FACS Project #PJ35033

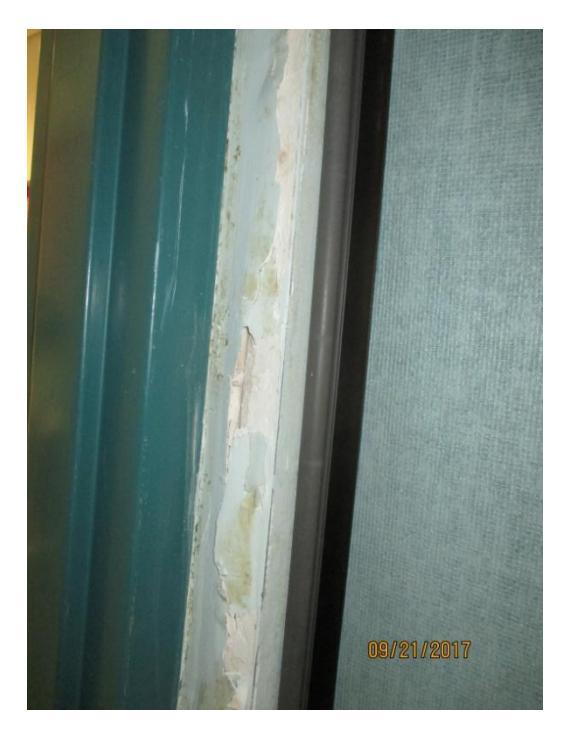
Ref #	Functional Area/Location	Observations/History	Area of Mold ^a	Area of Moisture ^b	Moisture Readings	Photo # ^d	Sample # ^d
н	Classroom 400	9/21/17: Water damage observed around door to break room, and on ceiling above. No elevated moisture noted.	١	~5-10 ft ² (damaged wall)	Drywall: 0.2%	2-4	IA4
Ι	Classroom 415	9/21/17: No significant findings with respect to mold or moisture.	١	/	١	5	IA3
J	Classroom 440	9/21/17: No significant findings with respect to mold or moisture.	١	/	١	6	IA9
К	Classroom 660	9/21/17: No significant findings with respect to mold or moisture.	١	/	١	7	IA10
Note	s:

Photo #3: Classroom 400 – water damaged walls around doorway to break room

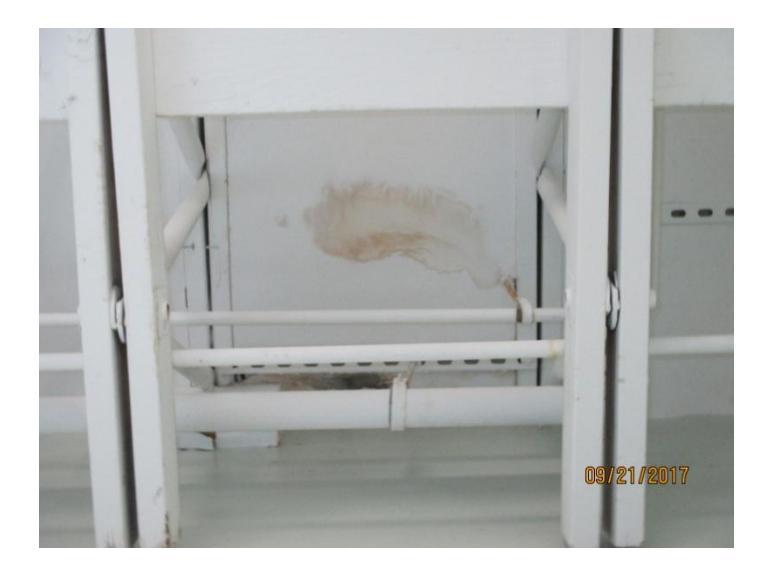
Photo #4: Classroom 400 – water damaged ceiling above doorway to break room
