Santa-Monica Malibu USD Energy Management Report

SANTA MONICA-MALIBU UNIFIED SCHOOL DISTRICT

3/13/2020

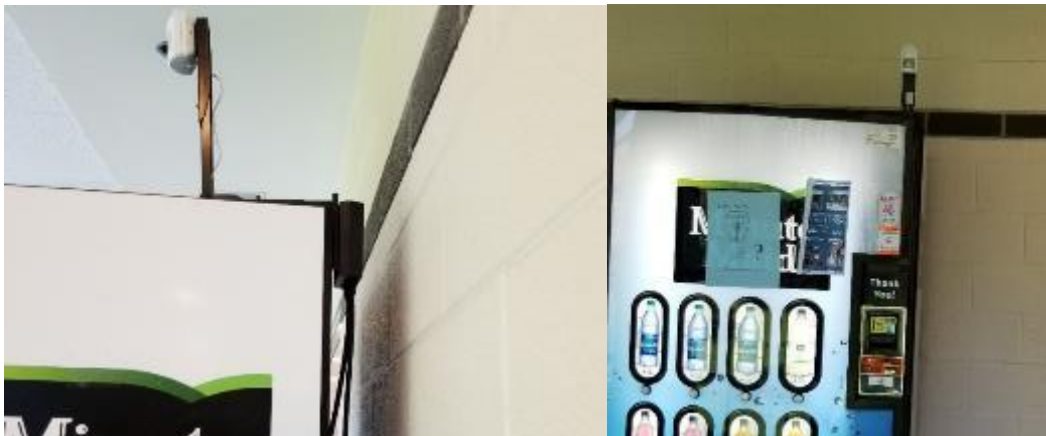
Figure 1. Vending misers retrofitted on vending machines at another District. Vending misers reduce energy consumption by turning off the machine when no motion is sensed for 15 minutes (turning on at regular 90-minute intervals to ensure the product remains cold).

- Cost **\$135 per unit**, and can save an estimated **\$80-140 per year** by reducing the energy consumption of vending machine by 30%
 - Based on the average K-12 school occupancy schedule, the unit will pay for itself within the first year through the savings generated

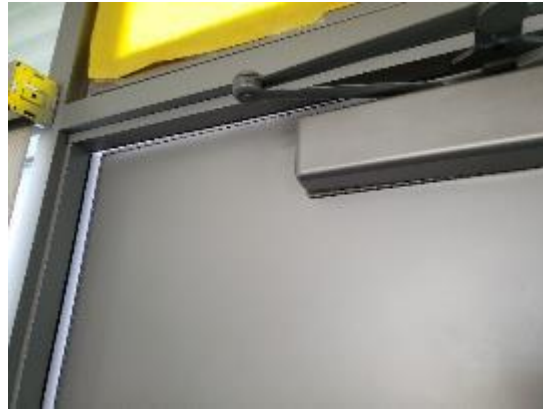
Figure 2. The spring-loaded door does not close by itself in classroom 207. When HVAC runs, it will lead to air leaking out of the space where the temperature should be adjusted.

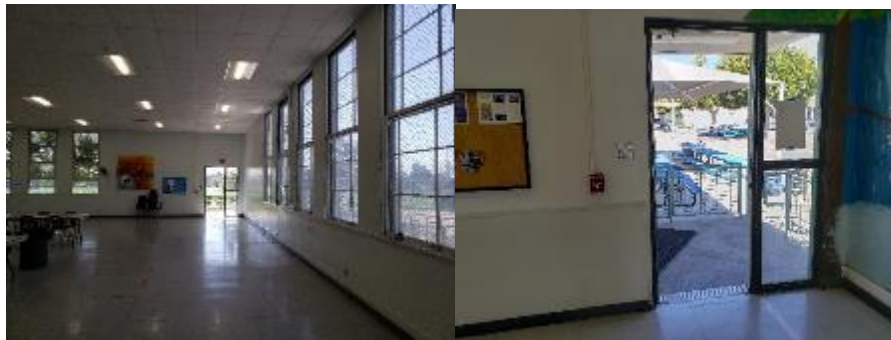
Figure 3. Exterior doors were wide open while the air conditioning is running in the cafeteria. It is recommended to have the doors closed while the unit is running.

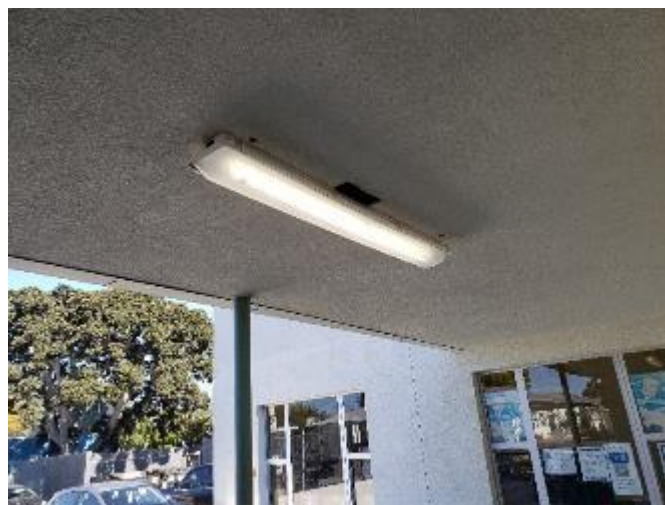
Figure 4. Exterior lights are on during the day near the cafeteria. It is recommended to have the exterior lights off during the day time.

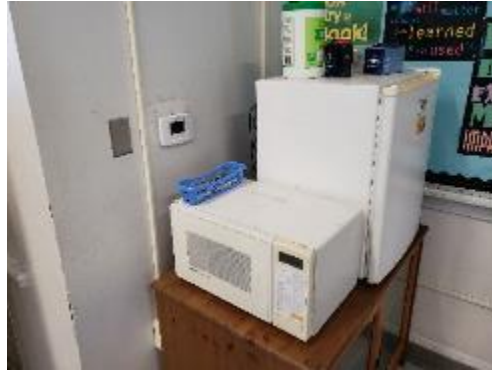
Figure 5. In classroom 53 (breakroom), a mini-fridge was found. To encourage and reduce the need for the mini-fridge, a recommendation to have a full size-fridge that is more efficient for the amount of storage space provided.

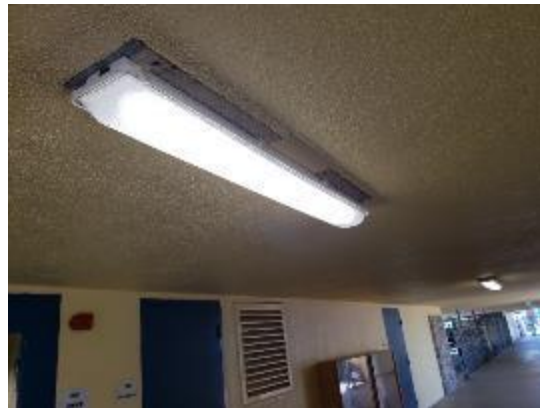
Figure 6. Exterior hallway lights on near the nurse's office during the daytime.

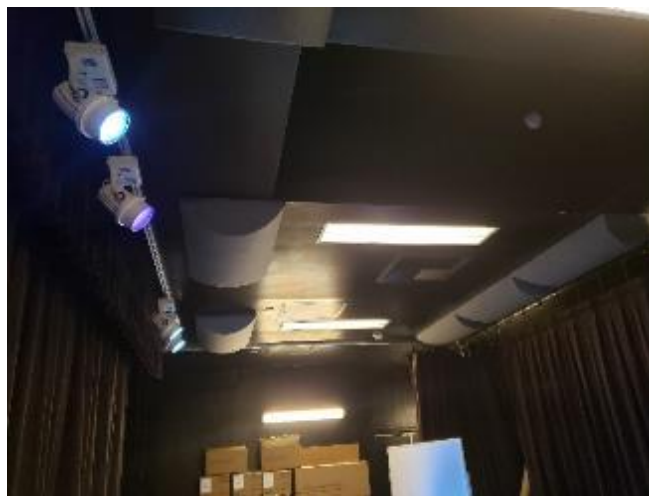
Figure 7. The stage lights left on while the stage was not used. The multipurpose room was set up to be a voting area, but curtains for the stage were pulled to close off the light.

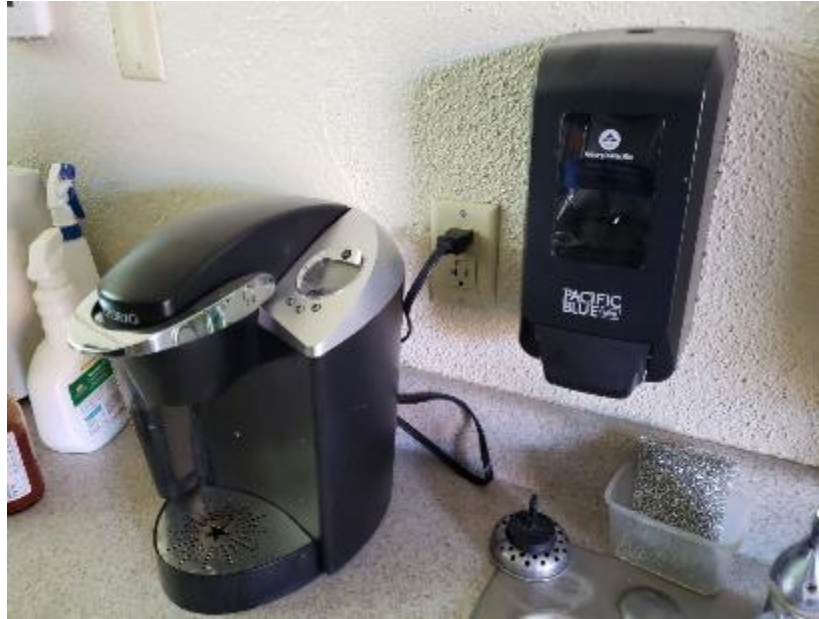
Figure 8. It is recommended to have the Keurigs off after school hours, weekends, and holidays due to the coils being heated continuously for some units while it is plugged in.

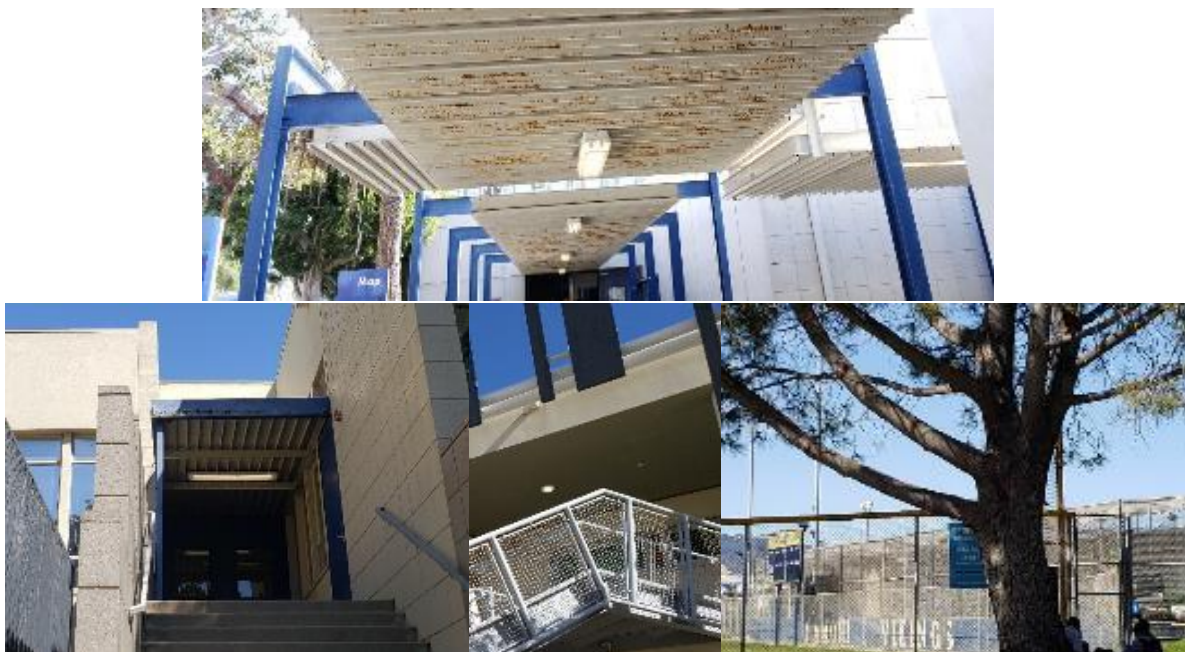
Figure 9. Exterior lights found turned on near the Admin building, multiple lights on around the innovation building, and near the construction of the parking lot.

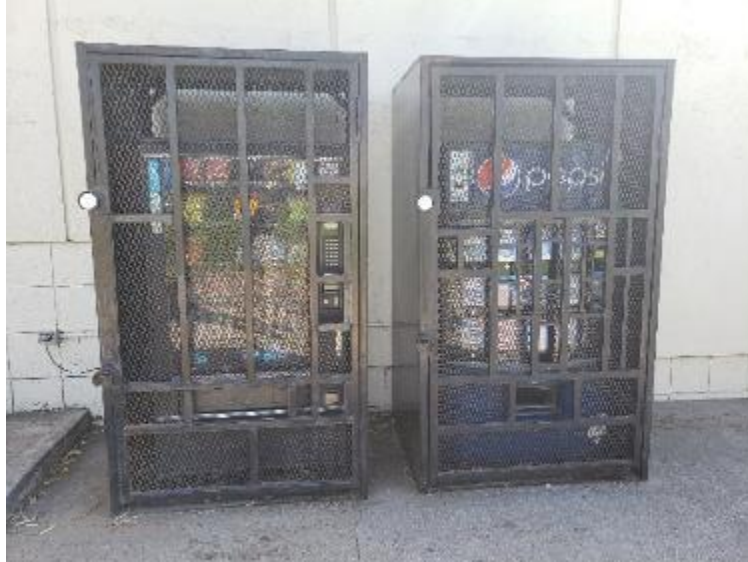
Figure 10. Multiple Caged Vending machines found around the campus that could benefit from motion detection sensor (vending misers).

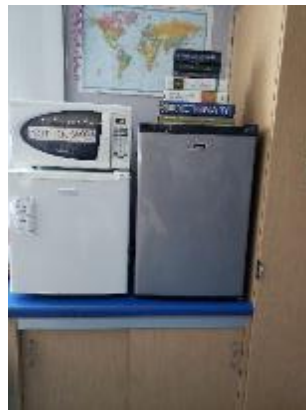
Figure 11. Classroom L109 had Christmas lights around the light board and two mini-fridges. It is recommended that these are off during the weekends and holidays to save energy.

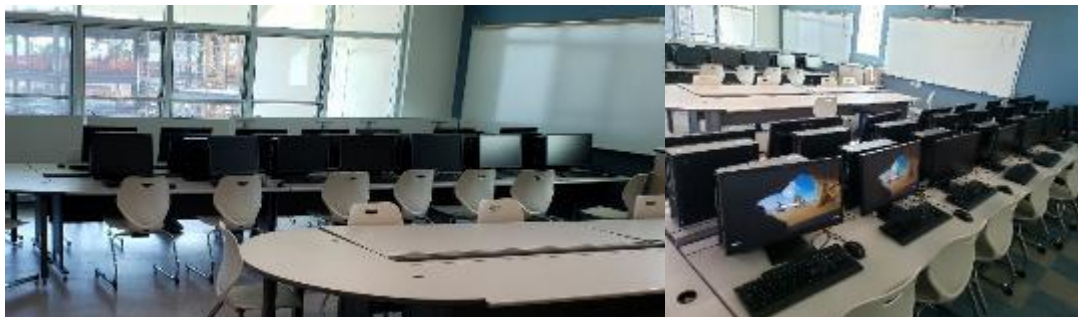
Figure 12. Computers in the computer lab of the innovation building had a power-saving mode. The displays did not have a screen saver, which is an excellent energy-saving practice.

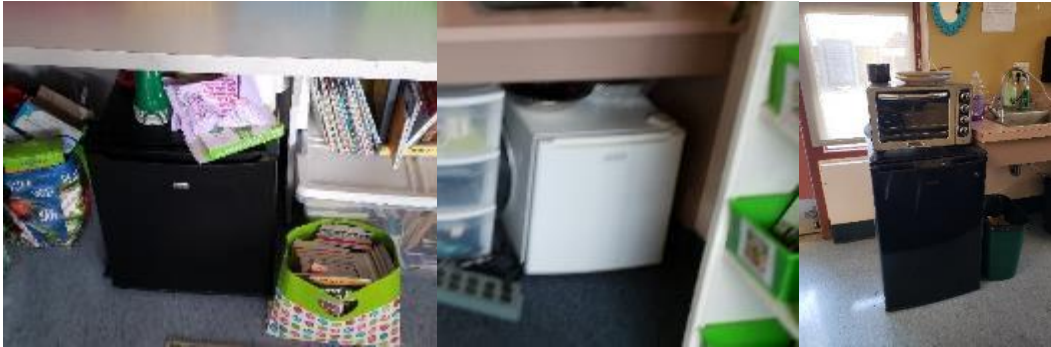
Figure 13. Mini-fridges found on-campus classrooms and break rooms. It is recommended to replace three mini-fridges with a single full-sized fridge. A mini-fridge uses roughly half of the power for a quarter of the storage capacity of a full-size refrigerator.

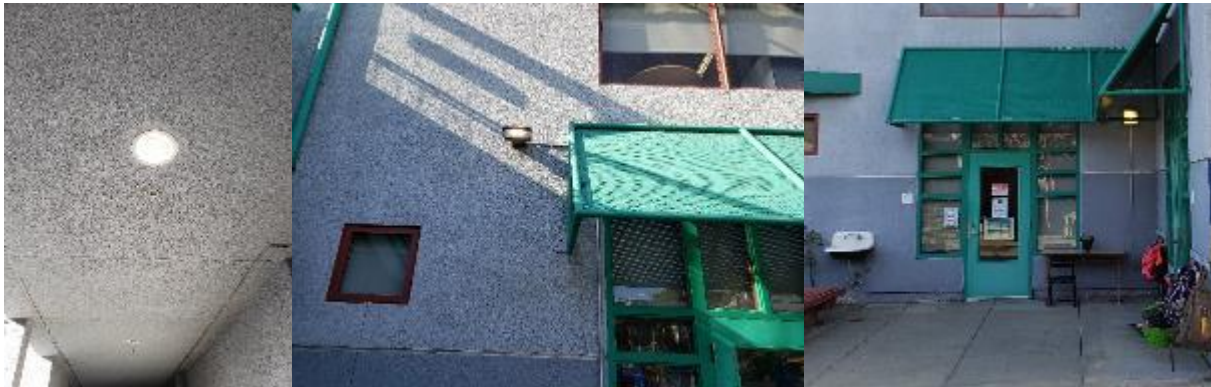
Figure 14. Exterior lights found near the library, classroom 600, and class 610.

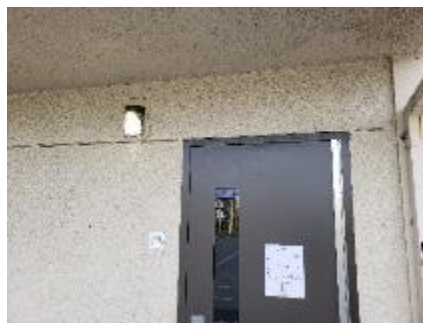
Figure 15. Exterior light was on outside of room B11.

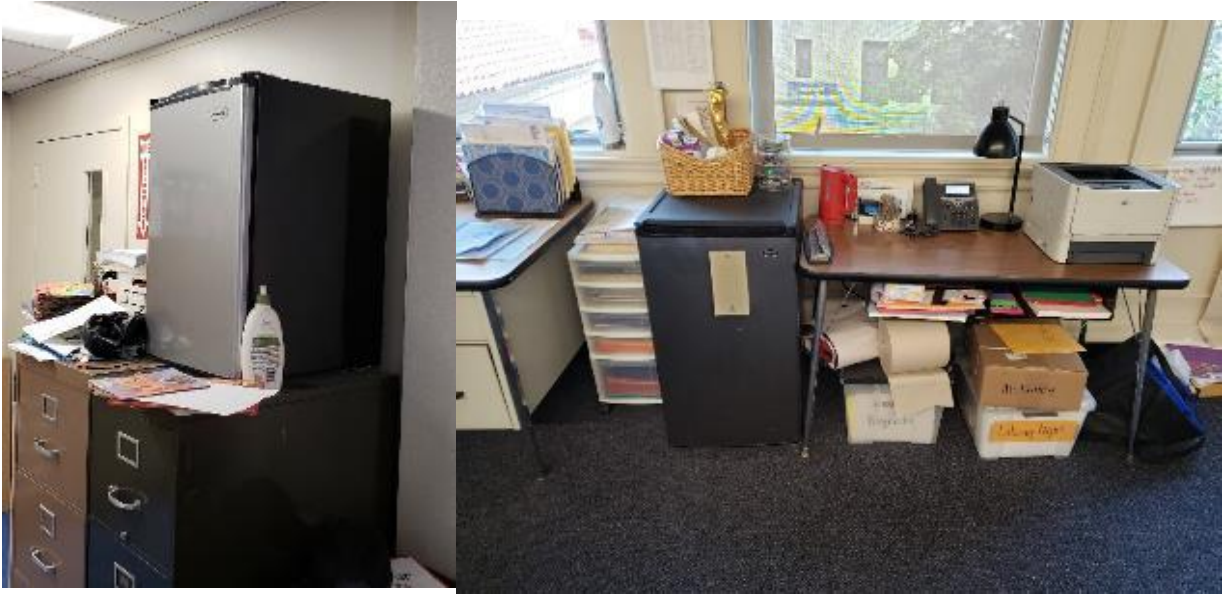
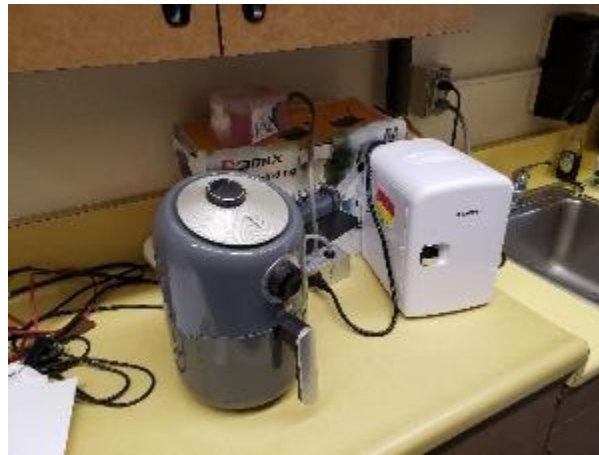
Figure 16. Six out of 16 of the rooms (38%) locations visited had mini-fridges.

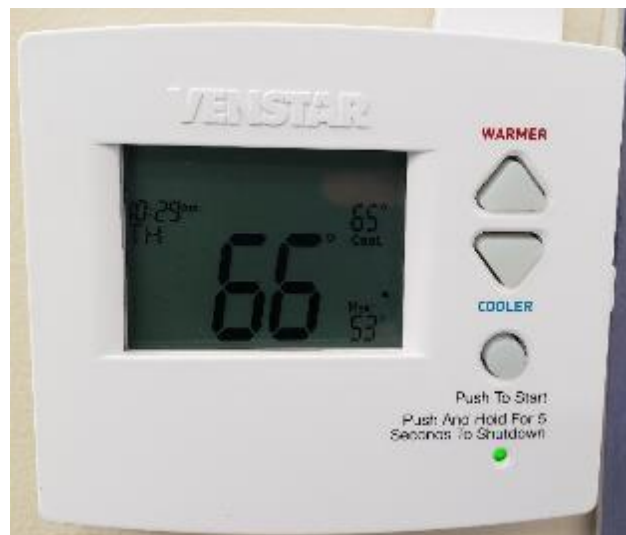
Figure 17. The setpoints are low, at 53°-65°F, in room 110.

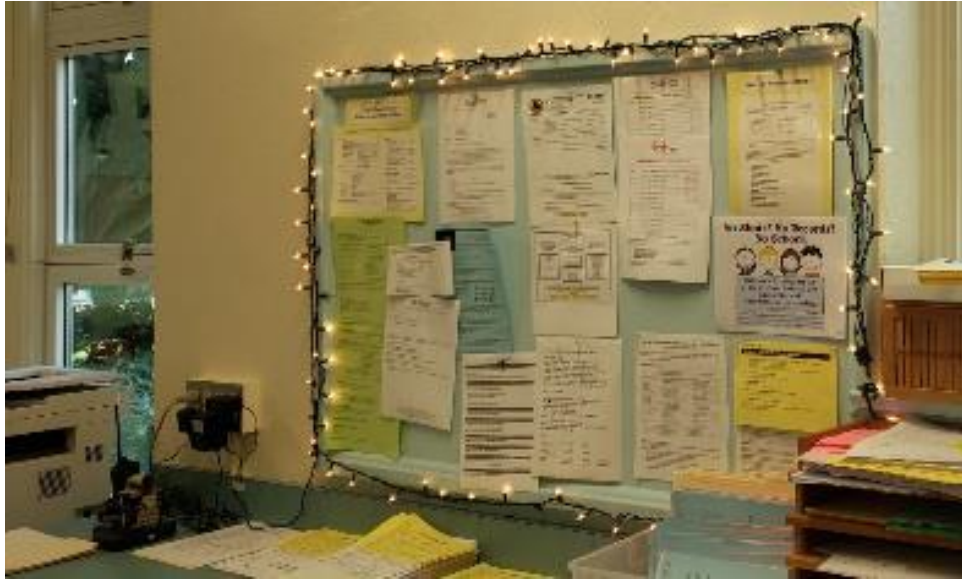
Figure 18. Christmas lights were found in the front office.

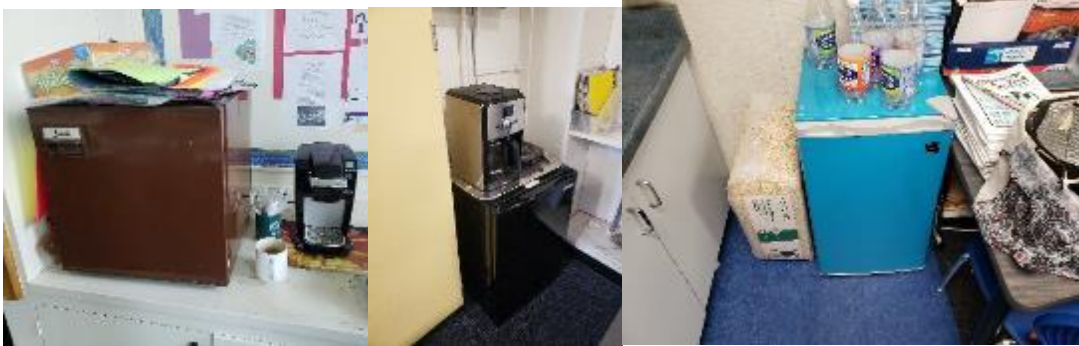
Figure 19. Seven out of 19 (37%) of the locations visited had a mini-fridge.

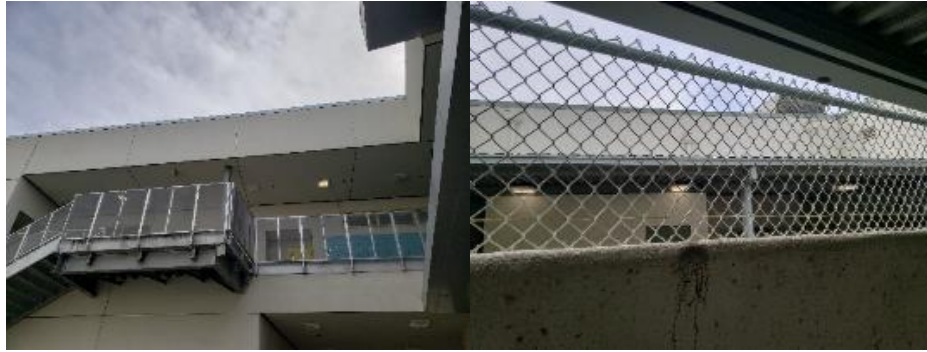
Figure 20. Exterior lights found on while walking from the library to the music room and near room 314.

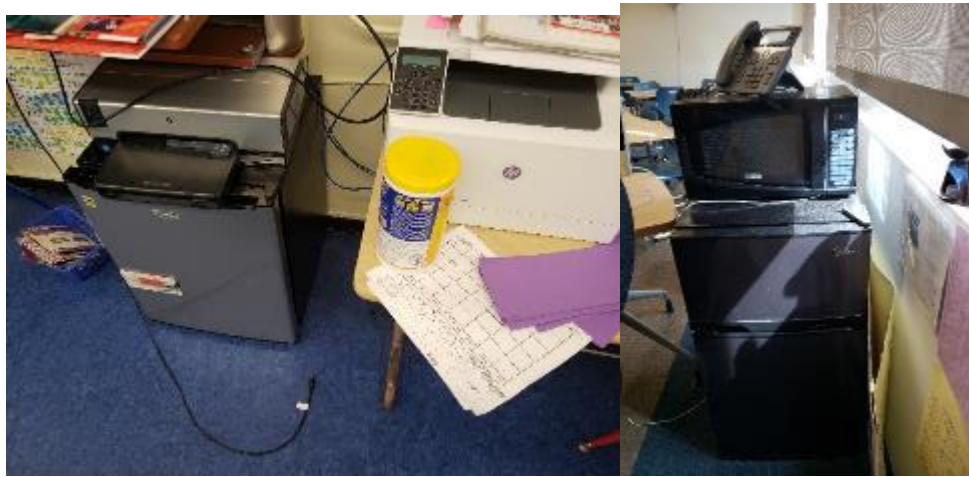
Figure 21. six out of 16 (38%) of the rooms visited had mini-fridges

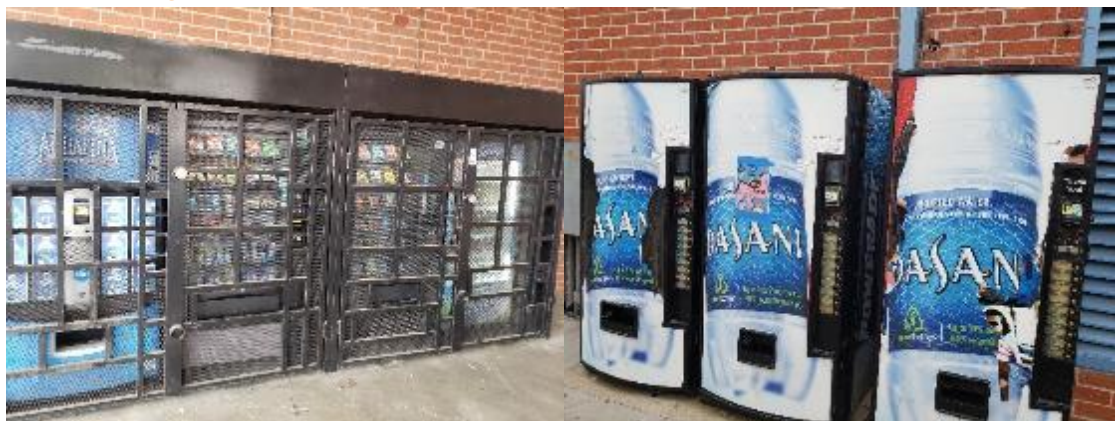
Figure 22. 8 caged vending machines near the cafeteria that could be equipped with a motion sensor vending miser. Also, six uncaged vending machines near the pool area by the bungalows.

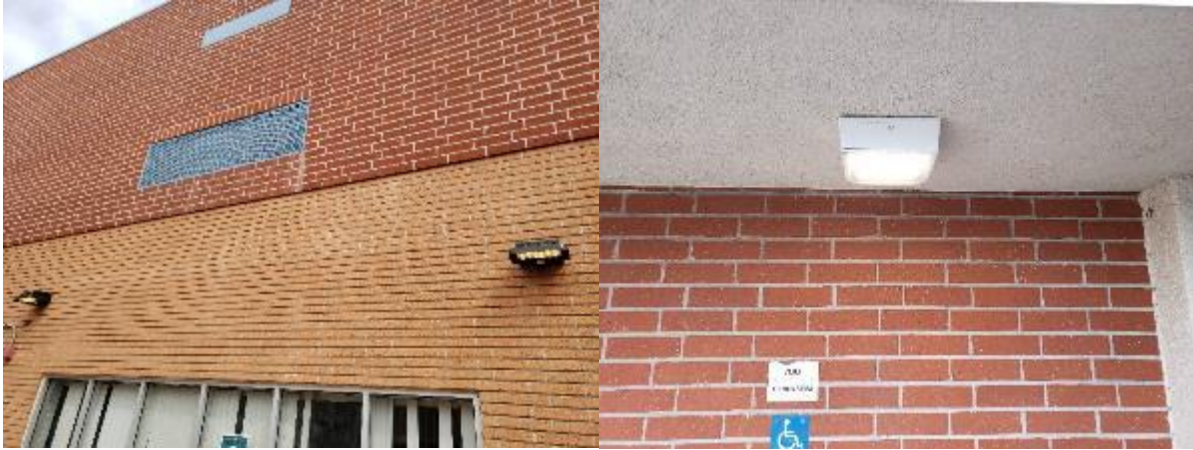
Figure 23. Exterior LED lights on seen from when traveling from auditorium to the teacher lounge. Also, light on during the day near the gymnasium.

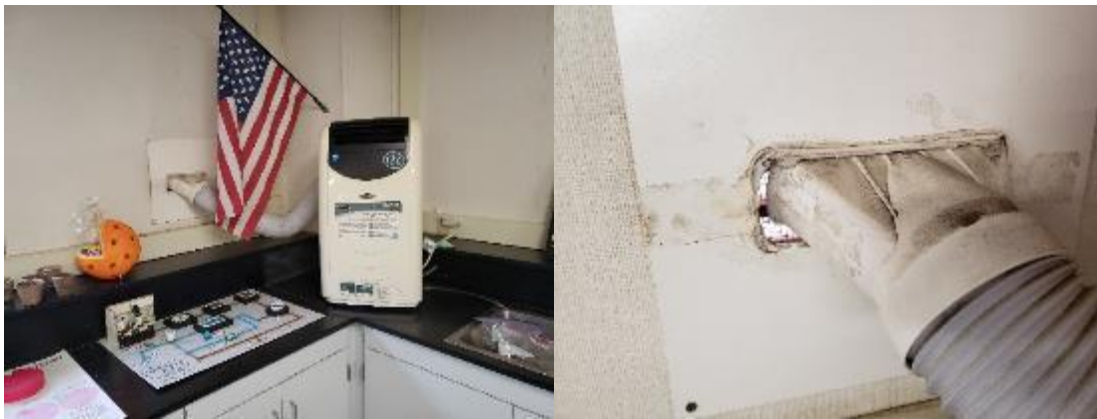
Figure 24. The air conditioning unit is not sealed well to the outside. It is recommended to ensure proper weather sealing during installation.

- Have proper weather sealing on wall mounted air conditioning units
- Install motion sensor vending misers on vending machines located indoors in the staff lounge
