Energy Management Report

SANTA MONICA-MALIBU UNIFIED SCHOOL DISTRICT

PREPARED ON:
5/14/2020

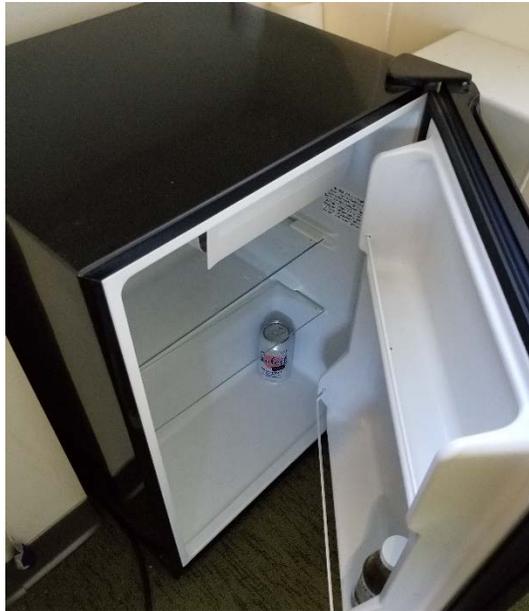
Figure 1. Mini-fridges in the front office and classroom were left plugged in and running during the school closure while they are not being used. A total of (7) mini-fridges were found in the (21) areas that were surveyed.

| Observations and Recommended Action | Check | Location |
|---|---|---|
| <p>Mini-fridges were found plugged in with minimal contents. It is recommended to clean out and unplug so that these are not using energy during the summer break. Mini-fridges were found plugged in within the following areas:</p> | | John Adams Middle School |

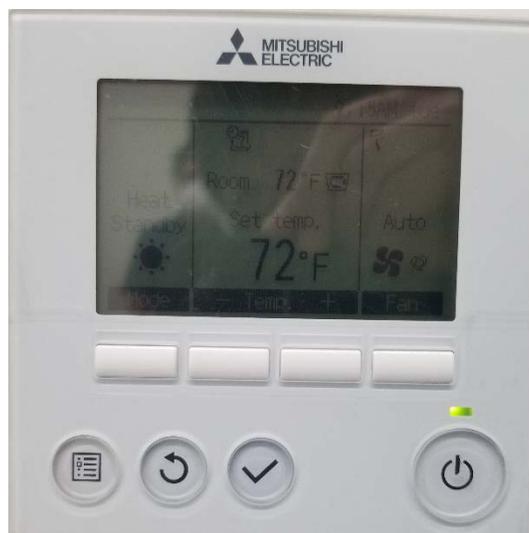
Figure 2. Heat pump thermostats in the front office were set to heat in the front office and in the conference room. This unnecessarily uses electricity when sites are closed and generally unoccupied.

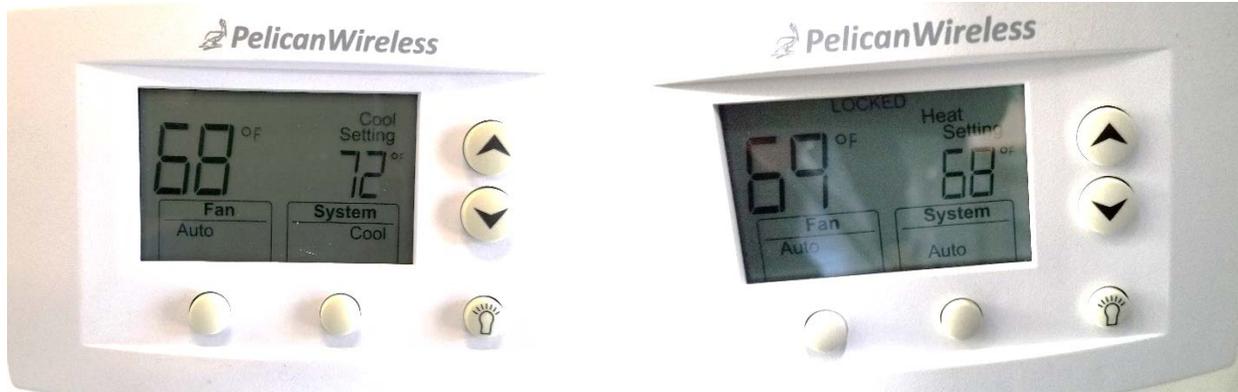
Figure 3. Thermostat set-points and setting on Pelican Wireless thermostats were inconsistent throughout the District. The thermostat in Room 54 (left) was set to 72°F for cooling but was open to changing set-points. The thermostat in Room 86 (right) was set to 68°F for heating and locked.

John Adams Middle School recently had new air conditioning units installed in August 2019 along with Pelican Wireless thermostats. These thermostats appeared to have inconsistent scheduling and functionality, where one room would be set to occupied settings (cooling at 72°F), while others had set-points that were locked. Efficient energy practice suggests keeping set-points and schedules consistent across all areas. **During school closures or breaks, it is advised to set all thermostats into a set-back mode (85°F for cooling/45°F for heating) to reduce the amount of electricity and natural gas being used.**

| Observations and Recommended Action | Check | Location |
|---|---|---|
| <p>Check Set-points on Pelican Wireless Thermostats. Set-points during the site walks were found to be 72°F in the following areas:</p> | | John Adams Middle School |

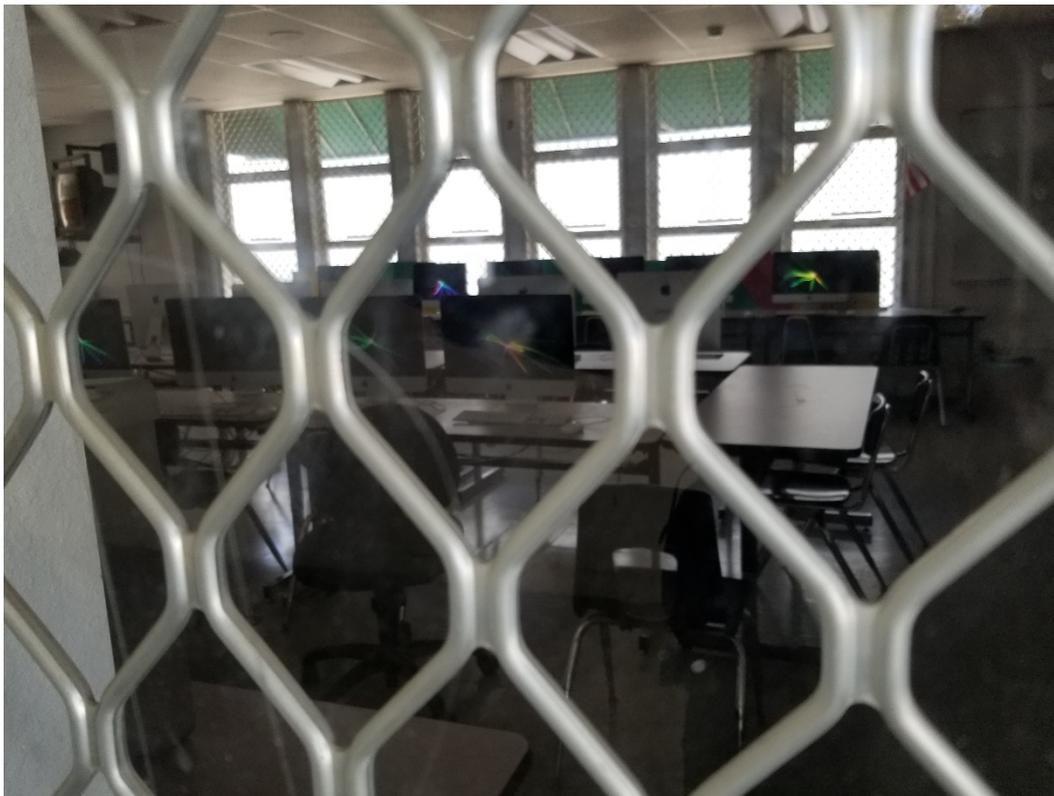
Figure 4. Computers left on in the Computer Lab (Room 45) during the closure. This room was not able to be accessed at the time of the site visit.

Lastly, the computer lab (Room 45) had all computers left on while unoccupied. The room was locked at the time of site visit and no action was able to be taken. **We recommend that desktop computers are turned off, as the computers use just as much energy with the screensaver as being fully on.**

| Observations and Recommended Action | Check | Location |
|---|---|---|
| <p>Computers that were not being used had the monitors turned off to prevent usage during the remainder of the closure.</p> | | John Adams MS - Room 45 (Computer Lab) |

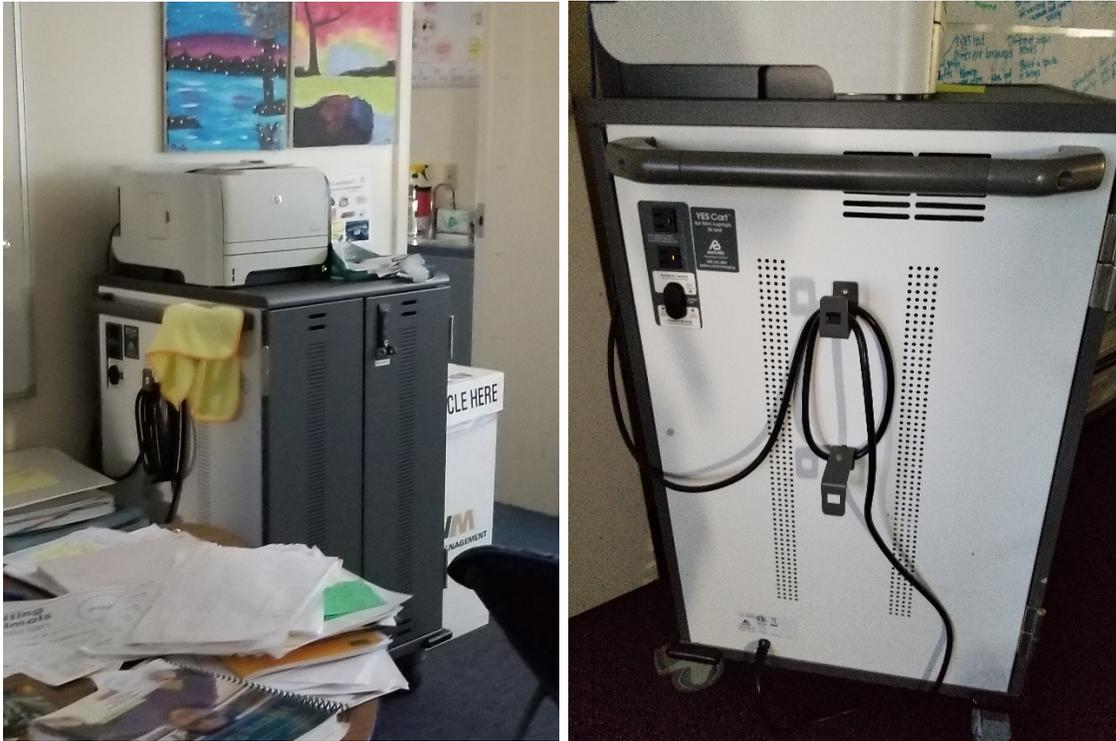
Figure 5. Multiple computer charging stations were left plugged in and operating. These units use about \$0.10 – 0.25 daily per unit, which can add up when there are hundreds throughout the District. Additionally, leaving laptops plugged in for extended periods can shorten battery life.

Each of the classrooms was equipped with a laptop charging station that was plugged in and charging. **We recommend that charging stations be turned off or unplugged until they are needed for the students**, as each of these units uses about 1.5-0.5 kWh per day. At the District's current rate, this equates to **\$0.10-0.25 per unit per day**, which annually equates to **\$36.50-\$91.25 per unit** at the District's current electricity cost rate if they are never unplugged.

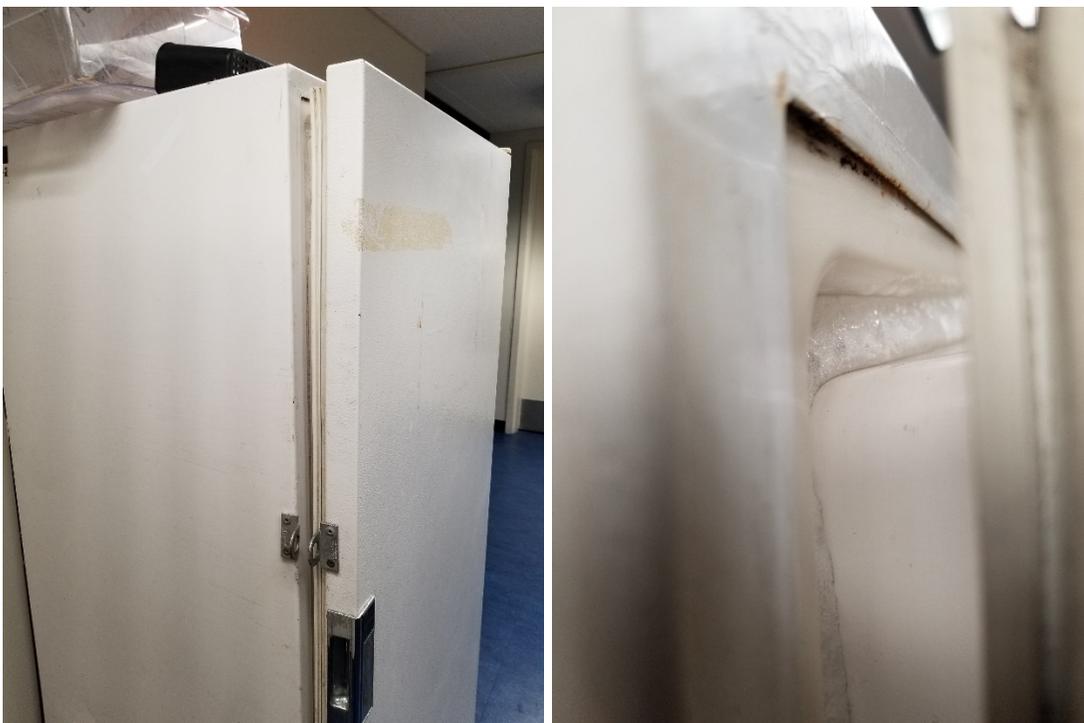
Figure 6. Freezer in the staff lounge was left plugged in, but the door was slightly open and frozen. This will need to be unplugged and slowly defrosted to be cleaned out. It is recommended to keep this unit unplugged throughout the remainder of the closure.

| Observations and Recommended Action | Check | Location |
|---|---|---|
| <p>Clean out breakroom refrigerators and unplug so that these are not using energy during the summer break</p> | | John Adams Middle School |

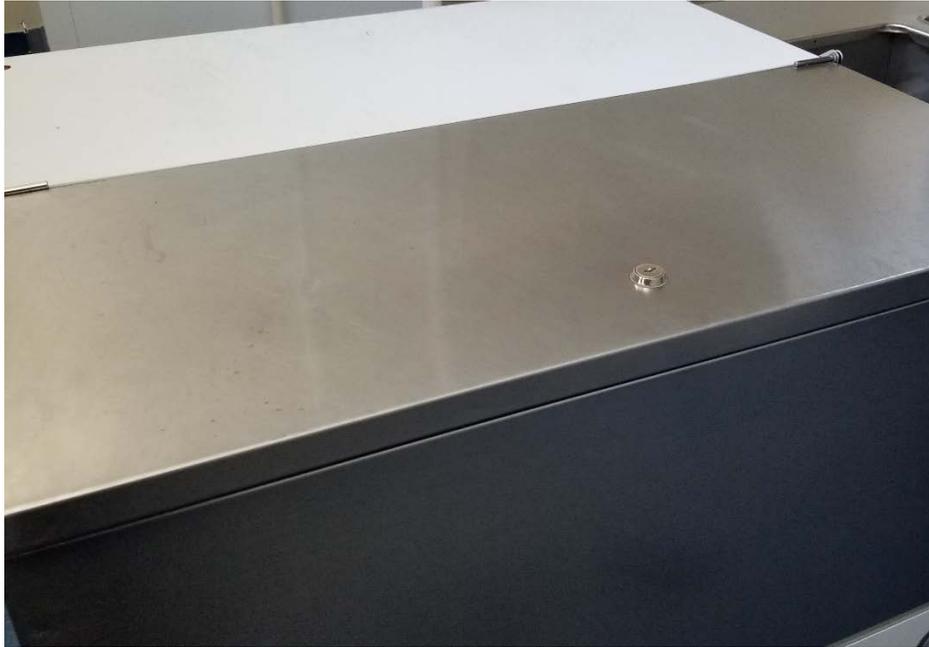
Figure 7. Serving refrigerator in the Kitchen of Will Rogers left plugged in with no product inside. It is recommended that any food left in the kitchen fridges and serving fridges be consolidated to a single refrigerator and freezer. At the same time, the rest of the units are cleaned out and unplugged.

Lastly, it was noted that the serving refrigerators were plugged in and operating without any product inside. These serving refrigerators cost an estimated \$0.60-0.75 daily per unit in energy costs, while full-sized, reach-in commercial refrigerators cost between \$2.00-3.50 daily per unit. At Will Rogers Elementary alone, this would equate to an estimated **\$150-250 in savings if these remained shut down throughout the summer.**

| Observations and Recommended Action | Check | Location |
|---|---|---|
| <p>Consolidate inventory in Kitchens to a single reach-in or walk-in refrigerator. Clean out unused reach-in or serving refrigerators and unplug during extended school breaks.</p> | | All Sites in which there are no meal services going on |

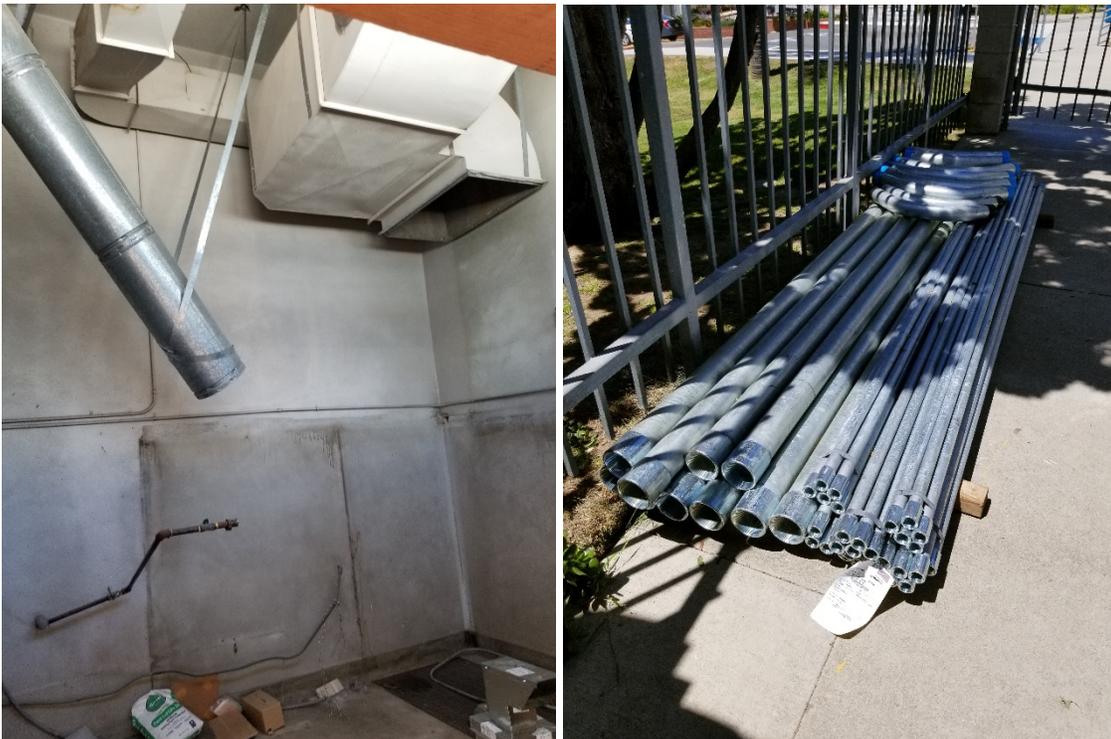
Figure 8. HVAC construction occurring at Webster Elementary

permanent, full-sized HVAC air handler units and ducts were being installed in each of the classrooms. Therefore, there should be very limited energy usage from HVAC until the project is complete.

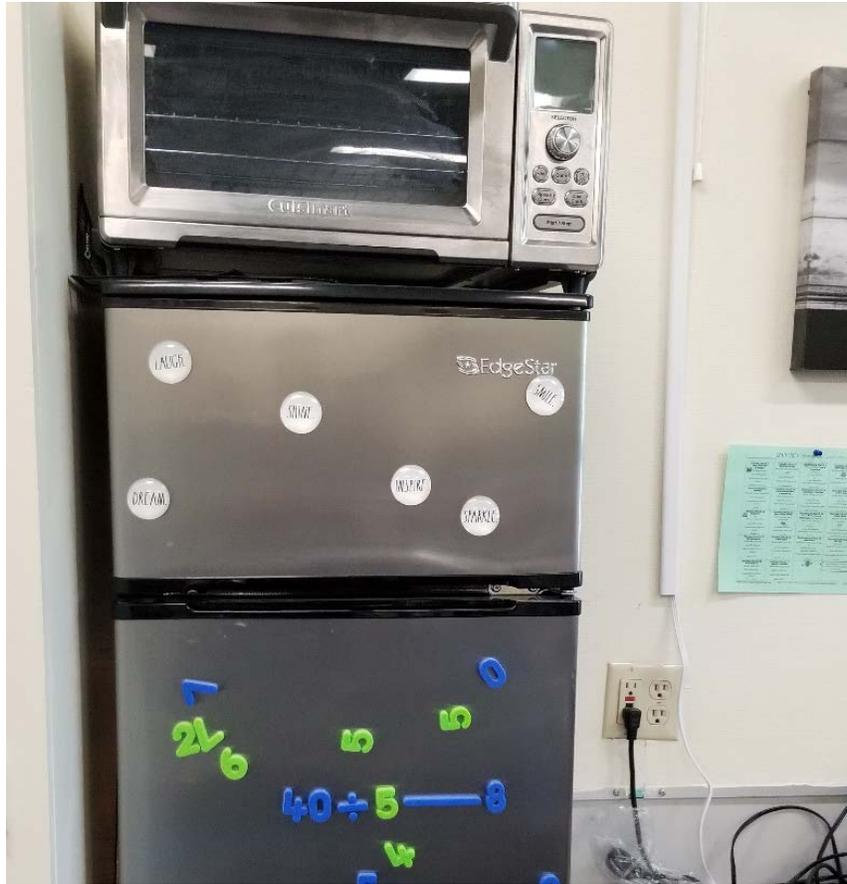
Figure 9. Mini-fridges were left plugged in and operating

Within the classrooms, there were several mini-fridges left plugged in and with food. As with the other sites, **we recommend emptying, cleaning, and unplugging these units while not used for the closure and summer break.** Additionally, all iMac computers located within the computer lab were found on and subsequently turned off at the time of the visit.

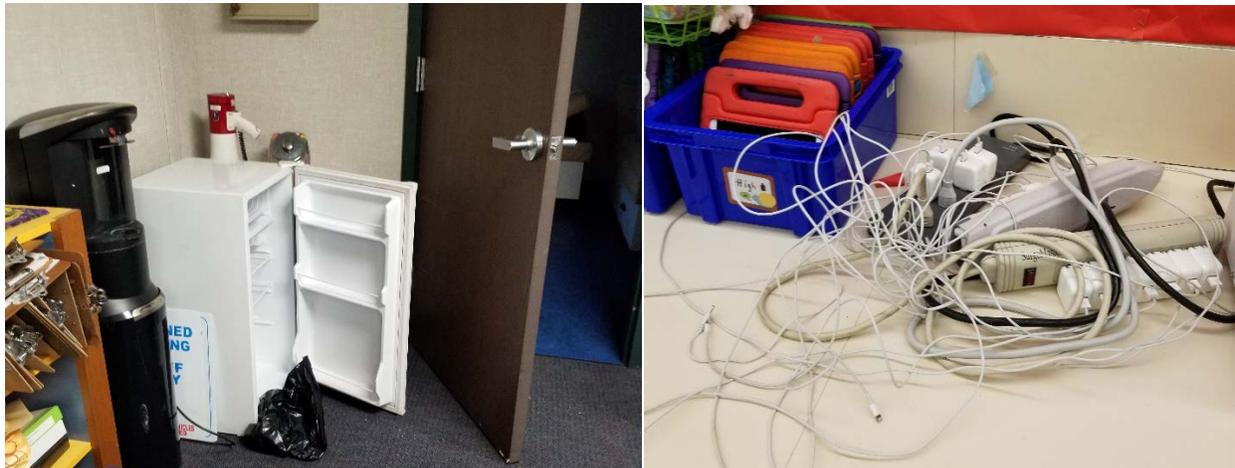
Figure 10. Examples of good energy management at Malibu Elementary School. (Left) Mini-fridge in the front office was unplugged, cleaned out and had a trash bag underneath to catch melted ice. (Right) Surge protector with iPad chargers was unplugged for the summer.

Lastly, as with most of the other schools, most mini-fridges and refrigerators were left plugged in and operating with food. The exception was the front office, which had cleaned out and unplugged the fridge with the door left open to prevent mold. **It is recommended that all other locations follow suit when performing site shutdown procedures.**
