Energy Management Report

SANTA MONICA-MALIBU UNIFIED SCHOOL DISTRICT

PREPARED ON:
9/22/2020

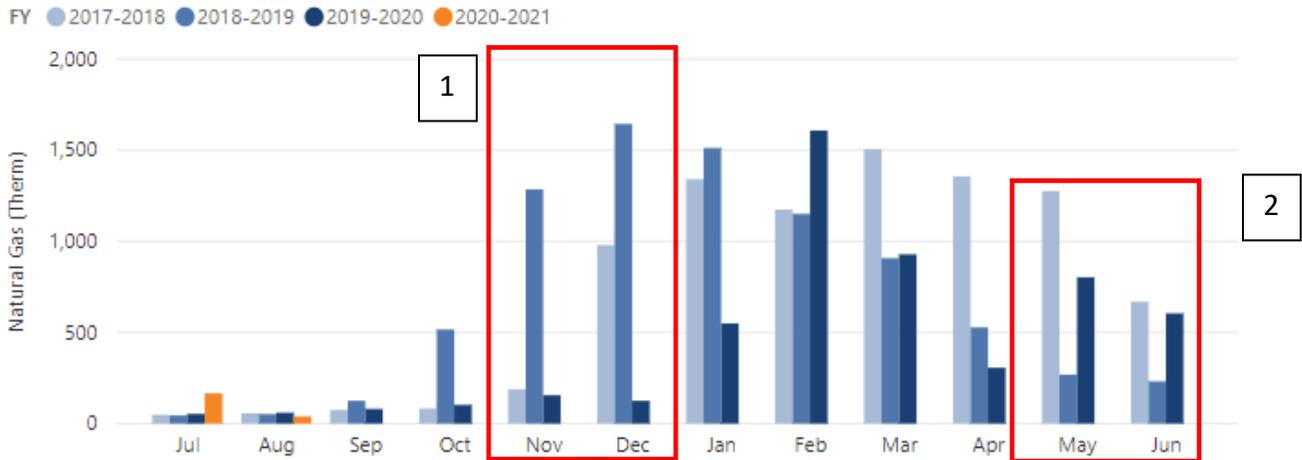
Total Natural Gas Use by Month and Fiscal Year

Figure 1. Monthly usage of natural gas energy consumption by fiscal year.

Natural gas energy consumption at Edison Language Academy has been consistently high in comparison to schools of a similar footprint.

1. As seen from the figure above, the highest usage generally occurs between November and February, though usage from year to year appears to be highly variable. For example, in November and December 2018, use was much higher than the November and December of 2017 and 2019. Weather data shows that the heating demand was a lot higher in 2019 than in 2018 during these months. This drastic difference indicates some of the natural gas equipment that may have been turned off entirely during these periods in 2017 and 2019.
2. Natural gas usage was much higher in the months of May, and June 2020, during which the school was closed with minimal activity, and the weather was not cold enough to warrant heating. This indicates most likely that the boiler serving the heating hot water line in the MPR/Cafeteria/Kitchen was in operation.

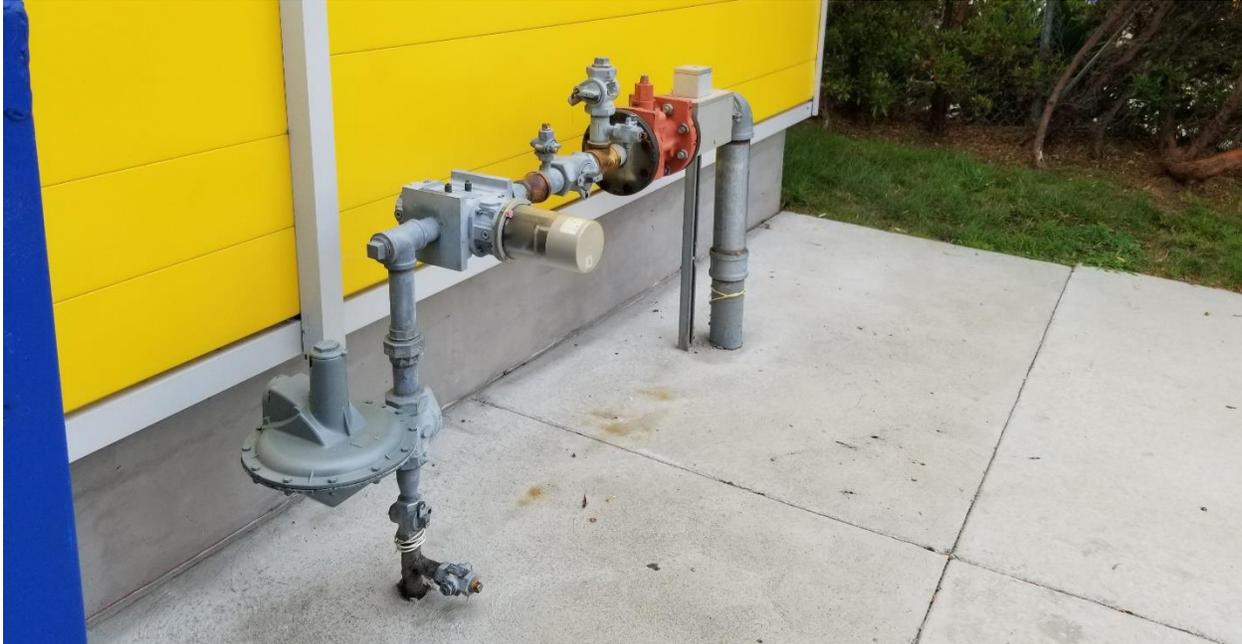
Figure 2. Gas meter at Edison Language Academy.

At the time of the site visit, there was no movement in the meter, indicating that there was little to no immediate usage when the meter was viewed.

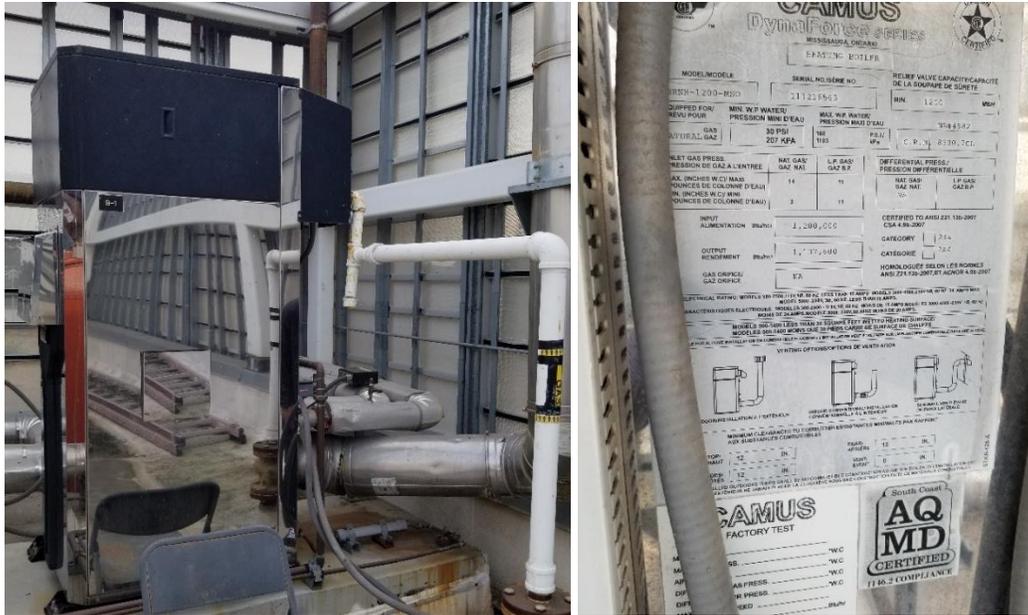
The first and most significant natural gas user is the heating hot water boiler on the roof of the multi-purpose room (MPR). This unit is sized at 1.2 MBtu and appears to serve the MPR, kitchen, cafeteria, and potentially the adjacent connecting rooms (offices and library). Since the boiler appears to be the largest-sized gas equipment in the school, the high usage during certain months is likely due to use of the boiler use for the space heating of the building. One possibility was the controllability and thermostat dead band assigned to the thermostat system in the kitchen and MPR.

Figure 3. Boiler located on the roof of Edison Language Academy's MPR

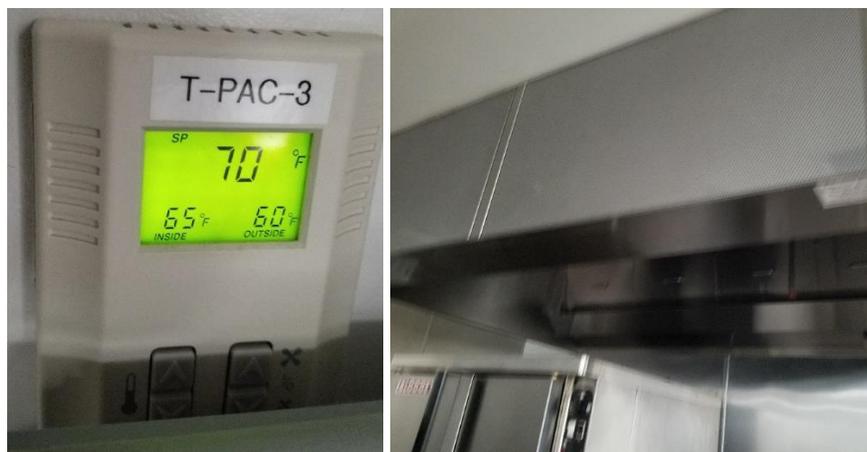
The figures below show the thermostat and the range hood located in the kitchen. During the site walks, the thermostat was at a set-point (SP in the photo below) of 70°F. However, there was no indication of whether this was for heating, cooling, or both. Typically, when there is a single set-point on a thermostat controller unit, the system will attempt to keep it within the dead band range defined (e.g., for an SP of 70°F at a dead band of $\pm 2^\circ\text{F}$, the cooling would turn on at 72°F and the heat would turn on at 68°F. The actual functionality of the thermostat was not confirmed during the site walks, as changing of the SP did nothing to activate cooling or heating.

Additionally, during the site walks, the range hood to exhaust fumes and bring fresh air inside was on, and there was not locatable switch to turn this off. This indicates that these fans are constantly running and bringing in outside air.

Figure 4. Thermostat and range hood in kitchen at Edison Language Academy

One possible explanation for months with increased gas usage is that there is the heating set-point during is not set back to cooler temperatures during off hours to reduce usage (e.g., at night thermostat set-points are changed to 50°F heating/ 85°F cooling). This can cause an issue if the range hood is bringing in cold air during the night. It is therefore imperative that either the range hood is turned off after hours or that thermostats are set back to unoccupied set-points in order to minimize heating and cooling.

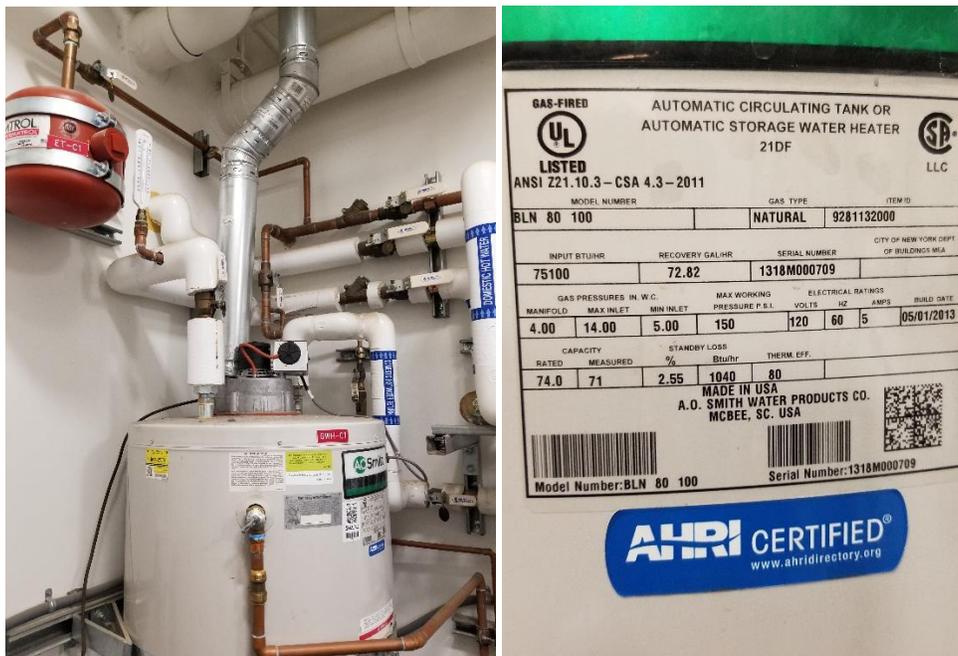
The second piece of equipment noted using natural gas is the domestic water heater in the cafeteria. The unit present appeared to be a 100-gallon tank natural gas-fired unit. During the site walks, it was noted that the pressure relief valve (PRV) was leaking, possibly leading to consistent gas usage even while not in use. The unit was turned off during the site walk, which would limit the use of natural gas. However, the PRV would need to be replaced to stop the leak. This would account for between 20-60 therms per month, which is small in comparison to months of high gas consumption.

Figure 5. Domestic water heater located in cafeteria

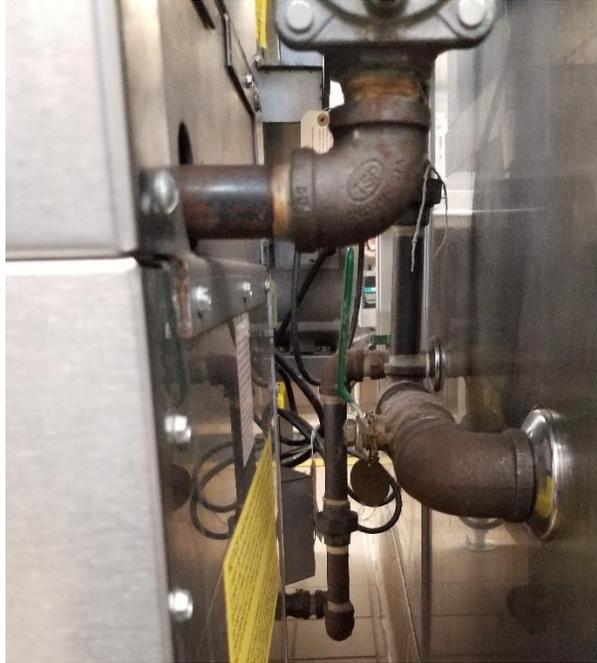
Third, and least significant to the current conditions, is the presence of the gas appliances in the kitchen. During the site walks, the gas valves were open on the appliances with the pilot lights lit. While the usage is little to negligible, these were turned off during the site walks since areas were not being used.

Figure 6. Gas appliance connections in the kitchen.

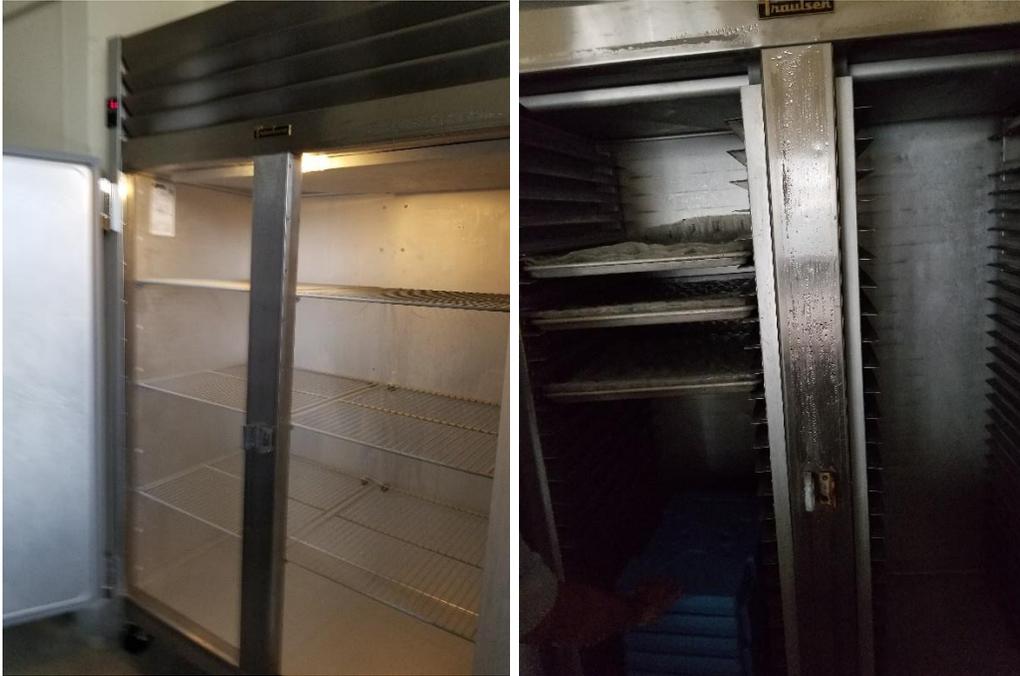
Figure 7. Commercial Refrigerator and Freezer left plugged in while empty and not being used. It is recommended to have these unplugged, emptied, and cleaned out while occupancy at the school is limited and common areas are not being used.

Location	Check	Observations/Action Items
John Adams MS		At the time of the site walks, there were only two teachers, indicating the majority of teachers are teaching from home in the distance learning conditions.
		Unplug, defrost, and clean out commercial reach-in refrigerator and freezer in the kitchen if not being used for the remainder of the year. Both units were completely empty during the site walks.
Will Rogers Elementary		Approximately 20% of the rooms were being used by teachers for distance learning.
		Milk serving fridges in the cafeteria were plugged in, empty, and running with doors left open. Unless the school is being used as a hub for serving meals, it is recommended to unplug, defrost, and clean out refrigeration units
		The refrigerator and freezer in the breakroom were mostly empty and plugged in and running. It is recommended to unplug, defrost, and clean out one or both of these units.

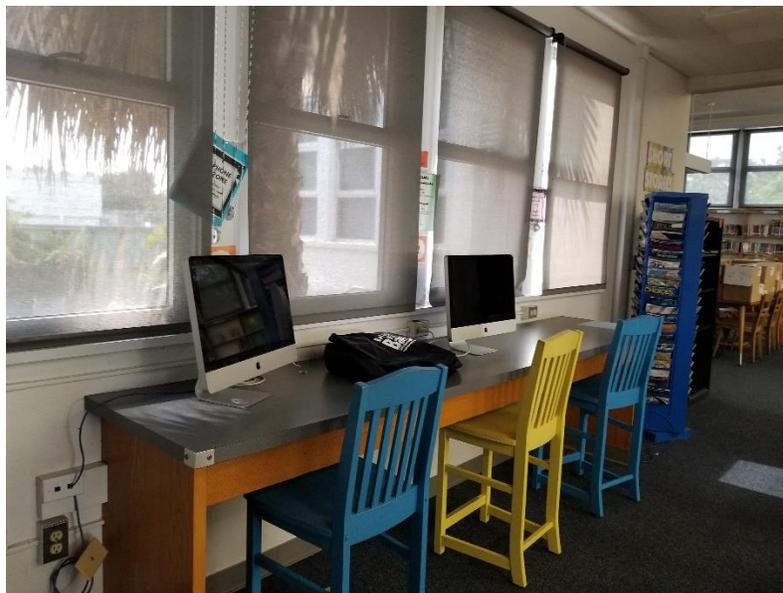
Figure 8. Computers in the library were turned off, and blinds were drawn. This shows good energy management practice.

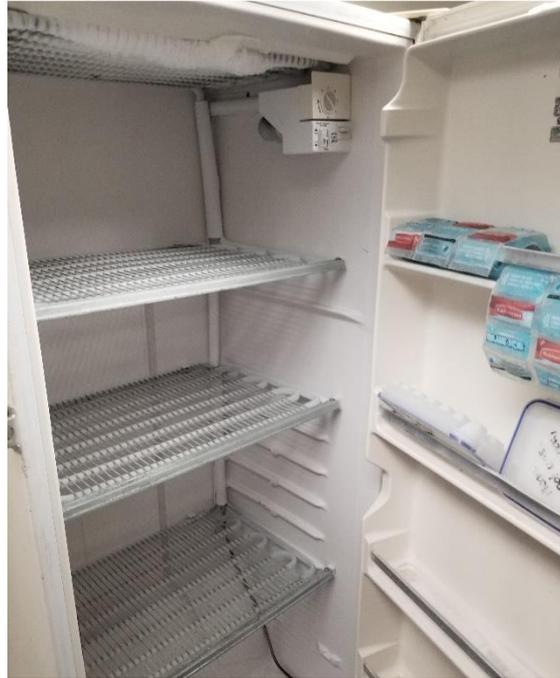
Figure 9. Older freezer left on and plugged in. It is recommended to have these unplugged, emptied, and cleaned out while occupancy at the school is limited and common areas are not being used.

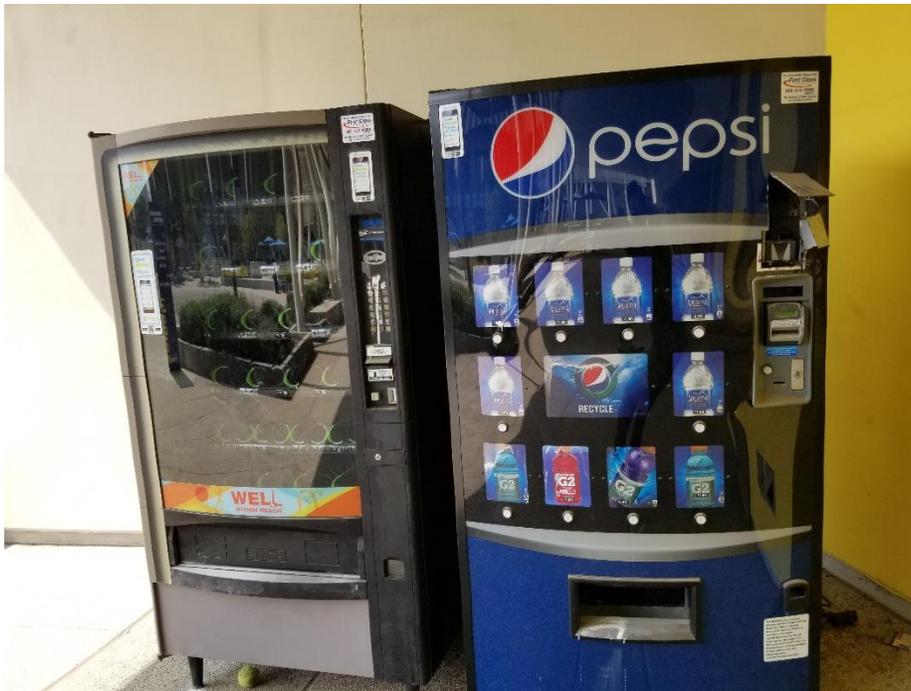
Santa Monica HS		Approximately 5% of teachers were teaching from their classrooms in the distance learning environment.
		Vending machines next to the Innovation building were unplugged, which was good, though the refrigerated vending machine appeared to be broken.

Figure 10. Unplugged vending machines next to the Innovation building at SAMOHI. While this shows good energy management, the Pepsi machine appears to be broken and will need repair.
