WATER USE SURVEY REPORT

Juan Cabrillo Elementary
30237 Morning View Dr.
Malibu, CA 90265

WaterWise
Consulting, Inc.

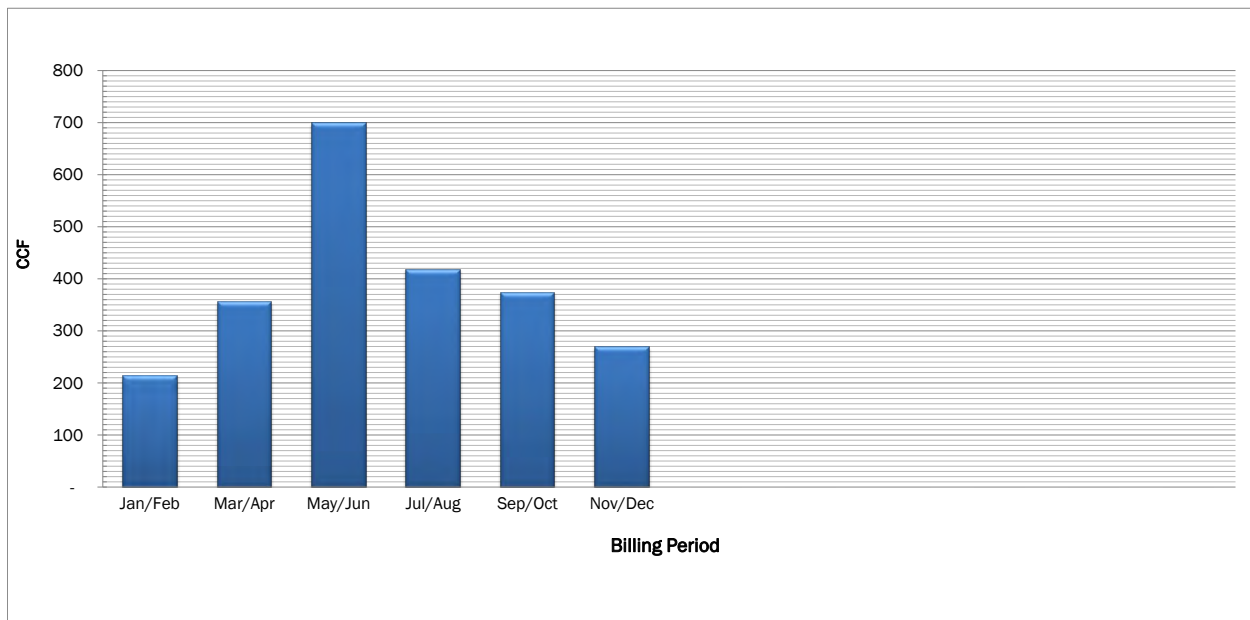
The twelve-month water use at this facility is 2,328 CCF (1,741,344 gallons). Monthly average water use is approximately 1,700 CCF (1,271,600 gallons).

The months with the highest water use were in May and June with 699 CCF (522,852 gallons). The surveyor did not visually observe any leaks at the meter while conducting the on-site evaluation.

The months with the lowest water use were in January and February during which the facility used 214 CCF (160,072 gallons).

This is the base year water consumption established by reviewing water use history.

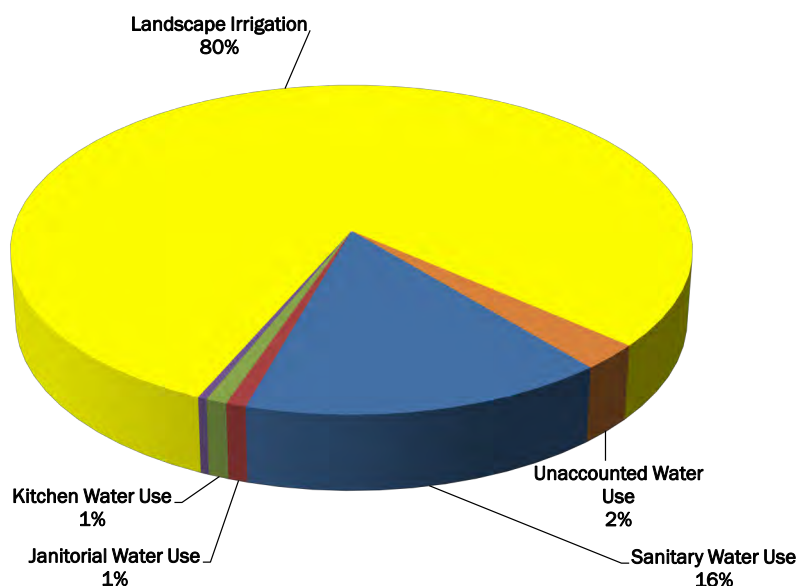
The estimated allocation of water use chart above shows water use at this site. The total water use is 2,328 CCF (1,741,344 gallons). The breakdown of water use per category is listed below. This allocation of water use may be helpful when deciding which recommendations should be implemented.

Landscape irrigation makes up 89%, sanitary use makes up 16%, janitorial use makes up 1% and kitchen use makes up 1%.

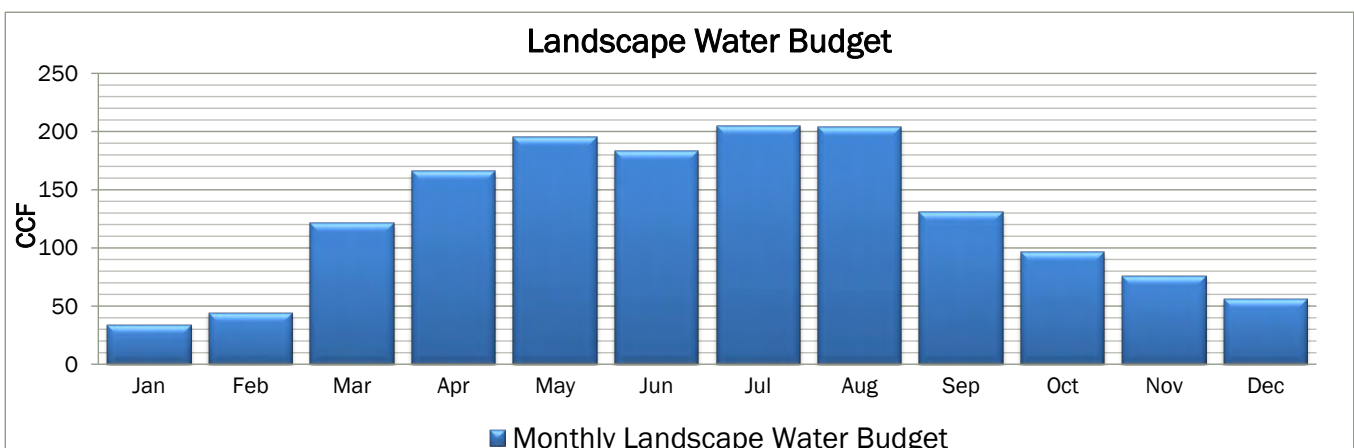
Landscape Water Budget											
Jan	Feb	Mar	Apr	May	Jun	Jul	Aug	Sep	Oct	Nov	Dec
34	44	121	166	195	183	205	204	131	96	76	56
Total Site Landscape Water Budget:						1,511	CCF	or	1,130,228	gallons	
*Minimum Distribution Uniformity (DU) Spray Systems, 65%, Rotor Systems, 80%, Micro Spray and Bubbler Systems, 80%, Drip Systems, 90%											
*Calculated Based on Local Weather, Landscape Area, Types of Plant Materials, and Irrigation System Variables (Type, Condition, Management).

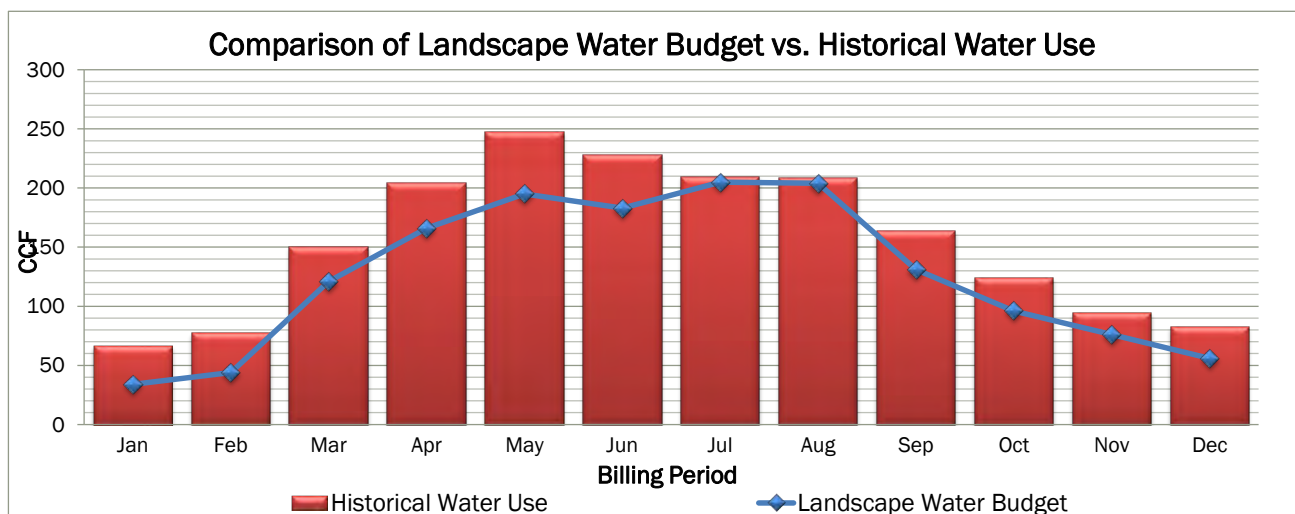
The landscape water budget from the previous page is 1,511 CCF (1,130,228 gallons). WaterWise can estimate the potential water savings by comparing historical water use to the landscape water budget. According to our calculations this landscape is using approximately 344 CCF (257,312 gallons) over the budget. The table below provides a comparison of historical water use versus landscape water budget for each month of the year.

Comparison of Landscape Water Budget vs. Historical Water Use												
	Jan	Feb	Mar	Apr	May	Jun	Jul	Aug	Sep	Oct	Nov	Dec
Landscape Water Budget	34	44	121	166	195	183	205	204	131	96	76	56
Historical Water Use	66	77	150	205	247	228	209	209	164	124	94	82
Usage Above Budget	32	33	29	39	52	45	4	5	33	28	18	26
Total Site Landscape Water Usage Above Budget:						344	CCF	or	257,312		gallons

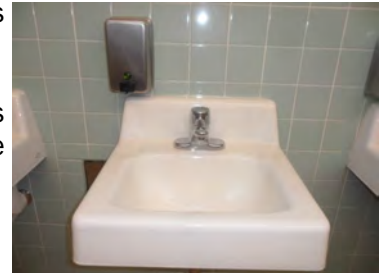
Lavatory Faucet

This site has 22 lavatory faucets in the public and staff restrooms that have flow rates of 2.2 gpm.

We recommend the replacement of these lavatory faucet aerators with new efficient models which have flow rates of 0.5 gpm.

The total potential water savings for replacing the faucet aerators is 95 CCF (71,060 gallons). The annual cost savings is estimated to be \$470.

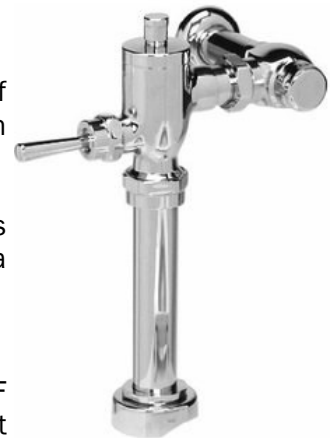
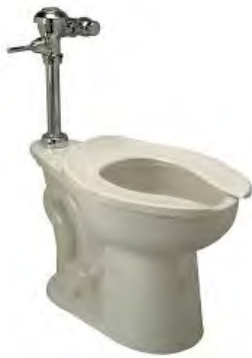
High Efficiency Toilet
(HET)

The facility has 22 flush valve toilets located in the public and staff restrooms that flush at 1.6 gpf. These toilets should be replaced with High Efficiency Toilets (HETs) that have a flush rate of 1.28 or less gpf.

These 1.28 or less gpf toilets save water with every flush since there is only a single flush option. These models use about 20% less water than a standard 1.6 gpf toilet.

The estimated water savings from this replacement is equal to 50 CCF (37,400 gallons) per year, which will yield an estimated annual cost savings of approximately \$248.

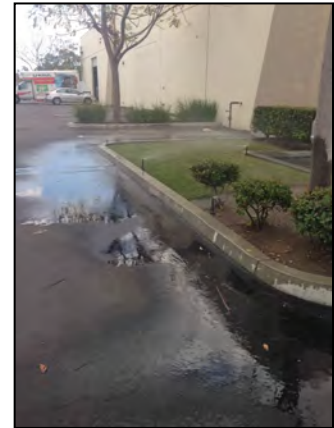
During the inspection, WaterWise surveyors inspected three irrigation controllers and a total of 11 active irrigation stations. A total of 75 sprinkler heads were inspected. At least 9 sprinklers of the sprinkler heads have problems and need repairs. Water will be wasted with every irrigation cycle until the irrigation problems are repaired.

- The WaterWise inspection team was able to locate multiple irrigation problems at this site, such as misaligned, overspraying, clogged and blocked sprinklers.

Overspraying Sprinklers

The total potential annual water savings for fixing the irrigation system problems is 190 CCF (142,120 gallons) or approximately \$941.

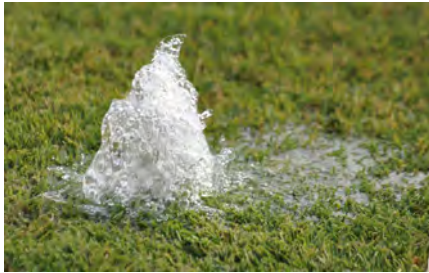
Example of Broken Sprinkler

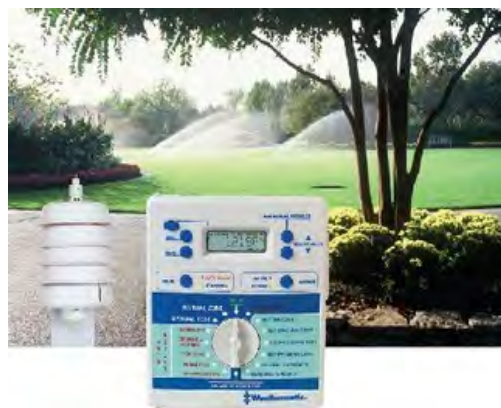
The irrigation system at this site is operated by three conventional irrigation controllers. We recommend retrofitting the conventional controllers to Smart Controllers.

Weather Based Irrigation Controllers (Smart Controllers) work by using specific information about the site, including weather patterns, plant types, soil type, slope, and irrigation system application rate to automatically adjust irrigation schedules. Smart Controllers help to improve the management efficiency of the irrigation system.

The total potential annual water savings for improving the management of the irrigation system with Smart Controllers is 89 CCF (66,572 gallons). This is equal to approximately a \$442 cost savings per year.

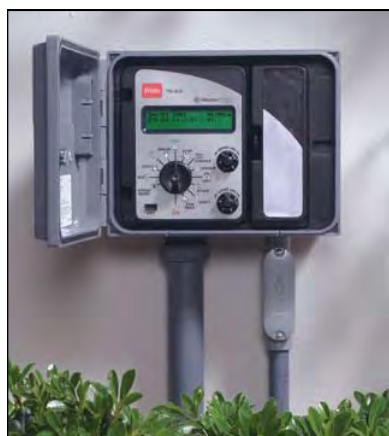
*Weather Based Irrigation
Controller (Smart Controller)*

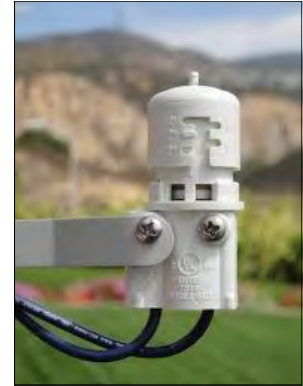
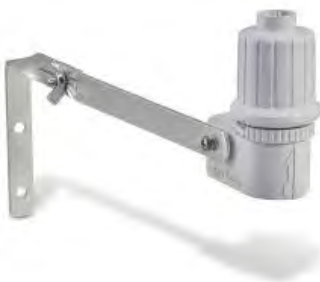
Rain Sensor

A rain sensor is a water conservation device that is set to automatically shut off the irrigation system when there is rainfall. A rain sensor will automatically interrupt the watering schedule of any irrigation controller. It can be manually adjusted to become activated at various rates of rainfall. Some rain sensors will shut off the irrigation after sensing one-eighth of an inch of rainfall or less. After rainfall, the rain sensor will automatically activate the irrigation controller to resume normal operation.

We recommend upgrading the existing irrigation controllers with rain sensors. The total potential annual water savings for improving the management of the irrigation system with rain sensors is 66 CCF (49,368 gallons). This is equal to a savings of approximately \$328 per year.
