WATER USE SURVEY REPORT

Malibu High School 30215 Morning View Dr. Malibu, CA 90265

Re: Water Use Survey Report

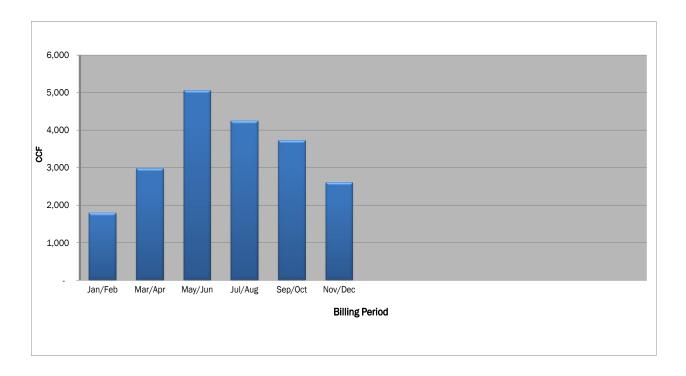
The twelve-month water use at this facility is 20,398 CCF (15,257,704 gallons). Monthly average water use is approximately 1,700 CCF (1,271,600 gallons).

The months with the highest water use were in May and June with 5,058 CCF (3,783,384 gallons). The surveyor did not visually observe any leaks at the meter while conducting the on-site evaluation.

The months with the lowest water use were in January and February during which the facility used 1,788 CCF (1,337,424 gallons).

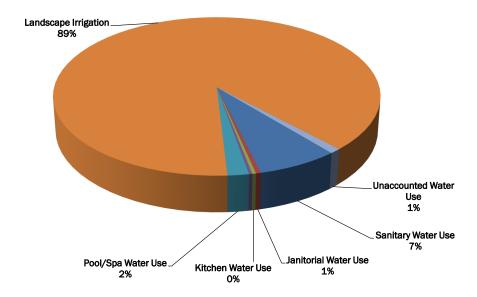
The estimated allocation of water use chart above shows water use at this site. The total water use is 20,398 CCF (15,257,704 gallons). The breakdown of water use per category is listed below. This allocation of water use may be helpful when deciding which recommendations should be implemented.

Landscape irrigation makes up 89%, sanitary use makes up 7% and pool use makes up 2%. Janitorial, kitchen and classroom and unaccounted use each make up 1 % or lower.

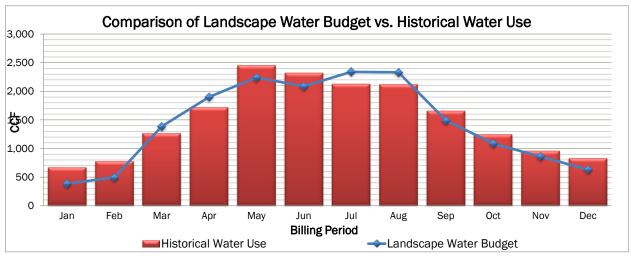
The landscape water budget from the previous page is 17,234 CCF (12,891,032 gallons). WaterWise can estimate the potential water savings by comparing historical water use to the landscape water budget. According to our calculations this landscape is using approximately 1,623 CCF (1,214,004 gallons) over the budget. The table below provides a comparison of historical water use versus landscape water budget for each month of the year.

Comparison of Landscape Water Budget vs. Historical Water Use											
	Jan	Feb	Mar	Apr	May	Jun	Jul	Aug	Sep	Oct	Nov	Dec
Landscape Water Budget	384	495	1,385	1,901	2,241	2,088	2,340	2,331	1,492	1,087	858	632
Historical Water Use	668	777	1,260	1,715	2,451	2,318	2,126	2,119	1,657	1,247	953	829
Usage Above Budget	284	282	-	-	210	230	-	-	165	160	95	197
Total Site Landscape Water Usage Above Budget: 1,623 CCF or 1,214,004 gallons
