September 1, 2016

WATER USE SURVEY REPORT

Pt. Dume Elementary School
6955 Fernhill Dr.
Malibu, CA 90265

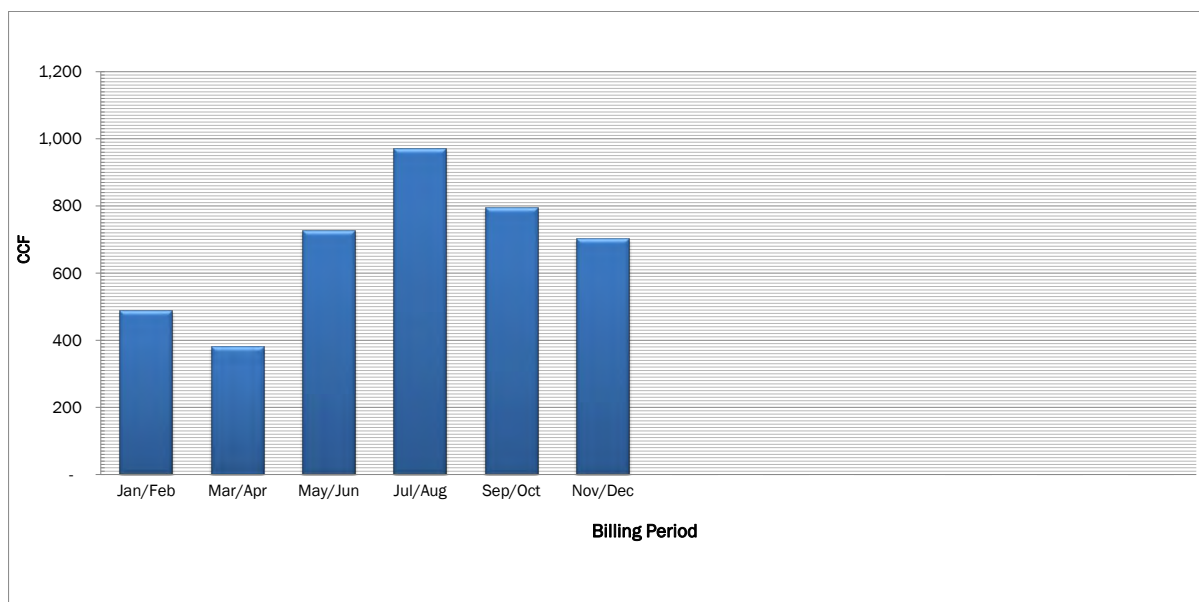
The twelve-month water use at this facility is 4,059 CCF (3,036,132 gallons). Monthly average water use is approximately 338 CCF (252,824 gallons).

The months with the highest water use were in July and August with 970 CCF (725,560 gallons). The surveyor did not visually observe any leaks at the meter while conducting the on-site evaluation.

The months with the lowest water use were in March and April during which the facility used 379 CCF (283,492 gallons).

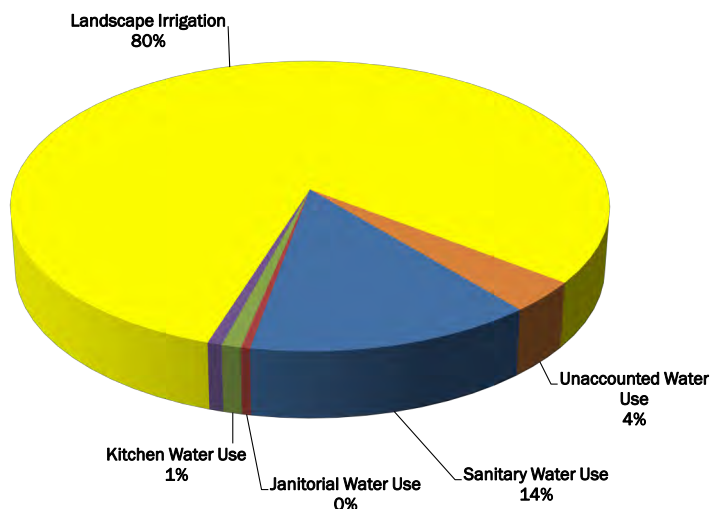
The estimated allocation of water use chart above shows water use at this site. The total water use is 4,059 CCF (3,036,132 gallons). The breakdown of water use per category is listed below. This allocation of water use may be helpful when deciding which recommendations should be implemented.

Allocation of water use is as follows: 80% is for landscape/irrigation, 14% is for sanitary water use, 1% is for kitchen water use, 1% is for classroom water use, and less than 1% is for janitorial water use.

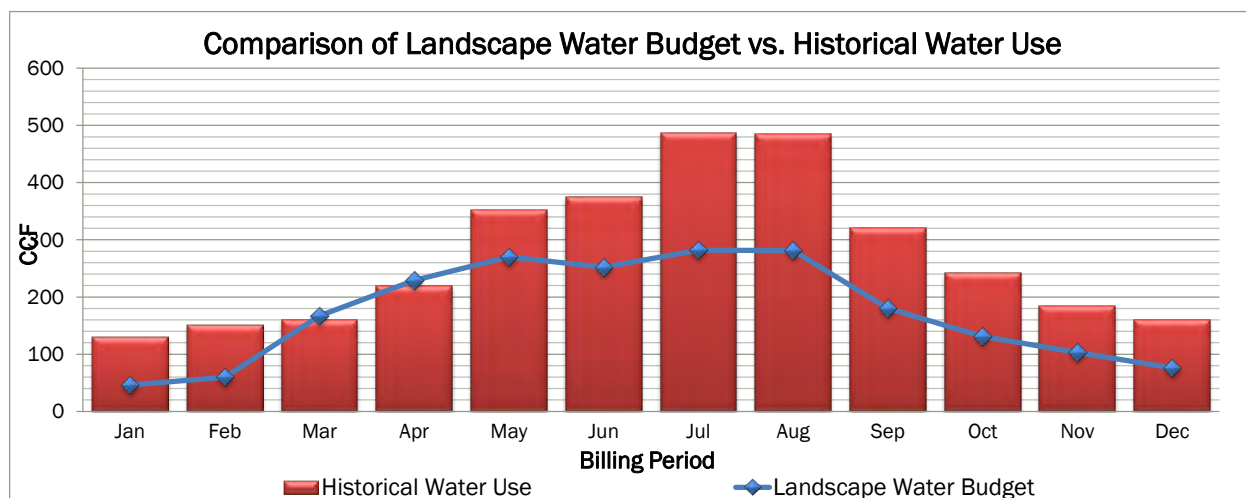
The landscape water budget from the previous page is 2,077 CCF (1,553,596 gallons). WaterWise can estimate the potential water savings by comparing historical water use to the landscape water budget. According to our calculations this landscape is using approximately 1,204 CCF (900,592 gallons) over the budget. The table below provides a comparison of historical water use versus landscape water budget for each month of the year.

Comparison of Landscape Water Budget vs. Historical Water Use												
	Jan	Feb	Mar	Apr	May	Jun	Jul	Aug	Sep	Oct	Nov	Dec
Landscape Water Budget	46	60	167	229	270	252	282	281	180	131	103	76
Historical Water Use	129	151	161	218	352	375	486	484	321	241	185	161
Usage Above Budget	83	91	-	-	82	123	204	203	141	110	82	85
Total Site Landscape Water Usage Above Budget:						1,204	CCF	or	900,592		gallons

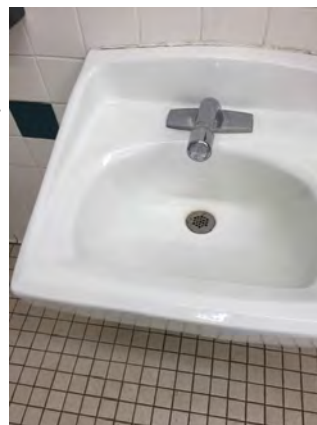
This site has 21 lavatory faucets in the student and staff restrooms that have flow rates of 2.2 gpm.

Lavatory Faucet at
Pt. Dume Elementary School

We recommend the replacement of these lavatory faucet aerators with new efficient models which have flow rates of 0.5 gpm.

The total potential water savings for replacing the faucet aerators is 119 CCF (89,012 gallons). The annual cost savings is estimated to be \$589.

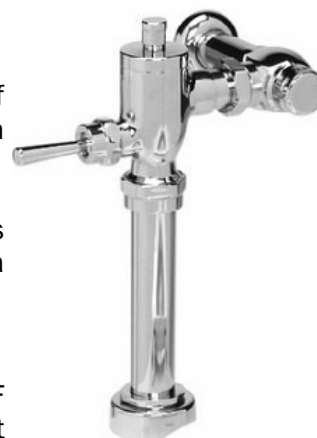
High Efficiency Toilet
(HET)

The facility has 16 flush valve toilets located in the student and staff restrooms that flush at 1.6 gpf. These toilets should be replaced with High Efficiency Toilets (HETs) that have a flush rate of 1.28 or less gpf.

These 1.28 or less gpf toilets save water with every flush since there is only a single flush option. These models use about 20% less water than a standard 1.6 gpf toilet.

The estimated water savings from this replacement is equal to 83 CCF (62,084 gallons) per year, which will yield an estimated annual cost savings of approximately \$411.

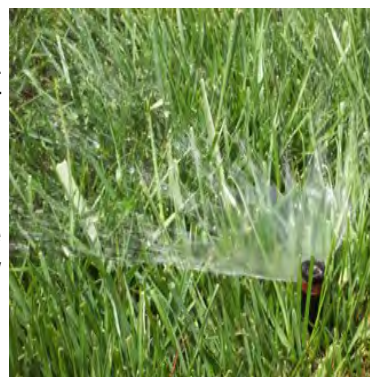
During the inspection, WaterWise surveyors inspected one irrigation controller and a total of 15 active irrigation stations. A total of 111 sprinkler heads were inspected. At least 6 sprinklers of the sprinkler heads have problems and need repairs. Water will be wasted with every irrigation cycle until the irrigation problems are repaired.

- The WaterWise inspection team was able to locate multiple irrigation problems at this site, such as broken and low sprinklers.

Example of Low Sprinkler

The total potential annual water savings for fixing the irrigation system problems is 1,019 CCF (762,212 gallons) or approximately \$5,022.

Fix Irrigation System Problems	
Estimated Annual Water Savings	1,019 CCF (762,212 gallons)
Estimated Annual Cost Savings	\$5,022
Estimated Implementation Cost	\$255
Simple Payback in Years	Immediate

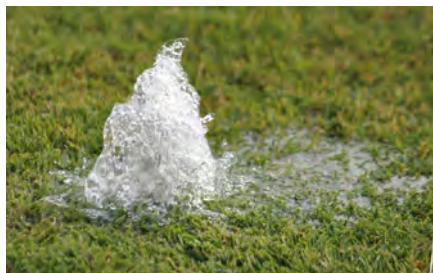
Example of Broken Sprinkler

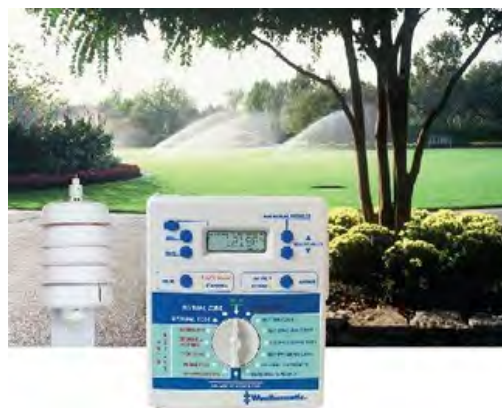
The irrigation system at this site is operated by five conventional irrigation controllers. We recommend retrofitting the conventional controllers to Smart Controllers.

Weather Based Irrigation Controllers (Smart Controllers) work by using specific information about the site, including weather patterns, plant types, soil type, slope, and irrigation system application rate to automatically adjust irrigation schedules. Smart Controllers help to improve the management efficiency of the irrigation system.

The total potential annual water savings for improving the management of the irrigation system with Smart Controllers is 112 CCF (83,776 gallons). This is equal to approximately a \$553 cost savings per year.

Smart Controllers can be purchased at most irrigation supply distributors.

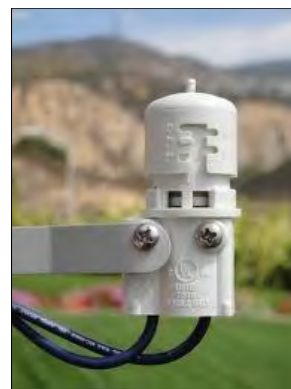
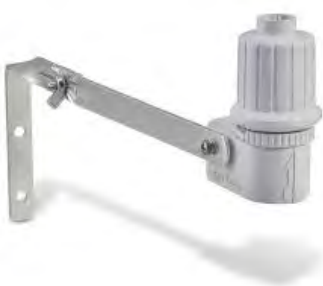
Rain Sensor

A rain sensor is a water conservation device that is set to automatically shut off the irrigation system when there is rainfall. A rain sensor will automatically interrupt the watering schedule of any irrigation controller. It can be manually adjusted to become activated at various rates of rainfall. Some rain sensors will shut off the irrigation after sensing one-eighth of an inch of rainfall or less. After rainfall, the rain sensor will automatically activate the irrigation controller to resume normal operation.

We recommend upgrading the existing irrigation controller with a rain sensor. The total potential annual water savings for improving the management of the irrigation system with a rain sensor is 71 CCF (53,108 gallons). This is equal to a savings of approximately \$347 per year.
