Final Removal Action  
Completion Report  
Building G Area  
Malibu High School  
30215 Morning View Drive  
Malibu, California

Prepared for:  
**Santa Monica/Malibu School District**  
Malibu, California

Prepared by:  
**ENVIRON International Corporation**  
Irvine, California

Date:  
**April 6, 2015**

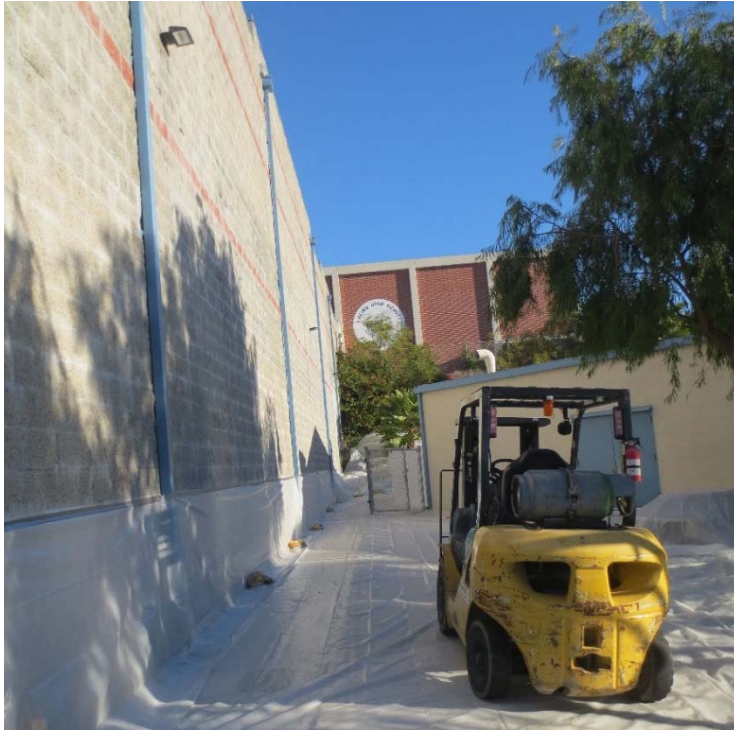
Photo 1: Pre-excavation: Plastic laid down along soil transport route, east of Gymnasium.

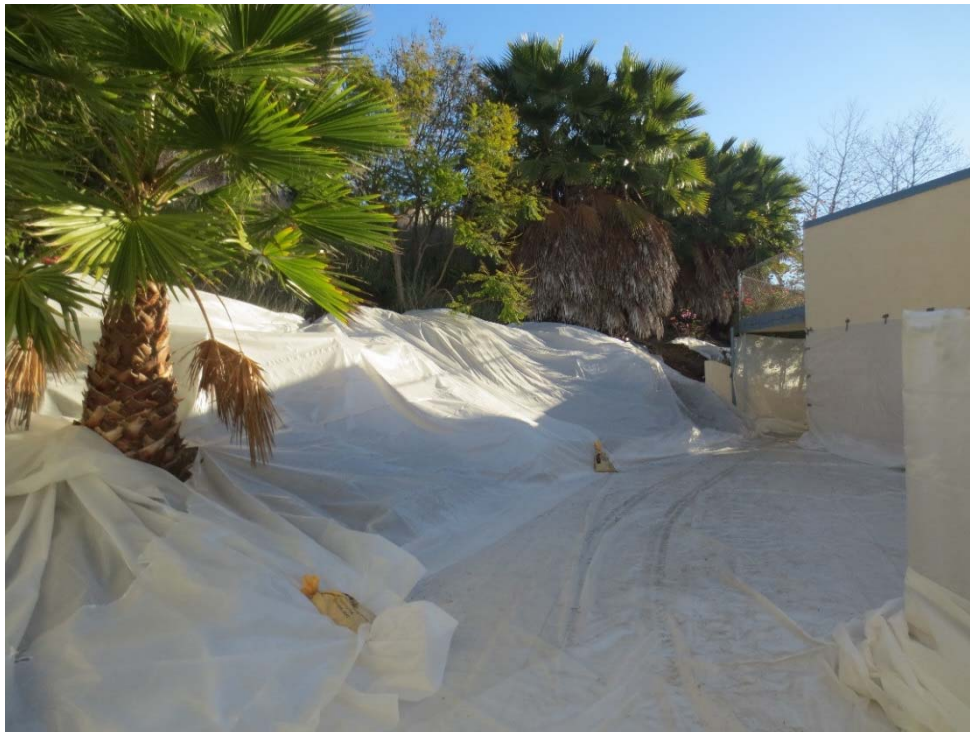
Photo 2: Pre- excavation: Plastic laid down along soil transport route, north of Building G.

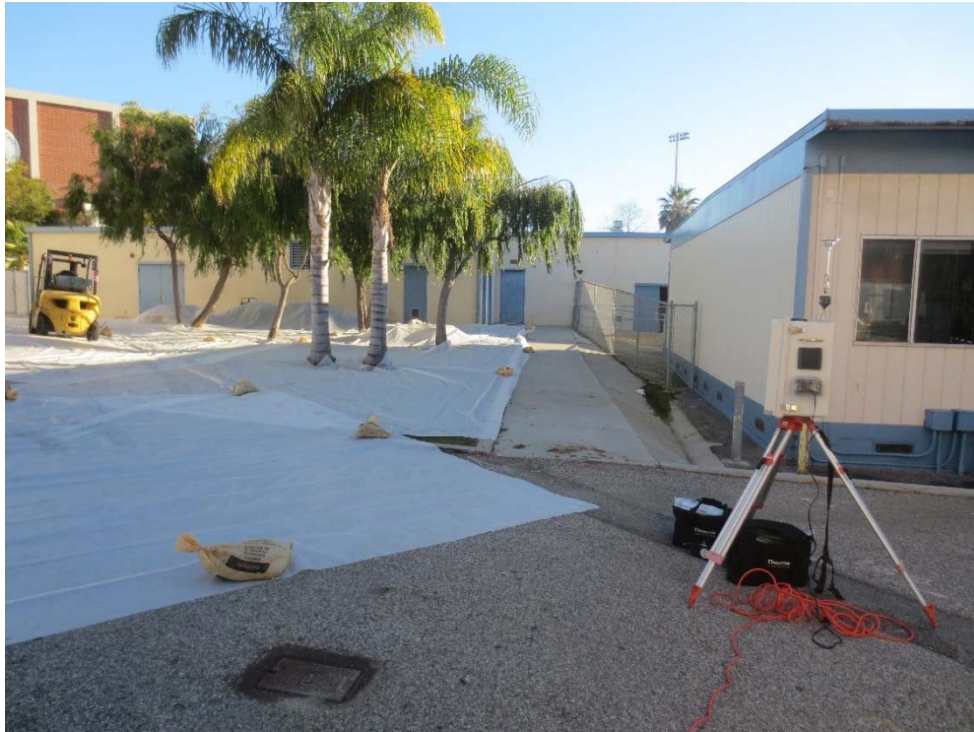
Photo 3: Pre-excavation: Setting up air monitoring station (ENVIRON), looking east toward Building G.

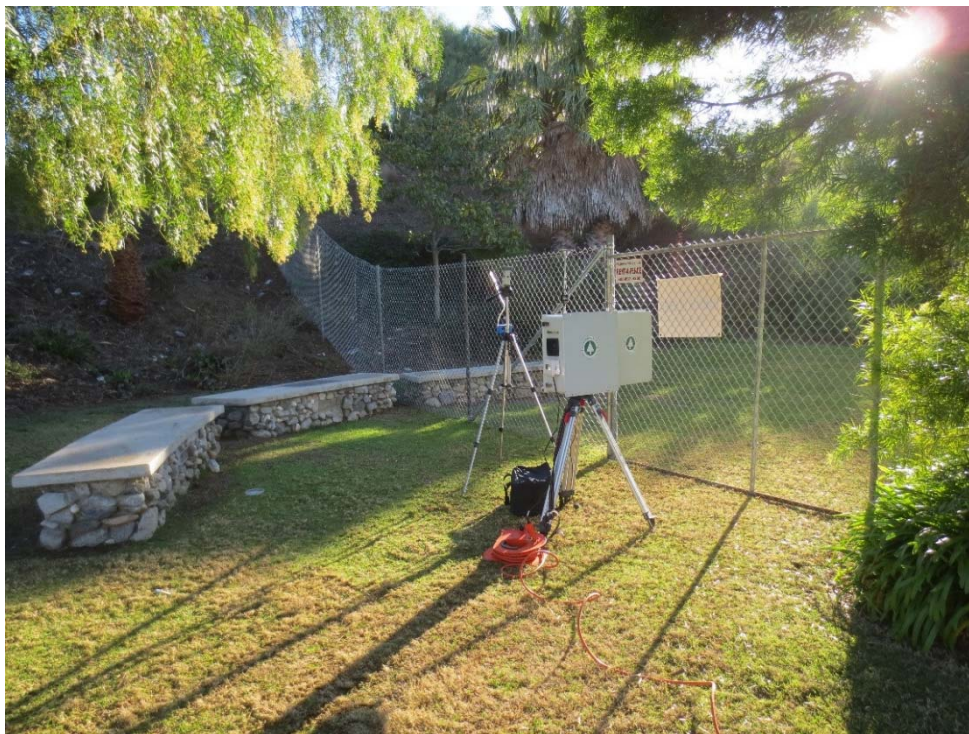
Photo 6: Pre-excitation: Setting up air monitoring stations (DTSC left, ENVIRON right) in front of temporary fencing by Building I.

During excavation activities, dust generation was controlled through wetting the soil and air monitoring was conducted at locations depicted on Figure 4 to confirm particulate concentrations were acceptable. Air monitoring stations were manually checked and logged in the field at five minute intervals (see Section 4.3 for more detail). Excavation was not conducted during times of high wind conditions (e.g., wind speed in excess of 25 miles per hour). Excavation activities were not conducted on December 26, 2014, due to local high wind conditions. At the end of each working day, temporary fencing was erected around areas where equipment was stored (Photo 6) and around the excavation area (Photo 15).

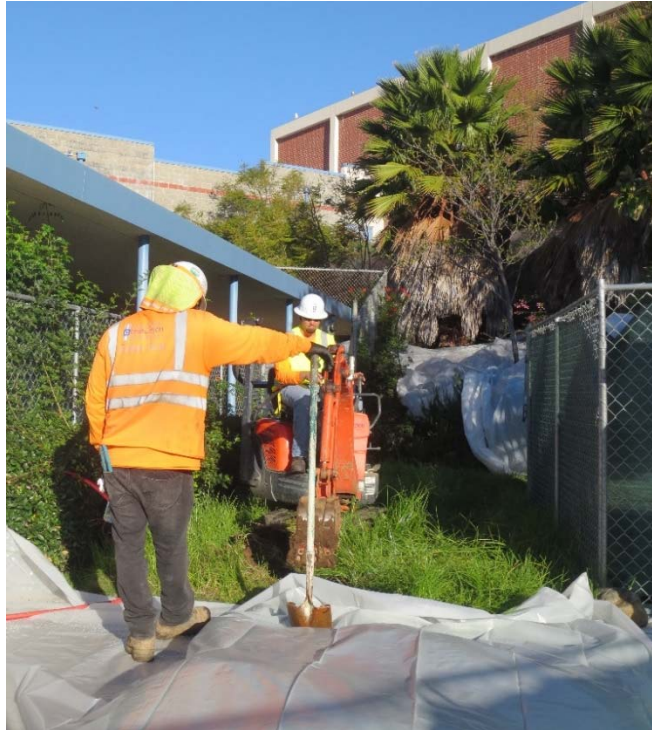
Photo 7: First day of excavation: Removing grass and surficial soil with mini-excavator, looking north.

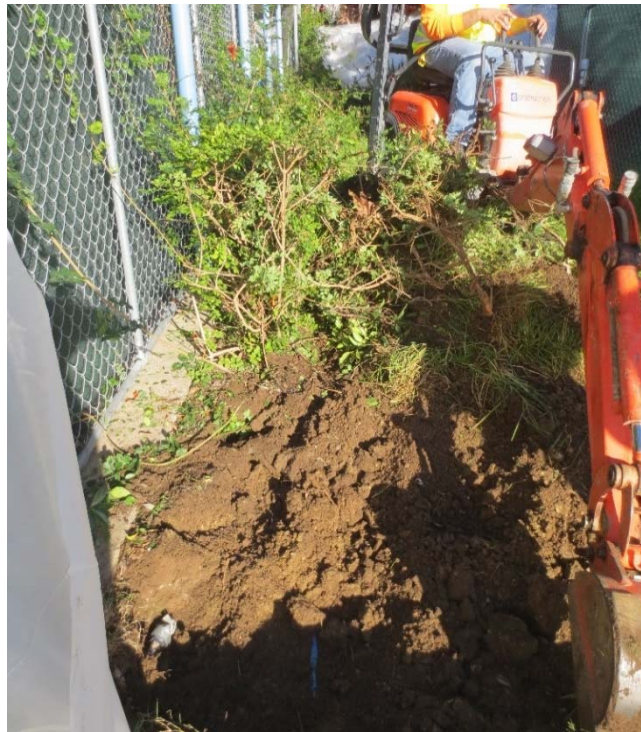
Photo 8: First day of excavation: Removing shrubbery adjacent to walkway; irrigation lines (blue, gray) exposed.

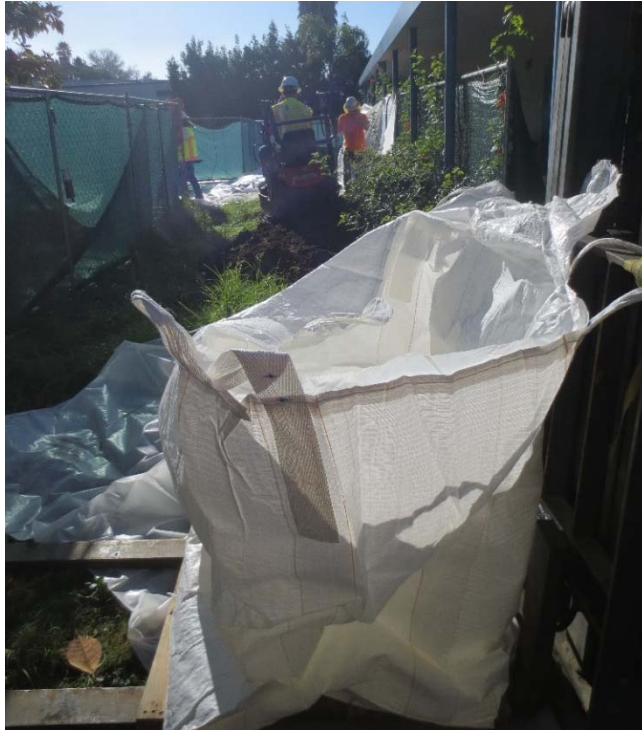
Photo 9: First day of excavation: Empty Super Sack® loaded on forklift, looking south.

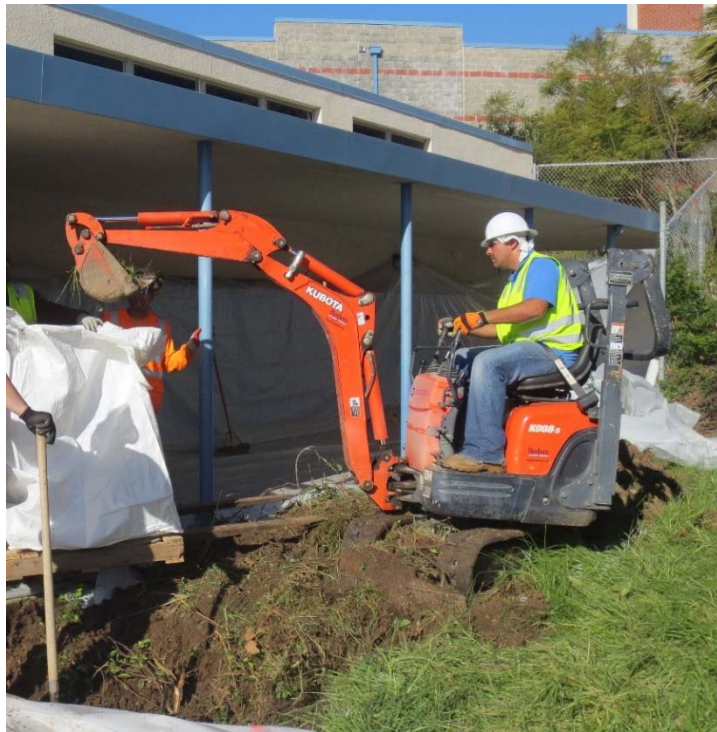
Photo 10: First day of excavation: Loading excavated soil into Super Sack®; lockers covered in plastic in background.

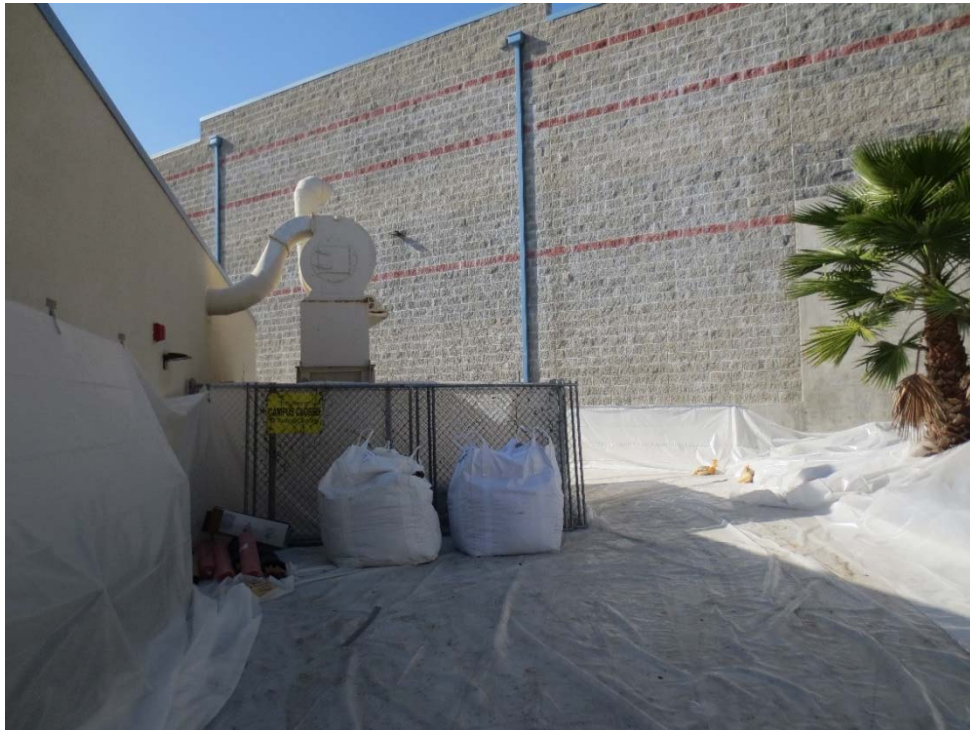
Photo 11: First day of excavation: Temporary Super Sack® staging location north of Building G; plastic sheeting on ground, walls, and hill.

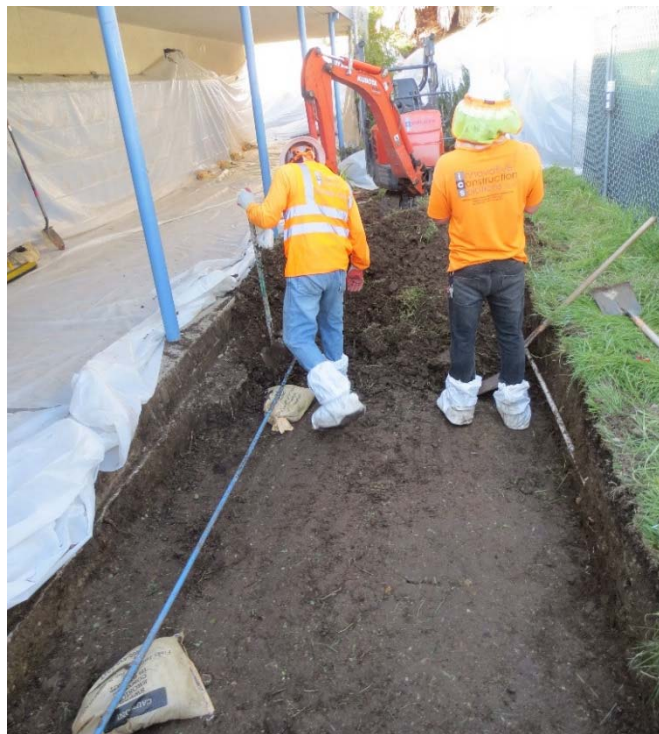
Photo 12: First day of excavation: Southern end of excavation down to total depth of 1.5 feet; blue irrigation line supported by sandbags.

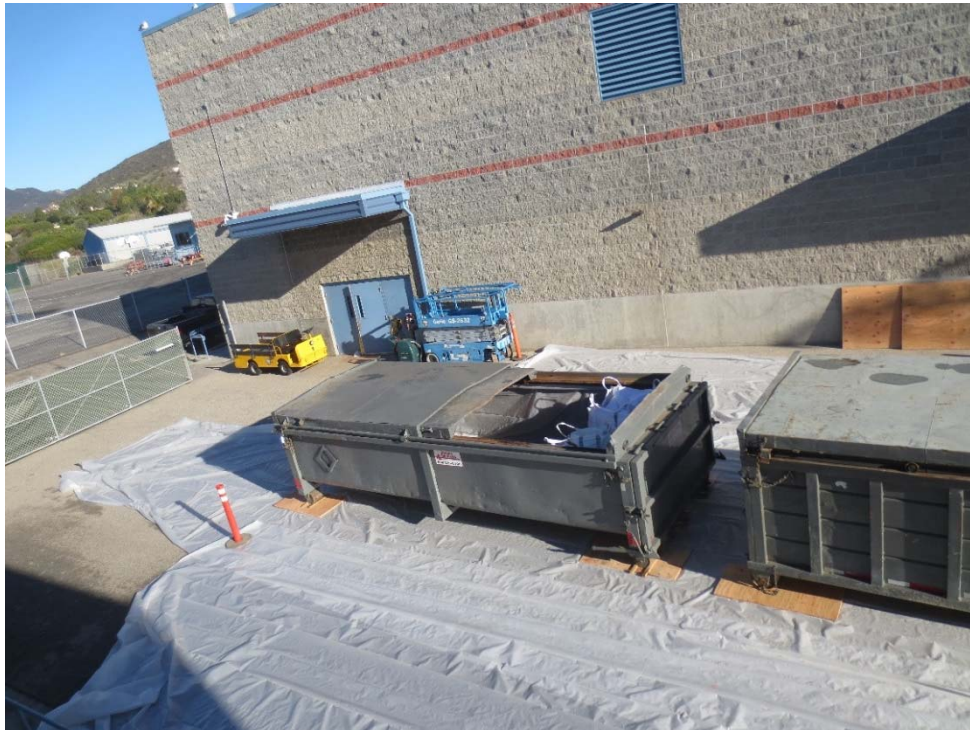
Photo 13: Second day of excavation: Roll-off bins staged on plastic by Gymnasium, looking northwest.

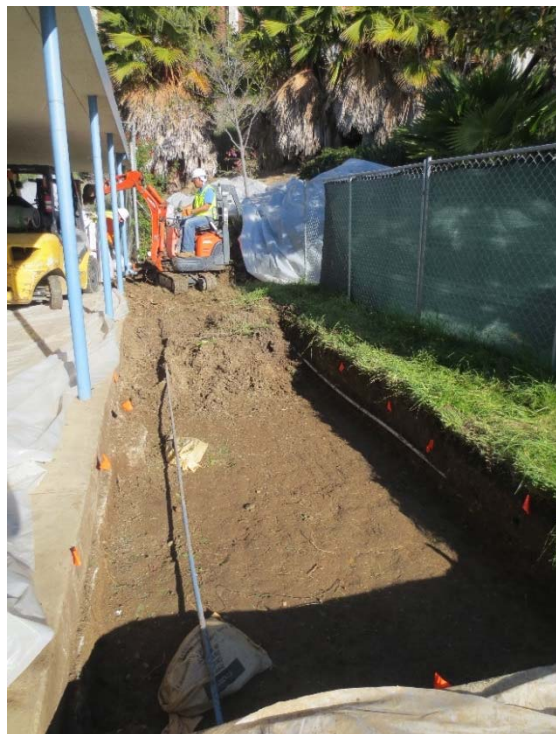
Photo 14: Second day of excavation: Completing northern half of excavation while southern half is flagged for incremental sampling.

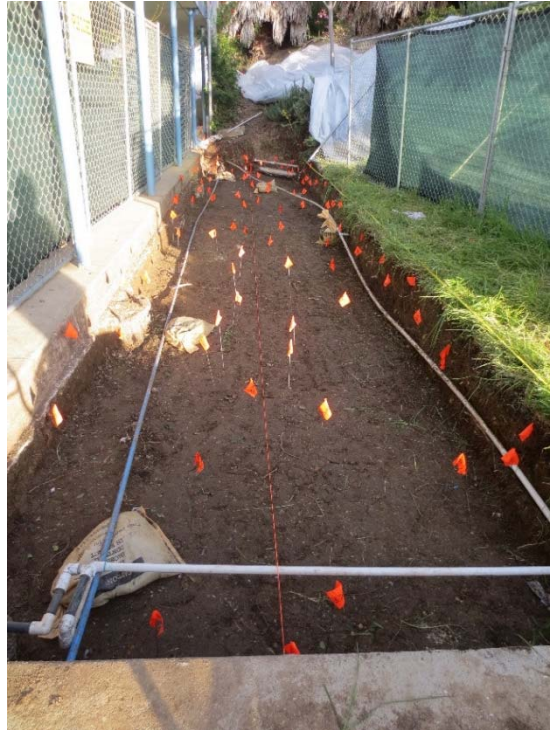
Photo 15: Completed excavation with flagged post-excavation sampling locations, temporary fencing, and plastic; looking north.

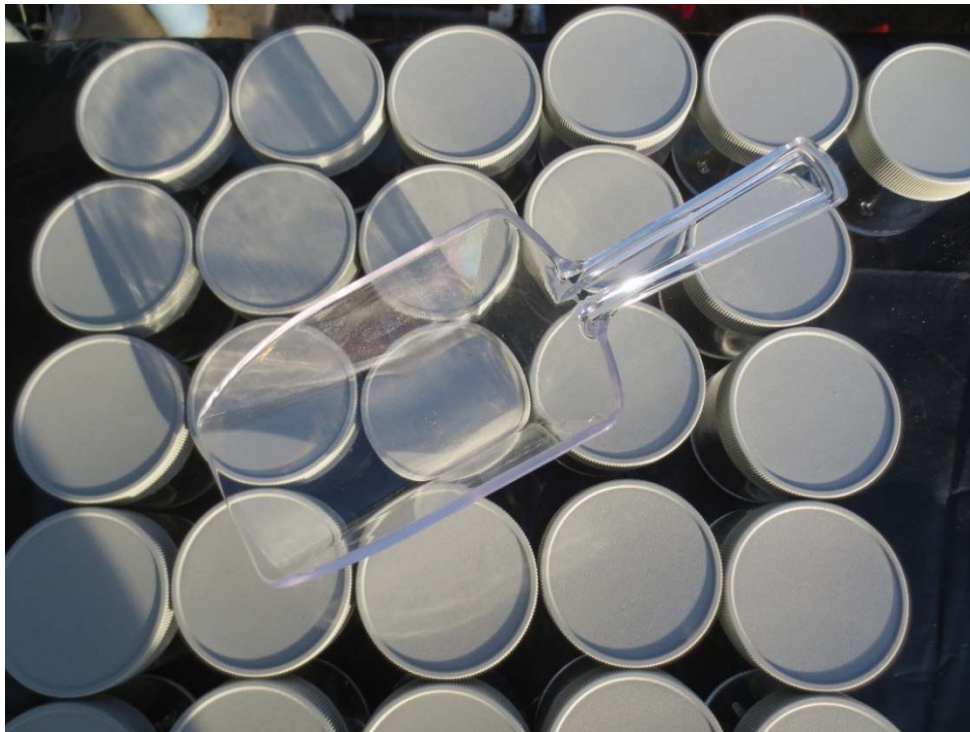
Photo 16: Sample jars and disposable sampler for post-excavation incremental soil sampling.

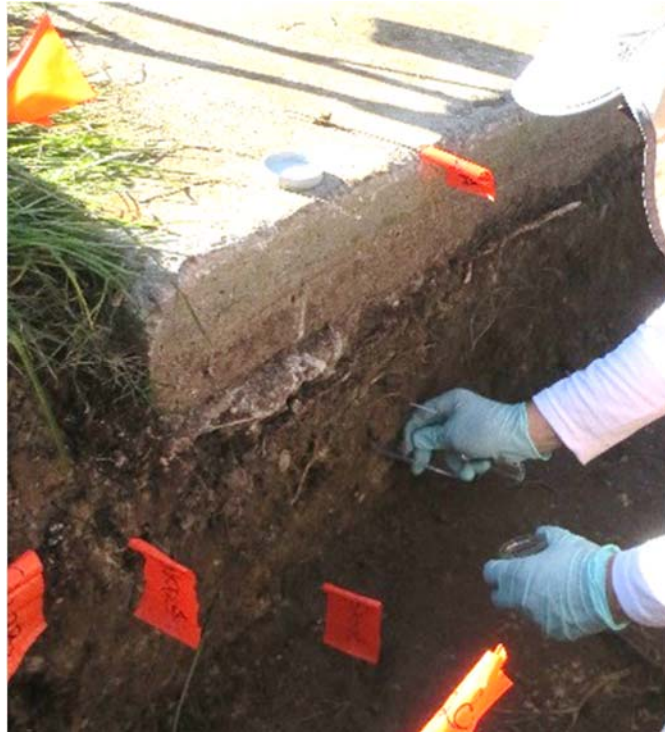
Photo 17: Collecting southern sidewall post-excavation incremental soil sample.

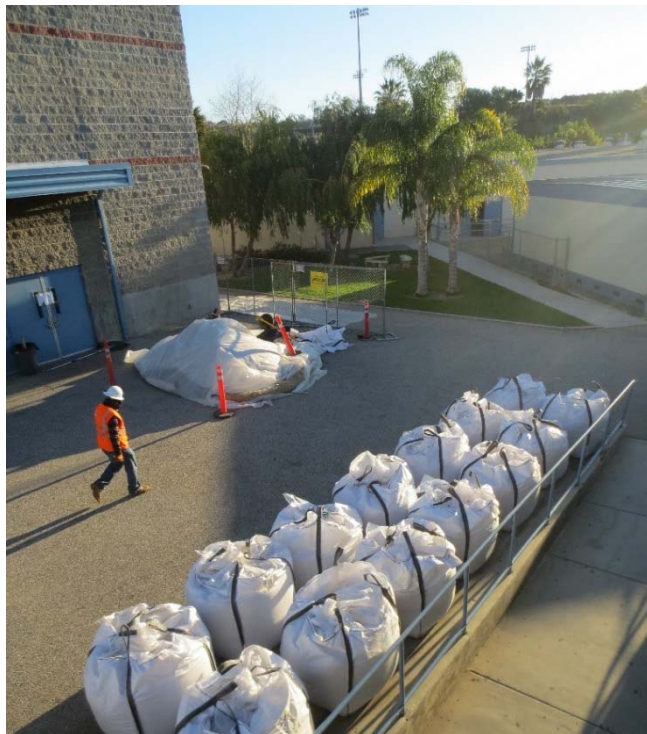
Photo 18: Looking east at Building G: Staging area for Super Sacks of clean imported soil for backfill (to the right) and stockpile of imported topsoil covered in plastic (to the left). Note that the fill soils were approved by DTSC.

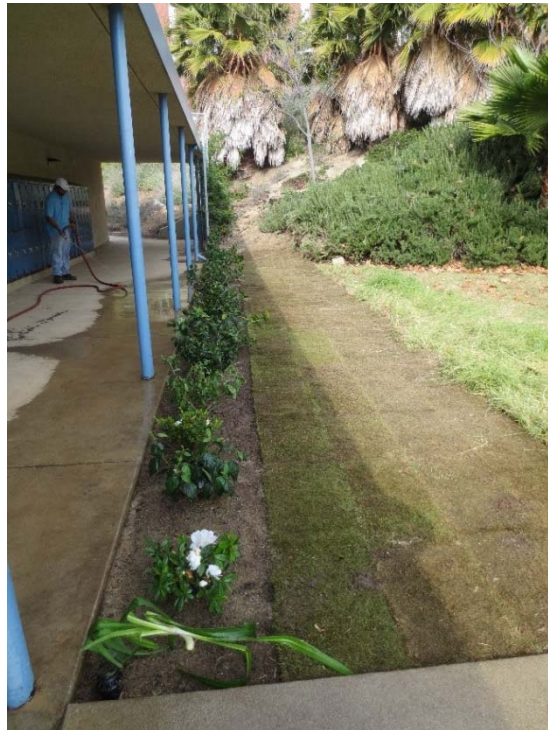
Photo 20: Post Excavation: Looking north - Excavation area restored to previous state with sod and plants.

The excavated area was backfilled using DTSC-approved clean fill soil and topsoil and restored to its original condition. The source of the imported fill material was sampled prior to the start of the field work in accordance with DTSC's guidelines entitled "*Information Advisory, Clean Imported Fill Material*," dated October 2001. Sampling results were submitted to the DTSC and were approved in an email dated December 17, 2014. After placement, the imported clean fill soil and topsoil were compacted using a vibrating plate. Sod was placed outside the planters to replace the grass that was removed. Bushes were planted inside the planters to replace those removed during the excavation (Photos 20 and 21).

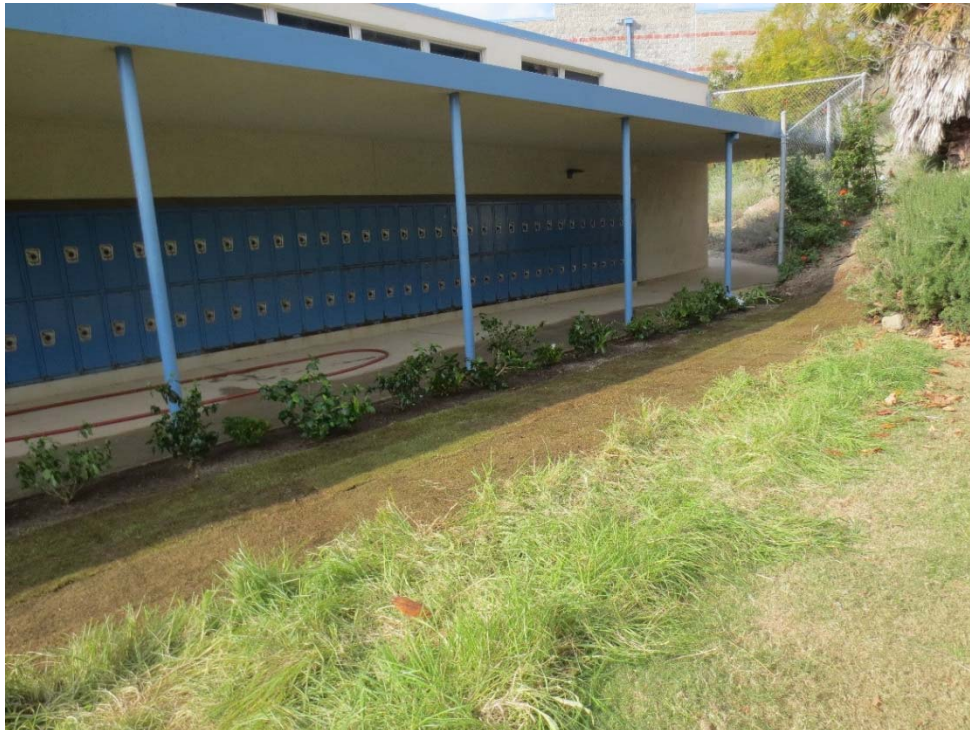
Photo 21: Post excavation: Looking northwest - Excavation area backfilled and restored.

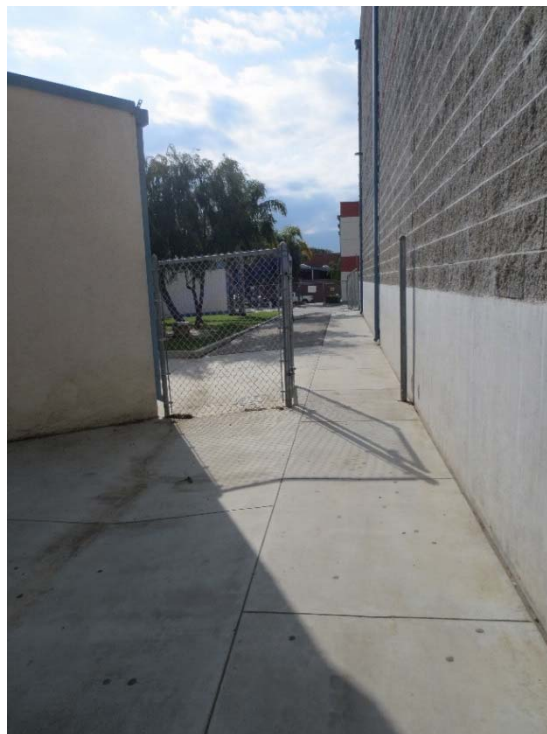
Photo 22: Post excavation: Looking southwest: Soil transport route adjacent to Gymnasium after excavation activities.
