**MEMORANDUM**

To: Michael Burke, NCARB  
From: Michael Mulgrew, P.E.  
Date: January 31, 2025  
Psomas Project: 1SAN080148  
Subject: Webster Elementary School Erosion Control  
Site Observation and Recommendations

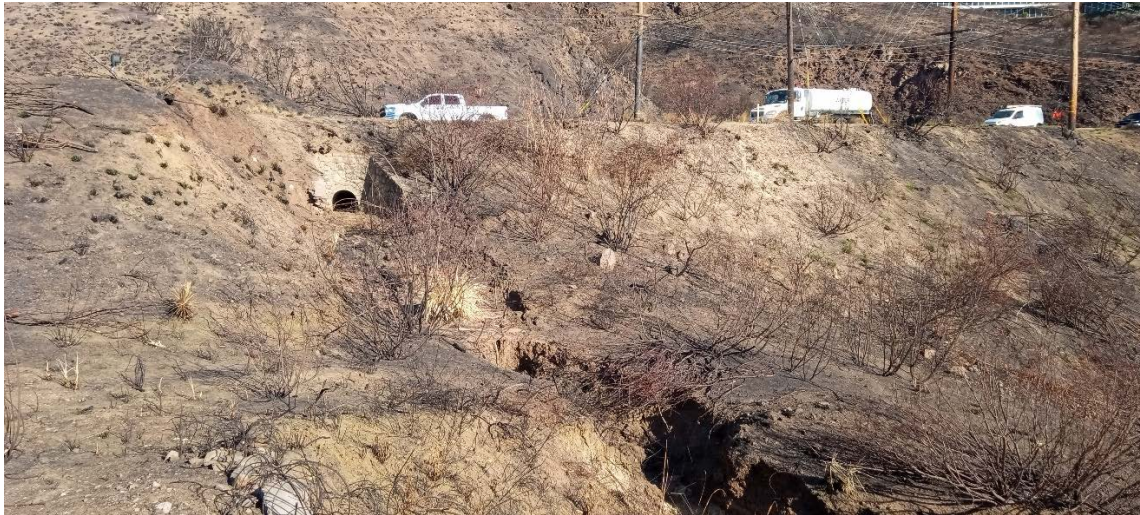
Easterly culvert headwall

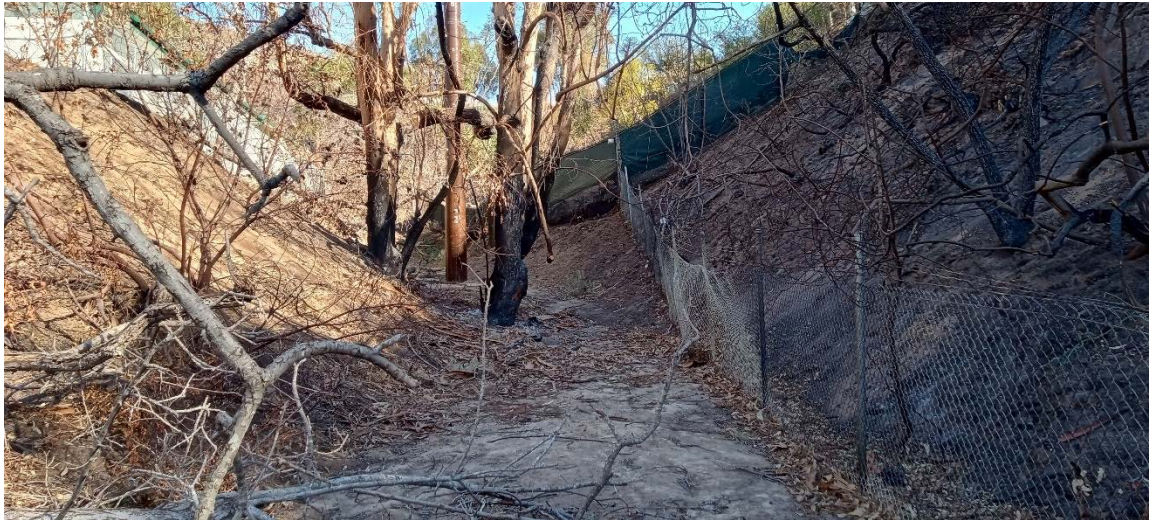
Existing earthen channel along east School property line

Debris has accumulated in the channel east of the School near the headwall inlet; this debris should be removed so that it is not flushed into the inlet, clogging it. Given the depth of the channel and its gradient, it would be expected that, should the inlet clog, the channel would back up and outlet through a vehicle access roadway and surface discharge through the apartment complex immediately southeast of the School. The headwall structure has a debris rack to capture debris before entering the storm drain system, however, large volumes of debris could overwhelm and clog this structure. The access roadway appears to be within an easement dedicated to the County of Los Angeles (per document recorded 9/24/1965 as Instrument No. 3958, OR).

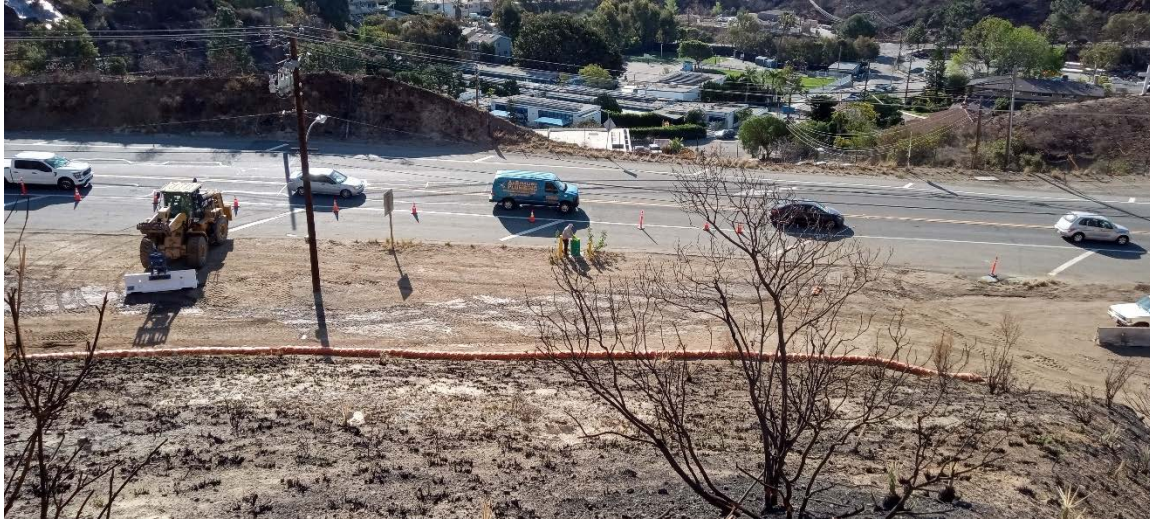
Looking south toward School from hillside north of Malibu Canyon Road

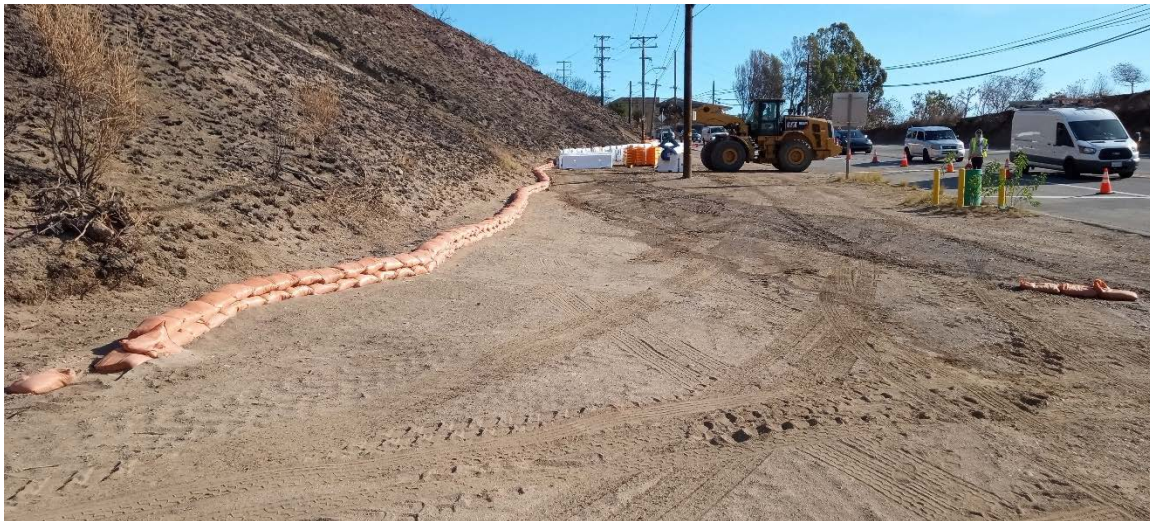
The Authority Having Jurisdiction (AHJ) over Malibu Canyon Road has deployed temporary erosion control measures along the roadway consisting of series of sand bag berms and concrete barriers to control run-off from the burn area and further direct flows to the existing culverts. These erosion control measures will help to mitigate flows toward the school. Additionally, embankments exist at locations along the south side of Malibu Canyon Road that would contain flows within the roadway.

Sand bag barrier and concrete barriers along toe of slope north of School

Psomas recommends regular maintenance of the temporary erosion control measures, including after each storm. All accumulated debris should be removed.

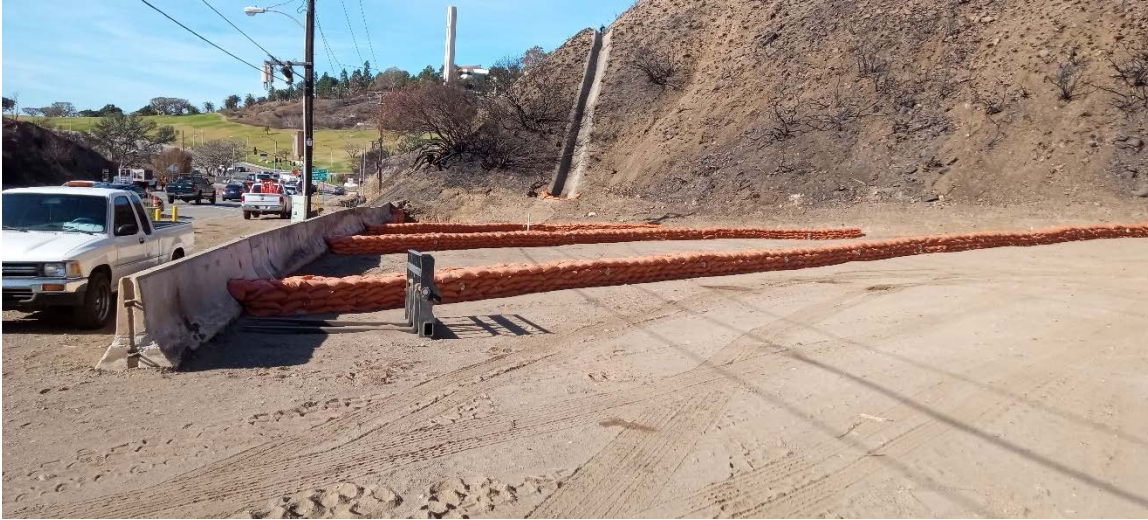
Sand bag barriers and concrete barriers at culvert inlet north of School, concrete terrace drain also visible

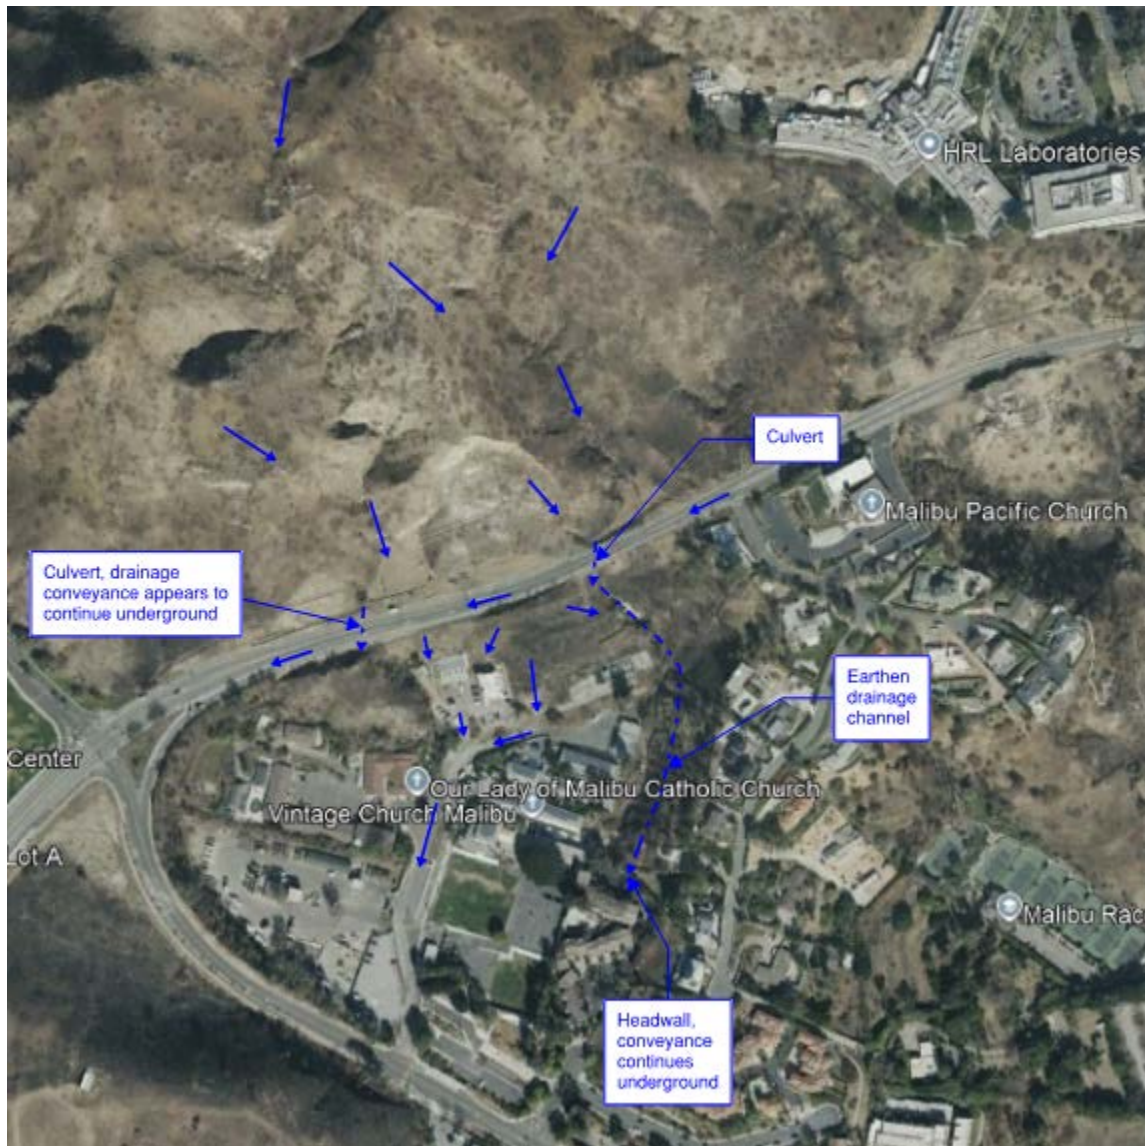
Most of the 50-acre tributary area is north of Malibu Canyon Road. In the event of a debris flow, the roadway would serve as the first barrier for the School, as the road slopes to the west and may intercept and direct flows away from the School. Several concrete terrace drains exist along the top of road cuts, and the majority of run-off from this area is directed toward two culverts that cross beneath the roadway. The easterly culvert daylights south of the road into an earthen drainage channel that runs along the east property line of the school, terminating in a headwall structure that conveys the flows into an underground storm drainage system. The outlet condition for the westerly culvert was not visible during the site walk and it was assumed to continue underground. The general surface drainage gradient for the School is north to south, with limited on-site storm drain infrastructures that serves the immediate campus property.

Existing drainage patterns in the vicinity of Webster Elementary School

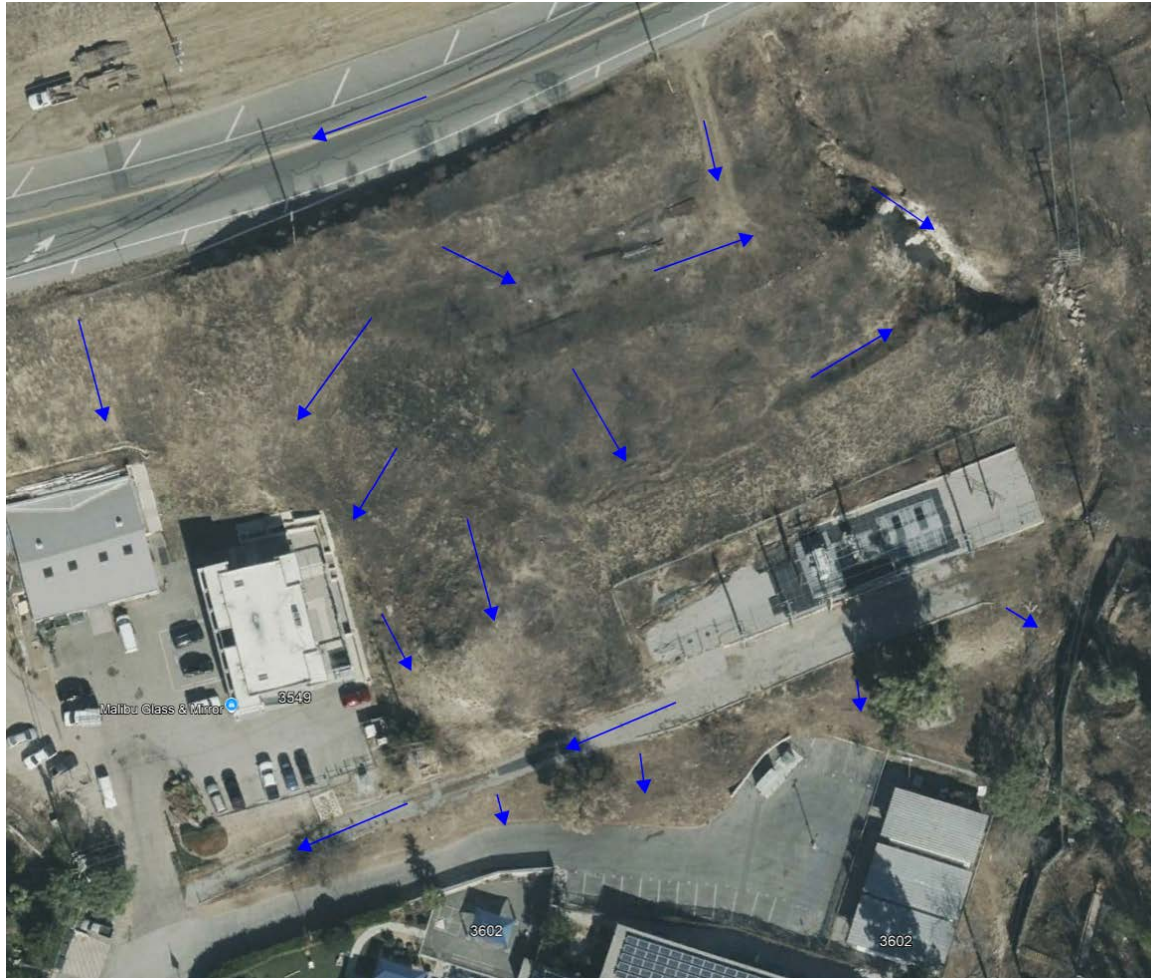
A business, Malibu Glass & Mirror, and a Southern California Edison substation are present immediately north of the School. Each of these facilities would also serve to protect the school in the event of debris flows occurring in the Santa Monica Mountain north of the School, should those flow bypass Malibu Canyon Road. A terrace and berm exist uphill over a portion of the Edison station, directing flows east toward the earthen channel. A gap exists between the facilities which could be an avenue for debris to move onto the campus. An access road serving the Edison station crosses this gap and drops from the east to the west, providing a potential conduit to capture flows and direct them down Winter Canyon Road, around School structures.

Existing drainage patterns immediately north of School

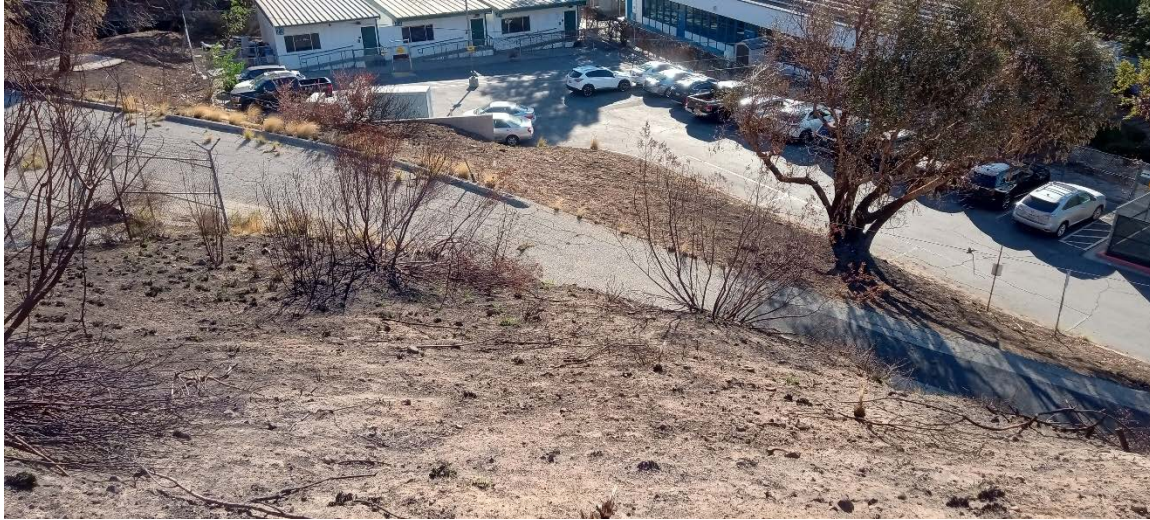
Looking south toward School through gap between Edison station and glass business

Outside of the School property, it is recommended to install a K-Rail barrier along the access road serving the Edison station. This would require permission from the property owner.

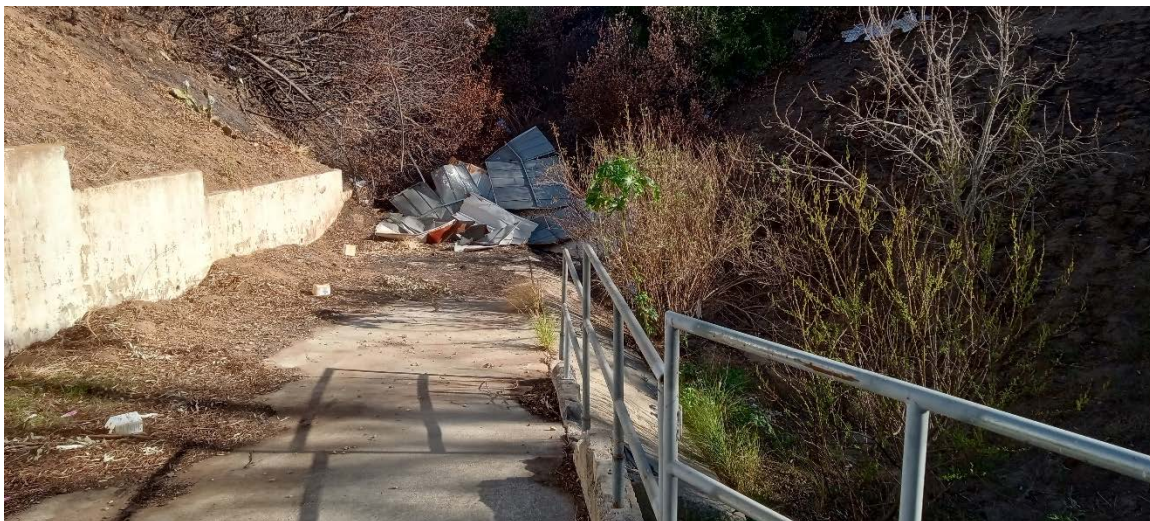
Looking upstream in earthen channel from top of vehicular access way, note debris accumulation

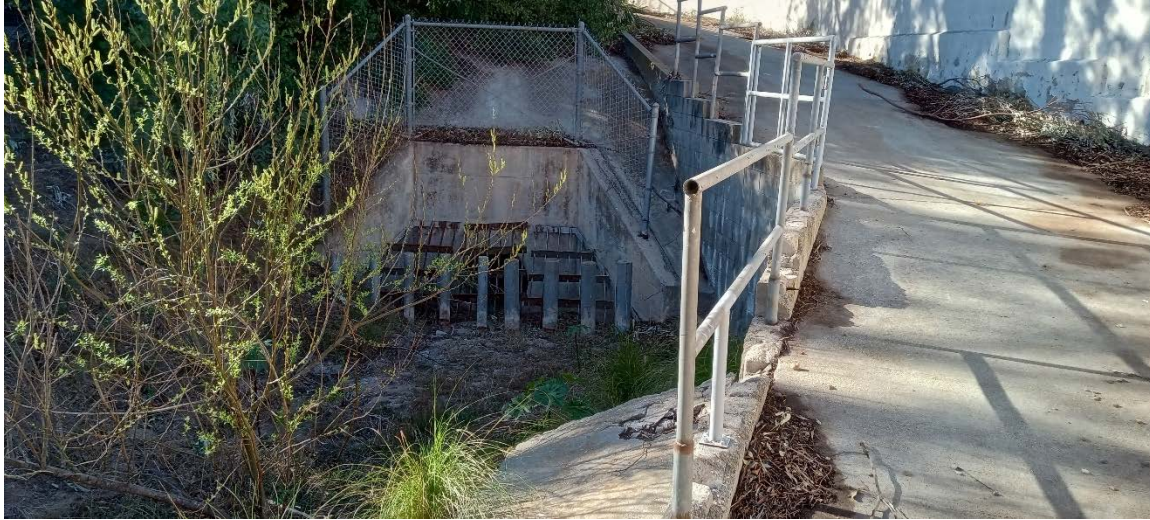
Headwall with debris rack at downstream terminus of earthen channel; vehicle access way on right

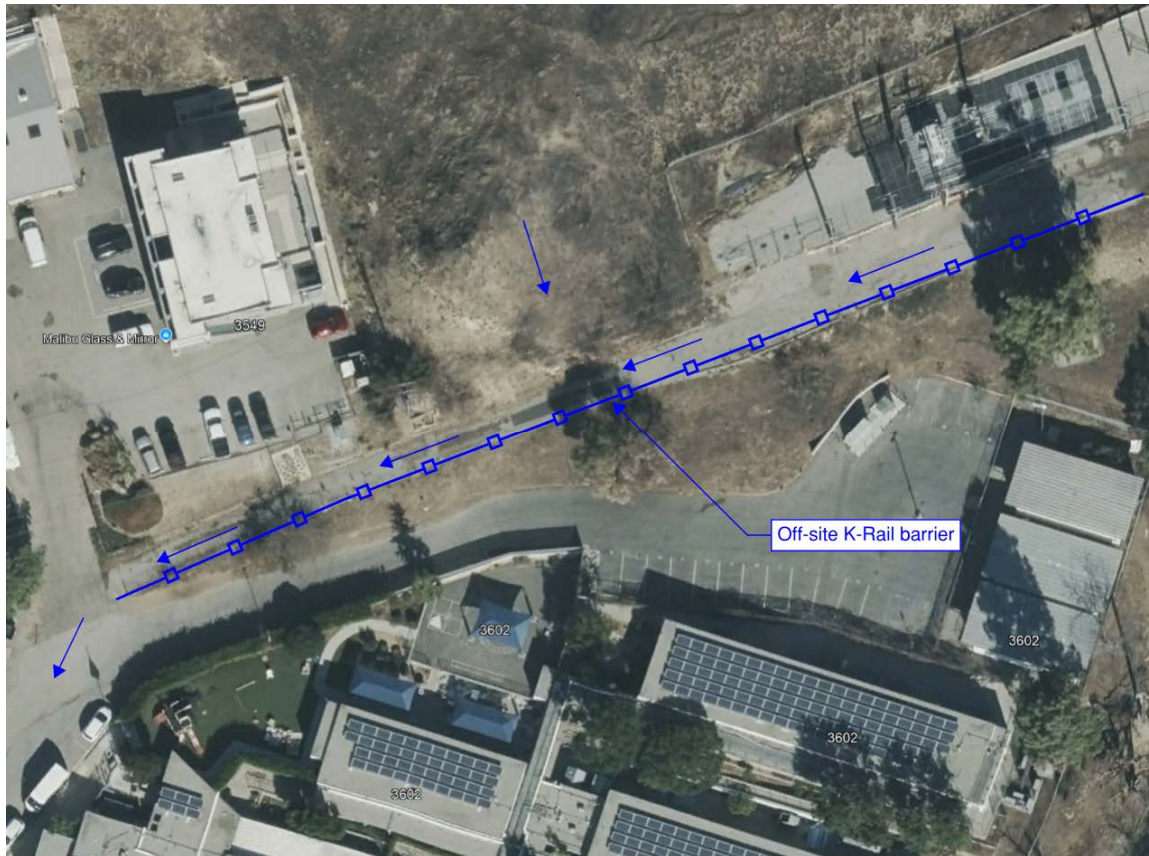
Work in this area would require permission from the property owner

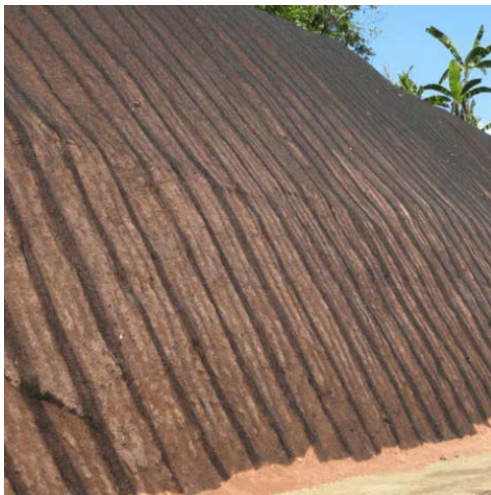
Example of geotextile erosion control mats installed on a steep slope

Additionally, with coordination from the adjacent property owner, geotextile erosion control mats could be installed along the slopes north of the School. The ground surface was observed to be firm and unyielding during the field walk, but this could change as the ground becomes saturated during a storm.
