RE **Wildfire Smoke Impact Post-Remediation Assessment – Webster Elementary School
(FACS# PJ88022)**

Forensic Analytical Consulting Services, Inc. (FACS) was retained by Santa Monica-Malibu Unified School District (SMMUSD) to provide a wildfire smoke post-remediation assessment at Webster Elementary School, located at 3602 Winter Canyon Road in Malibu, California.

In July 2025, SMMUSD requested that FACS perform an additional post-remediation assessment. The purpose of FACS' post-remediation assessment was to document current conditions at the school and confirm that remediation efforts were adequate to ensure a safe and healthy environment for students and staff.

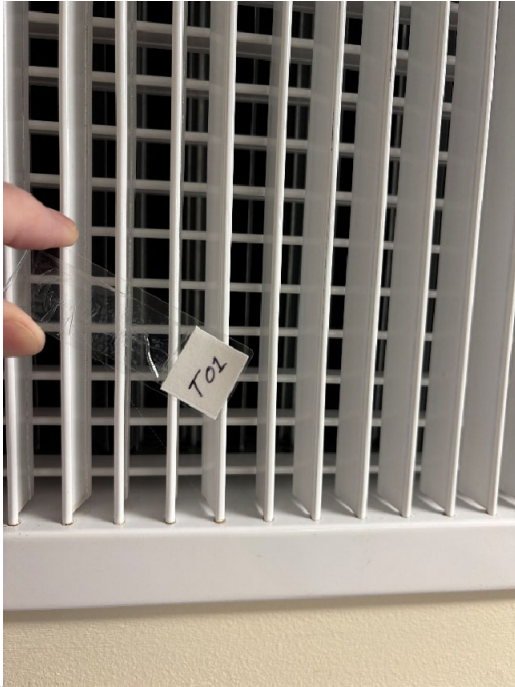
Photo #1: Building H – Classroom 2, HVAC register -
Sample T01 -

SUMMARY CONCLUSIONS : Fire/combustion residue not detected**QUALITATIVE / ASSEMBLAGE OBSERVATIONS -Reflected & Polarized Light Microscopy (10-500x)**

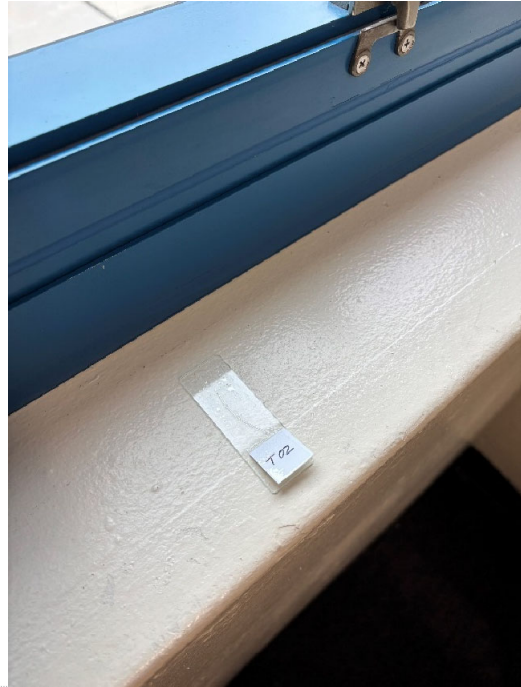
Photo #2: Building E – Library, window sill – Sample
T02

SUMMARY CONCLUSIONS : Fire/combustion residue measured in the typical / upper background range

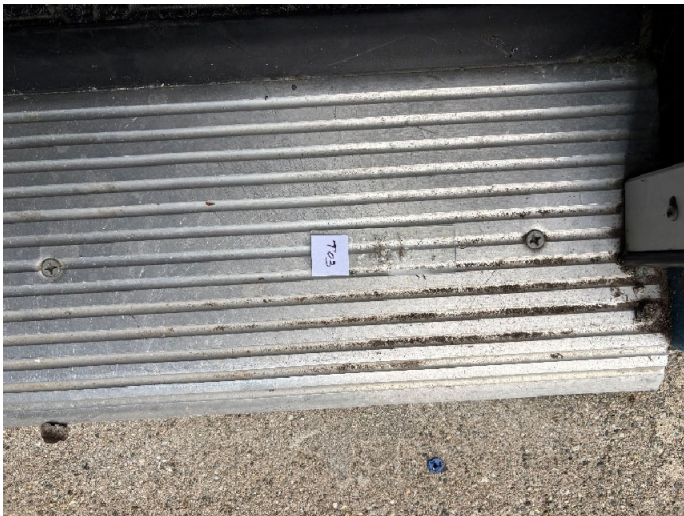
Photo #3: Building E – Classroom 7, door threshold
– Sample T03

SUMMARY CONCLUSIONS : Fire/combustion residue concentration measured above typical background concentrations
 Qualitative observations confirm the presence of indicator fire/combustion particles

Sample description - color / texture :	Brown / black powdery & fibrous dust		
Smoke or fire odor present :	No		
Large char (>500µm) / aciniform soot clusters (>50µm) present :	Yes - Char		
Large ash particles present :	Yes		
Wildfire or structure fire indicator/signature particles present :	Yes	Vegetation/wildfire indicators	
FIRE / COMBUSTION RESIDUE CONSTITUENTS		Particle Concentration	Estimated
		Cts/area (mm²)	Area Ratio %
Totals ►		74.3	18.7 %
Vegetation/wildfire indicators	Aciniform soot	not detected	not detected
	Char (pyrolyzed vegetation)	23.4	8.8
	Ash	26.1	6.5
	Burned clay, mineral grains, phytoliths	24.8	3.4
INORGANIC CONSTITUENTS			
Fibrous Constituents :	Cellulosic / synthetic fabric fibers	11.0	18.3
	Fiberglass fibers	not detected	not detected
Non-fibrous Constituents :	Mixed inorganic mineral dust / soil	390.6	29.3
	Other opaque / paint / metal corrosion / rubber	144.4	20.0
BIOAEROSOLS			
Mold Spores / Structures :	Unspecified	6.9	0.2

Based on assessment findings collected during the post-remediation assessments, surfaces were visually clean of smoke related particulates and no smoke odors were observable. Sampling found smoke particulates above background levels at entry points (windows and door thresholds) and exterior surfaces. Additional and more frequent routine cleaning is recommended. Flooring and window surfaces

should be HEPA-vacuumed and/or wet-wiped with a detergent mix as appropriate. Refer to general recommendations for remediation in the initial FACS report dated December 16, 2024.

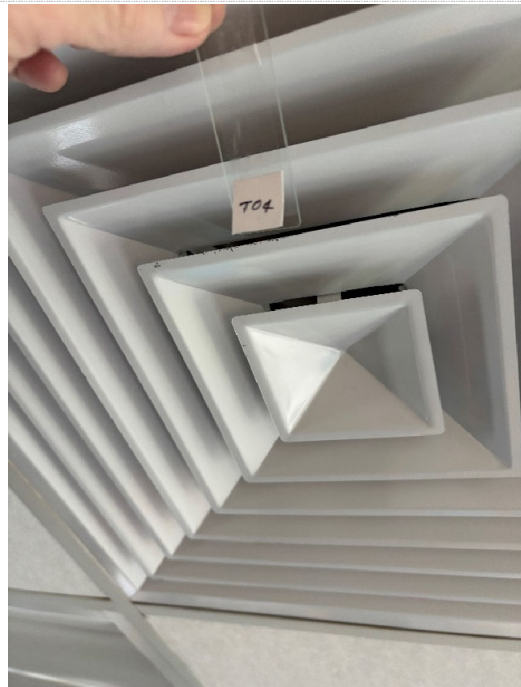
Photo #4: Building F – Classroom 10, HVAC register
– Sample T04

SUMMARY CONCLUSIONS : Fire/combustion residue measured in the typical / upper background range

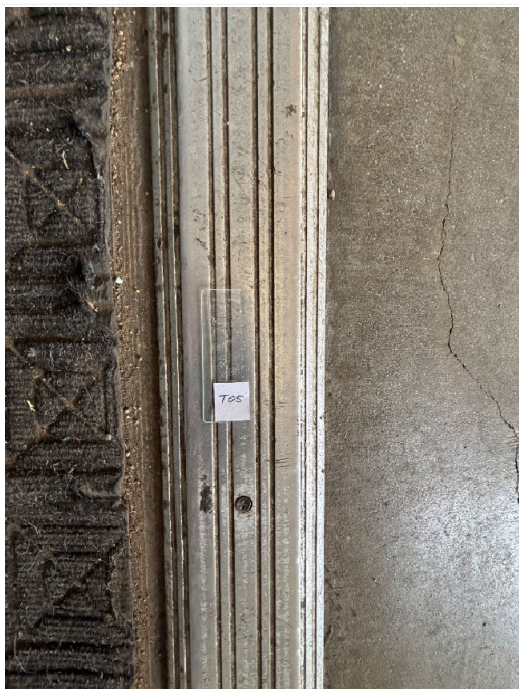
Photo #5: Building G – Auditorium, door threshold – Sample T05

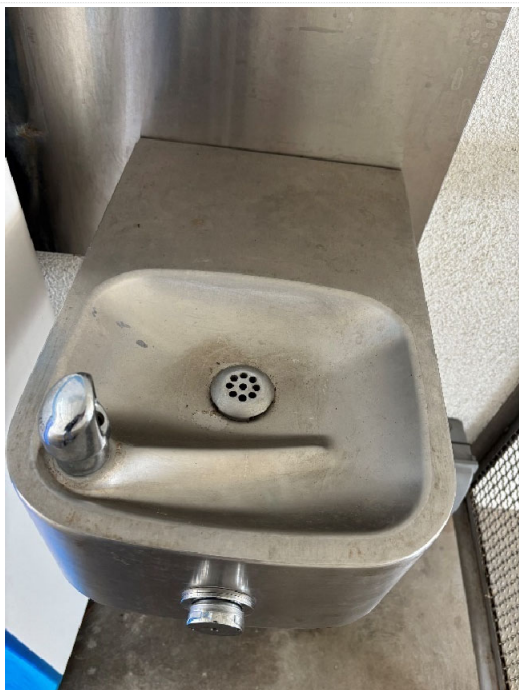
Photo #7: Building C – Drinking fountain – Sample T07

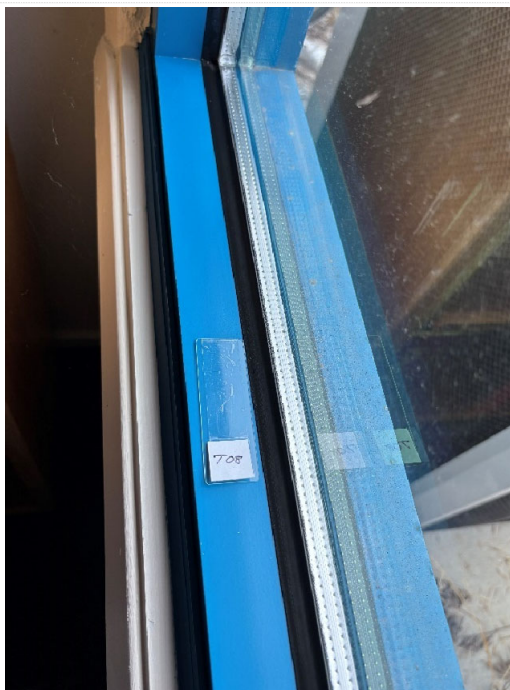
Photo #8: Building C – Classroom 16A, window frame – Sample T08

T08	BLDG C, Class Rm 16A, NE Window Frame	0.8	0.8	not detected	not detected		2.3			
T09	BLDG A, Class Rm 20, N Window Trough	6.0	0.2	3.9	1.3	0.6	8.3	Yes - Char (isolated)	Yes	
T10	Bungalow 22, E Windowsill	1.9	not detected	1.9	not detected		1.4

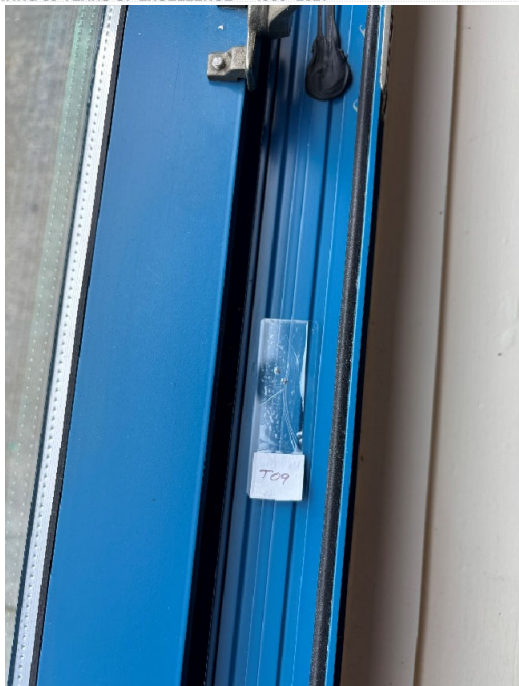
Photo #9: Building A – Classroom 20, window trough
– Sample T09

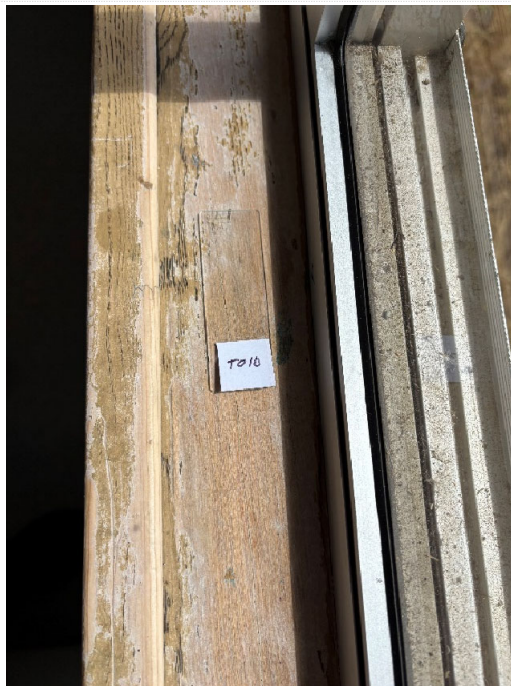
Photo #10: Bungalow Room 22, window sill –
Sample T10
