**INDUSTRIAL HYGIENE SURVEY REPORT
SANTA MONICA-MALIBU UNIFIED SCHOOL DISTRICT
MALIBU HIGH SCHOOL
30215 MORNING VIEW DRIVE
MALIBU, CALIFORNIA 90265**

October 17, 2013
EE Project # 13-A0118-0255
ASCIP Project # LC5115

Survey Date: September 20 and October 4, 2013

School Site: Malibu High School, Classrooms 1, 2, 3, 10, 14 and the Costume Storage Room (also known as Room 17)
30215 Morning View Drive
Santa Monica, California 90265

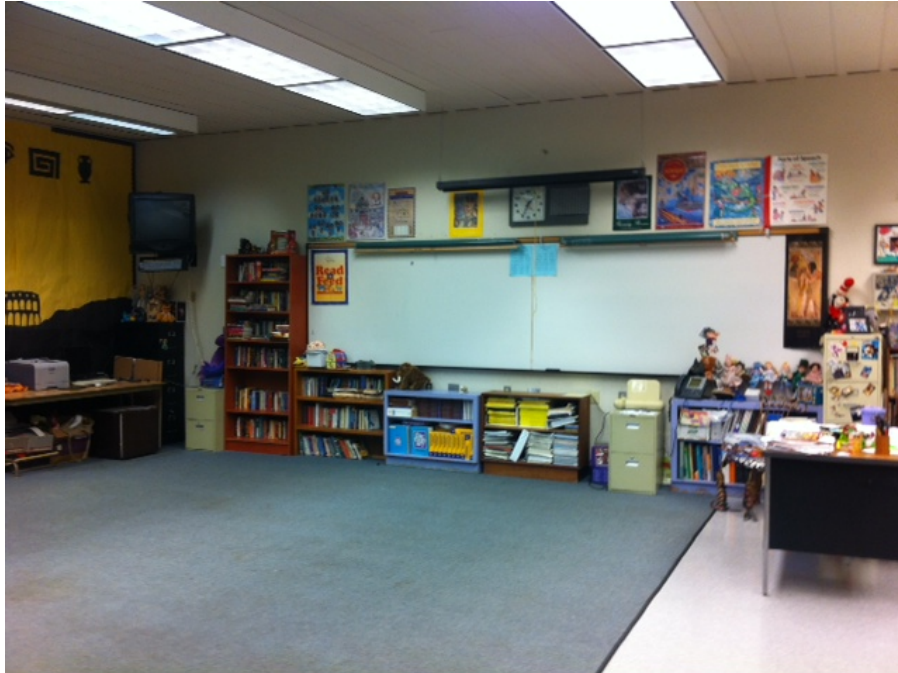
Photo 1 – Classroom 1, facing northeast; air samples 130920-0255-VMU-ST02 and 130920-0255-VMU-ST03.

Classroom 1 Field Observations: Photos 1 and 2 show the layout of the classroom. There were no water-damaged ceiling tiles. There was a noticeable dusty and animal-like odor. There was clutter on horizontal surfaces which prevents them from being dusted and cleaned. Rat droppings, silverfish and spiders were observed in the classroom.

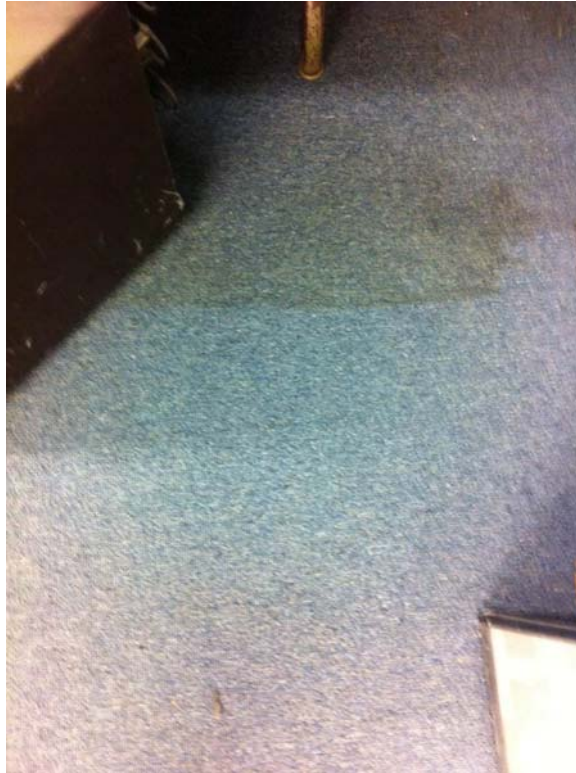
Photo 3 – Carpet stain by refrigerator in northeast corner of Classroom 1.

Photo 3 shows a large carpet stain under the refrigerator. Ms. Leonard reported that her refrigerator had been unplugged during the construction and the contents defrosted and leaked onto the carpet. A small area in front of the refrigerator, approximately one inch by one inch in diameter, measured 25% moisture but the remaining carpet was dry, below 15%. It was most likely from condensation from the refrigerator when the door was opened during the inspection.

One small area measured in Classroom 1, in front of the refrigerator, approximately one square inch, was in excess of 20 percent moisture. This was most likely due to opening the refrigerator door and condensation dripping onto the carpet. The remainders of the readings were below 15 percent moisture.

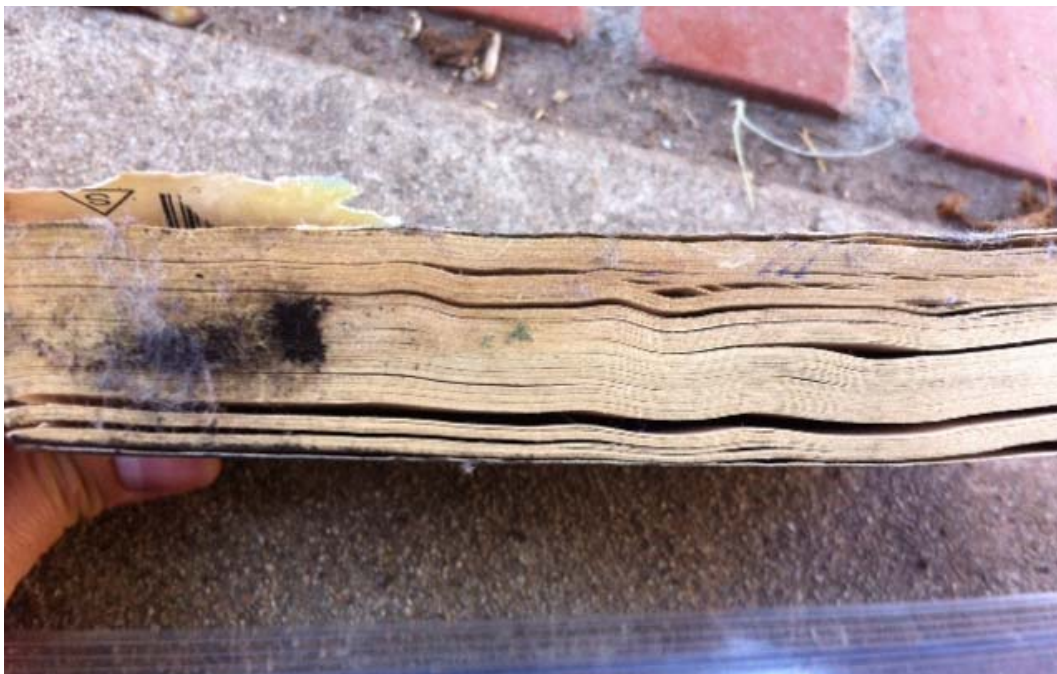
Photo 4 – Water stained paperback book collected from Classroom 1;
Sample 130920-0255-VMU-B01.

Photo 4 shows a water stained paperback book with suspect mold. A small patch of carpet from underneath the book was collected and is shown in Photos 5 and 6. Photo 7 shows the top of the personal refrigerator in the northeast corner of Classroom 1. Photos 8 and 9 show the Environizer, electric air cleaner that uses an ionizer.

Bulk Sample: Mold growth was found on the two bulk samples collected in Classroom 1, a water stained paperback book and carpet sample collected from underneath the book. The predominating mold types were *Aspergillus*, *Ascomycetes* and *Stachybotrys* species.

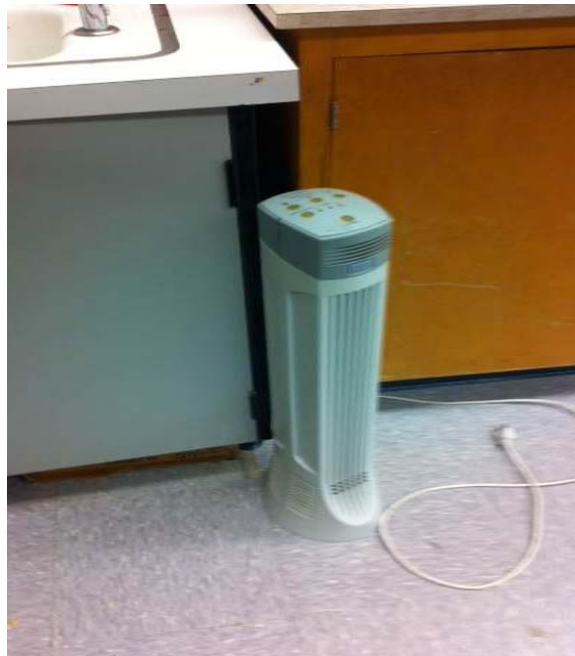
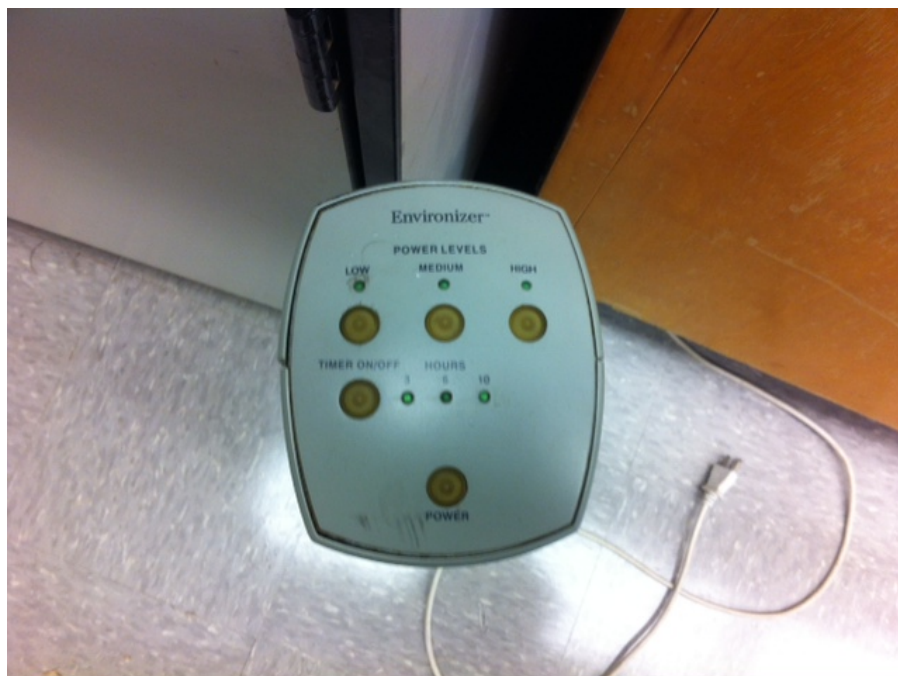
Photo 8 – Air cleaner in Classroom 1.

Photo 9 – Top view of air cleaner in Classroom 1.

The October 2003 issue of Consumer Reports rated portable room air cleaner's effectiveness in removing smoke under controlled conditions. Their top picks include the Friedrich C-90A electrostatic precipitator and the Whirlpool HEPA (High Efficiency Particulate Air) Filter; however, neither model was effective in removing odors; further, the Friedrich model may generate ozone which is a respiratory irritant. The study found that the heavily promoted Sharper Image Ionic Breeze and the Honeywell Envirionizer (as used in Room 1) are quiet **but ineffective**.

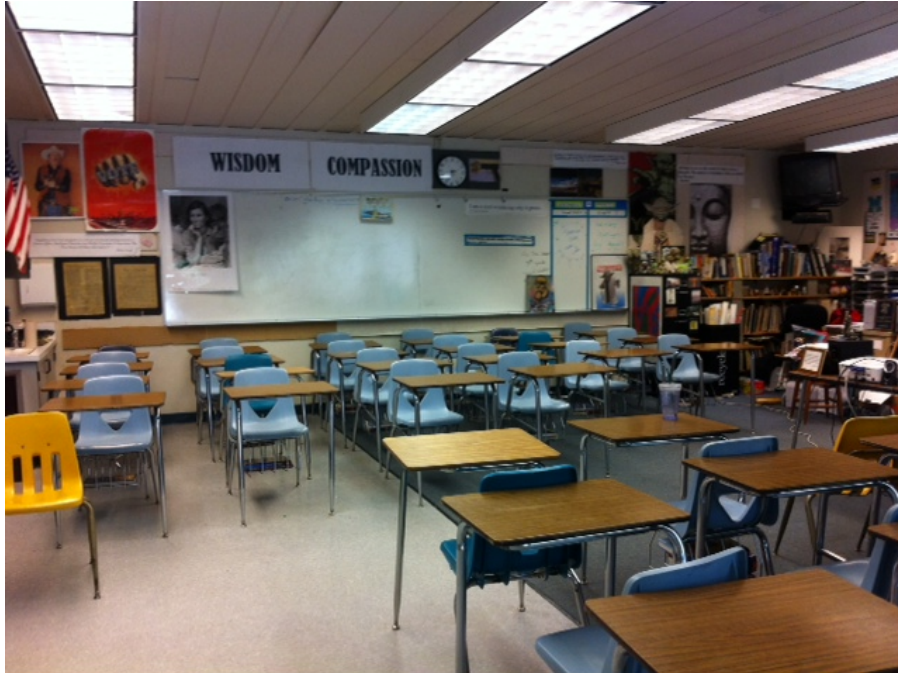
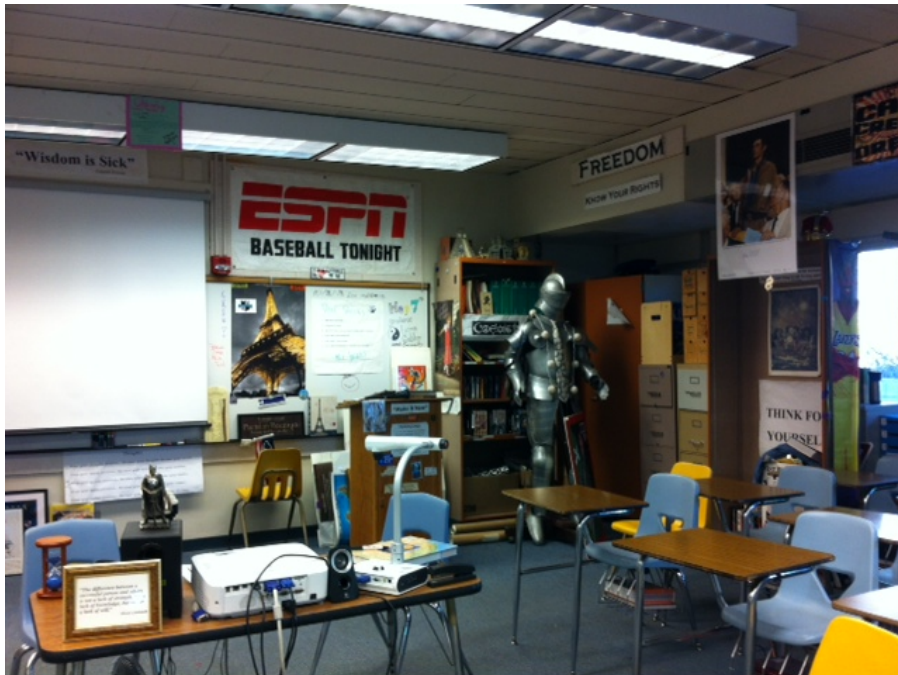
Classroom 2 Field Observations: Classroom 2 is located directly east of Classroom 1. Photos 11 and 12 show an overview of the classroom. There is a noticeable dusty and musty odor in the room. There was clutter on horizontal surfaces and surfaces were dusty. No water stained ceiling tiles or suspect mold were observed.

Photo 11 – Classroom 2 facing west; Air Samples 131004-0255-VMU-ST02 and 131004-0255-VMU-ST03.

Photo 12 – Classroom 2 facing southeast corner.

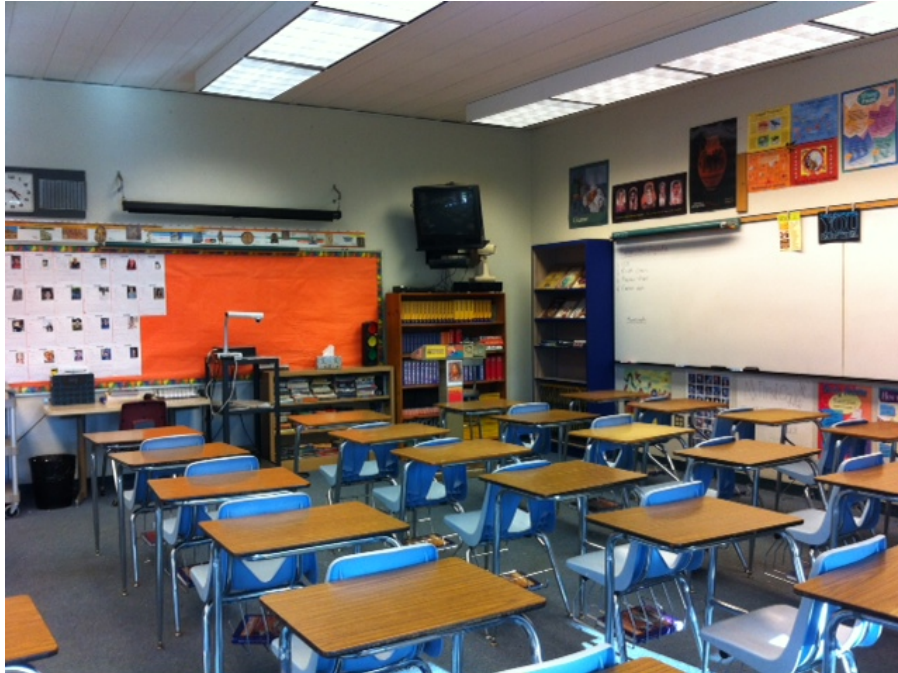
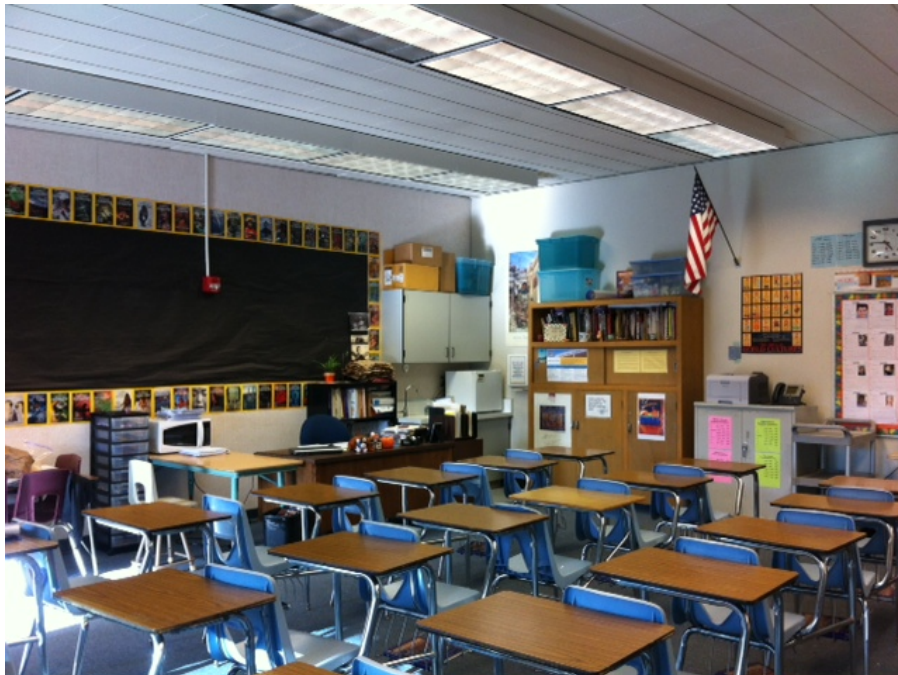
Classroom 3 Field Observations: Classroom 3 is located on the west side of Building E. Photos 13 and 14 show the overview of the classroom. There was a slight dusty and musty odor in the classroom. There were no water stained ceiling tiles. Horizontal surfaces were dusty.

Photo 13 – Classroom 3, facing southeast corner; Air Samples 131004-0255-VMU-ST08 and 131004-0255-VMU-ST09.

Photo 14 – Classroom 3, facing northeast corner.

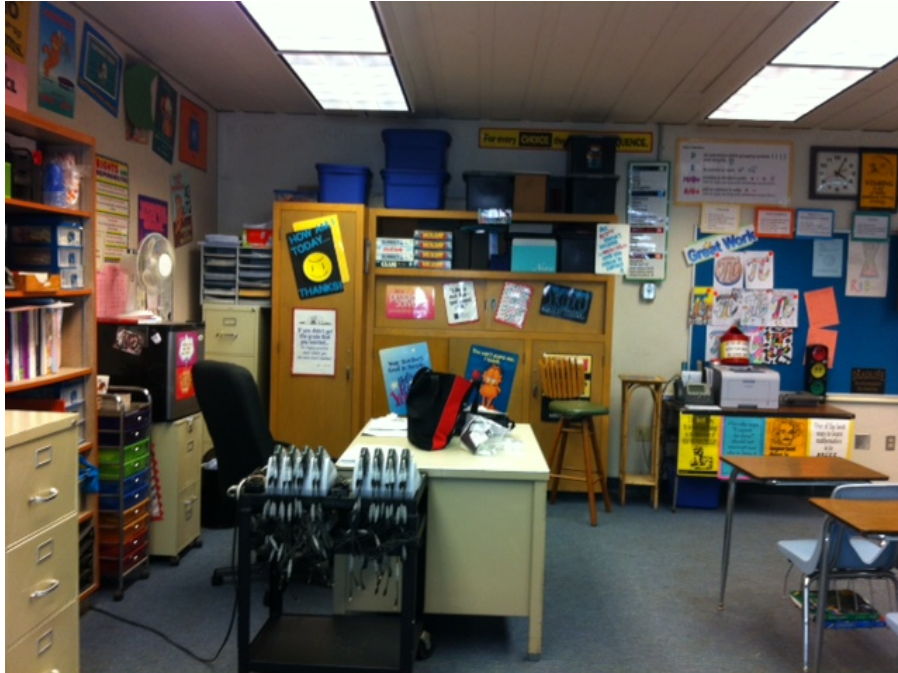
Classroom 10 Field Observations: Classroom 10 is located on the north side of the building between Classroom 8 and the Boys Restroom. The doors and windows were closed prior to entry and the room had a slight dusty and musty odor. Photos 15 and 16 show an overview of the classroom.

Photo 15 – Classroom 10 facing the southwest corner; Samples 131004-0255-VMU-ST04 and 131004-0255-VMU-ST05.

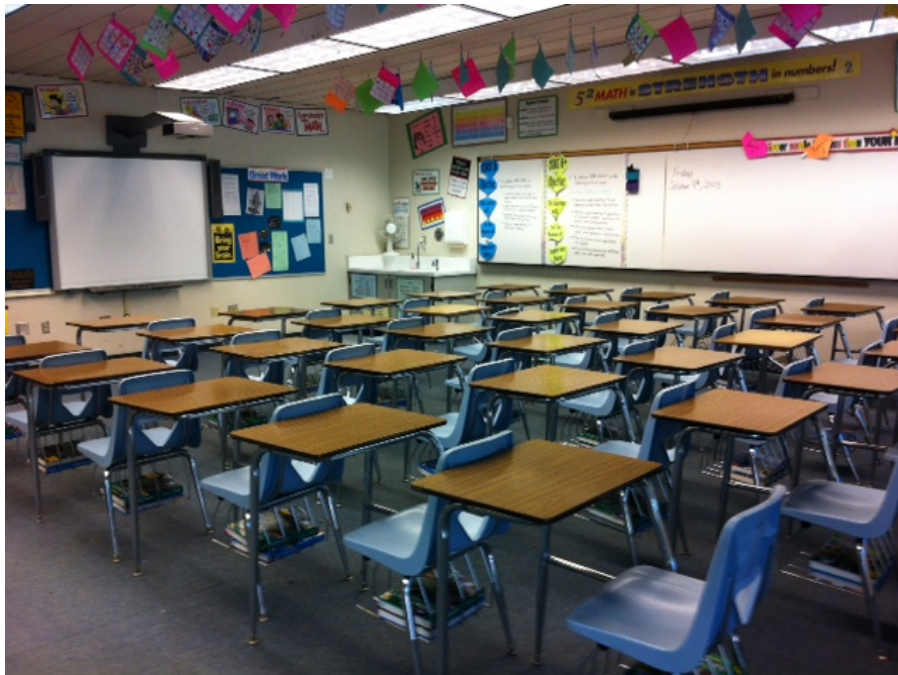
Photo 16 – Classroom 10 facing the northwest corner.

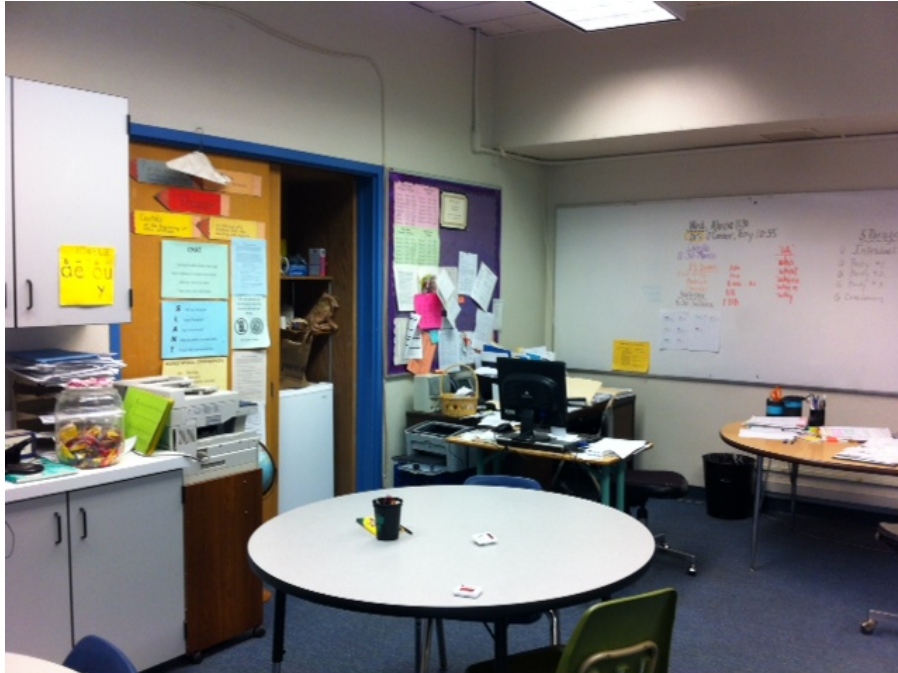
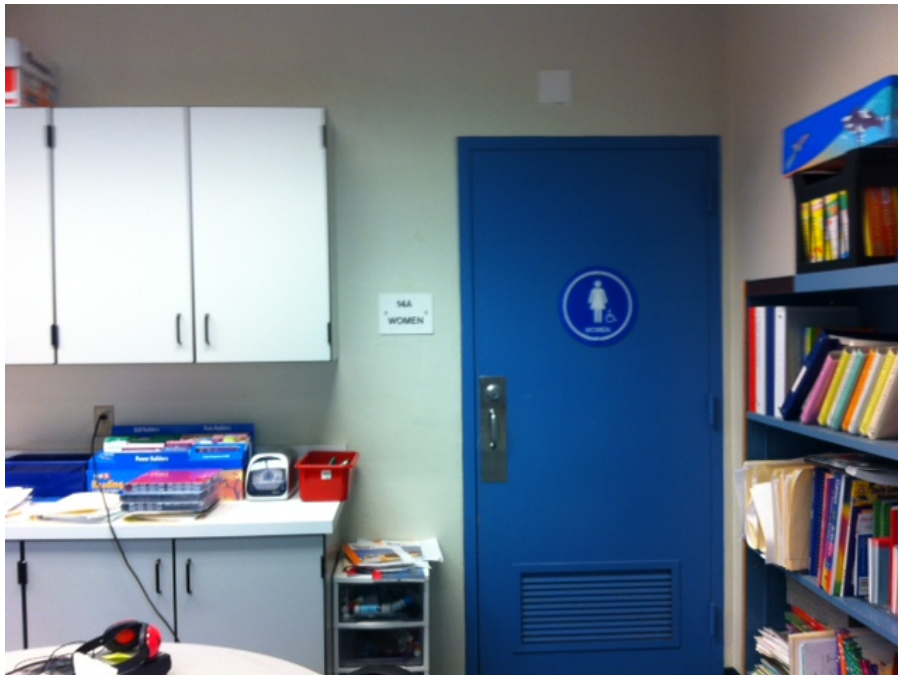
Classroom 14 Field Observations: Classroom 14 is located on the north end of the building. The room has one exterior door and no windows. Two restrooms are located adjacent to the classroom. Photos 17 and 18 show the overview of the room. There was a slight musty odor in the room. There were no water stained ceiling tiles. Horizontal surfaces were dusty.

Photo 17 -, Room 14, facing southeast corner; Air Samples 131004-0255-VMU-ST07 and 131004-0255-VMU-ST08.

Photo 18 – Room 14, facing west.
