PCB DELINEATION SAMPLING

Doors and Windows Replacement Project
Buildings A, B, C, D, E, F, G and H
Webster Elementary School
3602 Winter Canyon Road
Malibu, California 90265

Project No.: SMSD-16-6514
Date: Revised, February 14, 2017

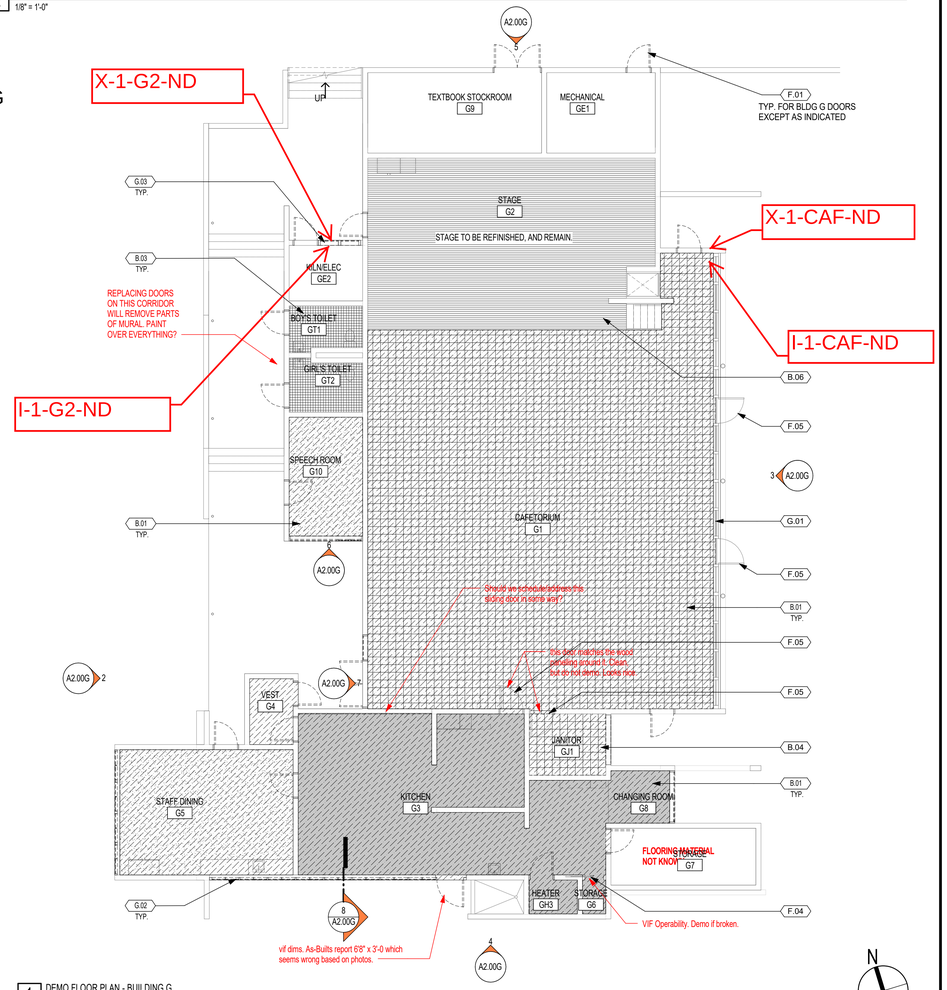
1 DEMO FLOOR PLAN - BUILDING G
1/8" = 1'-0"

X-1-G2-ND

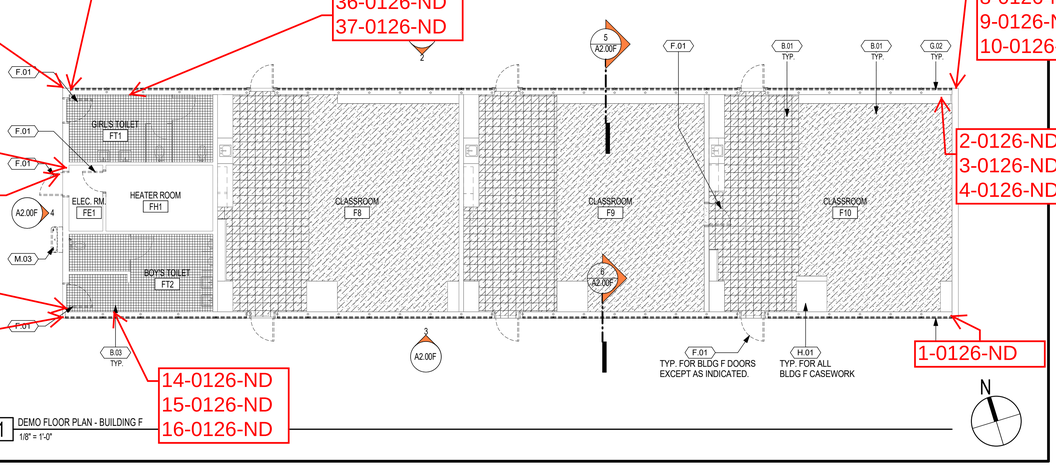
1 DEMO FLOOR PLAN - BUILDING F
1/8" = 1'-0"

14-0126-ND
15-0126-ND
16-0126-ND

1-0126-ND
