SMASH-Muir Elementary School

**Structural Assessment
Due to Water Intrusion**

2526 6th Street
Santa Monica, CA 90405

June 29, 2022

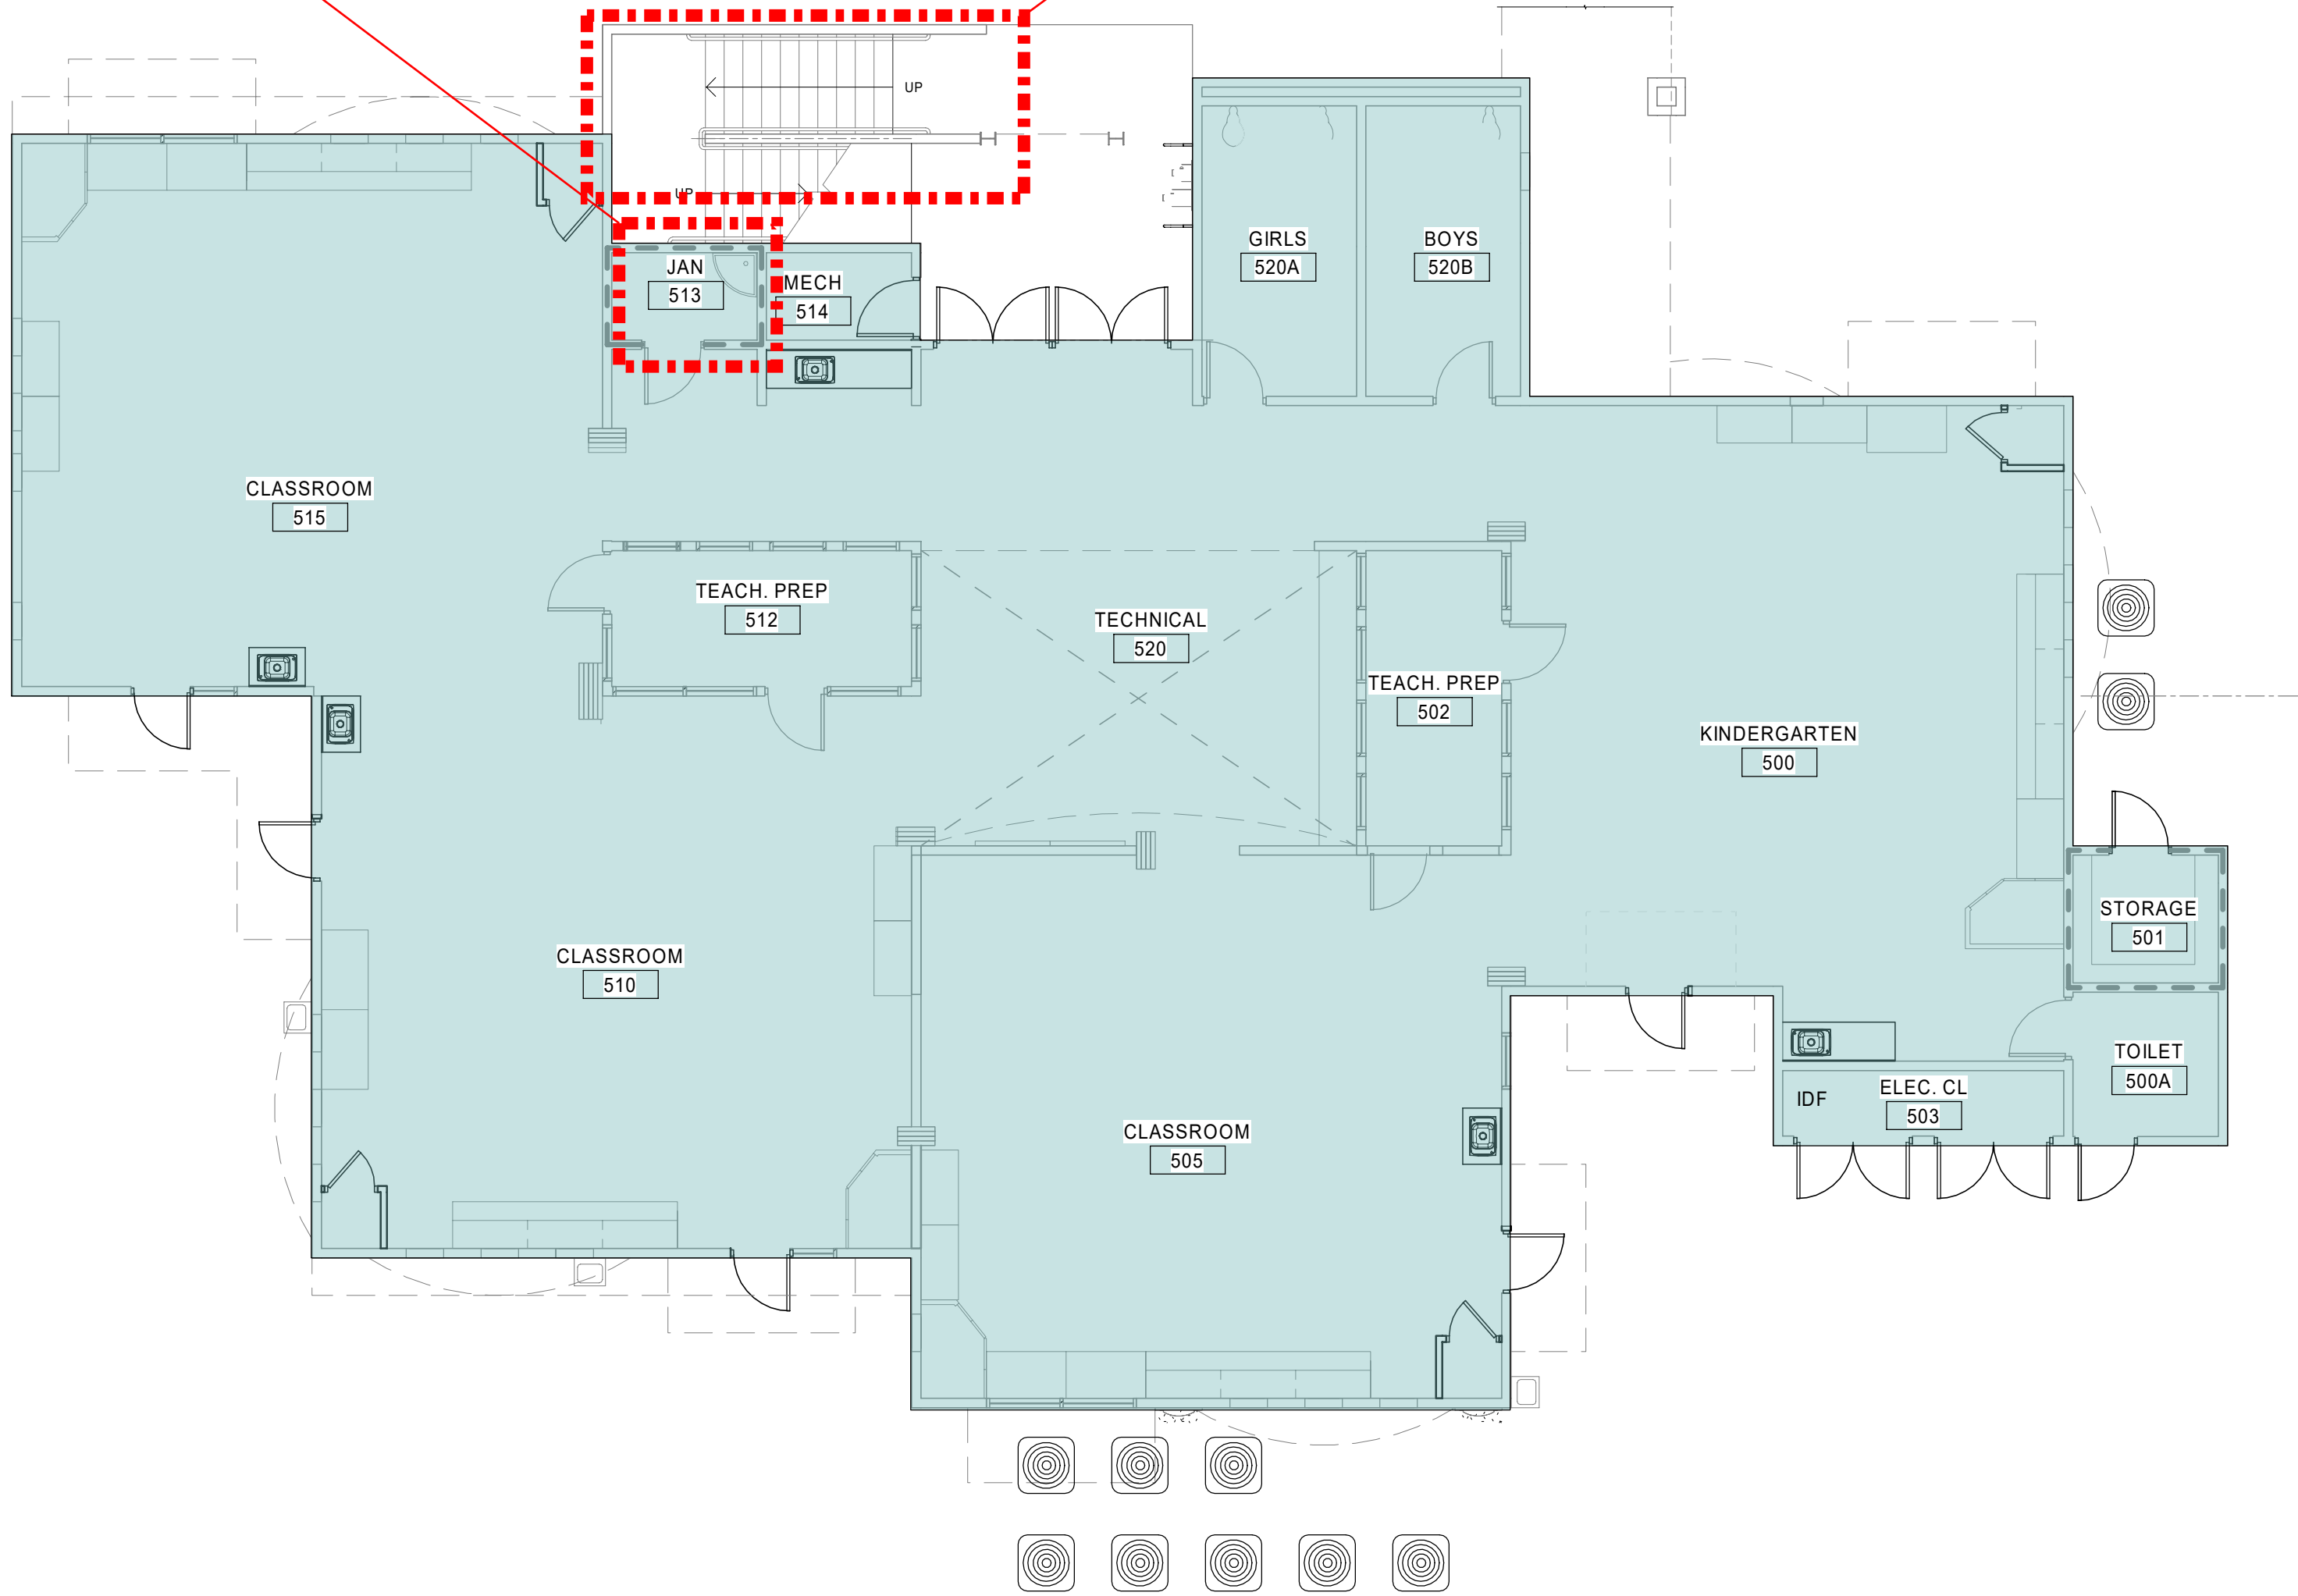
BLDG 'C' - FIRST FLOOR PLAN

Location 09 - First Floor Room 513
(See Photos 14 and 15)

Location 10 - Underside of Exterior Stair
(See Photos 16, 17, and 18)
