SANTA MONICA-MALIBU UNIFIED SCHOOL DISTRICT 1717 4TH STREET SANTA MONICA, CA 90401

> prepared by: NAC 837 N Spring St, 3rd Floor Los Angeles, CA 90012 (323) 475-8075

> > AUGUST 11, 2023 Final

1.2 EXECUTIVE SUMMARY

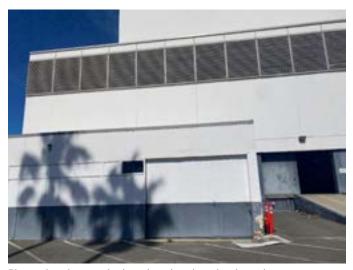
Along the south elevation of the building are aluminum louvers letting air flow to the exterior mechanical equipment areas. Behind a portion of the louvers are aluminum framed windows.

Photo showing south elevation showing aluminum louvers

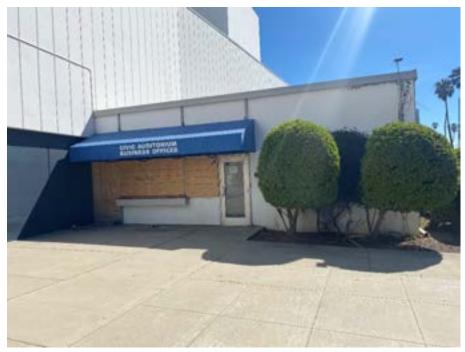
The windows along the north elevation have been boarded up. The as built drawings show full height storefront windows while the windows on site have a low wall below them, a counter, and a fabric awning over them. These items do not appear in the original drawings.

Photo of north elevation of West Wing (Administration) building

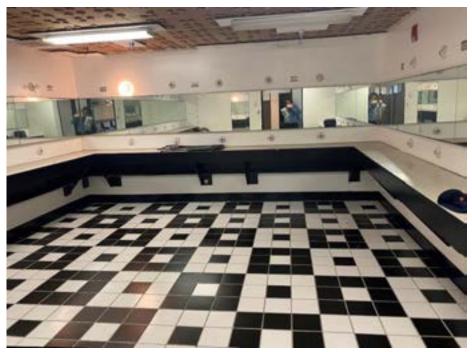
There are several dressing rooms and performance related support spaces at the stage level/first floor and on the second floor. There is a Men's restroom with showers on the stage level/first floor and a Women's restrooms with showers on the second floor. The rooms appear to match the as built drawings. The existing plumbing fixtures, casework and built in features appear to be the original. Several of the ceiling tiles have fallen off the ceiling substrate.

Photo of dressing room

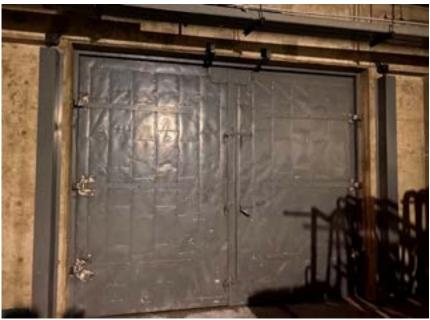
The orchestra lift is accessed by a set of large double doors. The doors were locked at the time of the site visit.

Photo of double doors in the basement at orchestra lift

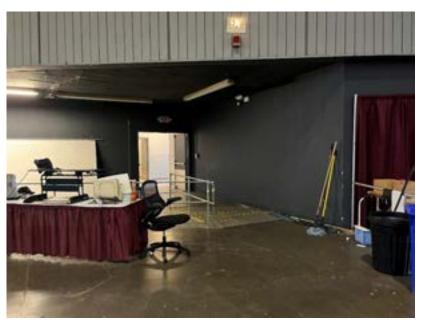
Stairs #7 & #8 appear to go below the fixed floor area in the Auditorium.

Photo of floor above & concealing Stair #7 & #8

The recommendation is to provide new compliant handrails and nosing on existing stairs.

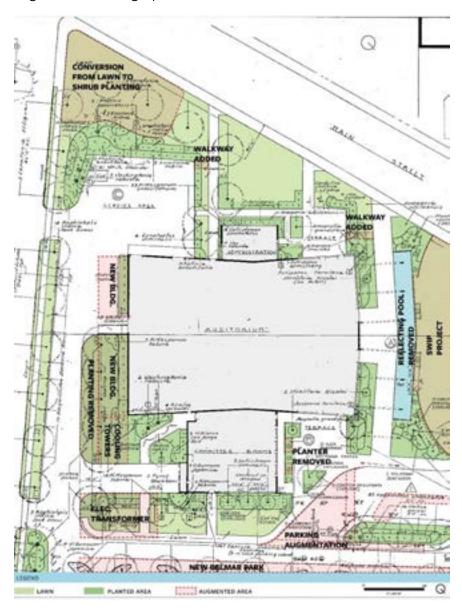
In addition, the original site design has been altered in significant ways, though some original sections remain (see Figure 3 for a diagram of the changes). In addition, the original site design has been altered in significant ways, though some original sections remain (see Figure 3 for a diagram of the changes).

Figure 3. Annotated original site plan documenting changes to Shellhorn's design.

The planted area at the very corner of Main St and Pico Blvd has been converted from lawn into shrub plantings. New buildings have been added on both sides of the backstage entrance parallel to Pico Blvd. In addition, infrastructural improvements, including cooling towers and electrical transformers have been added to the back of house, replacing planted areas. A planter that helped screen the Committee Rooms has been pared back and chopped up into three small planter boxes. The parking along the eastern edge has been augmented, especially with the development of New Belmar Park. Walkways were added to the service / parking area and between the admin terrace and the front entrance promenade. Lastly, the entire grassy

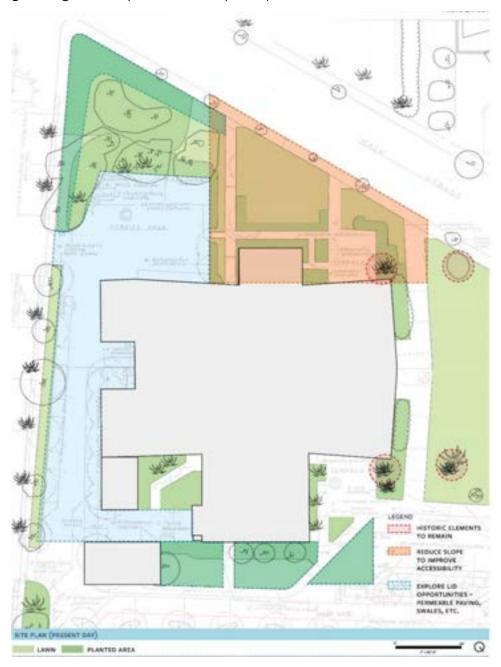
Figure 5. Current site plan with historical elements to preserve and future study areas

Lastly, plantings would also be subject to and in compliance with Santa Monica, LA County and CA Coastal Commission regulations for drought tolerance, habitat and biodiversity. (See Figure 5 for diagram of improvement study areas).

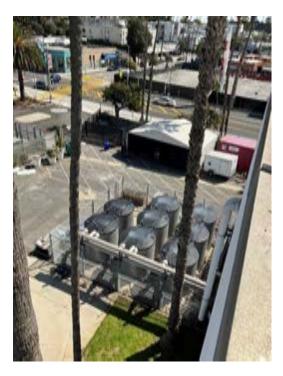
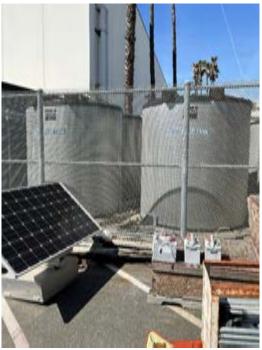
D. Thermal Energy Storage System An ice thermal energy storage system with 144 ton cooling capacity was installed in 2005, along with the chiller upgrade. The system utilizes the main chilled water pumps for distribution, and can store cooling capacity to offset energy usage during peak demand. The system appears to be in good condition.

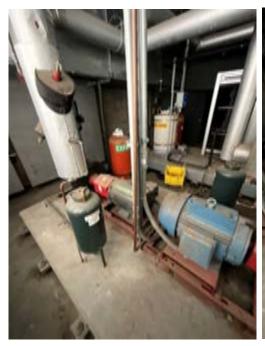
The chilled water pumps and were replaced as part of the 2005 chiller upgrade with single speed end suction Bell and Gossett HSC series pumps, with a total output of 1550 GPM. These pumps had 10 15 years of useful life remaining when the civic center was closed.

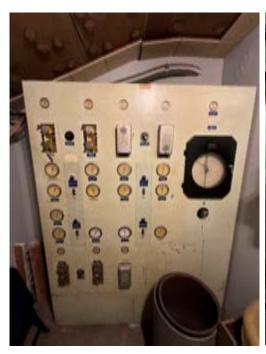
The original pneumatic controls are still in place but are no longer functional. A new Trane model BMT controller for the chiller was added along with the 2005 upgrade, but the front end interface has been removed making it inaccessible.

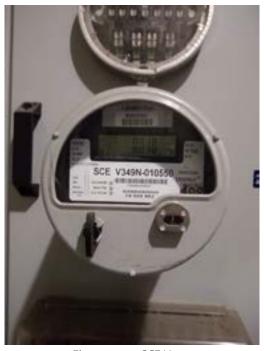
Figure 4.3.5 – SCE Meter

The civic auditorium has a transformer vault where the utility transformer is located. SCE provided a new 16kV-48oY/277V transformer supplying a 3000A bus duct as part of the 2007 electrical system upgrade. The bus duct feeds a 3000A service entrance switchboard in the main electrical room.

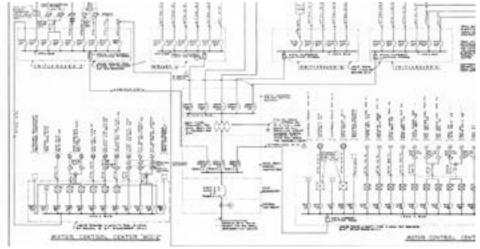
Figure 4.3.1 – Original Single Line

The original distribution consisted of a unit transformer with high side breakers feeding two MCCs and a 48oV distribution panel ('P'). The secondary side of the transformer fed four distribution switchboards (A,B,C, and D) which distributed power throughout the Auditorium to panels located in hallways and closets.

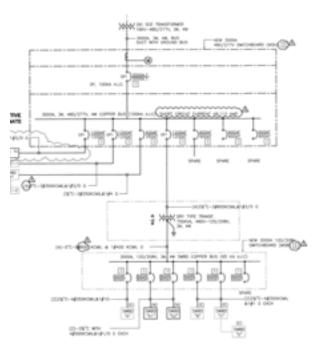
Figure 4.3.3 – Renovation Single Line

The 2007 electrical upgrade replaced the unit transformer with a separate 480Y/277V switchboard, a dry-type transformer, and a 120Y/208V switchboard. The MCCs, 480V Switchboard P, and 280V Switchboards A-D were all maintained and refed from the new distribution equipment. Additionally, two 208V distribution boards were added to stage right and supply panels located throughout the main floor of the auditorium. New panels were also added to switchboards A-C.

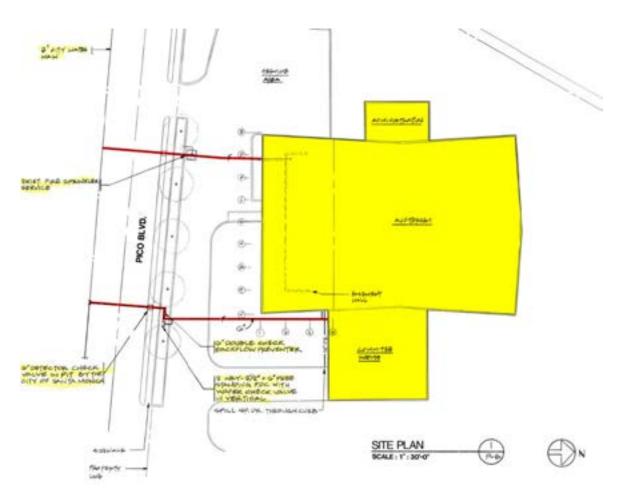
Figure 4.5.1 - Site Plan

The building has two connections to the city's water network, and each one feeds a different fire sprinkler system. During the visit it was only possible to identify a backflow preventer in the newer connection that serves the meeting room. The original connection has check valves not in compliance with the current codes. Both connections have a fire department connection on Pico Boulevard.

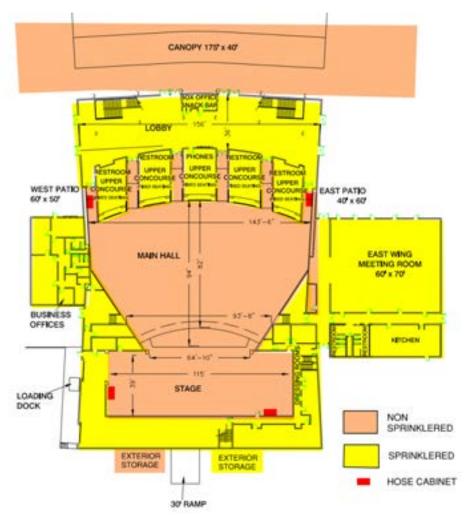
Figure 4.5,2 – Fire Sprinkler Coverage

The building is partially sprinklered. The original connection serves the office areas, restrooms, lobby, mechanical rooms, electrical rooms, dressing rooms, the backstage

storage area and only one of the storage areas outside the building. The second connection feeds the kitchen, bathrooms, and the meeting room in the east wing.

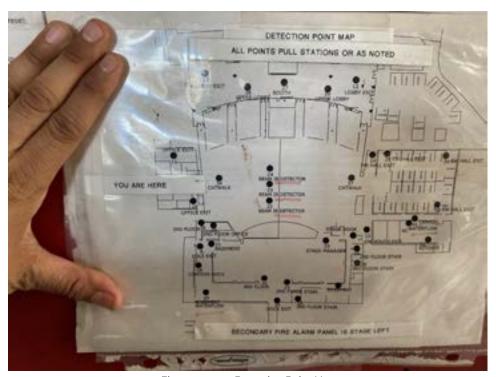
Figure 4.5.10 – Detection Point Map

The building has an existing Radionics fire alarm control panel and a separate voice vac panel. The detection includes partial coverage of smoke detectors and total coverage of the pull station; additionally, the system monitors the valves of the fire system. Occupant notification includes speaker/strobes throughout the building and exterior fire bells.

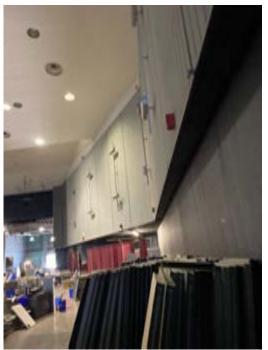
Figure 4.5.13 – Audio-Visual Notification in the Main Hall

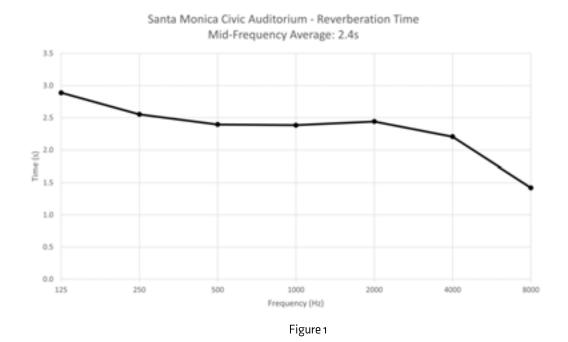
A mid frequency reverberation time of 2.4 seconds, was measured in the main Auditorium on March 15, 2023. The measured reverberation time is plotted as a function of frequency in Figure 1 below.

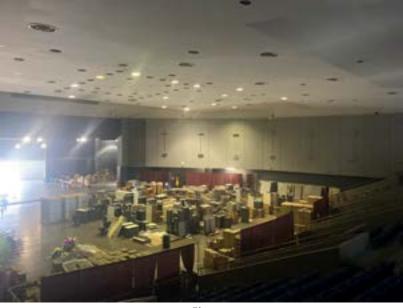
Photo 3

It should be noted that there were lots of boxes etc. being stored within the auditorium space at the time of these measurements. See Photos 1, 2 and 3 below. Please note that the reverberation time would be higher without the presence of these boxes etc. within the space. Similarly, the reverberation time of the space when in use will be reduced with increasing occupancy (people absorb sound), likewise chairs deployed on the main level would be expected to absorb sound and reduce the reverberation time to some extent.

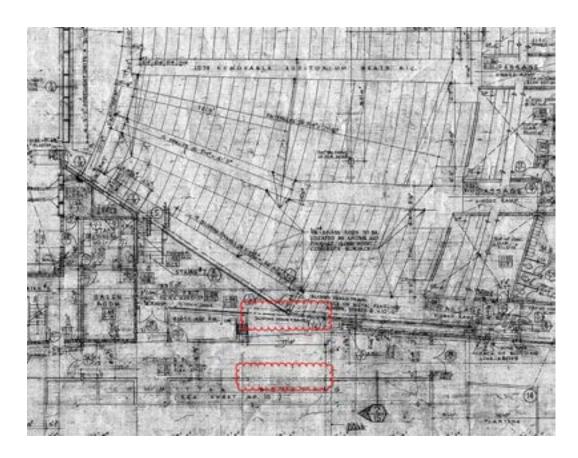
It is understood that the horizontally sliding doors circled in Mark-Up 1 below are considered to be features with historical significance.

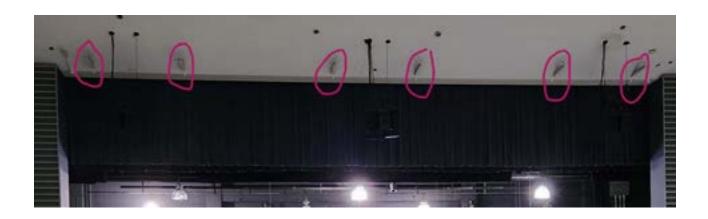
Accommodation for suspending a temporary truss element, for lighting and speakers, just forward of the proscenium appears to have been added at some point. The steel beams (painted to match the ceiling) seen in the photo below would allow chain hoists or other temporary rig points to be attached.

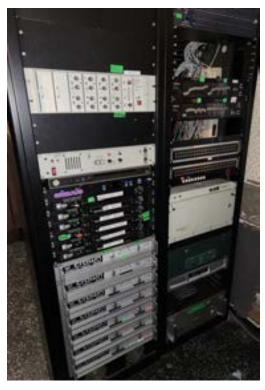
All amplifiers and processing for the audio system are located in a second floor office, stage left.

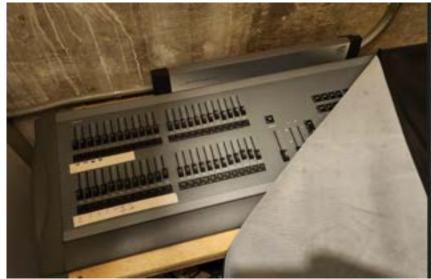
The theatrical lighting system appears to have received some upgrades in the 1990s. There is a single 96 channel dimming rack (ETC SR48 loaded with D20 dimmer modules). For a stage of this size, this is barely enough dimming to provide a minimal wash. It appears that most shows brought in their own lighting equipment and the permanent systems were just for the most basic of events or even just for worklight / houselight. An ETC Express lighting console is located in the closet next to the dimming rack, which means it was not used much since an operator would not have any means of seeing the stage or what the lighting looked like.

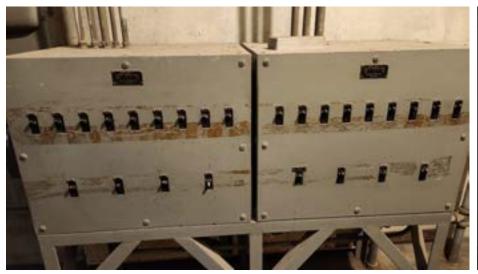
The original Century dimming system is also still in place. It was not possible to determine whether it is being used solely for houselight, or if it was just abandoned in place.

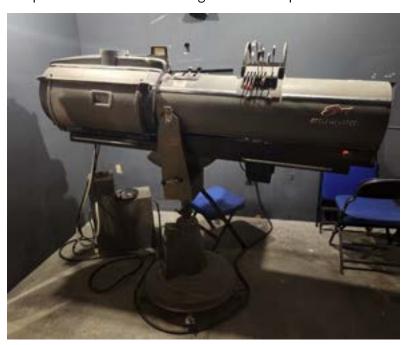
There are two carbon arc followspots located in the followspot booth. These do not appear to be operational but would make great museum pieces.

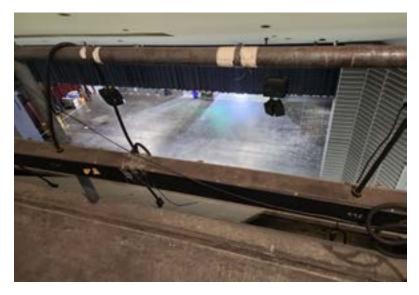
There is only one catwalk for front light, located over the front part of the main floor. The lighting angle from this location is quite steep, and the depth of the stage and apron (with the orchestra pit lift in the up position) really require at least 2 catwalk positions to be adequately lit.

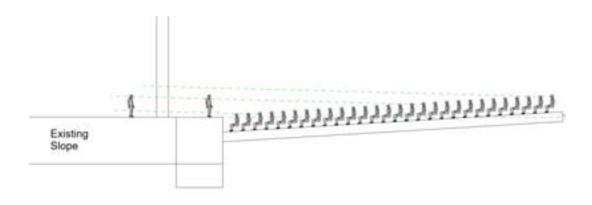
An analysis of the sightlines for an audience seated on the floor, when sloped, shows mediocre to poor sightlines for the back half of the main floor seating.

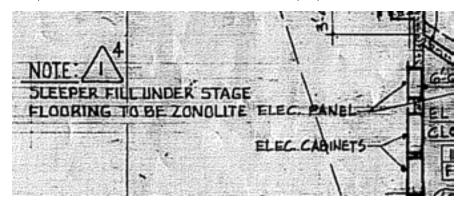
The existing stage floor has what appears to be a sacrificial top comprised of painted, tempered hardboard (Masonite). This is a common stage finish and it shows a normal level of wear, including paint blemishes and a few damaged panels.

There is no area where the buildup of the floor can be seen, but the as built drawings indicate that the floor has a system of sleepers (also common for stage floors). The space between the sleepers is called out to be filled with Zonolite, proper containment will need to be considered.

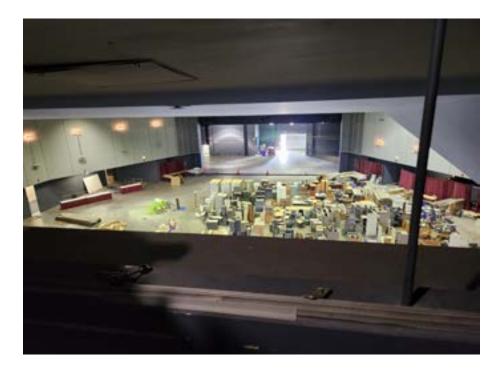
There is a set of technical spaces located above the rear row of the auditorium seating. These were used as followspot booths and other functions, but other than followspot it is not possible to tell what at this point as most of the equipment has been removed or relocated.

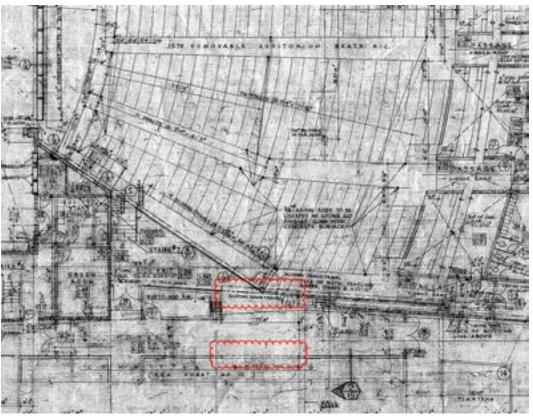
C. Existing Horizontal Sliding Doors It understood that the horizontally sliding doors circled in Mark-Up 1 below are considered to be features with historical significance.

The doors currently provide a very poor level of sound isolation. It is considered unlikely that the acoustical performance of these doors could be substantially improved by retrofitting new seals (for old doors, usually increased acoustical performance comes at the cost of increased difficulty in operating the doors.) However, it may be worthwhile consulting a specialist contractor such as Pacific Sound Control on this matter.
