SURVEY FOR ASBESTOS AND LEAD IN PAINT

Gymnasium Building
John Adams Middle School
2425 16th Street
Santa Monica, CA 90405

Project No.: SMSD-18-7431
Date: January 30, 2018

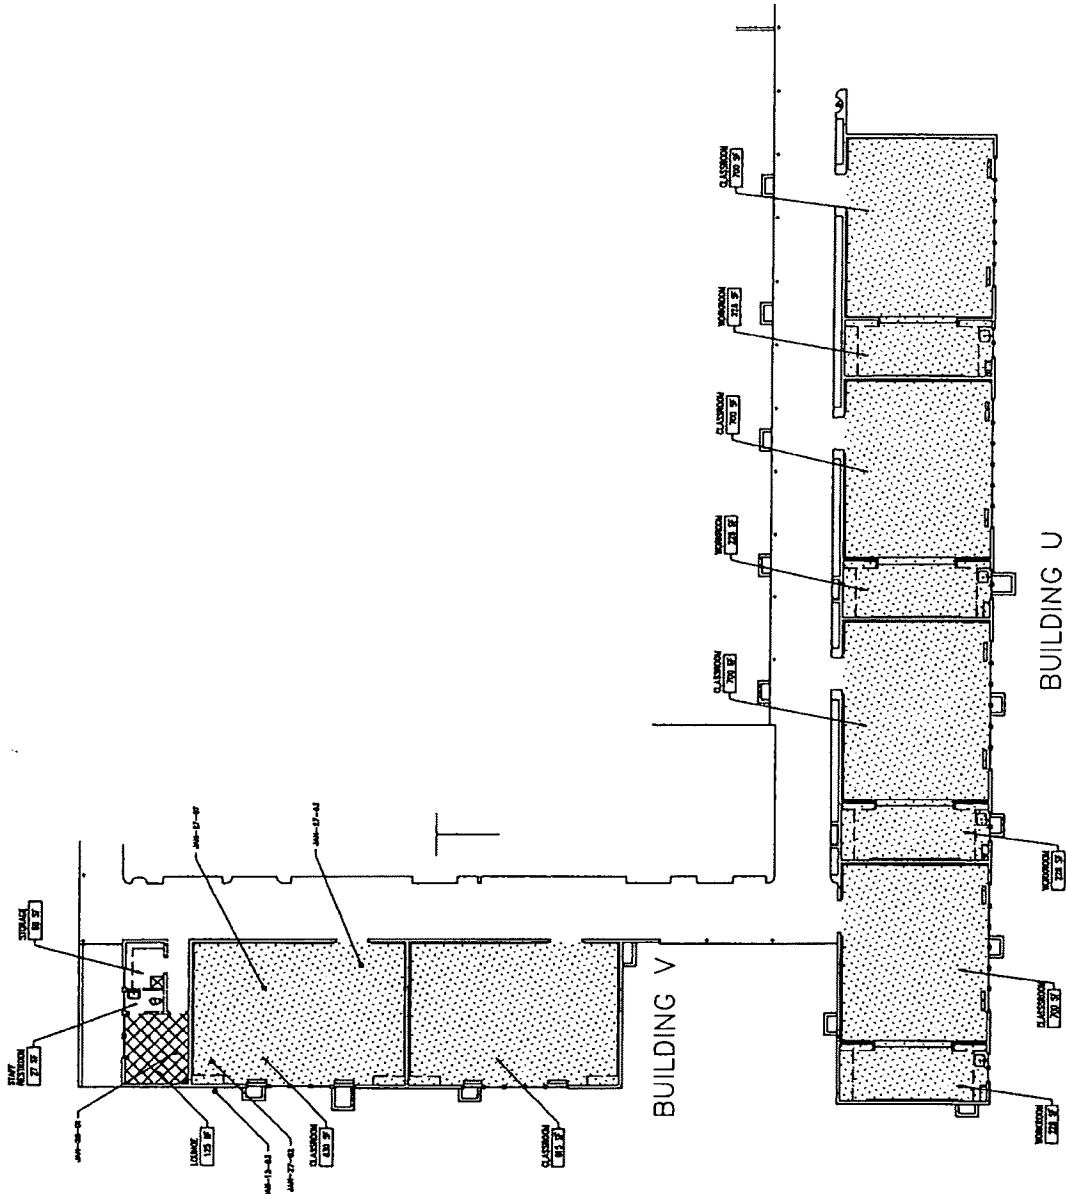
1. ASBESTOS CONTAINING WINDOW PUTTY LOCATED ON EXTERIOR WINDOW FRAMES.
2. ASSUMED ASBESTOS CONTAINING CHALKBOARDS LOCATED IN CLASSROOMS.
3. ASSUMED ASBESTOS CONTAINING CEMENT PLUMES LOCATED IN BUILDING.
