Native Tree Protection Plan

For: Point Dume Marine Science School - Malibu Schools Alignment Project

Prepared by: **Greg Applegate, RCA #365
Arborgate Consulting, Inc.
1131 Lucinda Way
Tustin, CA 92780
714/ 731-6240**

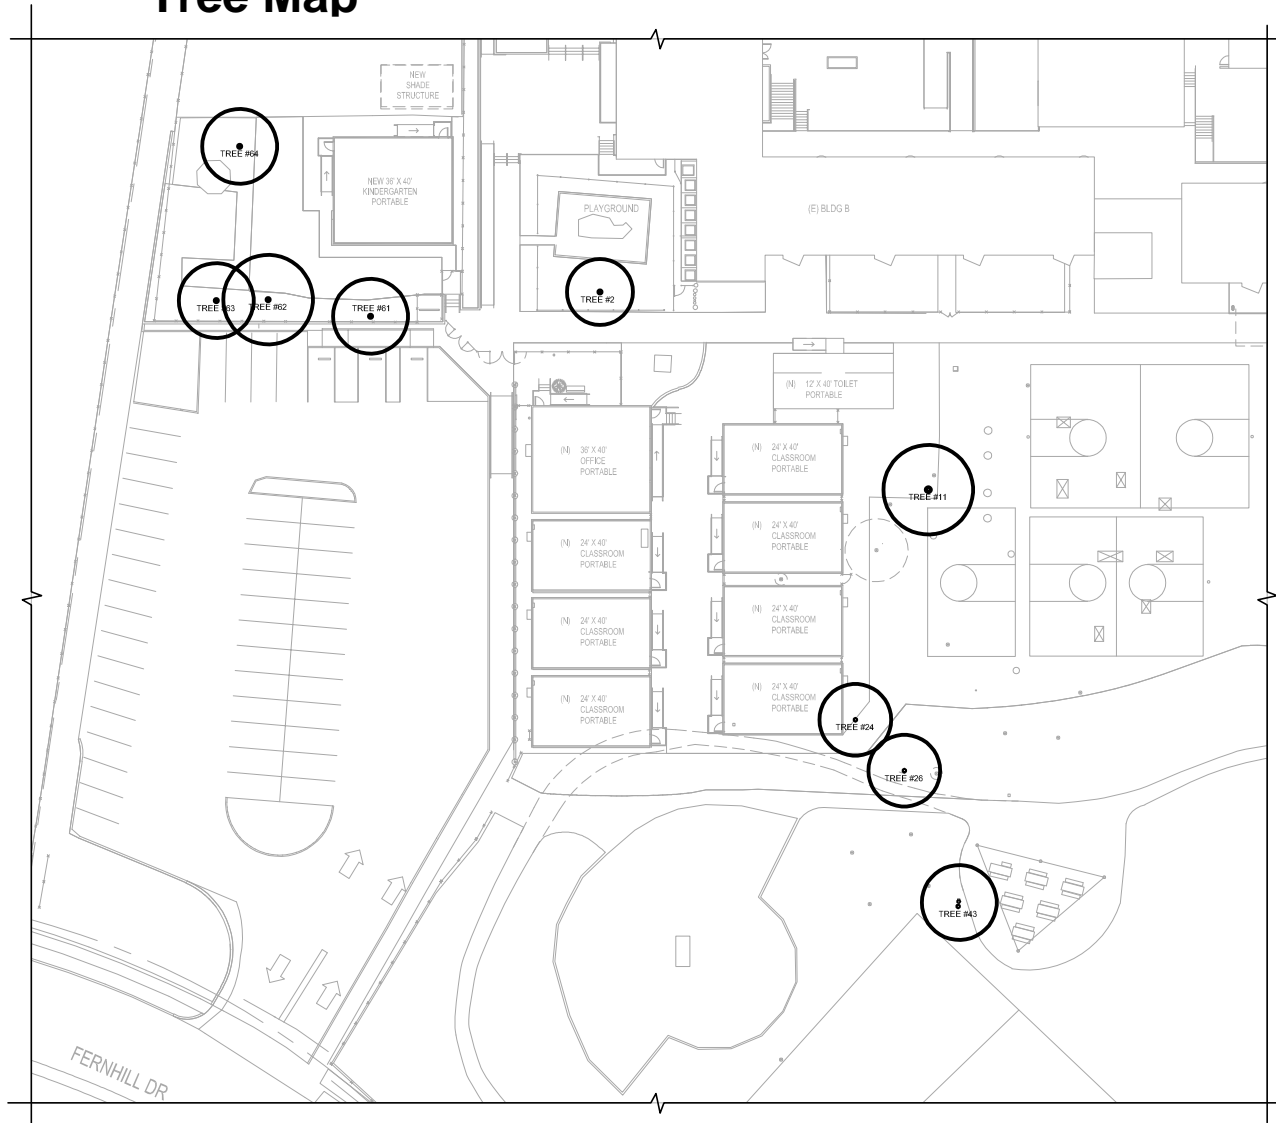
Tree Map

LIST OF TREES (PLATANUS RACCMOSA)		
TREE #	DBH (IN.)*	WIDTH (FT.)
2	14	22
11	21	30
24	10	24
26	8.2	24
43	5+6+10	32
61	14	25
62	14	30
63	15	25
64	14	25

Construction impacts include increased foot and vehicular traffic over or near the root systems of the sycamores (#11, 26, 43 and 64), and removal of sycamores too close to the work area to survive the work performed, i.e. tree #24. These impacts can be mitigated by mulching and fencing off at least the clearance radii listed in the Recommendations section of this report.

Tree #	Species	Circumference	Health	Root condition	Defects	Remove	Clearance
2	Platanus racemosa	44	B	Okay	Epi	No	10.5'
11	Platanus racemosa	66	B	Okay	Cod DL	No	15.75'
24	Platanus racemosa	31	B	1sRF	1s	Yes	7.5'
26	Platanus racemosa	26	B	Sh	leans T-injs	No	6.15'
43	Platanus racemosa	16+19+31	B	Sh	Cod Xing-Ts	No	11'
61	Platanus racemosa	44	C	planter	top'd	No	11'
62	Platanus racemosa	44	C-	Sh	Hd	No	11'
63	Platanus racemosa	47	B	Sh	Hd	No	12'
64	Platanus racemosa	44	B	Sh	cod	No	11'
