AHERA THREE-YEAR RE-INSPECTION

John Adams Middle School
2425 16th Street
Santa Monica, California 90405

Project No.: 110-0006

Date: July 14, 2010

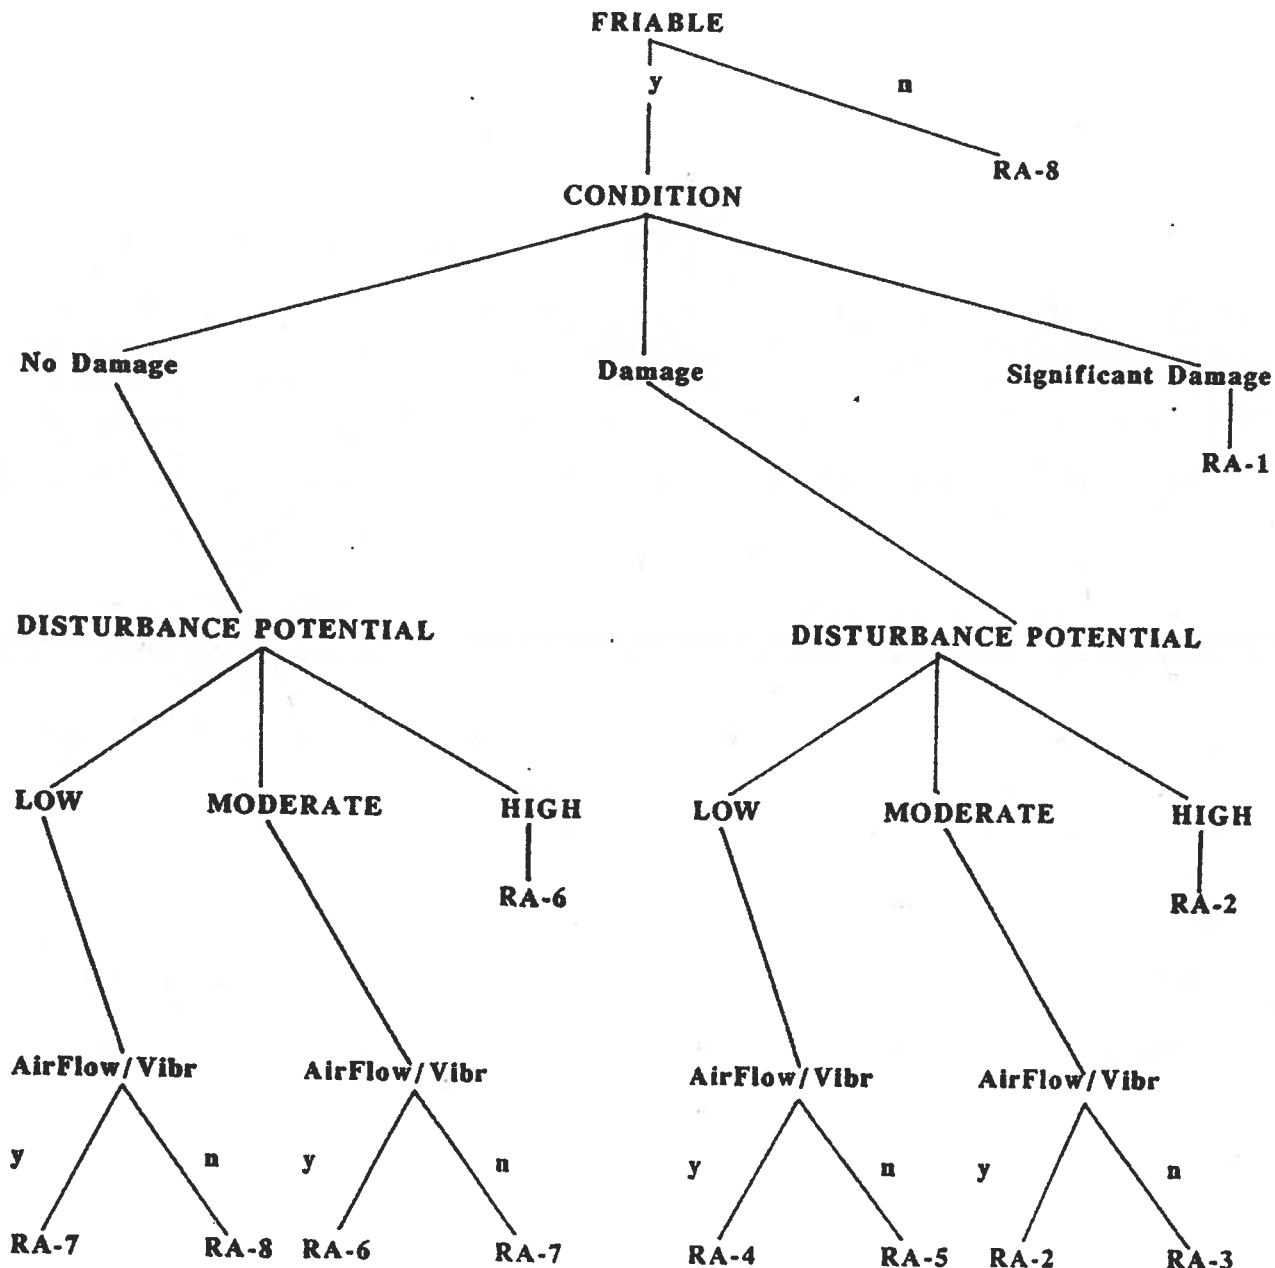
FIGURE 2 - DECISION TREE

SURFACING MATERIAL
ASBESTOS CONTAINING BUILDING MATERIALS
(SURFACING-ACBMs)
