LIMITED ASBESTOS AND LEAD SURVEY HVAC AND FIRE ALARM UPGRADE PROJECT

John Adams Middle School
2425 16th Street
Santa Monica, CA 90405

Santa Monica-Malibu Unified School District
1651 Sixteenth Street
Santa Monica, California 90404

Project No.: SMSD-18-7674

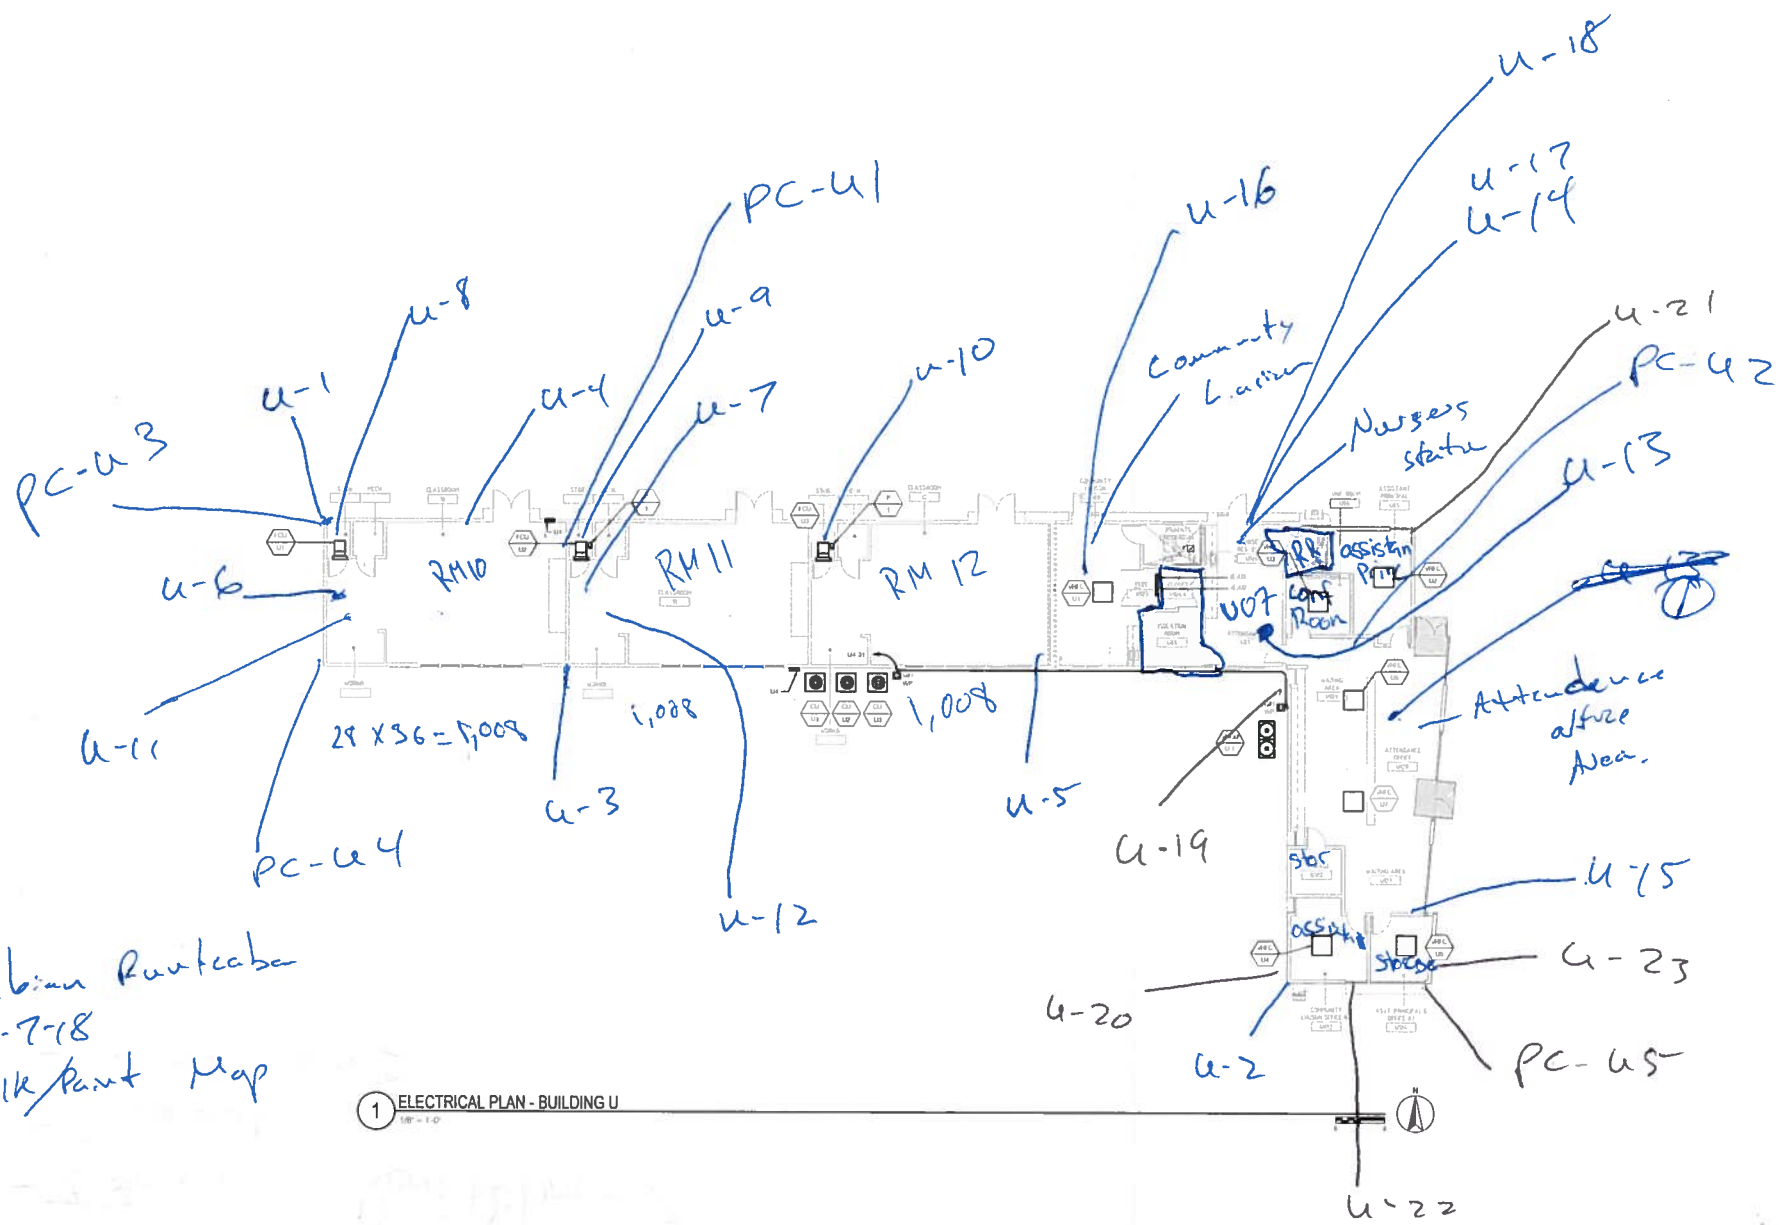
1 ELECTRICAL PLAN - BUILDING U
 1/8" = 1'-0"

Fabian Rautaba
 5-7-18
 Bulk/Paint Map
