LIMITED ASBESTOS AND LEAD SURVEY

Floor and Paint Project
Roosevelt Elementary School
801 Montana Avenue
Santa Monica, California 90404

Project No.: SMSD-16-6280
Date: October 26, 2016

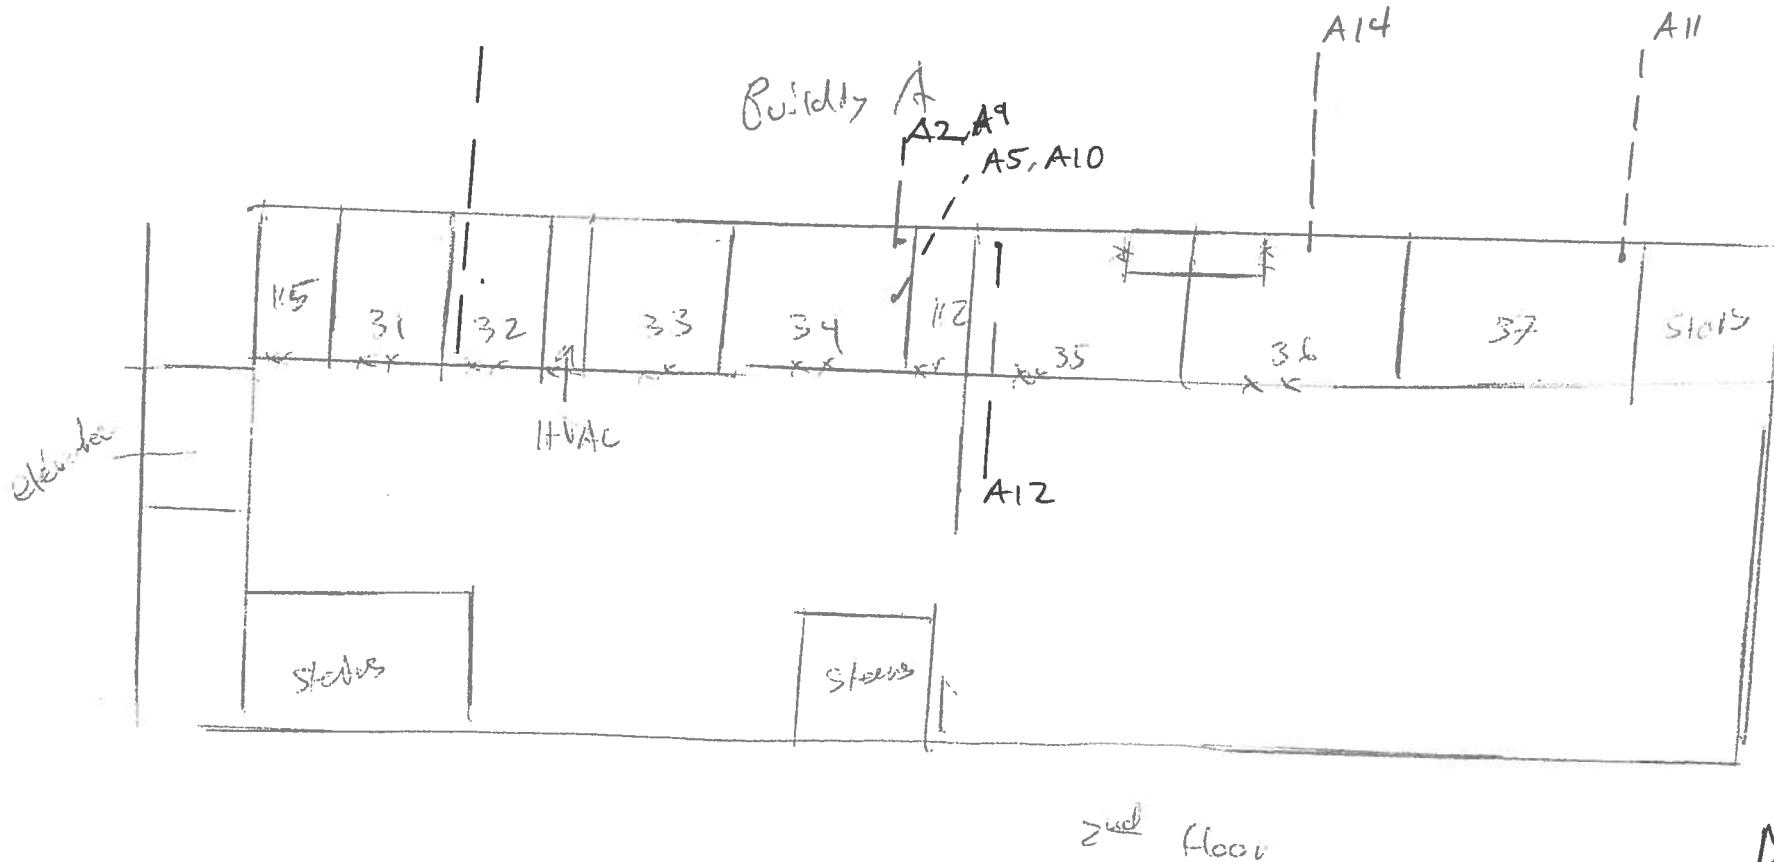
Sample Location Map: Asbestos

A1, A4, A8

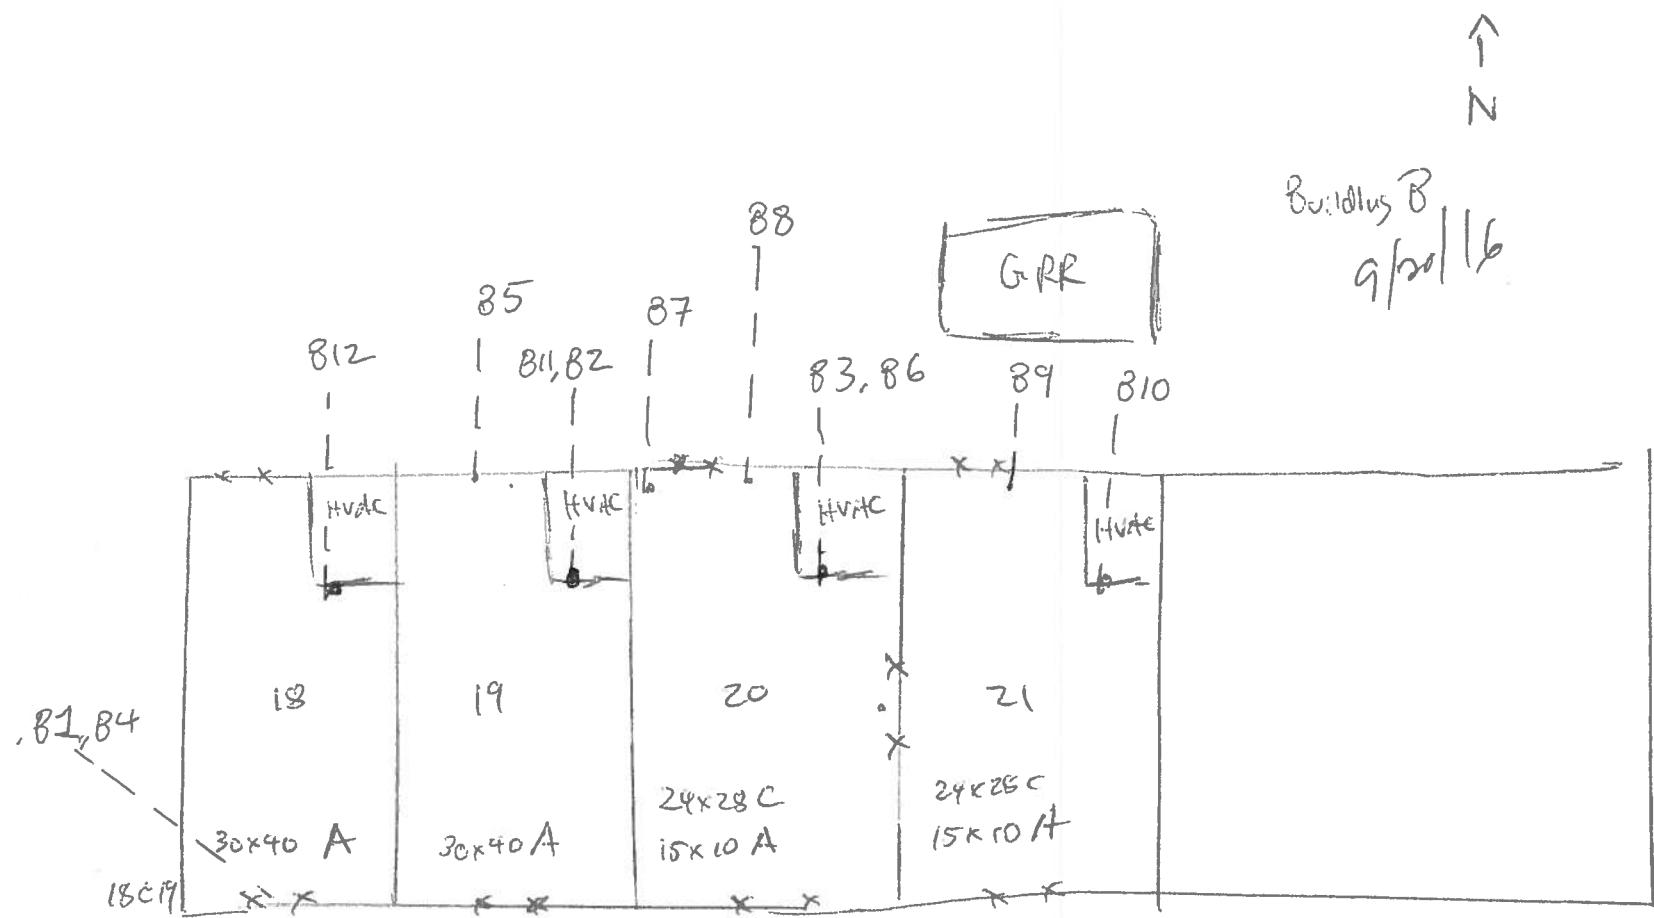
A-9/00/16

~~A~~ - 12x12 Grey speckled tile with yellow mastic

B - 4 inch Grey cove base with adhesive

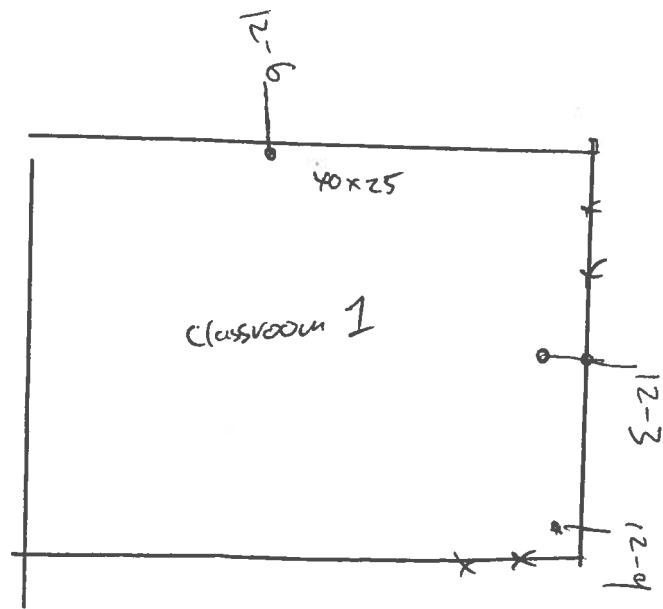
Bldy H

250 sq ft of 12x12 speckled
300 sq ft of dark grey carpet
130 linear ft of 4 inch grey cornice.

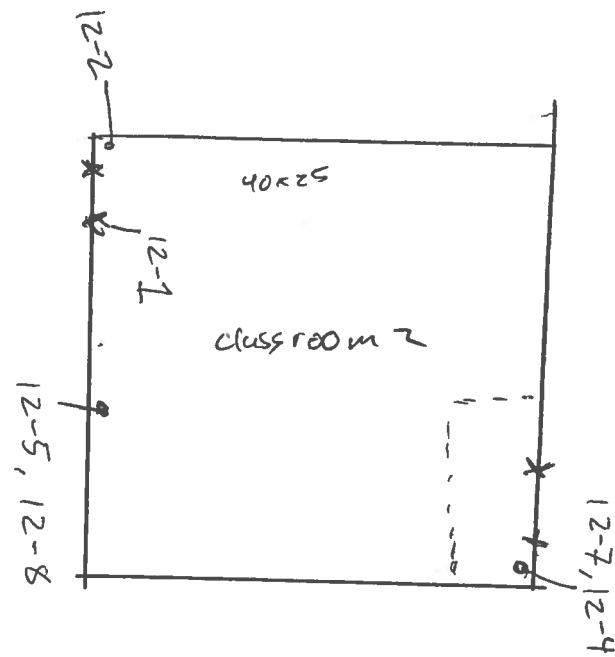
9 | 20 | 16

280 sq ft 12x12 speckled F/T.
300 sq ft of dark grey carpet.
130 linear ft of 4 inch grey cornice.

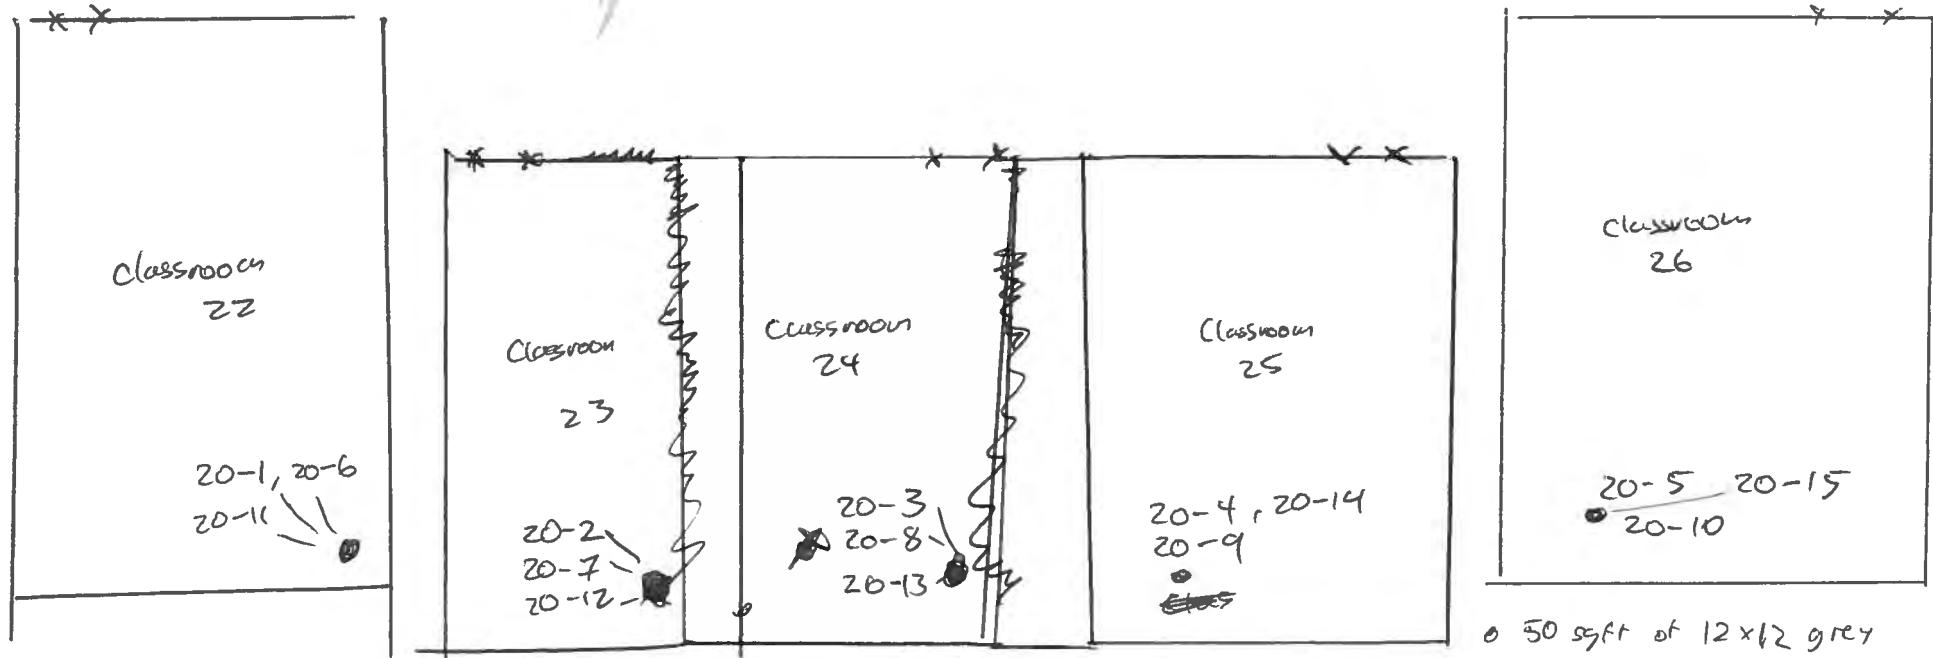
40 x 23

- o 50 sqft of 12x12 grey speckled F1
- o 920 sqft of Dark green carpet
- 126 linear ft of 4 inch Dark grey baseboard

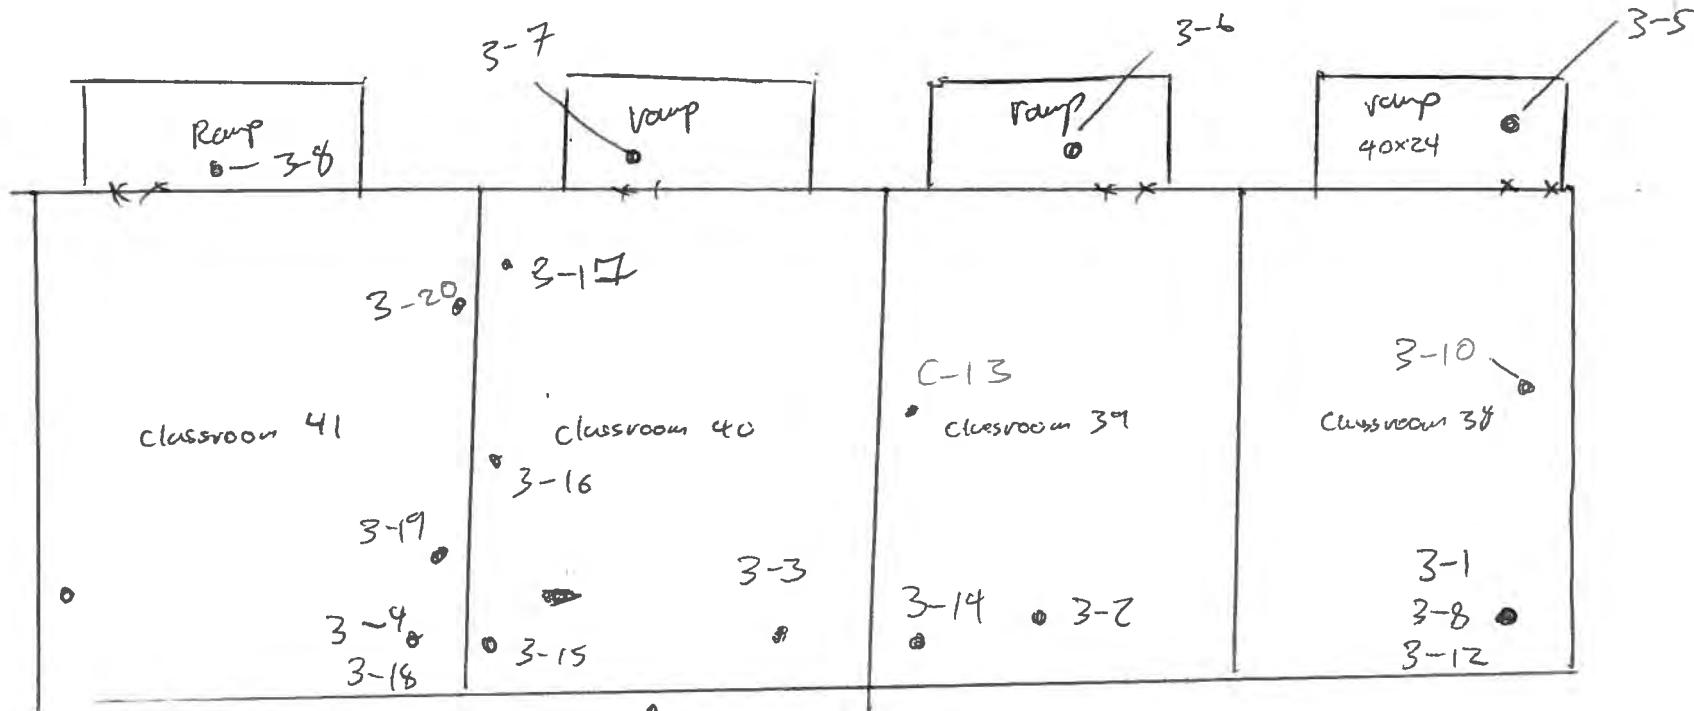
• 960 sqft of 12x12
grey speckled FT

• 130 linear ft
of 6 inch Black
cove base

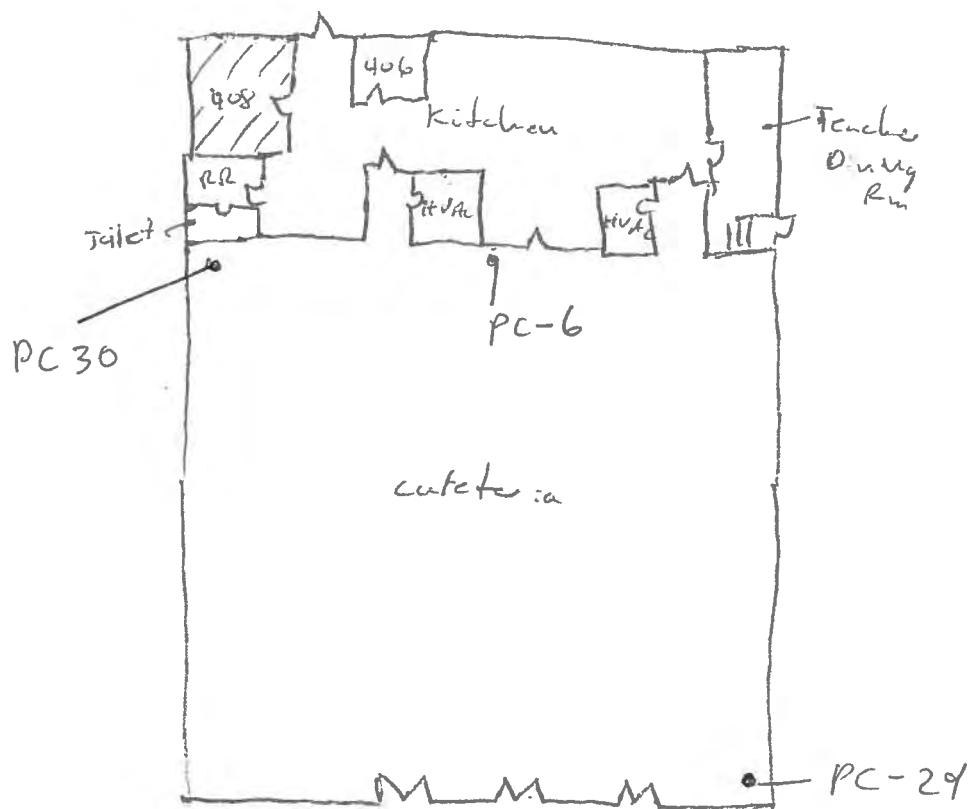
Sample Location Map: Lead

Paint chip sample list 9/22/16

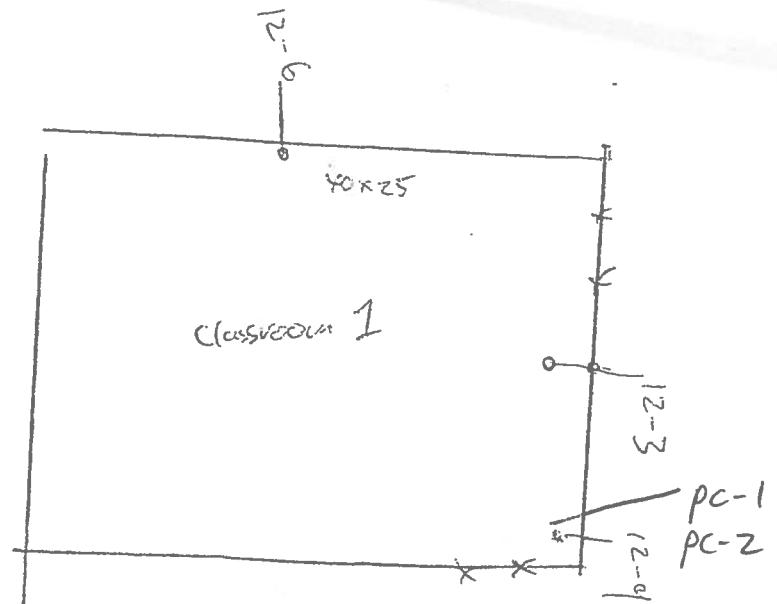
250 sq ft of 12x12 grey speckled

750 sq ft of dark grey carpet

130 linear ft of 4 inch grey concrete

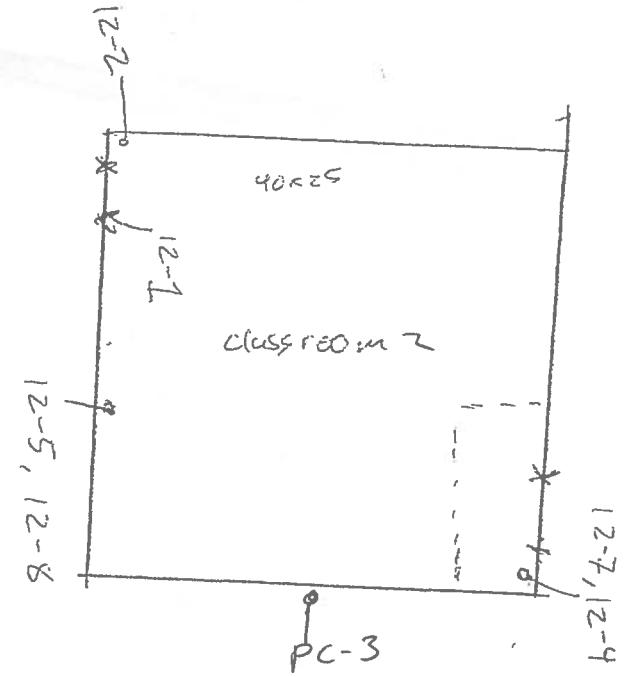
280 sq ft 12x12 grey speckled F/T.

700 sq ft of dark grey carpet

130 linear ft of 4 inch grey concrete

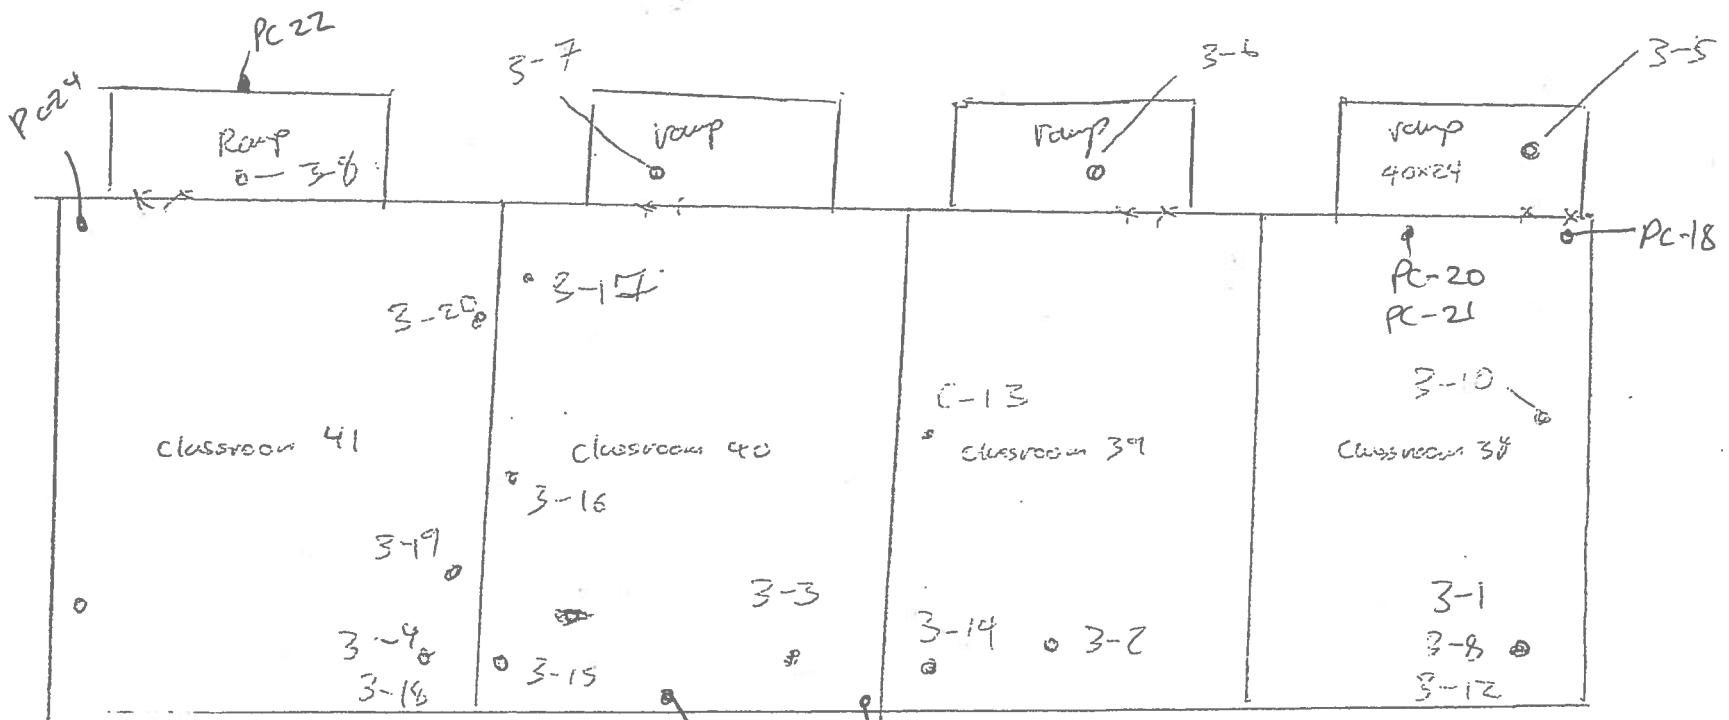
• 960 sqft of 12x12
grey speckled FT

• 130 linear ft
of 6inch Black
cove base
