LIMITED ASBESTOS AND LEAD SURVEY

Floor and Paint Project
Webster Elementary School
3602 Winter Canyon Road
Malibu, California

Project No.: SMSD-16-6285
Date: October 26, 2016

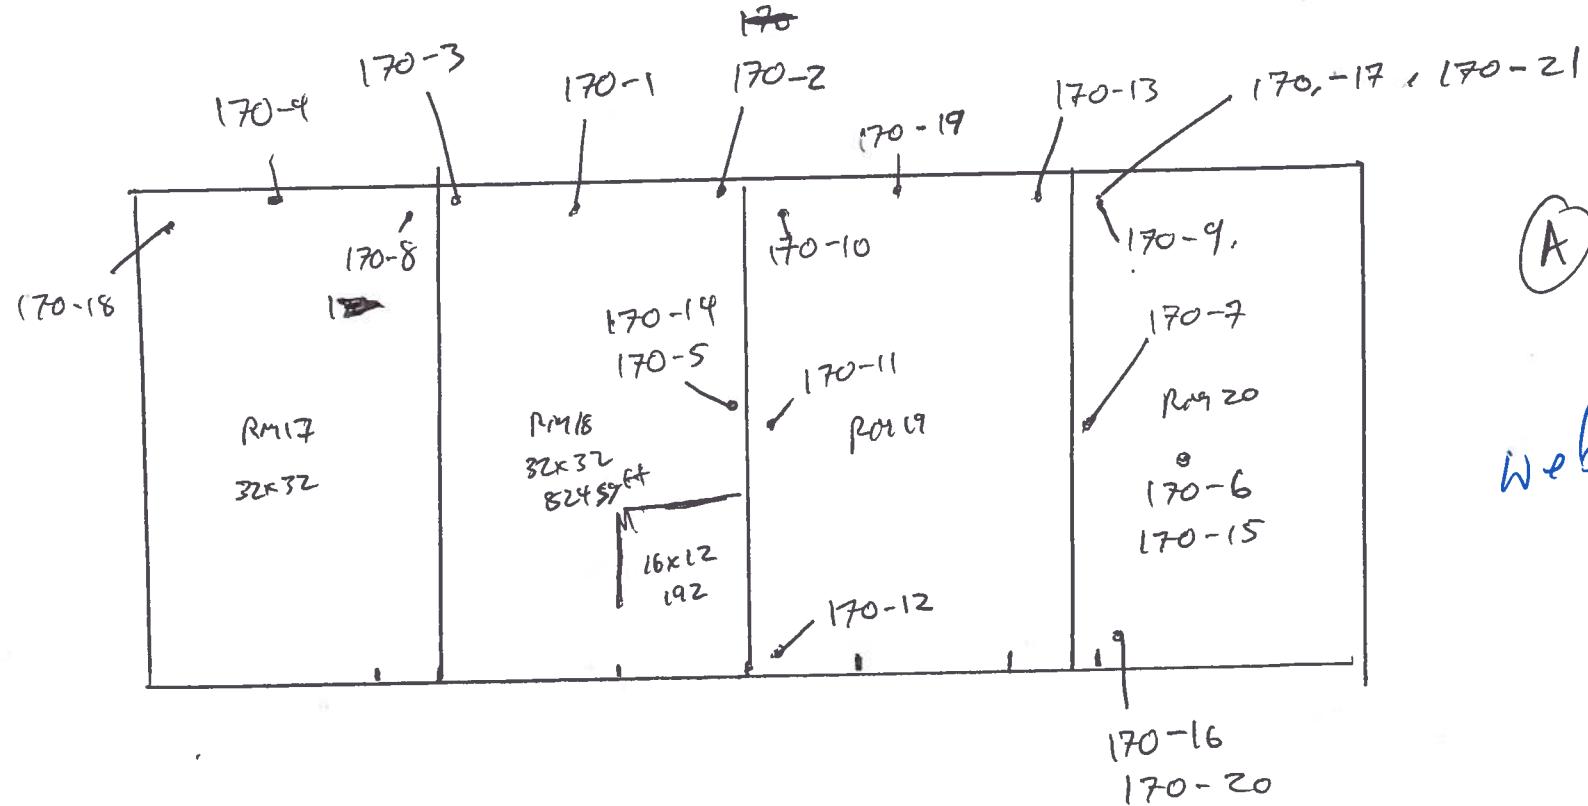
Sample Location Map: Asbestos

Room 17
640 sq ft of Dark carpet
90 lin. ft of each

Room 18
128 1/4 ft Black carpet
60 lin ft grey carpet
824 sq ft dark brown green carpet
192 ft of Navy blue carpet

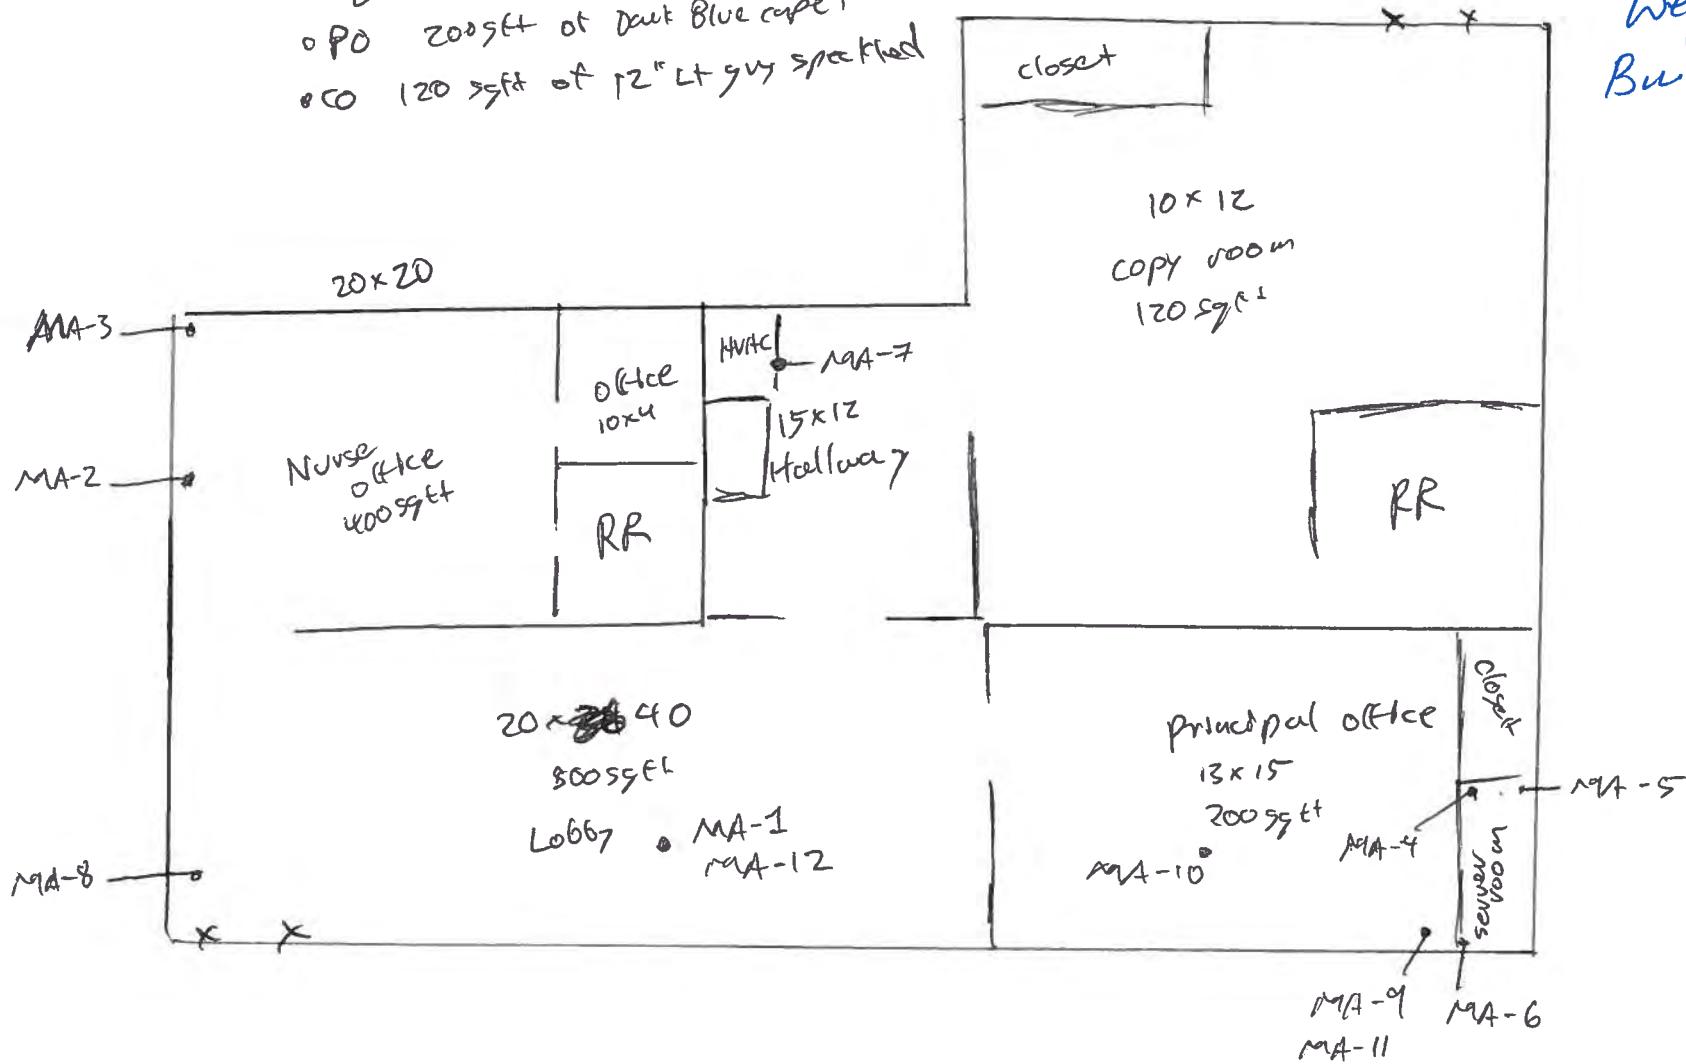
Asbestos Sample Location

* 700 linear ft of 4" grey cove base with adhesive

* server room 100 sqft of 9x9

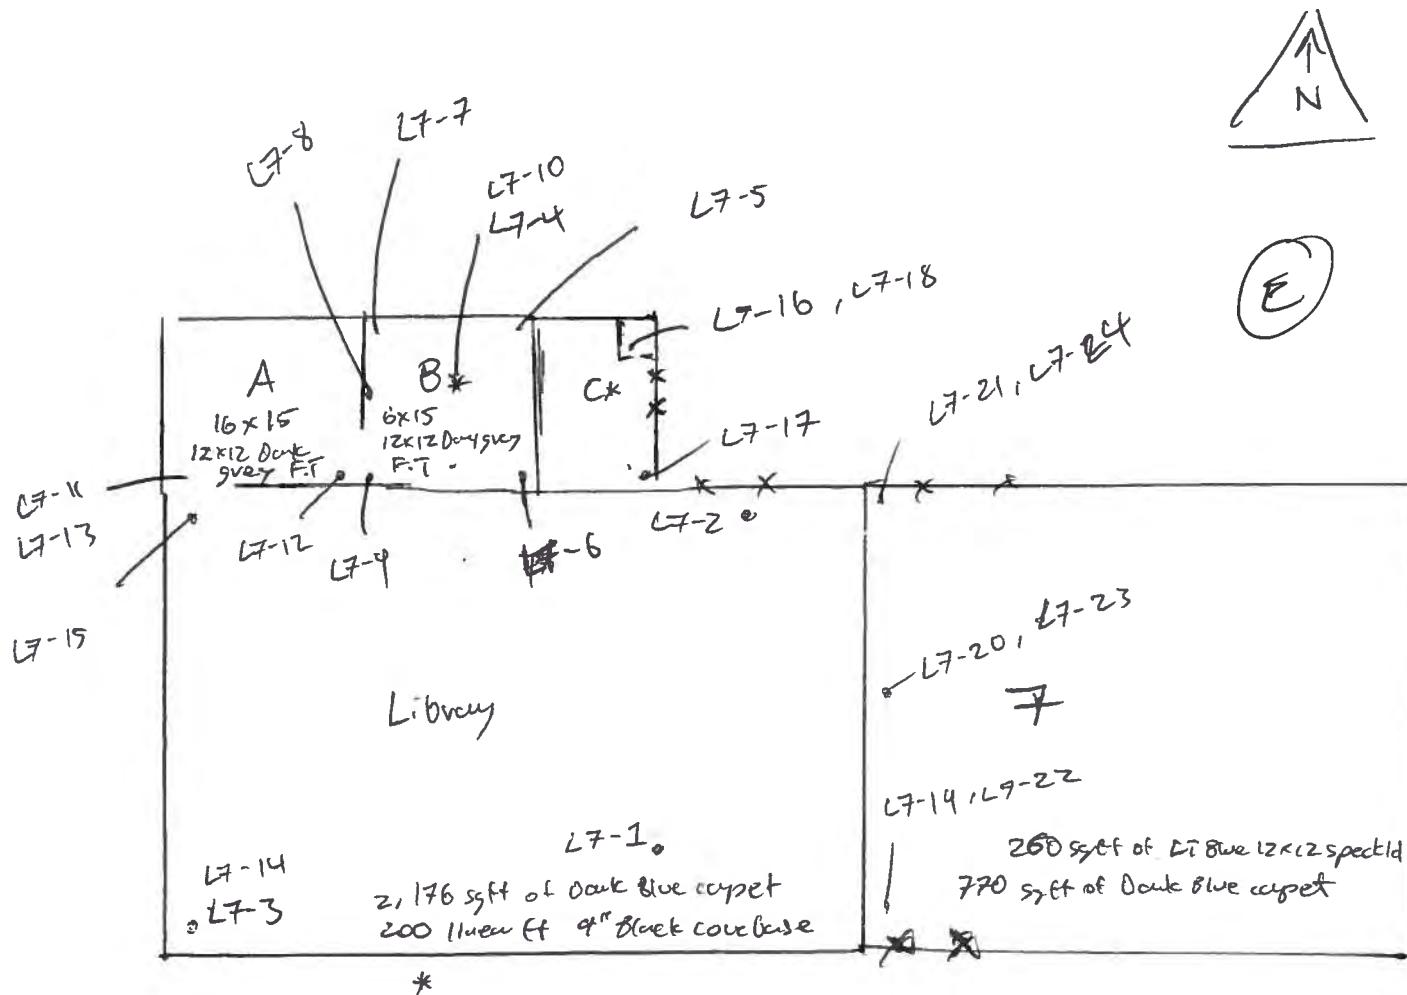
* Library B 42 linear ft of 4" Dark Blue carpet
 Library C 370 sq ft of 12"x12" Lt Blue speckled F.T.
 80 linear ft of 4" dark blue carpet

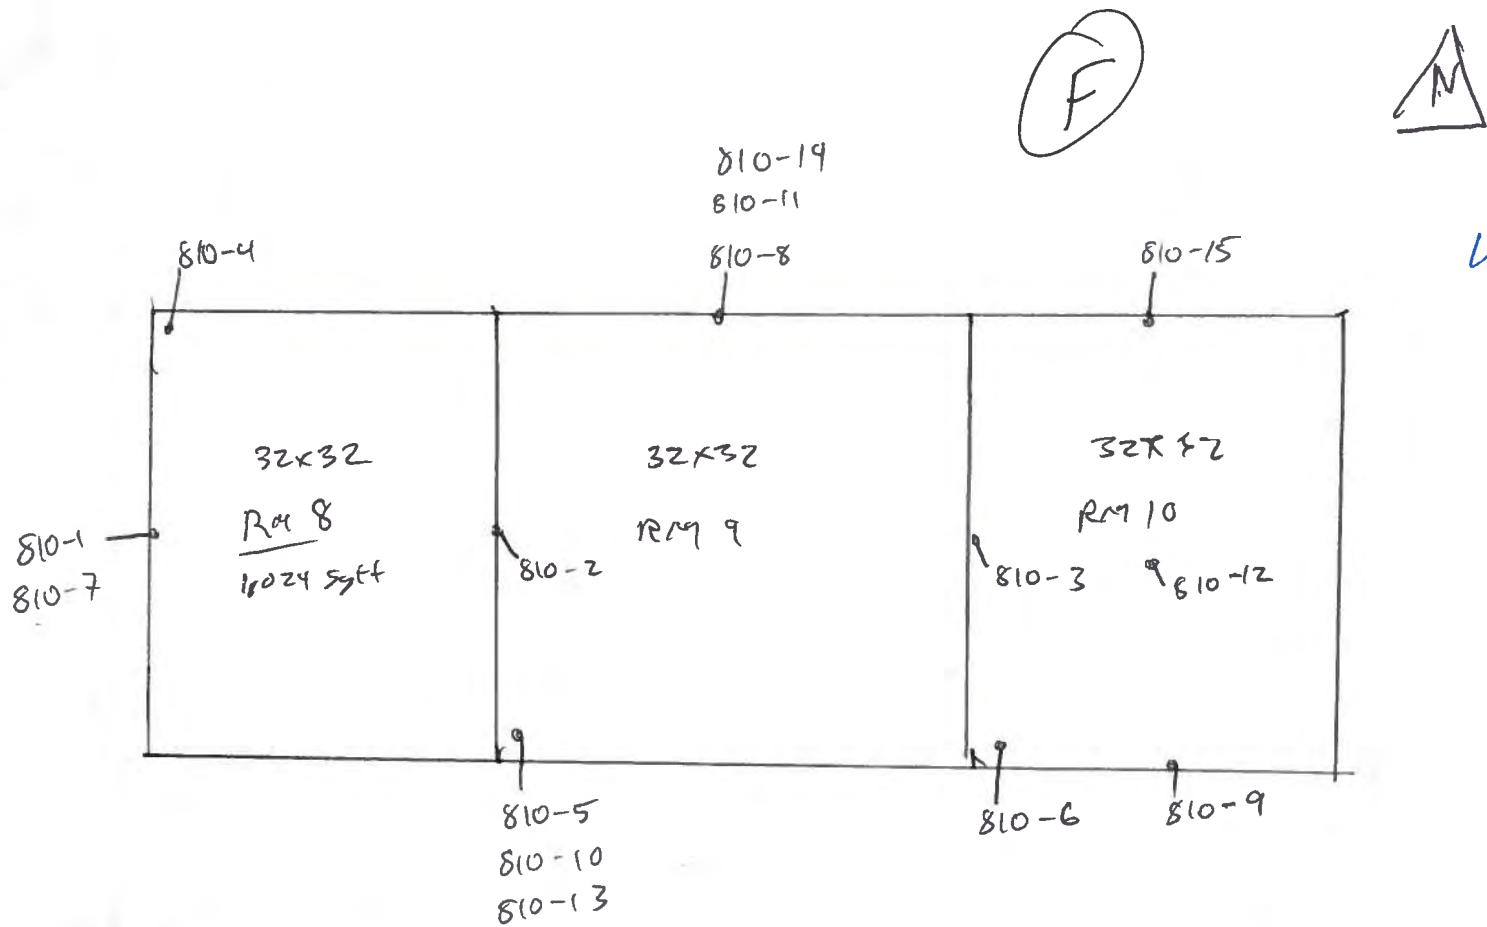
RM 8 1024 sq ft 12x12
96 linear ft of each baseboard

RM 9-10 640 sq ft of Day gray carpet
96 linear ft of each baseboard

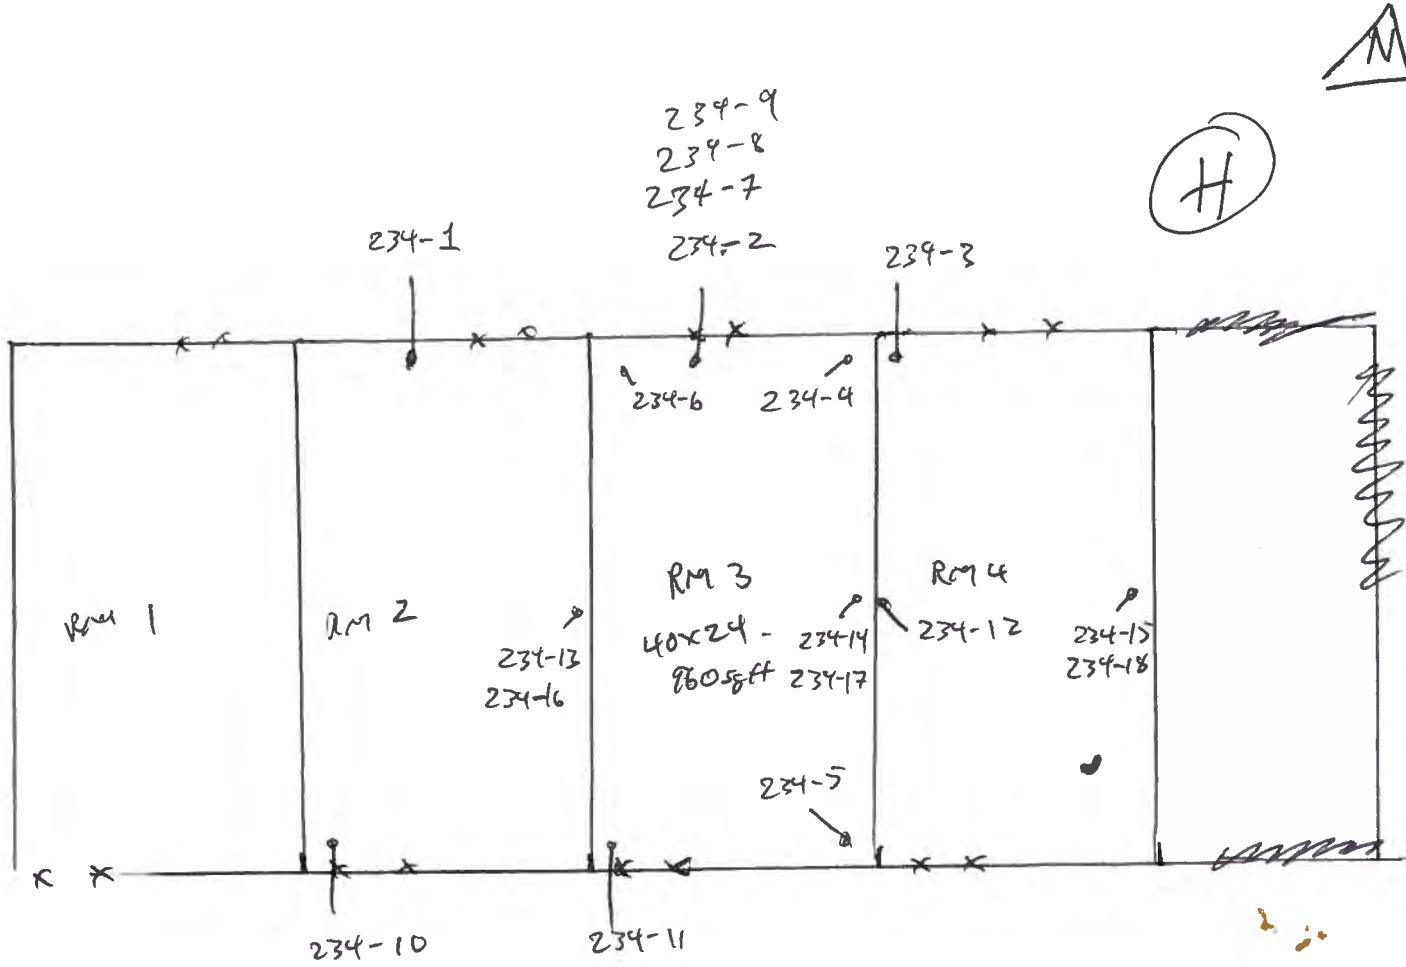
Webster ES
cafeteria Blg

Rm 3

270 sq ft 12x12
890 sq ft Dark grey carpet

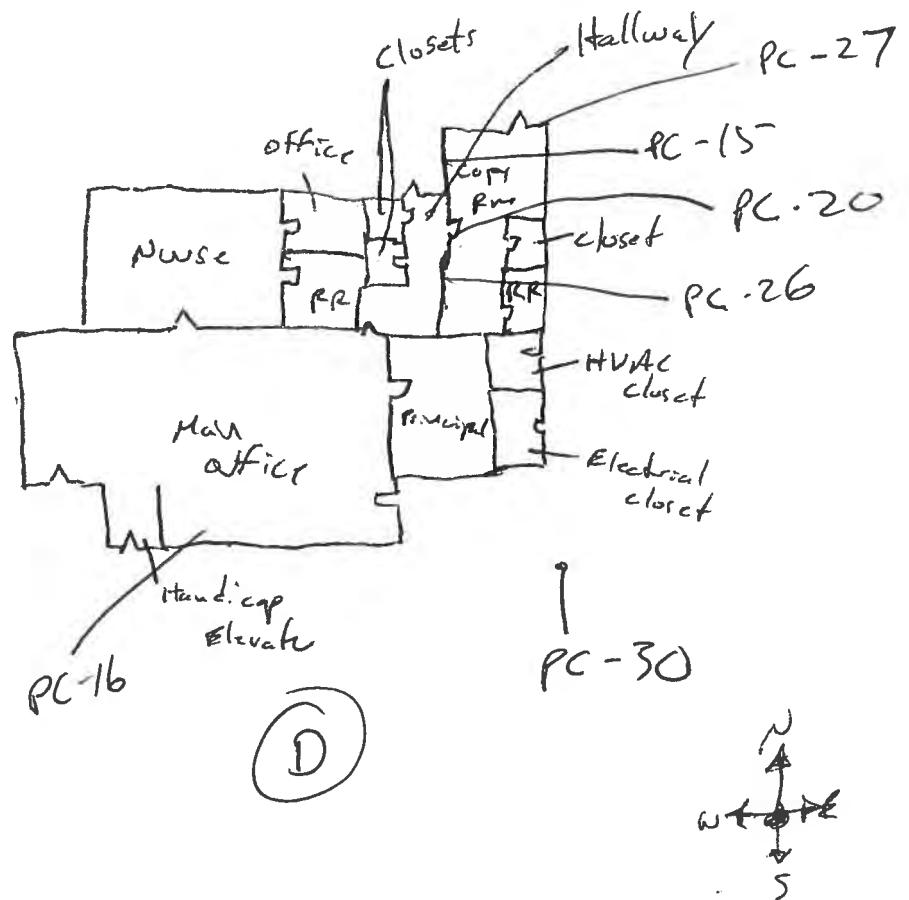
Sample Location Map: Lead

Paint chip
 Map
 PR pencil
 9-27-16

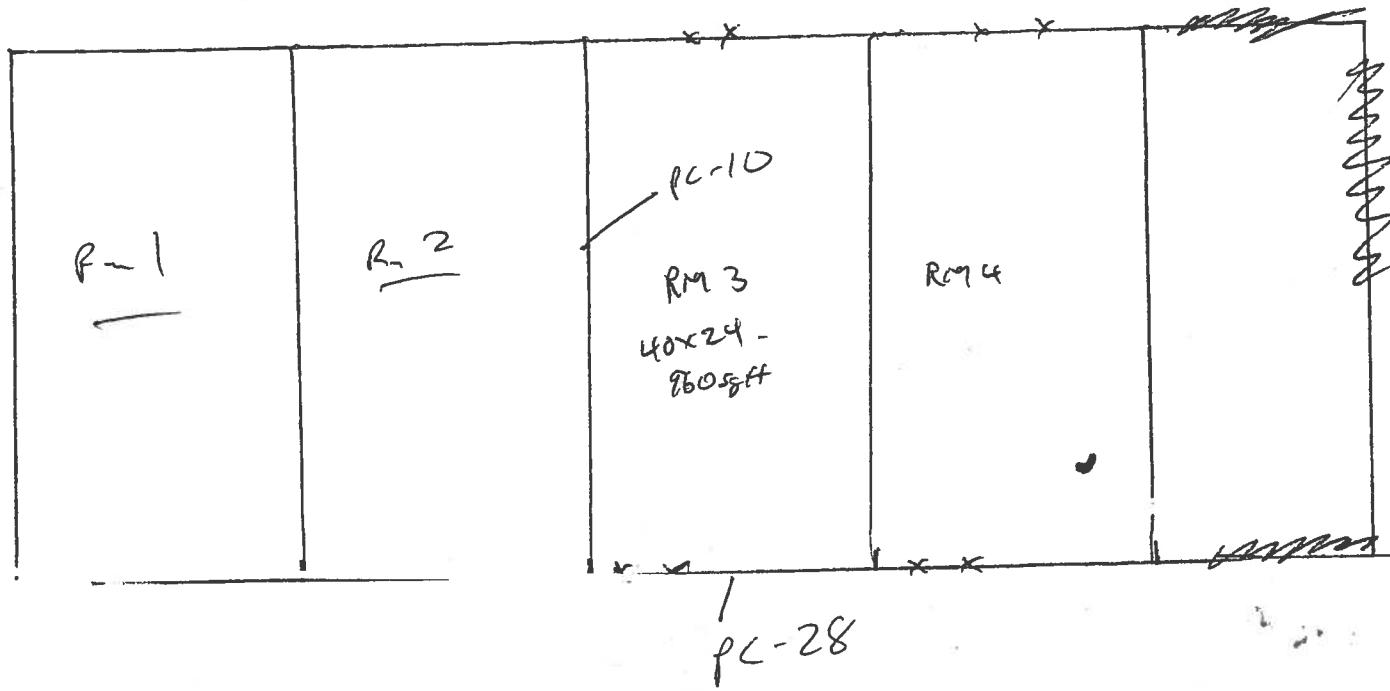
RM 3
 27 ~~28~~ 12x12
 690 sq ft Dark grey carpet
 65 ~~60~~ place ft Dark Blue cover
 65 grey cover

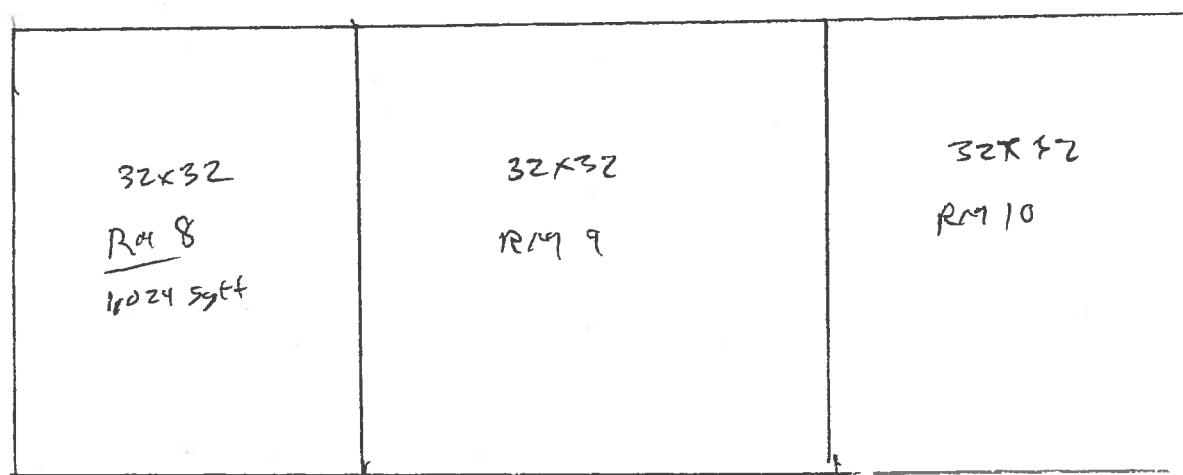
RM 8 1024 sq ft 12x12
96 linear ft of each concrete

RM 9-10 640 sq ft of Day grey carpet
90 linear ft of each carpet border

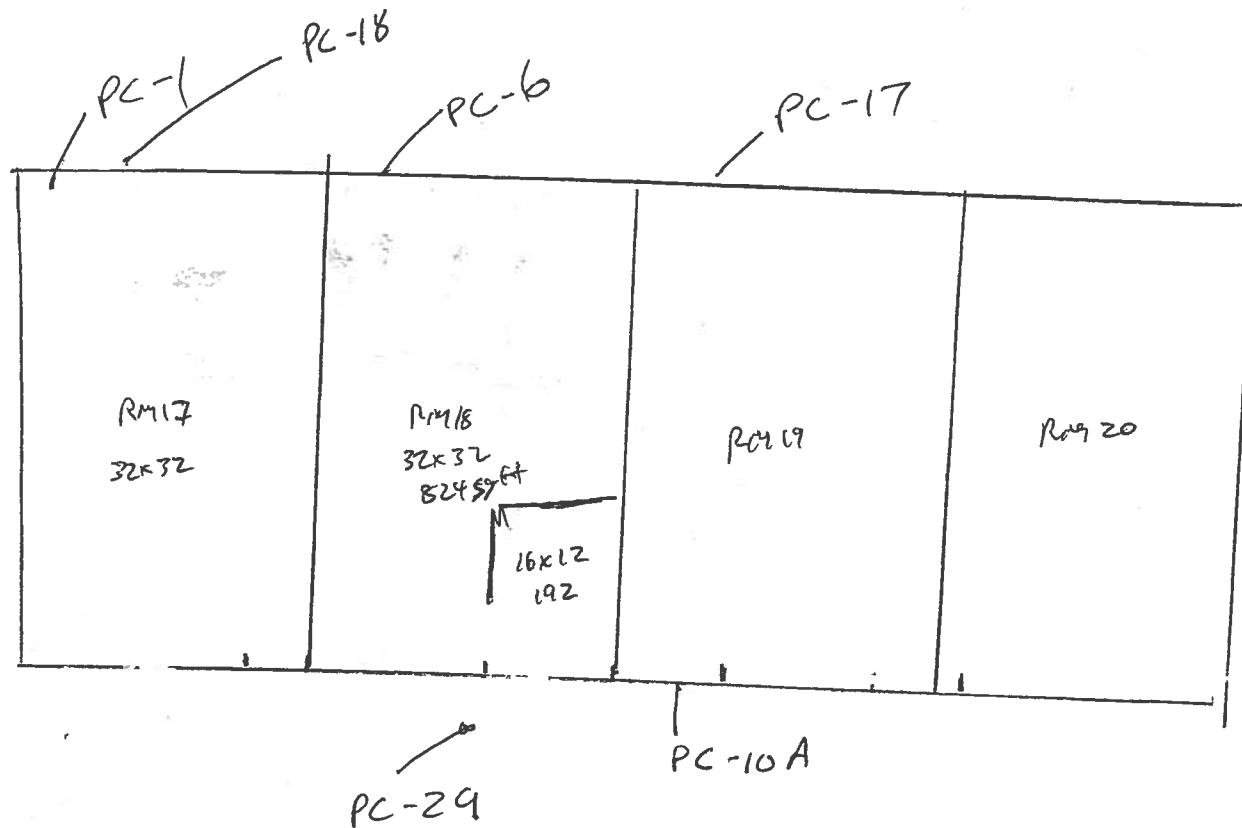
Rm 17
640 SF of Dark carpet
90 linear ft of walls

Rm 18
128114 ft Black carpet
60 linear ft grey carpet
814 ft dark Brown green carpet
192 ft of Navy Blue carpet
