LIMITED ASBESTOS AND LEAD SURVEY

Playground Project Webster Elementary School 3602 Winter Canyon Rd Malibu, California 90265

Project No.: SMSD-19-8519 Date: February 15, 2019

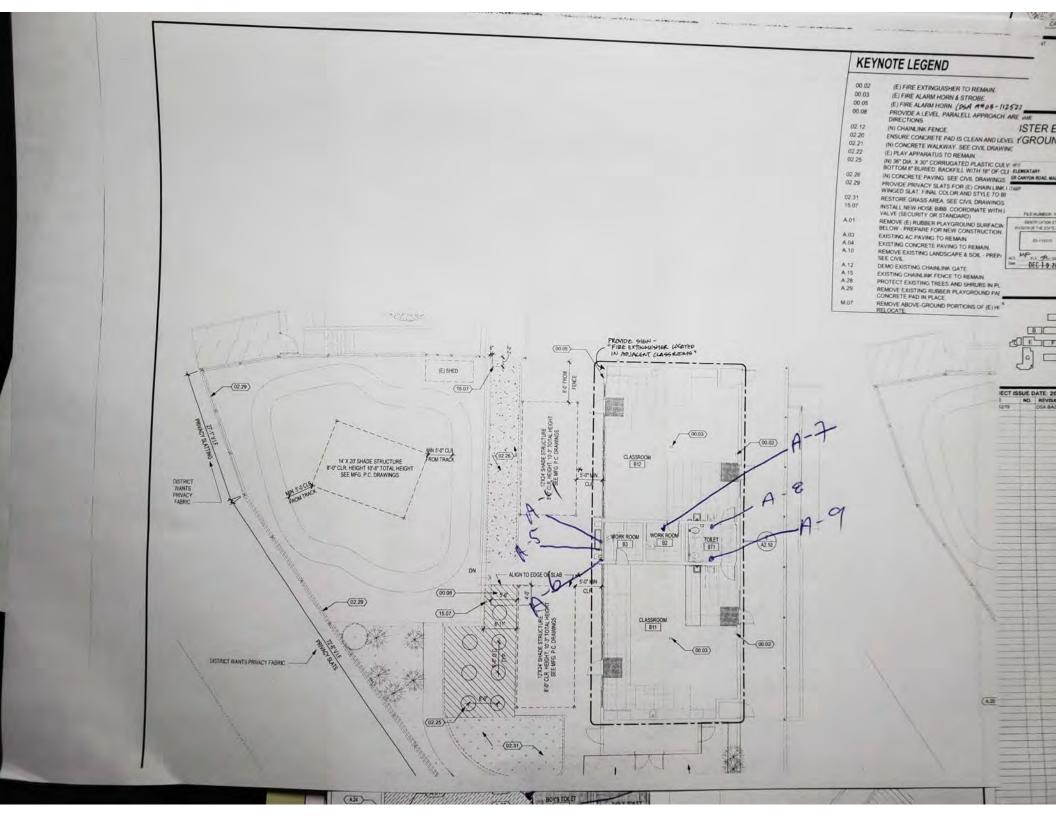
Sample Location Map: Asbestos

RE FOR NEW CONSTRUCTION, SEE CIVIL NEW COMPACTED GRANITE SURFACE EW CONSTRUCTION, SEE CIVIL EXISTING CHAIN-LINK FENCE TO REMAIN OOTS. SEE CIVIL. EXISTING ORNAMENTAL FENCE TO REMAIN DARD, PATCH & PAINT (E) WALL AS REQ'D TO MATCH EXISTING O ROOTS AND PREPARE FOR NEW WORK.

IG. CAP PIPING AS INDICATED ON PLAN: PATCH & PAINT WALL AS PING. NEW CHAIN-LINK FENCE CLASSROOM H4 (A02) (A32) KEY PLAN (A 16) INTERIOR OF BUILDING H NOT IN SCOPE (A 10) (A0A) FNI ARC
