#### BIENNIAL 2022 – PCB AIR & WIPE SAMPLING Franklin Elementary School Building B

September 13, 2022

SMSD-21-10596

- CLIENT: Santa Monica-Malibu Unified School District Facility Improvements Projects 2828 4<sup>th</sup> Street Santa Monica, California 90405
- ATTENTION: Mr. Carey Upton
- REF: Biennial 2022 PCB Sampling Report Franklin Elementary School 2400 Montana Ave Santa Monica, CA, 90403

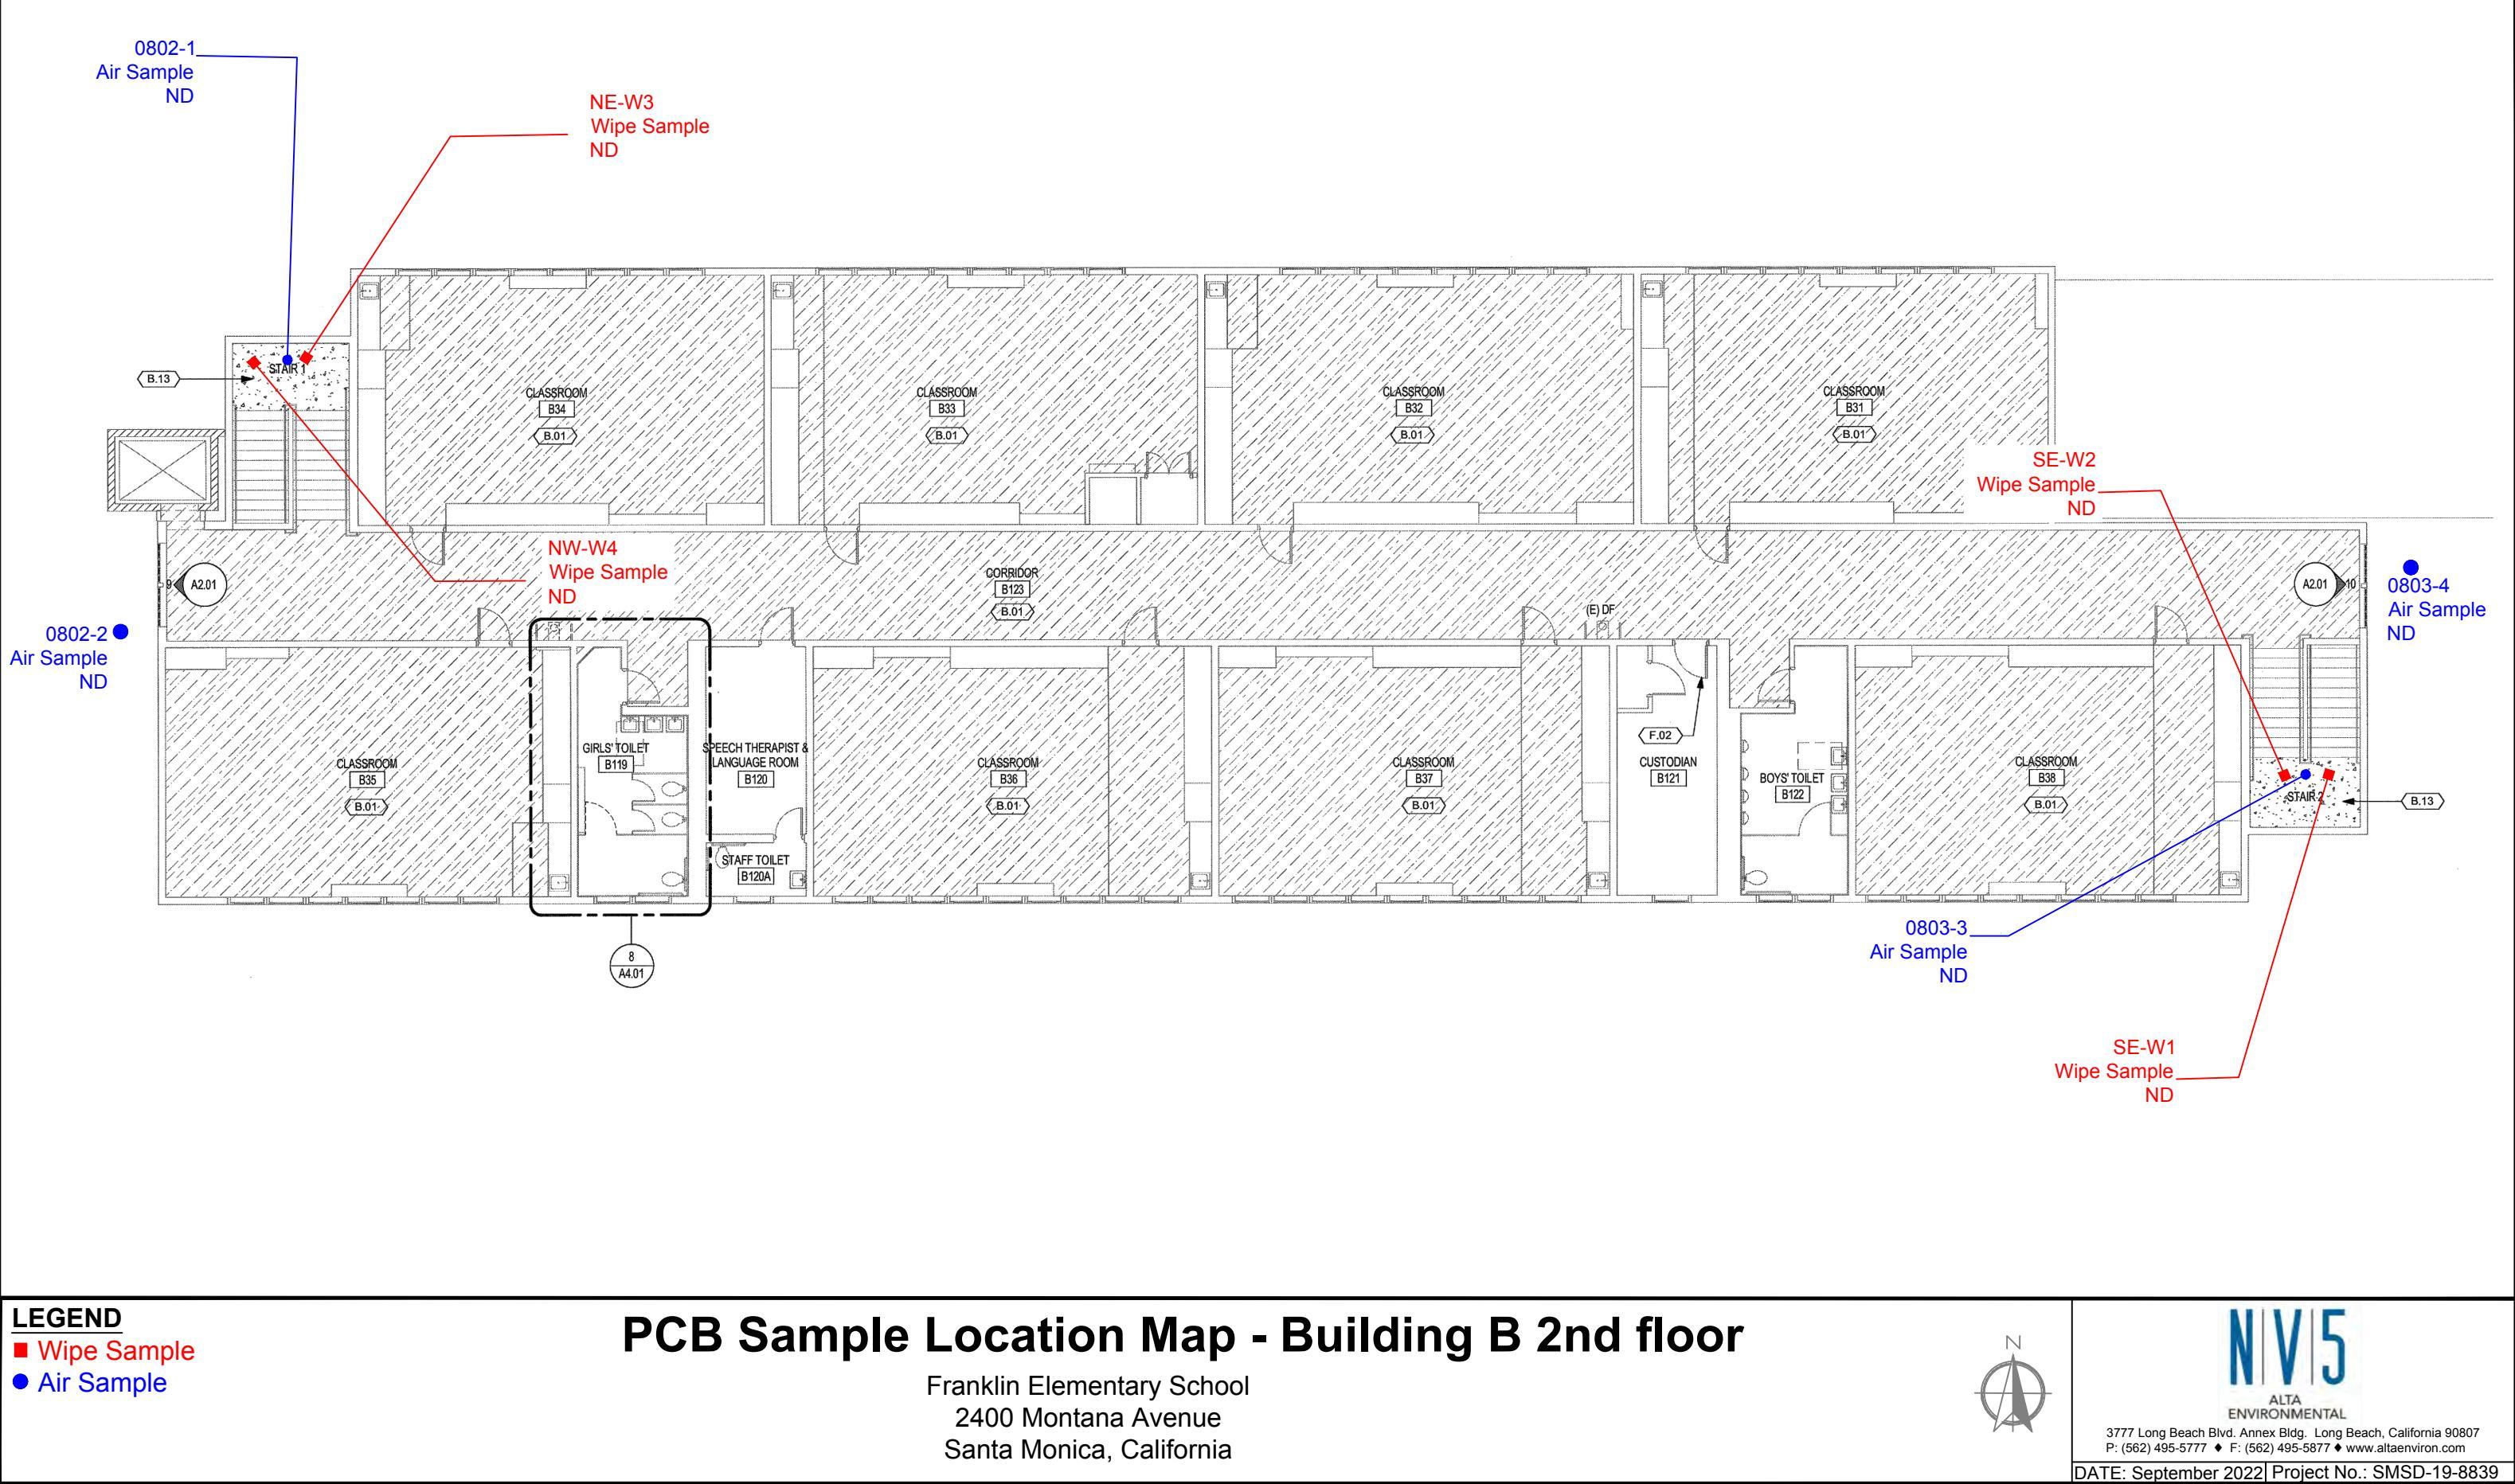
During this sampling event, NV5 conducted air and wipe sampling within the northeast and southwest stairwells of Franklin Elementary School Building B (2 locations). Figures depicting the sample locations are presented in Appendix A.
