**Santa Monica-Malibu  
Unified School District**  
John Muir - SMASH Elementary School

**Findings Report**  
**Building Envelope Investigation**

Report Date: June 30, 2022

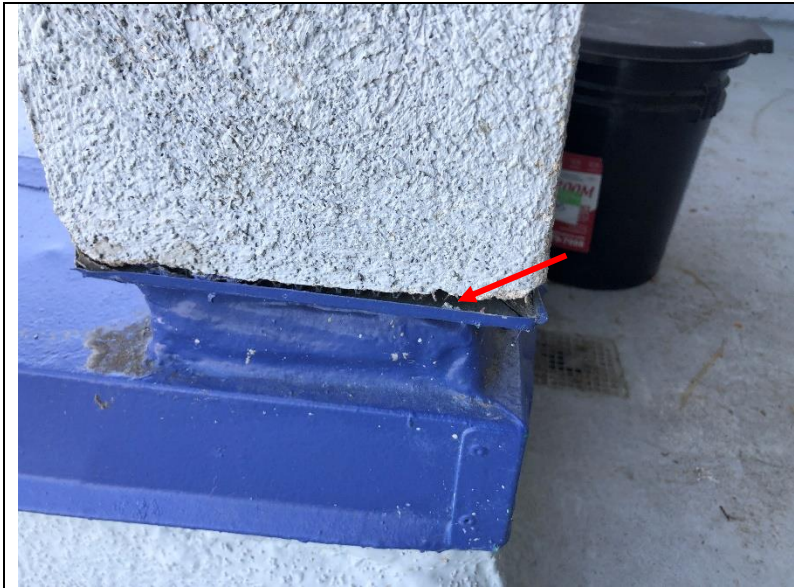
**Photo 05:**  
Abrasion and impact damage at the bottom of a plastered column.

The buildings are in heavy use by the student body and show much of the wear and tear associated with school campuses with young students. Impact and abrasion damage was present in the lower areas of the walls and was more prevalent at corners and entry points (**Photos 01 – 05**).

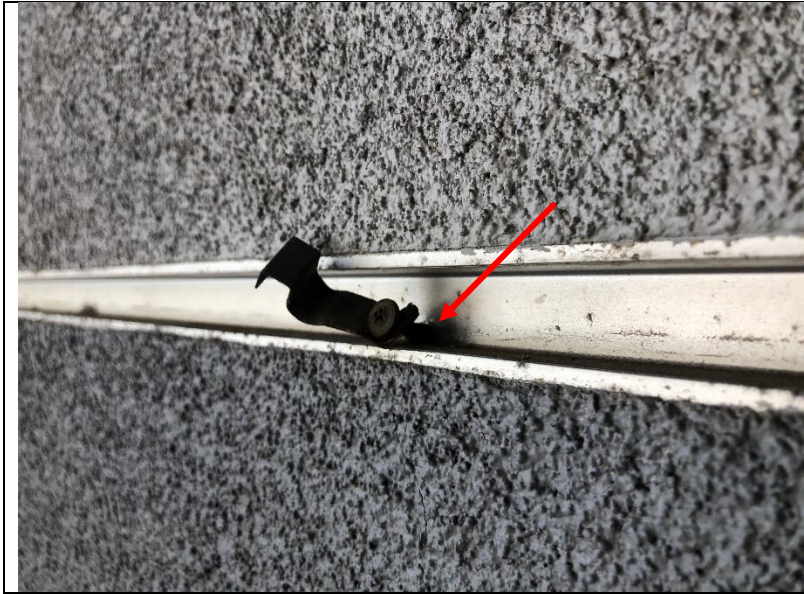
**Photo 09:**  
An un-sealed penetration in a cement plaster control joint.

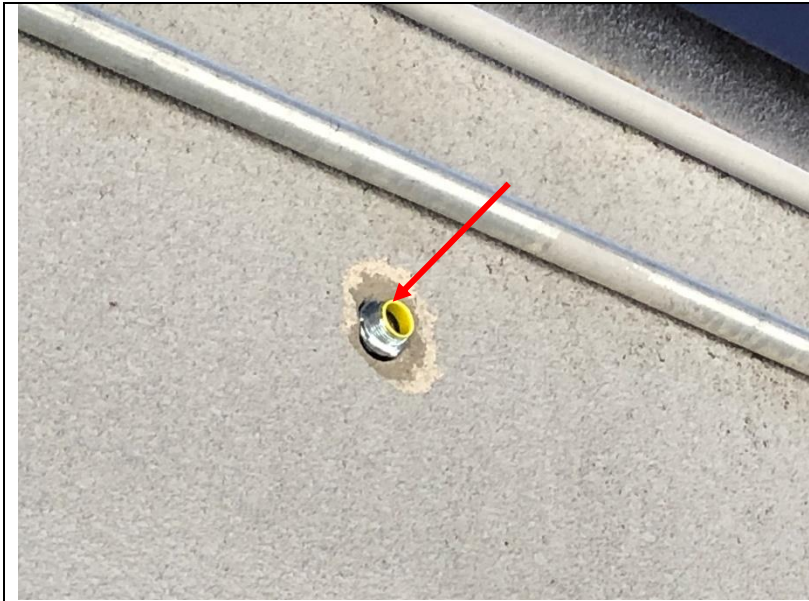
**Photo 10:**  
An open penetration in the cement plaster assembly with no visible sealant.

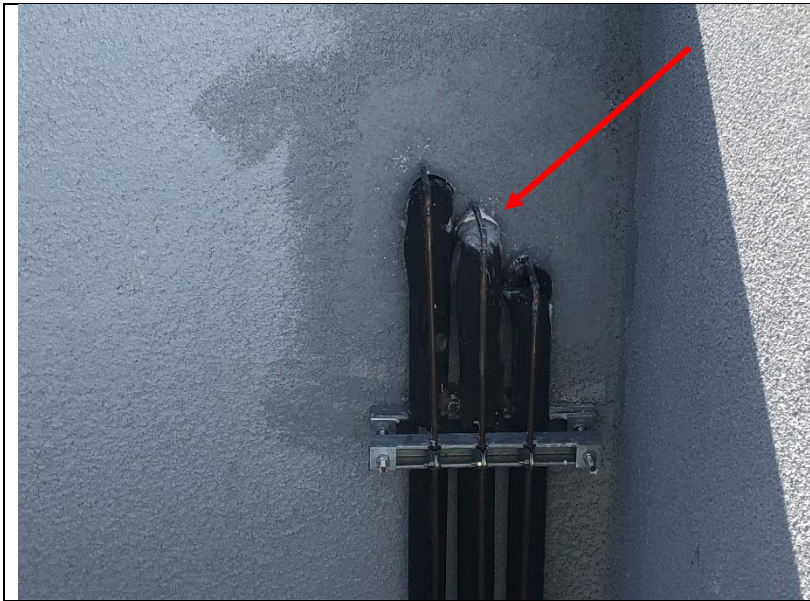
**Photo 11:**

Penetrations in the cement plaster assembly.

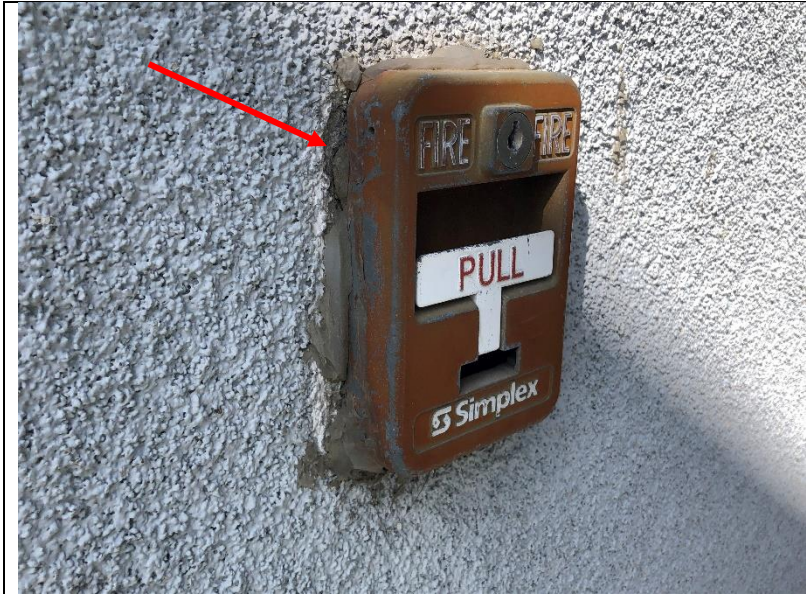
**Photo 13:**  
A fire alarm pull penetration in the cement plaster assembly with a failed sealant application.

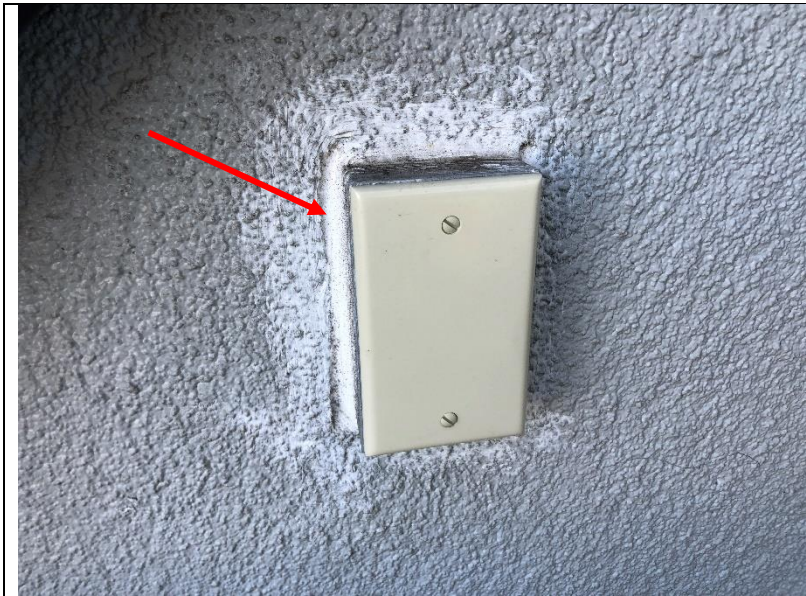
**Photo 14:**  
A penetration in the cement plaster assembly with a new sealant application.

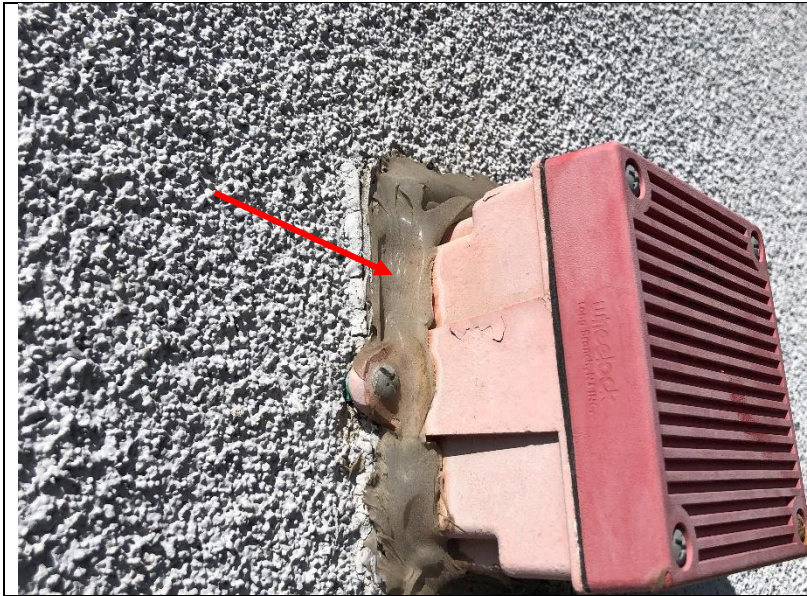
**Photo 15:**

A penetration in the cement plaster assembly with a failed sealant application.

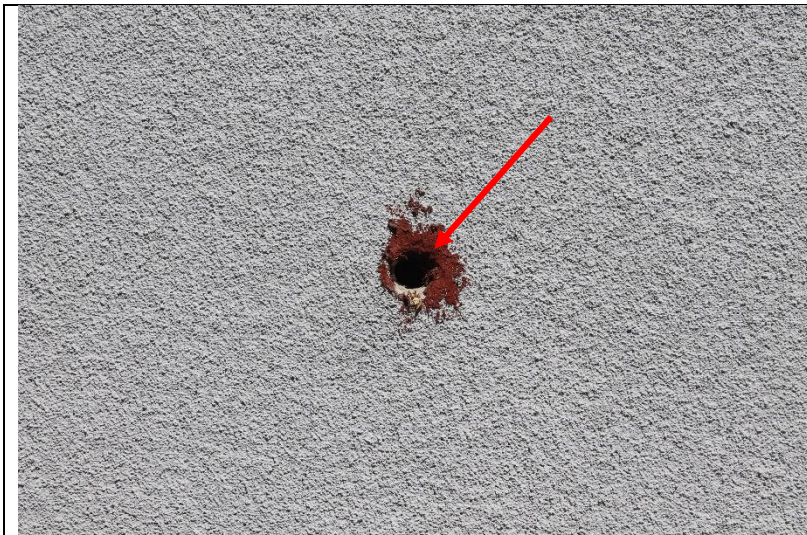
**Photo 16:**

The exterior walls have numerous penetrations including electrical conduits, canopy mounting brackets, and HVAC and plumbing pipes. Many of the penetrations were not part of the original construction. In some locations (e.g. fire pull stations) sealant had been added to the perimeter of the penetrations. It is unclear if the sealant was applied due to water leaks or to aesthetically close the openings around the penetrations. In other locations, penetrations appeared to have been abandoned and not properly sealed (**Photos 06 – 15**). Some of the penetrations in the cement plaster assembly have been made for mounting items on the walls including hook and eyelet anchors, drywall fastener attachments, and coat racks attached to the walls with screws. Some of the penetrations appear to be part of the installation of new HVAC equipment and had not been connected to any equipment at the time of DTR's observations (**Photos 16 – 24**).

An abandoned penetration in the cement plaster assembly with what appears to be fire caulk (rather than a weather sealant) applied.

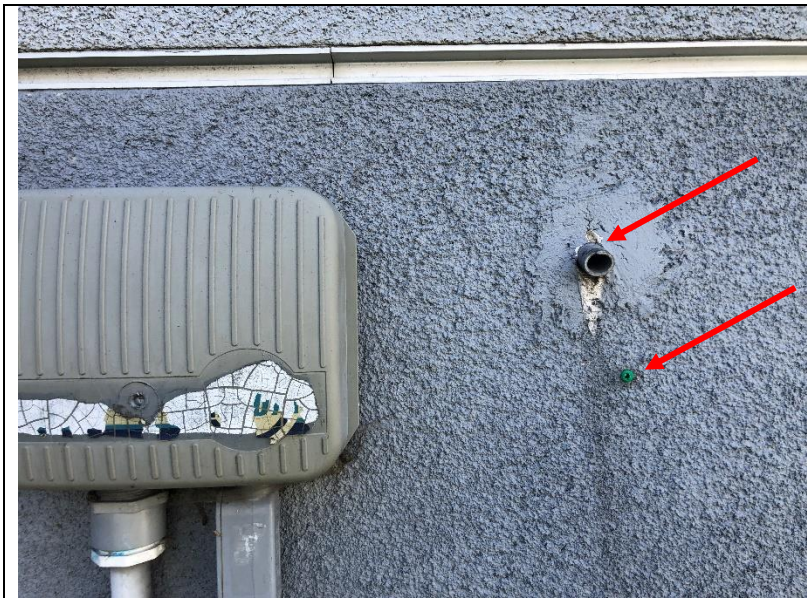
**Photo 18:**  
An abandoned penetration in the cement plaster assembly

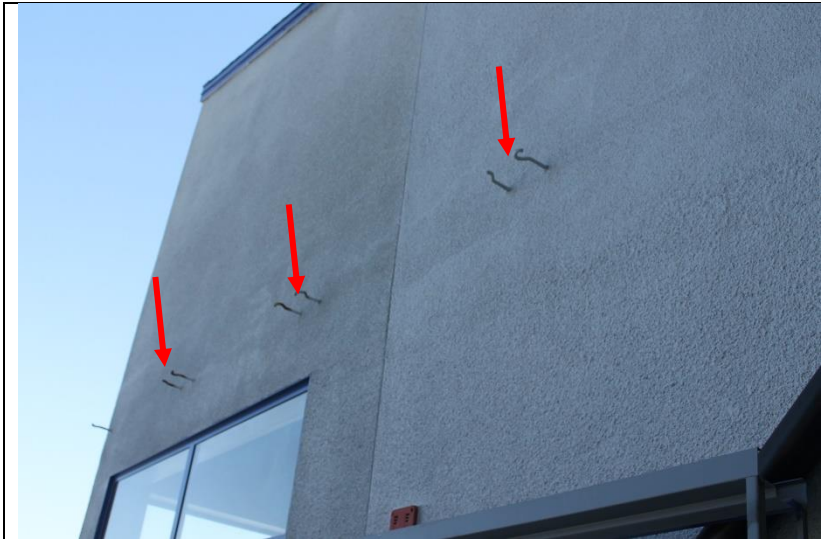
**Photo 21:**  
Hook anchor penetration in the  
cement plaster assembly

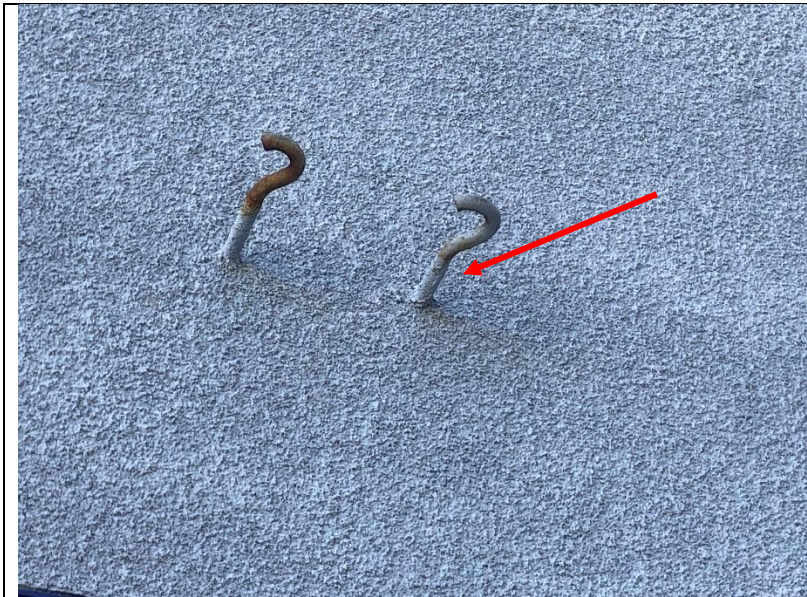
**Photo 22:**  
Hook anchor penetration in the  
cement plaster assembly

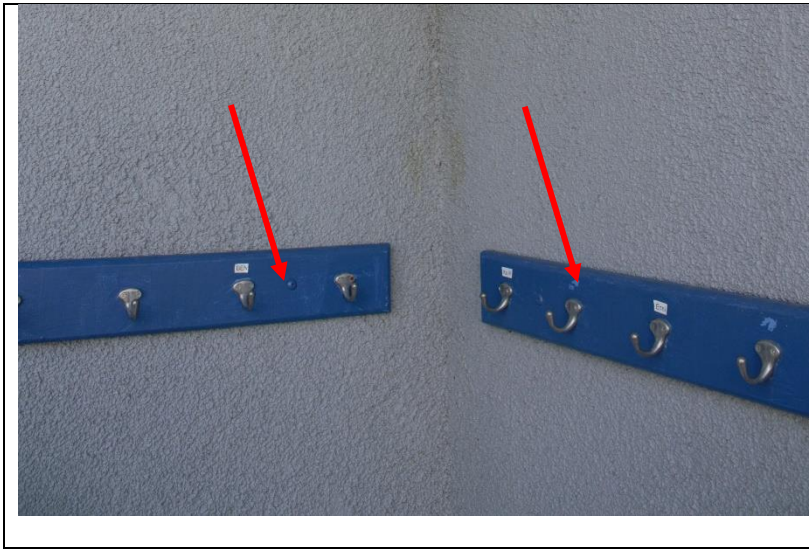
**Photo 24:**  
Coat racks were mounted to the cement plaster walls.

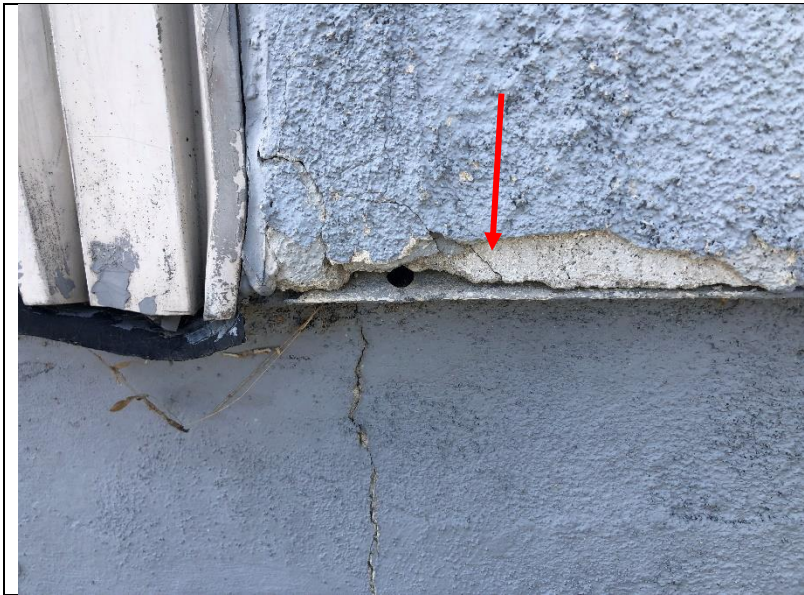
**Photo 25:**

Cracks, spalling, and chipping were observed in several locations. While deficiencies were observed on every elevation, they were more prevalent along the metal control joint trim, at the base of the walls, and at other transitions (**Photos 25 – 31**).

Deficiencies in the cement plaster were observed at the base of the walls

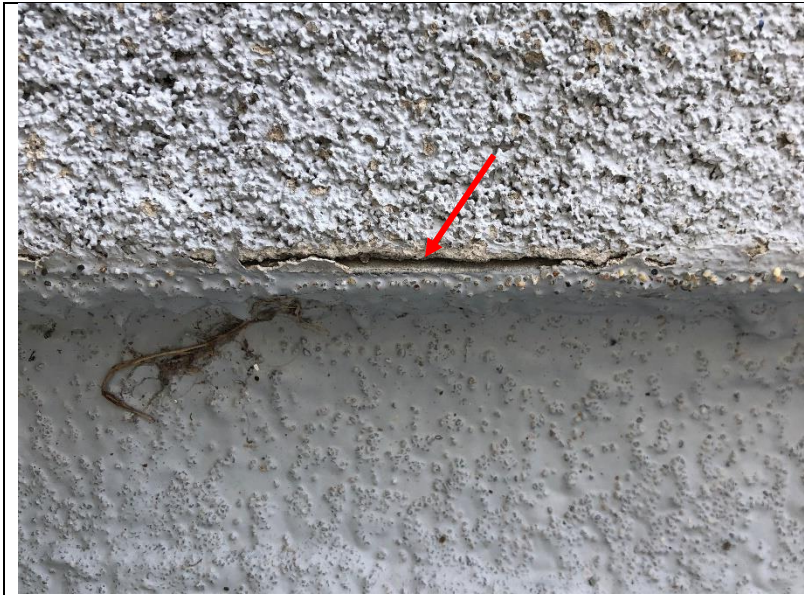
**Photo 26:**

Deficiencies in the cement plaster were observed at the base of the walls

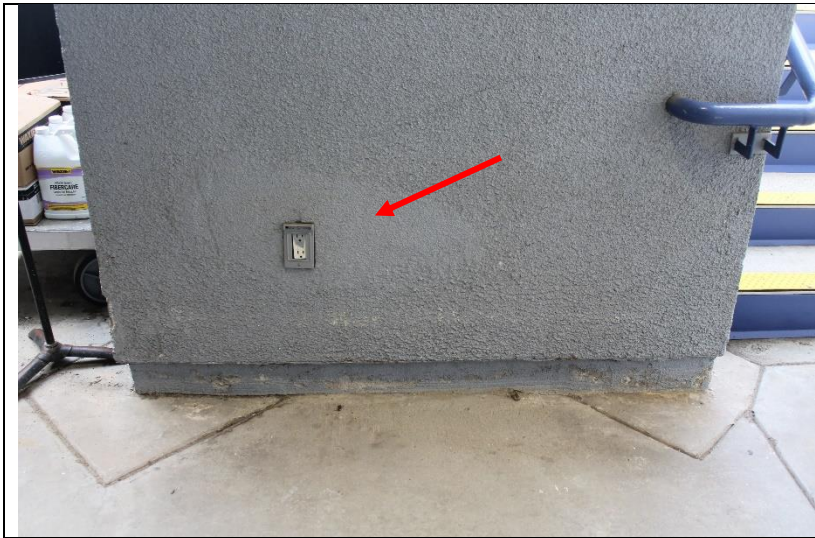
**Photo 33:**

New paint had been applied over repairs to the cement plaster

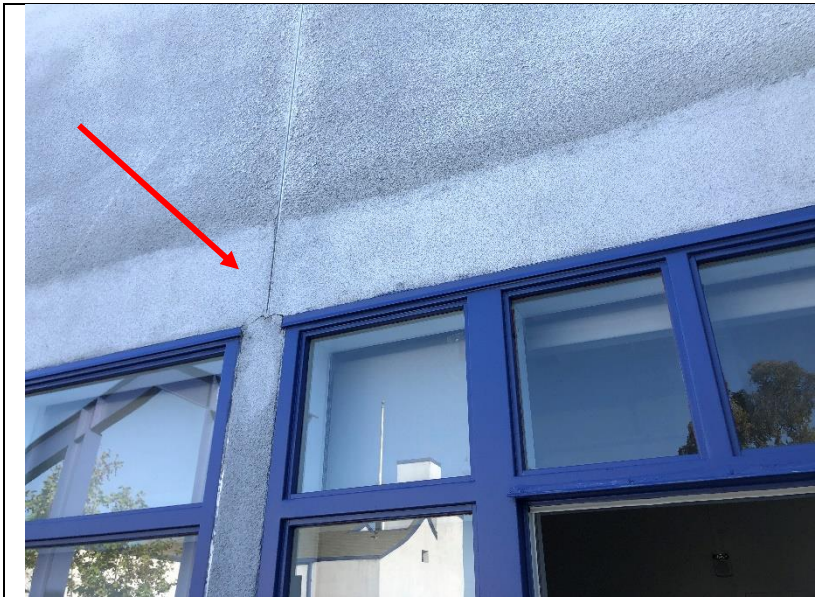
**Photo 34:**

New paint had been applied to the cement plaster above two hollow metal frame assemblies.

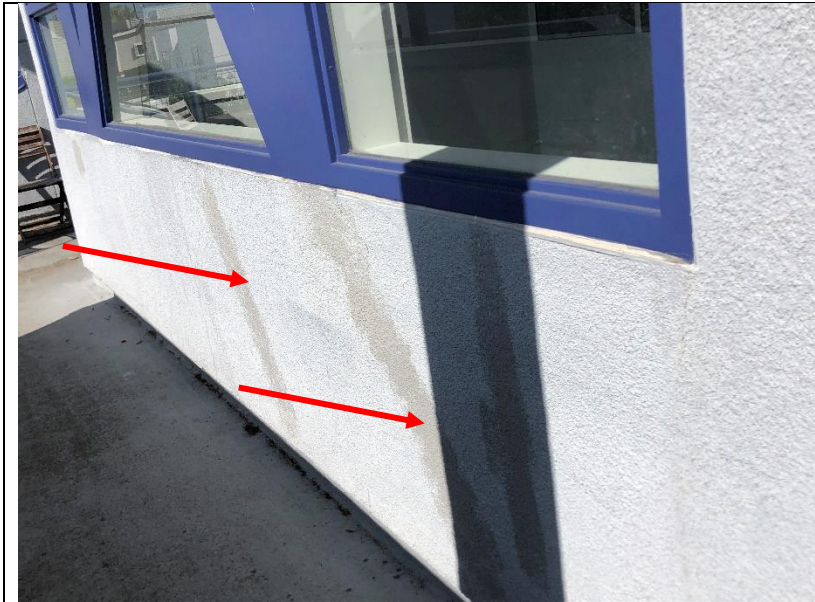
**Photo 35:**

New paint had been applied on the cement plaster.

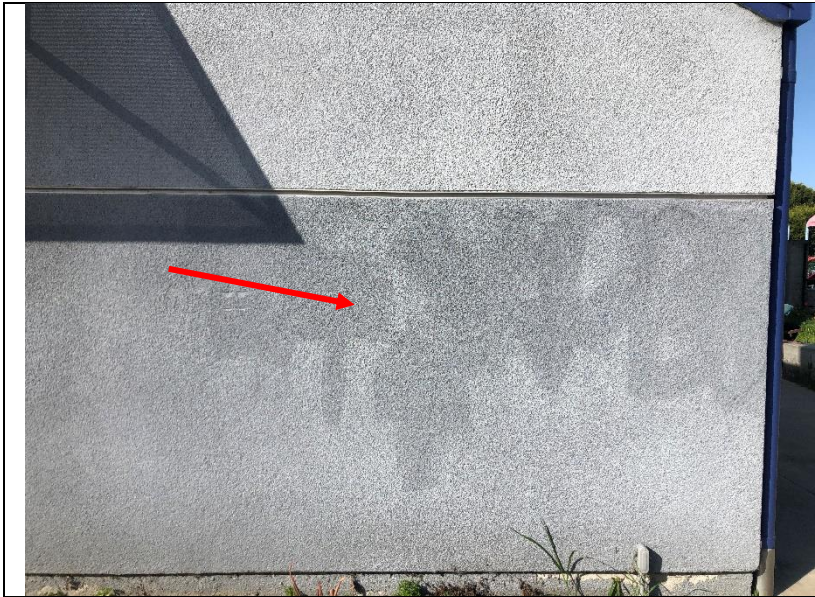
**Photo 36:**

New paint had been applied on the cement plaster.

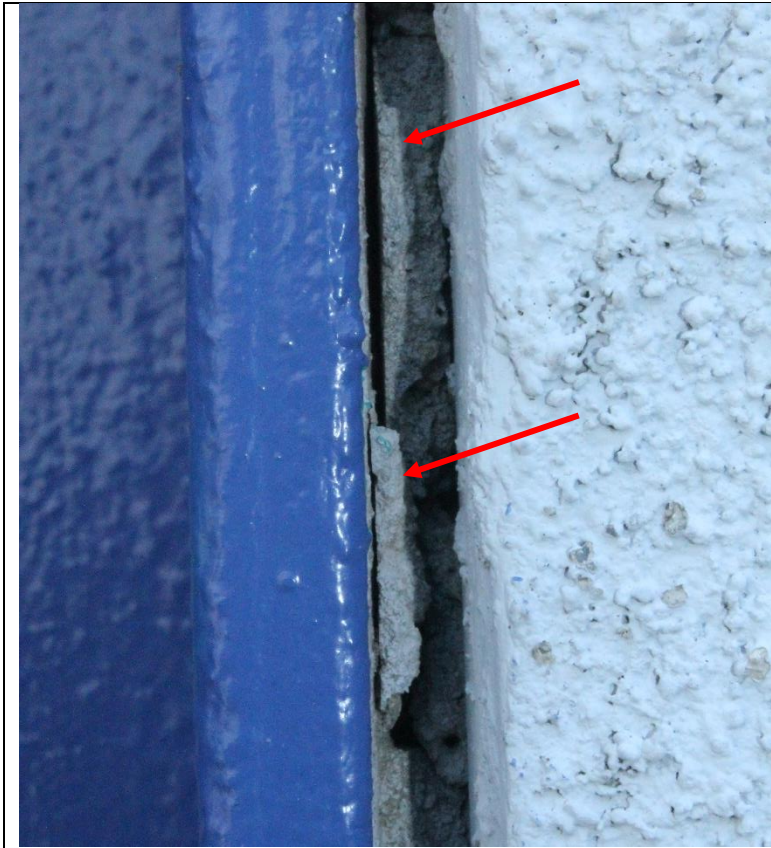
**Photo 43:**  
An un-sealed opening in the cladding system where the cement plaster assembly intersects a structural beam.

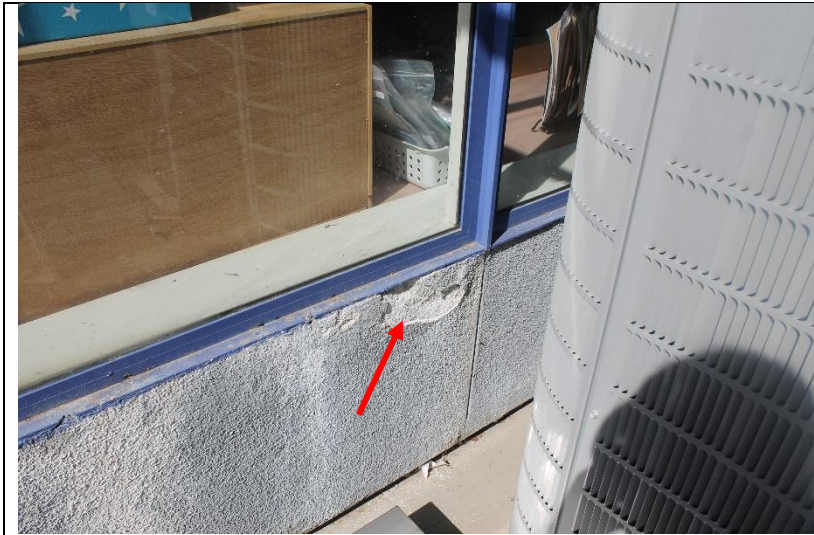
plaster below a window. Substantial surface deterioration was visible on the face of the cement plaster (**Photo 44 – 45**).

**Photo 44:**  
What appears to be salt corrosion of the cement plaster cladding under a window frame on the east side of building D.

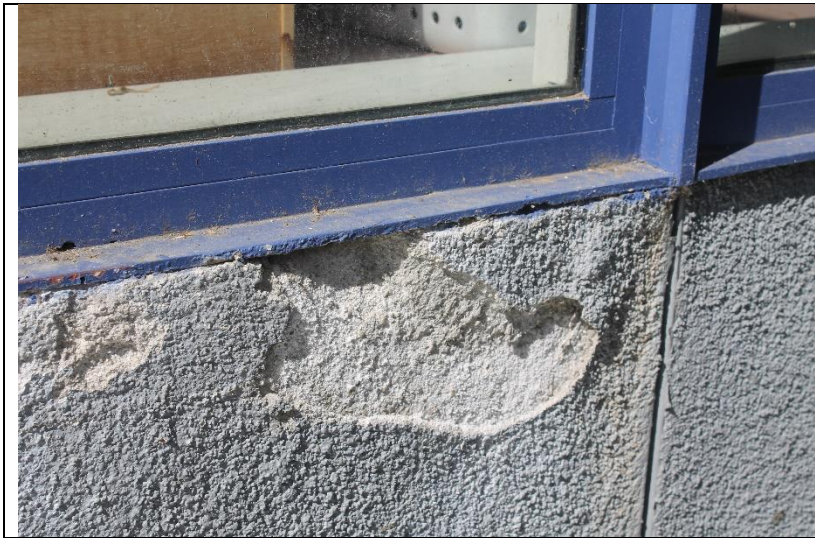
**Photo 45:**

What appears to be salt corrosion of the cement plaster cladding under a window frame on the east side of building D.

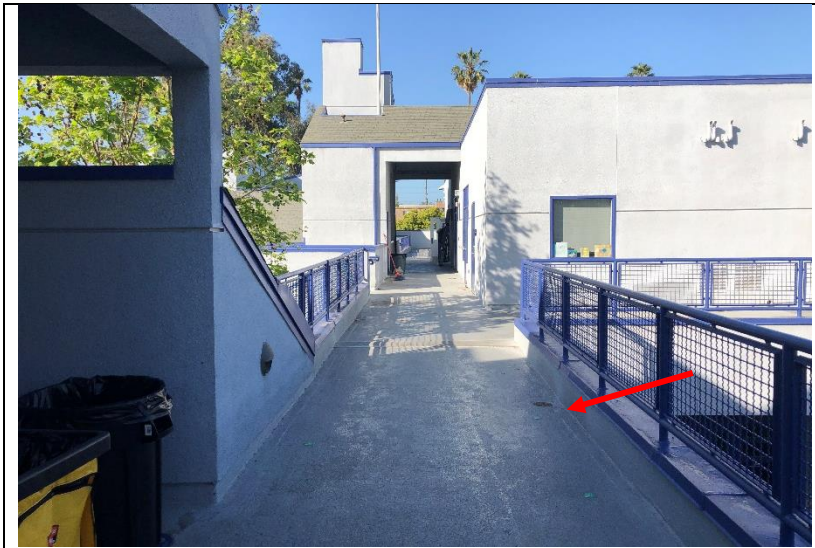
**Photo 46:**

Many of the elevated pedestrian walkways and exterior stairs were built as part of the 2001 modernization project. Approximately 5 years ago, the elevated walkways were resurfaced with a Tremco traffic coating with embedded granules. The traffic coating was flashed up onto the walls below the cement plaster. Nearly all of the plaster system base of wall drainage system weep screeds were blocked or obstructed by the coating directing water behind the traffic coating upturn and into the wall system (**Photos 46 – 49**).

Overview of the traffic coating on an elevated walkway.

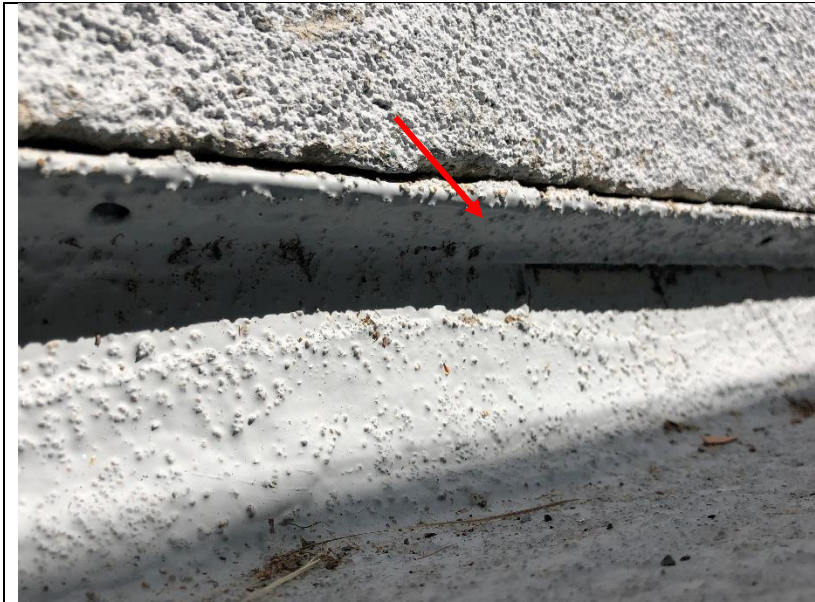
**Photo 47:**

The traffic coating lapped up onto the weep screed with some of the weep holes blocked.

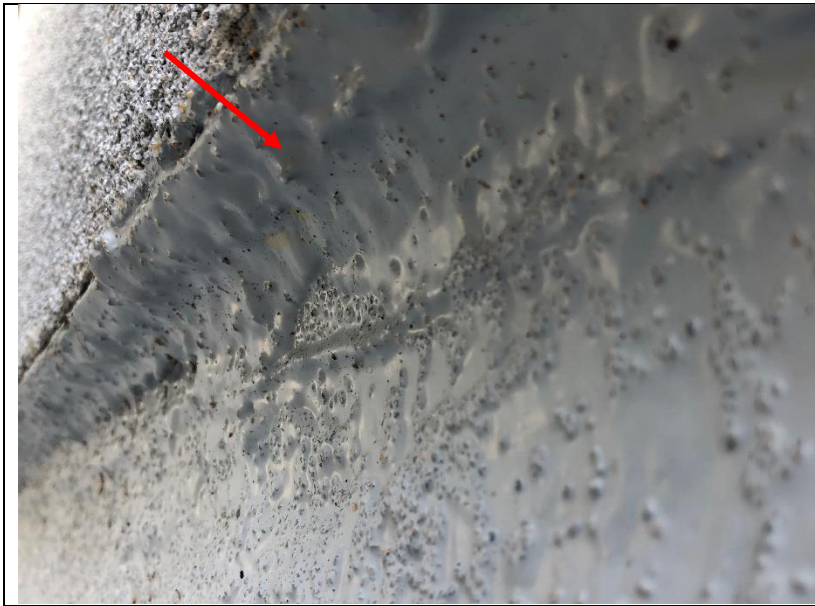
**Photo 49:**  
The traffic coating lapped up onto the weep screed. No weep holes were visible at this location.

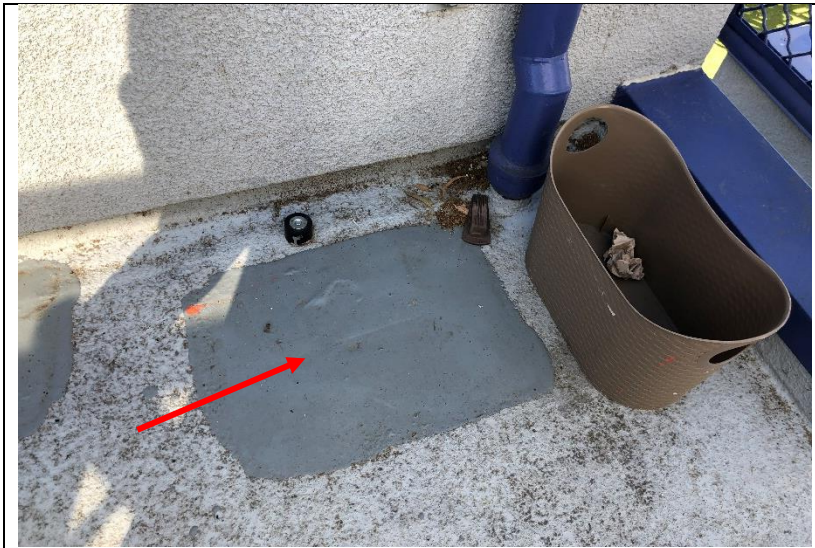
In general, the traffic coating is well adhered to the substrate and in good condition. Several patches were observed around the campus. Blistering and pinholes were observed at several of the traffic coating patches (**Photos 50 – 52**).

**Photo 50:**  
A patch in the traffic coating.

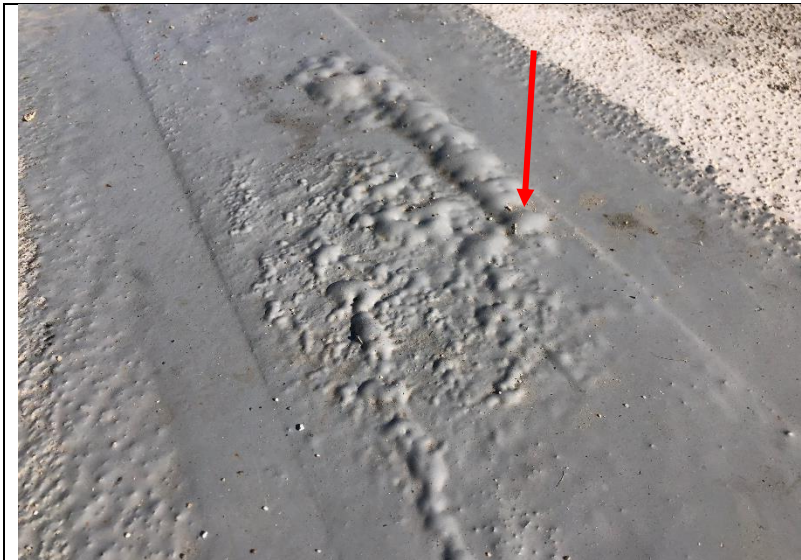
**Photo 52:**  
Blistering at a traffic coating patch indicating trapped water and/or coating failure.

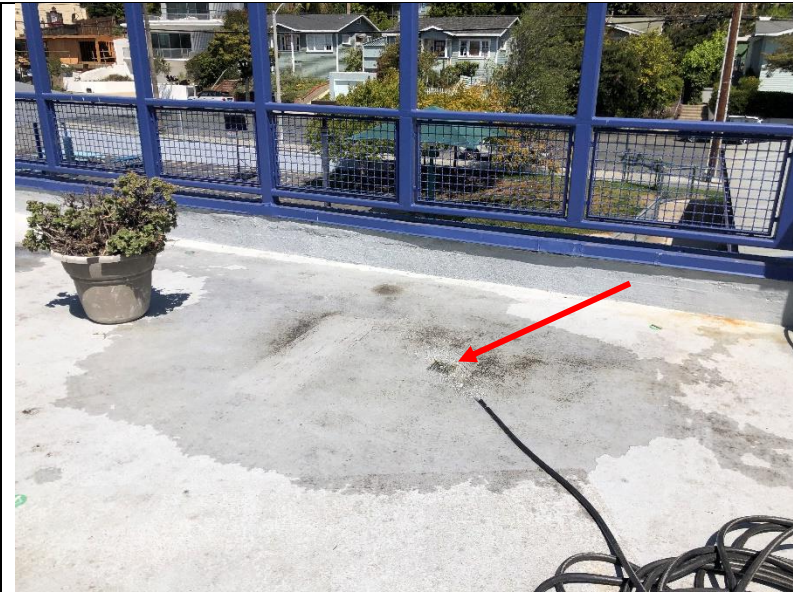
**Photo 55:**

Per request of the school district, several of the surface drains were tested outside Classroom 555, on the walkway above Communications room 205, and Kindergarten Classroom 600. Staining was observed under several of the drain assemblies but DTR was not able to recreate a leak when the drains were flooded. In some locations, it appeared that new drain assemblies and plumbing had been installed. Above Kindergarten Classroom 600 there was evidence that the drains had been relocated at some point during the life of the building. Current drains appear to have a 2" opening while the pipes under the deck are larger. Various drain covers were used in different locations, some were round and some were square (**Photos 55 – 62**).

Flood testing of a square traffic coating drain over Communications room 205.

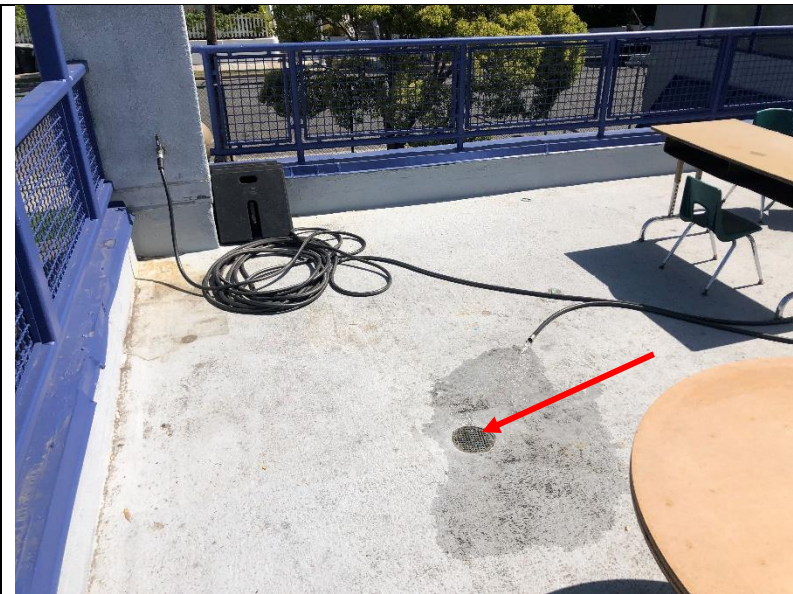
**Photo 56:**

Flood testing at a drain outside of classroom 555.

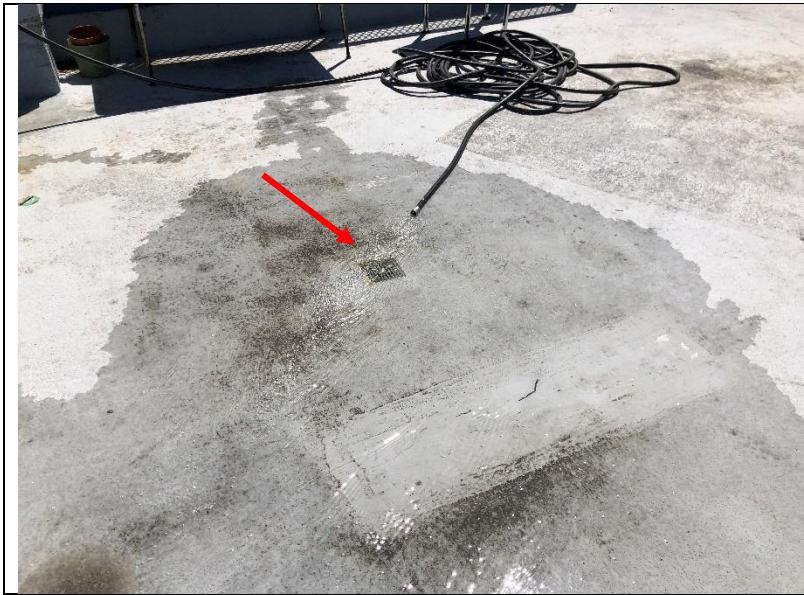
**Photo 57:**  
Flood testing outside classroom 555.

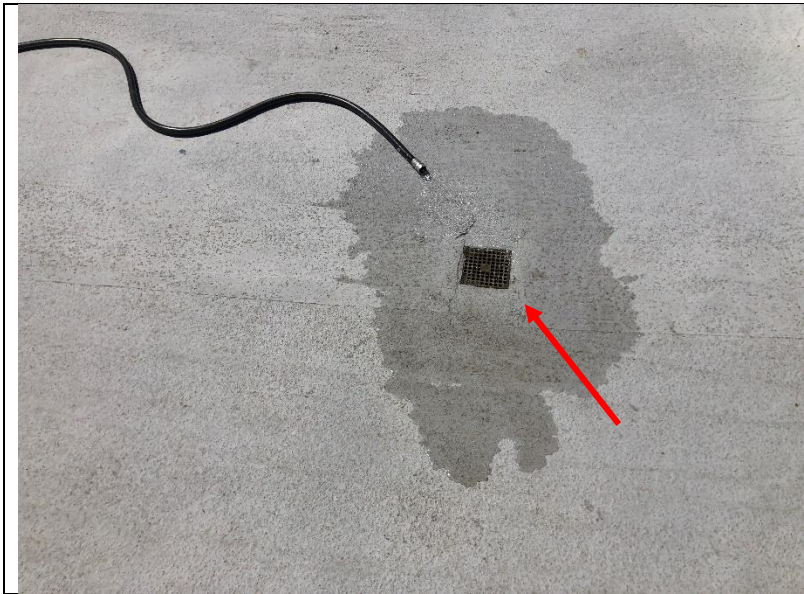
**Photo 58:**  
Flood testing a drain on the elevated walkway.

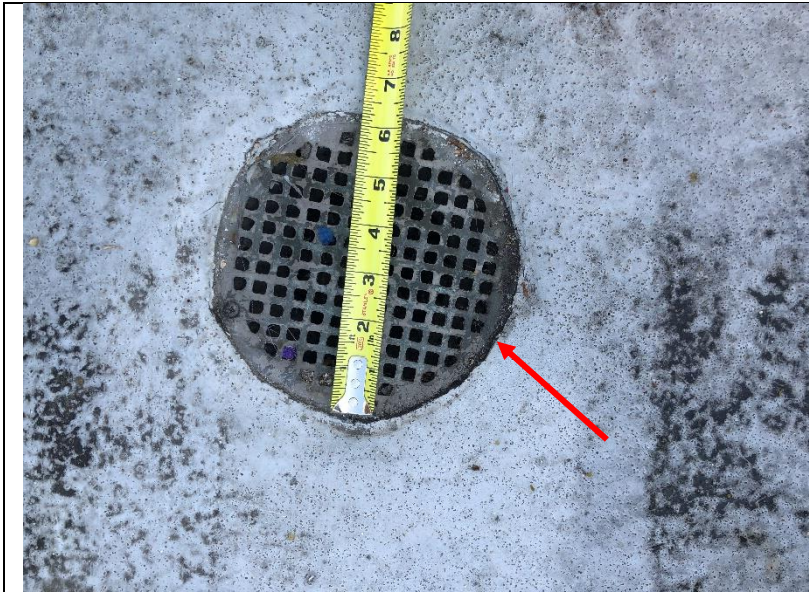
**Photo 59:**  
A 6-inch round drain cover over a 2-inch pipe.

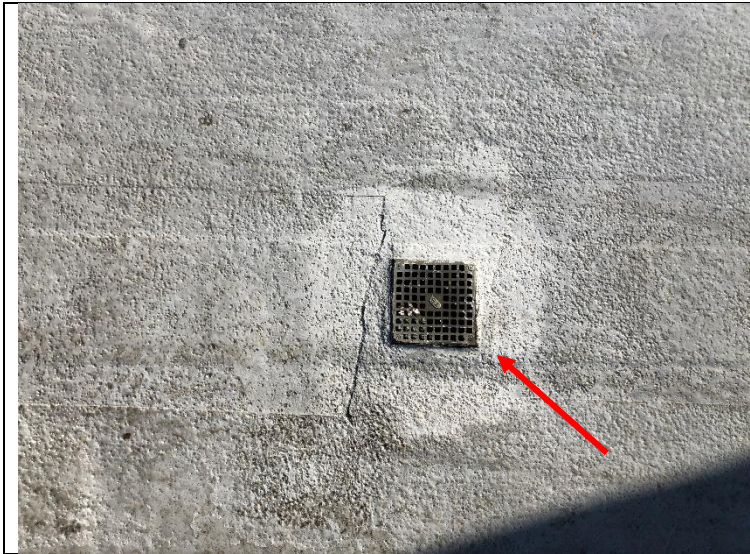
**Photo 60:**  
A square drain cover over a 2-inch pipe.

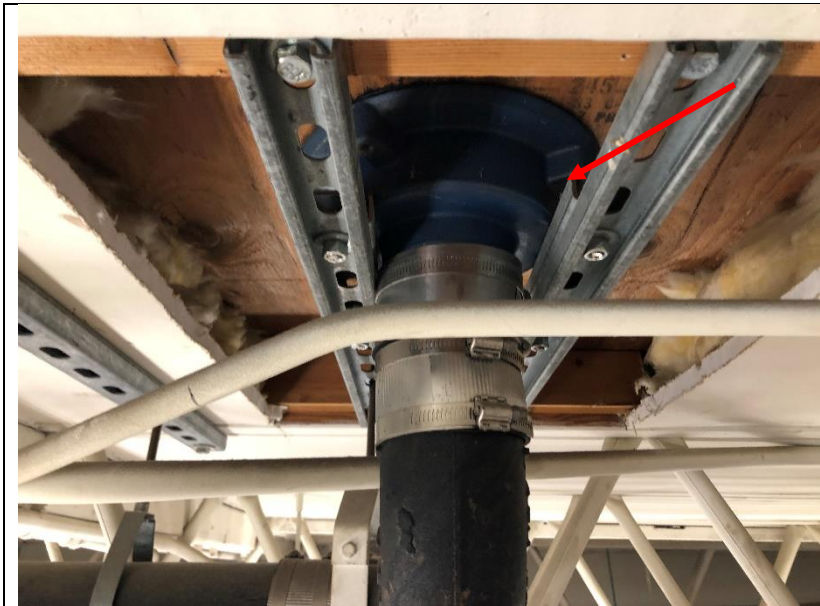
**Photo 62:**  
A drain assembly was attached to the bottom of the deck with uni-strut. No anchor bolts were holding the assembly to the deck.

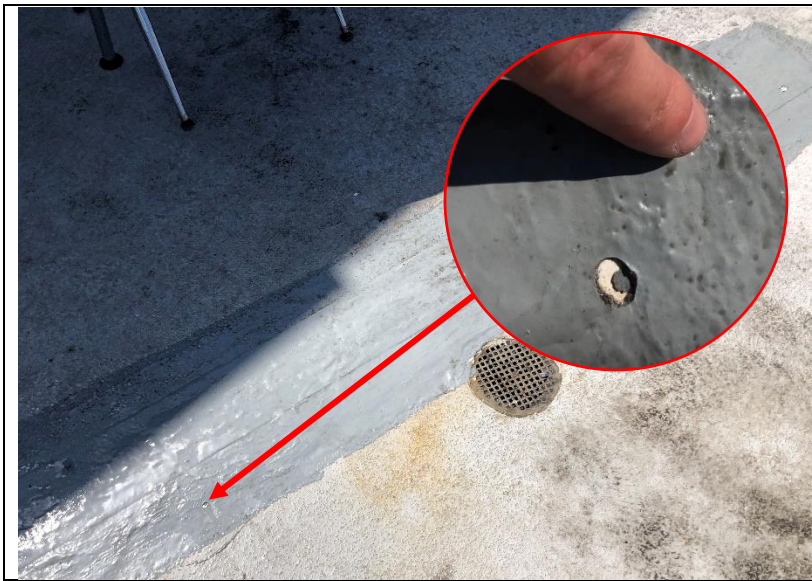
During the flood testing, one of the traffic coating patches outside classroom 555 became saturated. DTR observed that a deficient location on the surface of the patch was allowing water to enter under the waterproofing. No water was observed inside the building during the test (**Photos 63 – 64**).

**Photo 63:**  
A failure in a traffic coating patch adjacent to a drain test.

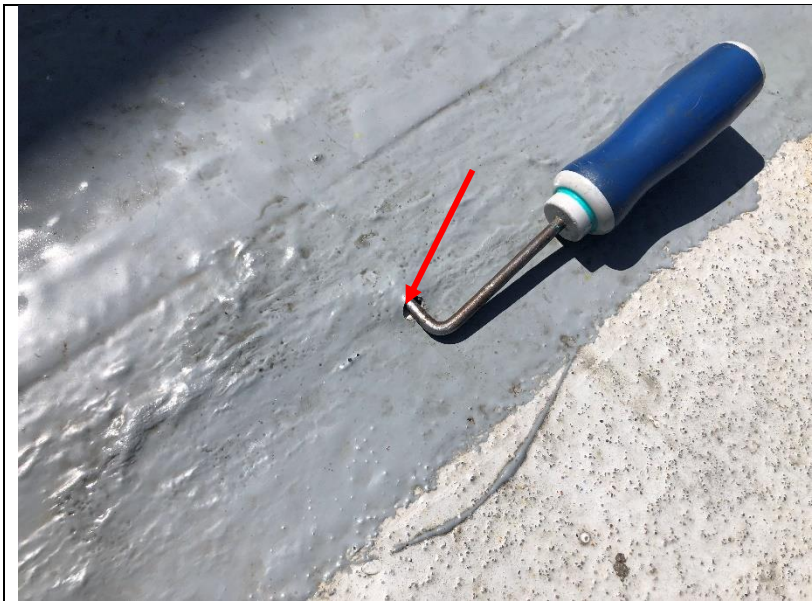
**Photo 64:**  
A failure in a traffic coating patch adjacent to a drain test.

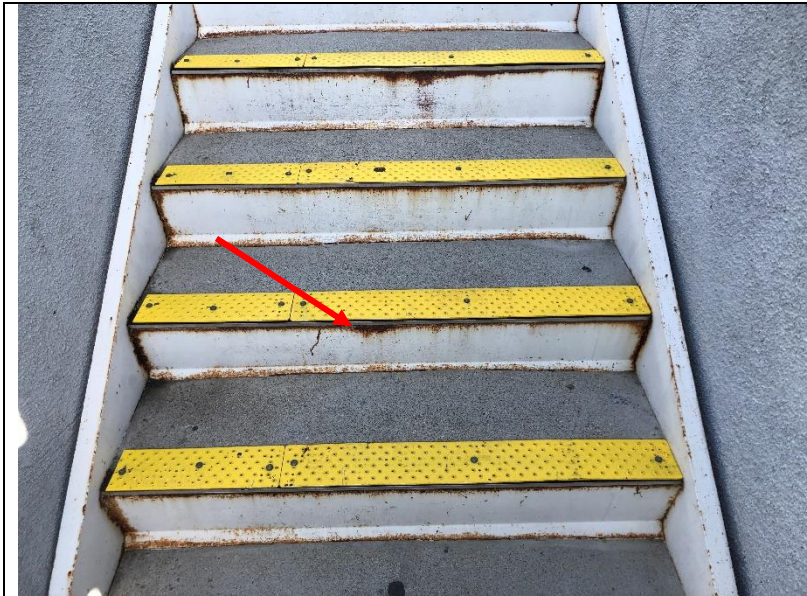
**Photo 65:**

Steel-framed stairs were located at various locations around the campus. At several locations, corrosion was observed at the metal stair treads and risers. A crew was painting various stairs and trim during the investigation. DTR did not observe any surface preparation taking place before the areas were painted. Corrosion damage was still visible in some locations after the new paint had been applied (**Photos 65 – 68**).

Corrosion was observed at the stairs prior to repainting.

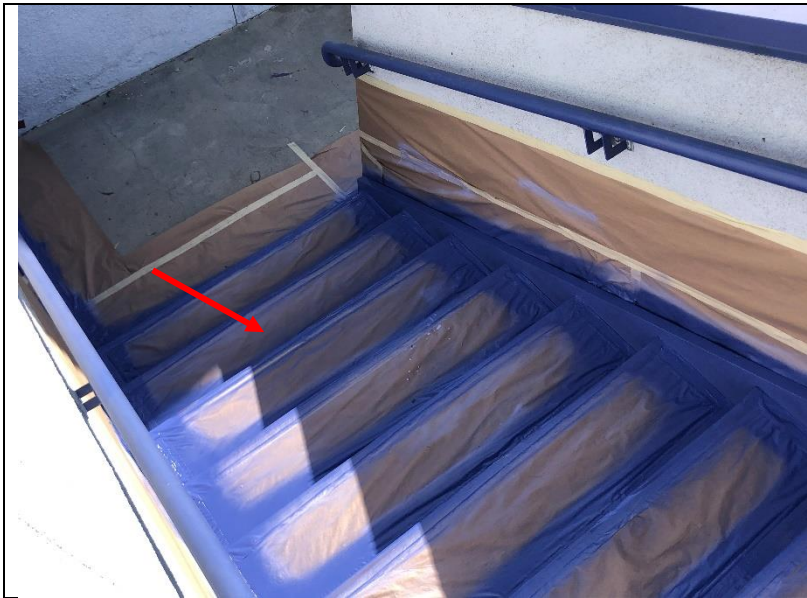
**Photo 67:**  
The stairs were masked off during painting.

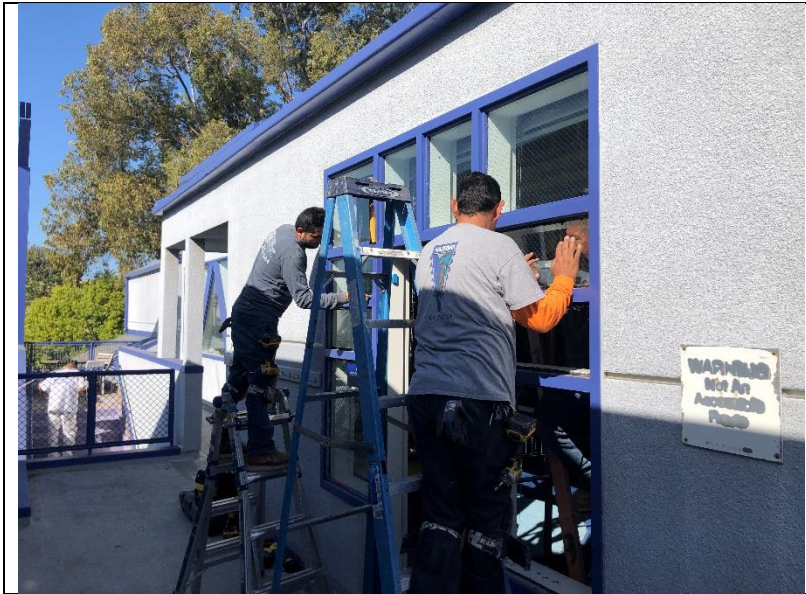
**Photo 69:**

The hollow metal frame was being removed at Classroom 480.

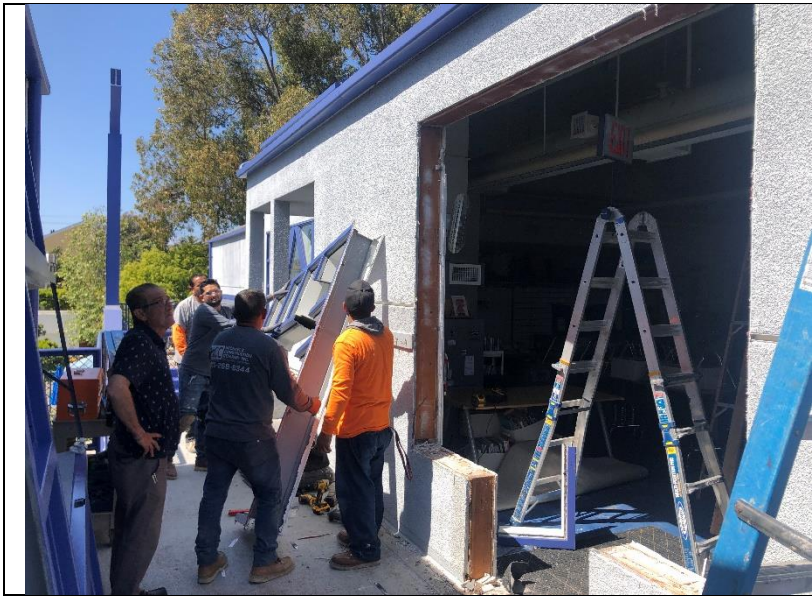
**Photo 70:**

The hollow metal frame after it was fully removed at classroom 480.

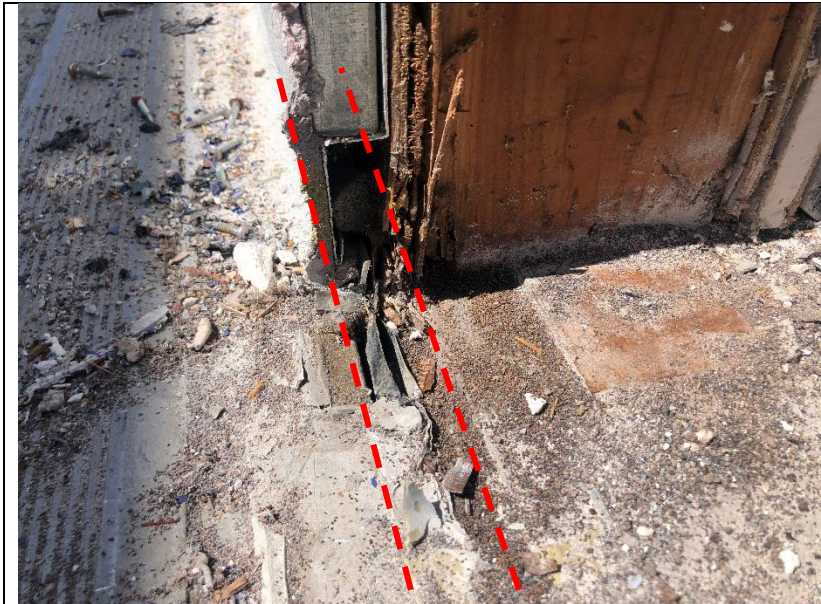
**Photo 71:**

The neoprene water stop at the expansion joint drainage was level with the interior of the cement plaster assembly.

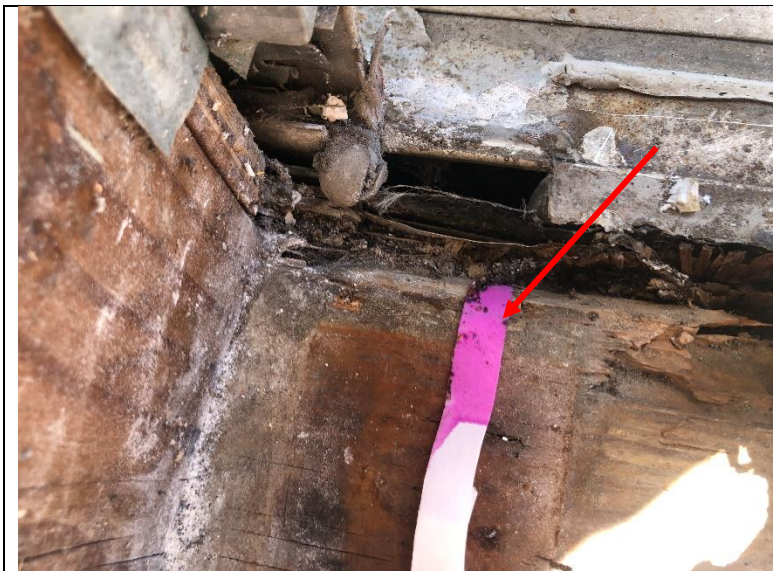
As each hollow metal frame was removed, DTR was able to observe the wall assemblies as well as the threshold transition to the traffic coating. At the threshold of classroom 480, an expansion joint ran parallel to the door. The expansion joint was meant to allow the elevated walkway to move separately from the building. A sufficient slope to drain was not achieved and standing water was observed in the neoprene water stop at the expansion joint. The neoprene water stop was installed at the same plane as the cement plaster which does not conform to the 2001 drawing set for the construction of the elevated walkways (**Photos 69 – 72 and Fig 02**). The exposed edge of the exterior plywood wall sheathing was damp to the touch. Moisture readings along the wood door sill framing ranged from 20.1 to 30.6 % moisture. These readings are high enough to result in wood damage. Dry rot and what appeared to be insect damage were also observed along the sill. Water damage was also observed at the upturn of the jambs (**Photos 73 - 79**).

**Photo 74:**  
A water activation strip shows a positive result for water at the deck to wall expansion joint at the threshold of classroom 480.

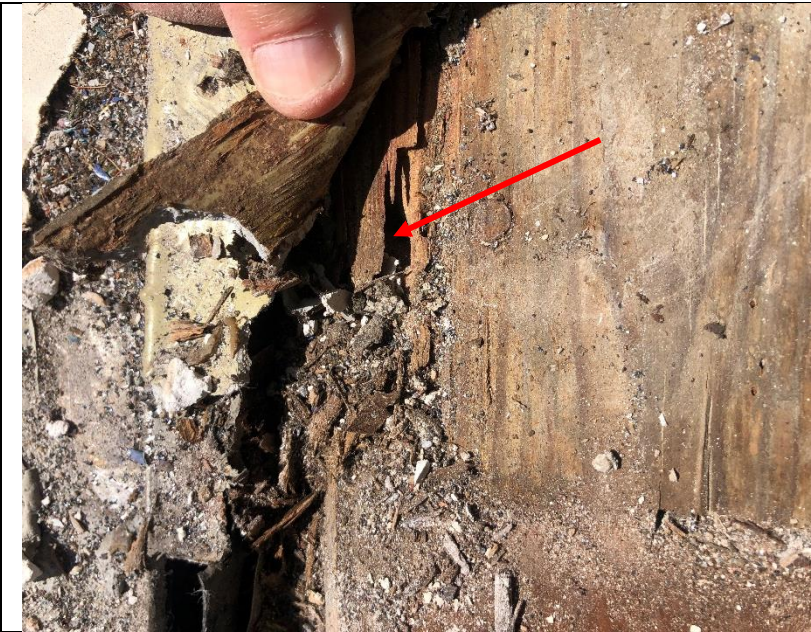
**Photo 79:**  
Dry rot, water damage, and suspected insect damage at the threshold of classroom 480
